Phase I Environmental Site Assessment

PHASE I ENVIRONMENTAL SITE ASSESSMENT
OF
Fairfield Inn & Suites LA LAX/ El Segundo & Aloft El Segundo - LA Airport
475, 525, 545 & 629 North Sepulveda Boulevard
El Segundo, California 90049

June 14, 2017

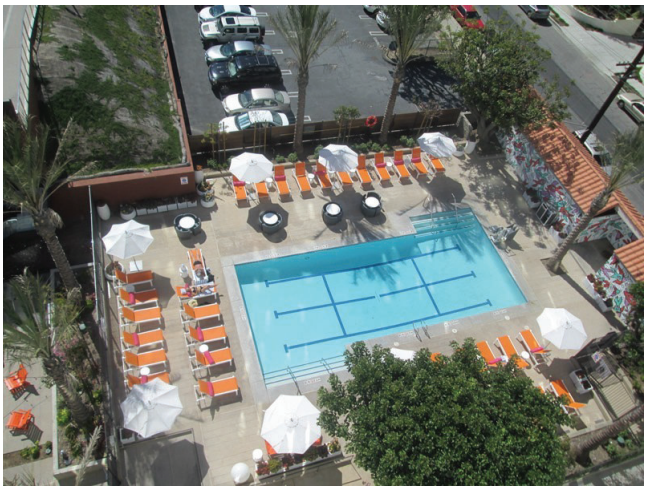
Pool area overview

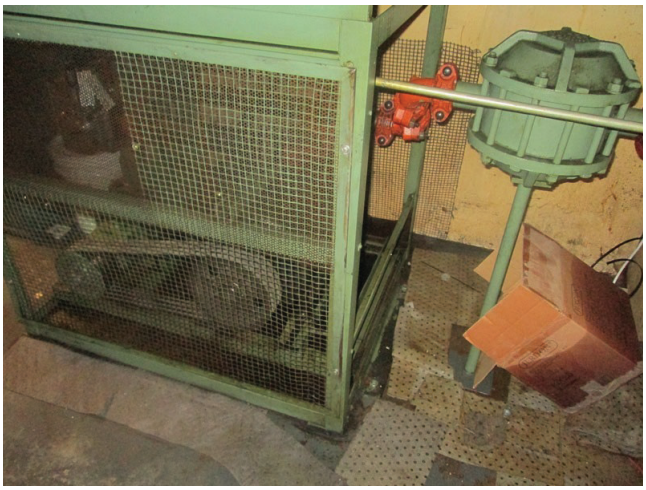
The hydraulic elevator located in the Food & Beverage building was observed to have staining and absorbent materials around the equipment during the site reconnaissance. The staining appeared to be de minimis as it appeared to be limited to the concrete surface in the area surrounding the equipment. No significant cracks were observed in the stained area. Furthermore, based on the reported date of modernization (2005) the hydraulic elevator equipment is unlikely to contain PCBs.

HYDRAULIC ELEVATORS	
Number of Elevators:	6 Hydraulic and 3 Traction Elevators
Owner:	Property
Age:	Reported to have been modernized after 1979
PCB Status:	Unlikely to be PCB-contaminated based on the apparent age of the equipment.
Spills or Leaks Observed:	Yes
Conclusion:	The hydraulic elevator equipment located in the Food & Beverage building was observed to have de minimis staining and absorbent materials around the equipment during the site reconnaissance. The staining appeared to be limited to the concrete surface in the area surrounding the equipment. No significant cracks were observed in the stained area. Furthermore, based on the reported date of modernization (2005) the hydraulic elevator equipment is unlikely to contain PCBs. Refer to Section 1.1 for further discussion.

Hydraulic elevator equipment with staining and absorbent materials in the Food and Beverage building

Hydraulic elevator equipment with staining in the Food and Beverage building

As part of property management operations, the elevator company should be contacted to repair the equipment and cleanup the staining, with any waste generated disposed of in accordance with applicable regulations.

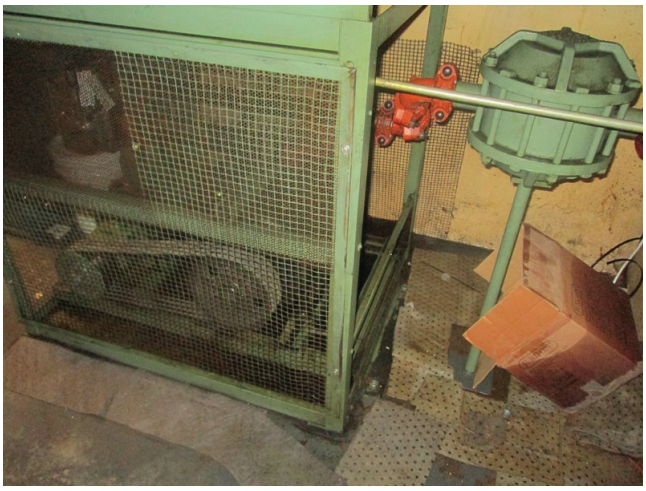
SURFACE STAINING				
LEVEL OF STAINING	ONGOING RELEASE	SURFACE MEDIA	SURFACE CONDITION	LOCATION
Moderate	Unknown	Concrete	Good	Hydraulic elevator equipment room located in the Food & Beverage building

Hydraulic elevator equipment with staining and absorbent materials in Food and Beverage building

Hydraulic elevator equipment with staining in Food and Beverage building

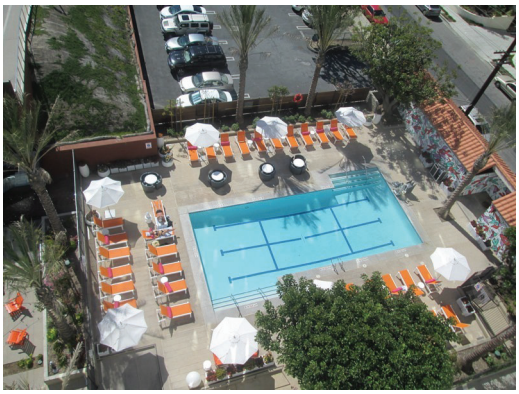
PHOTO #8	POOL AREA OVERVIEW

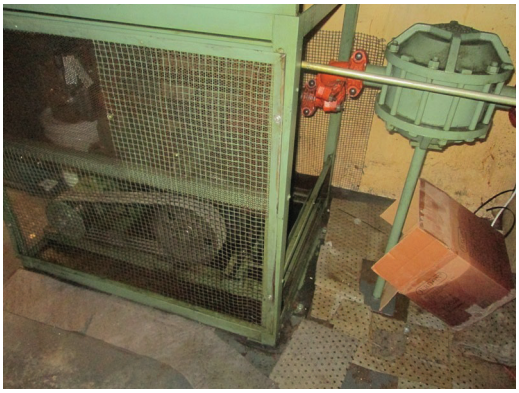
PHOTO #28	HYDRAULIC ELEVATOR EQUIPMENT WITH STAINING AND ABSORBENT MATERIALS IN FOOD AND BEVERAGE BUILDING

PHOTO #29	HYDRAULIC ELEVATOR EQUIPMENT WITH STAINING IN FOOD AND BEVERAGE BUILDING
