Phase I Environmental Site Assessment

br40345
3401 Etiwanda Avenue - Bldg 1011
Jurupa Valley, California 91752

April 14, 2021 (April 1, 2021)

PSI Project Number: 00662058-13

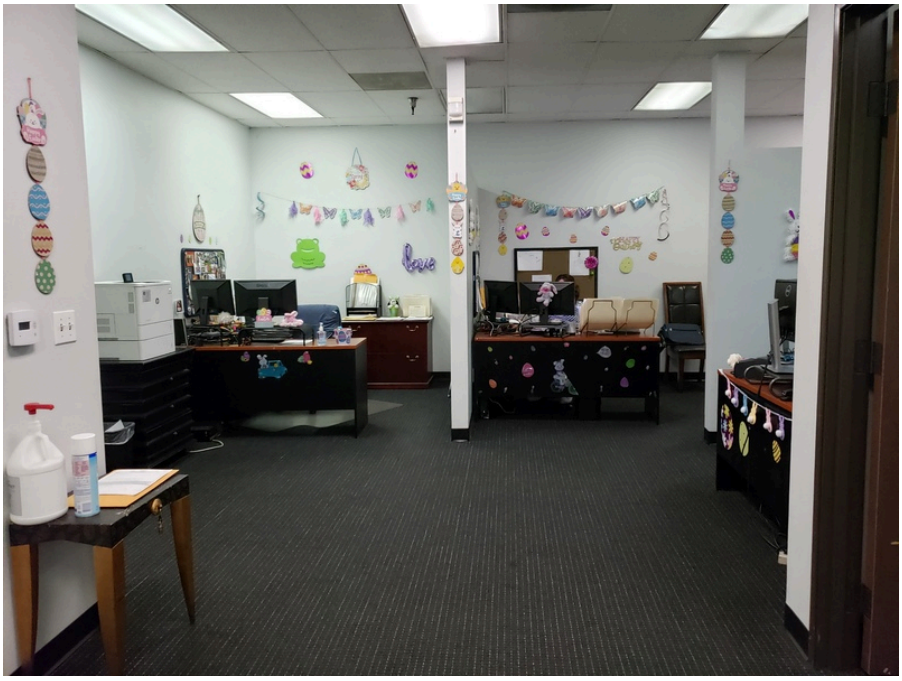
Photo 15: Office inside American West.

Photo 16: Office inside American West.
