Phase I Environmental Site Assessment

br40346
3401 Etiwanda Avenue, Buildings 711-931
Jurupa Valley, California 91752

May 21, 2021 (May 11, 2021)

PSI Project Number: 00662085-4

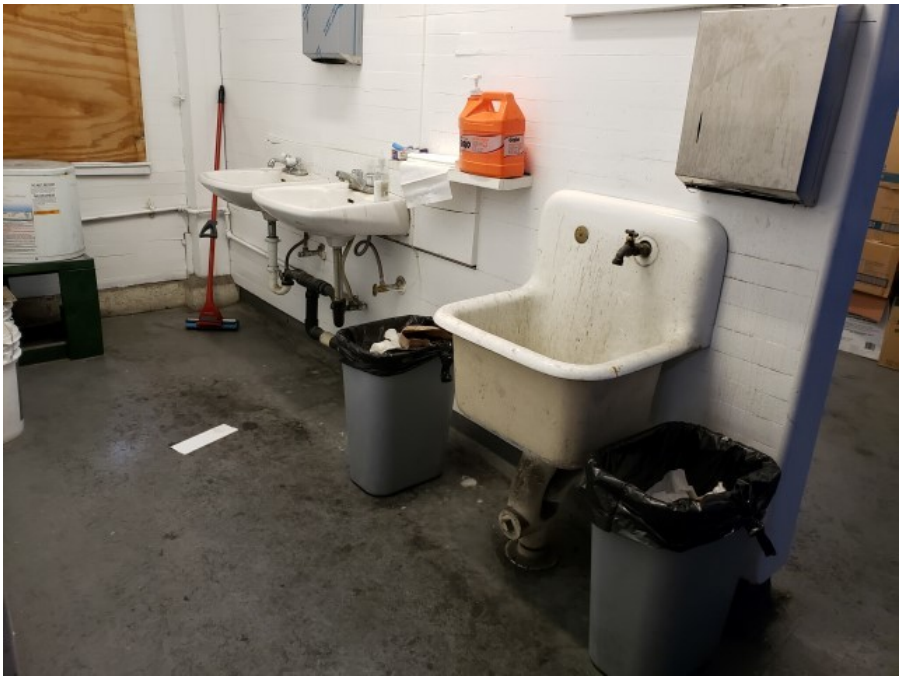
Photo 3: 711: Janitor's sink and cleanup area.

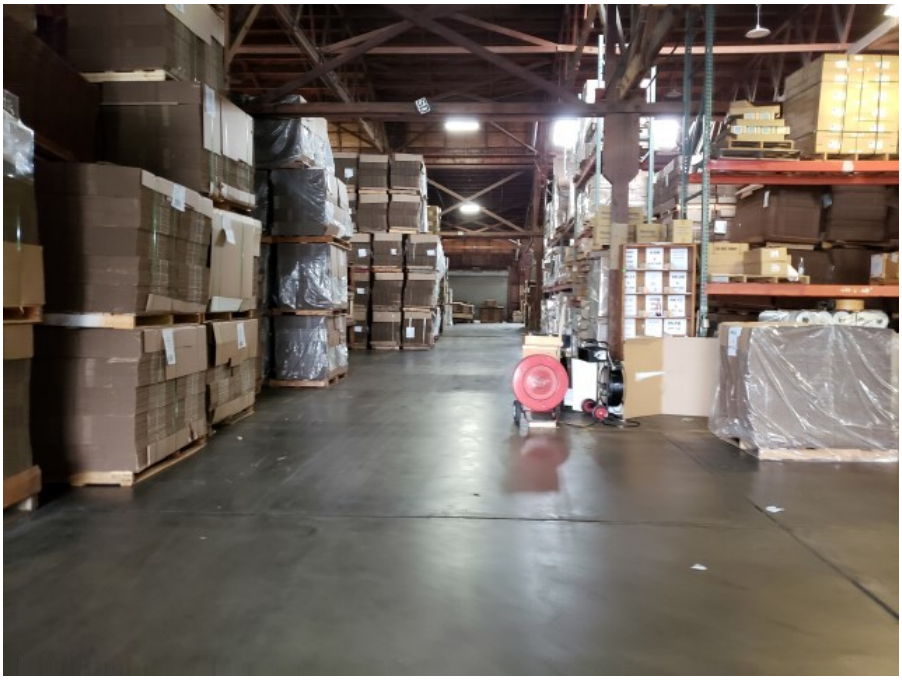
Photo 27: 721: View of the warehouse.

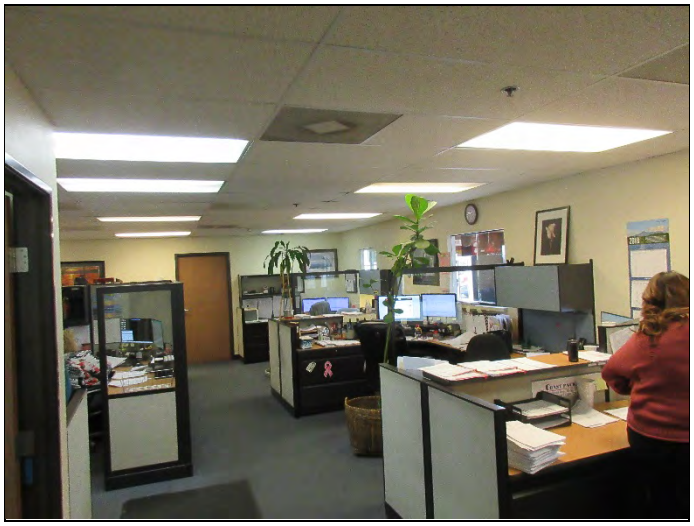
17. View of office (Coast Packaging Company).

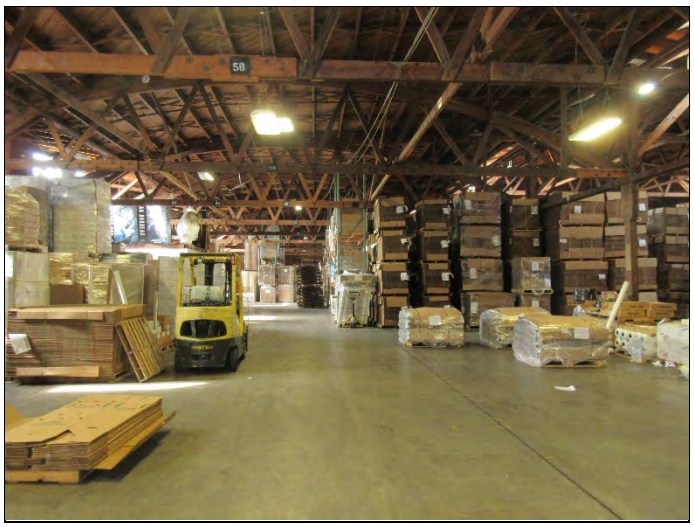
20. View of warehouse (California Packaging).

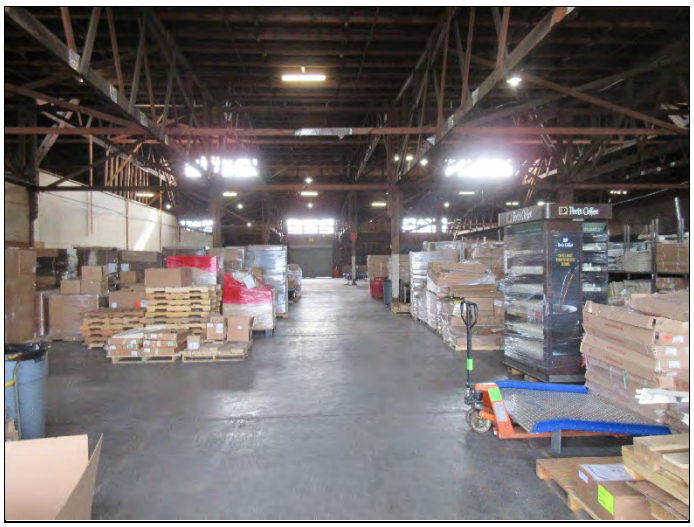
40. View of warehouse (Triways Inc.).

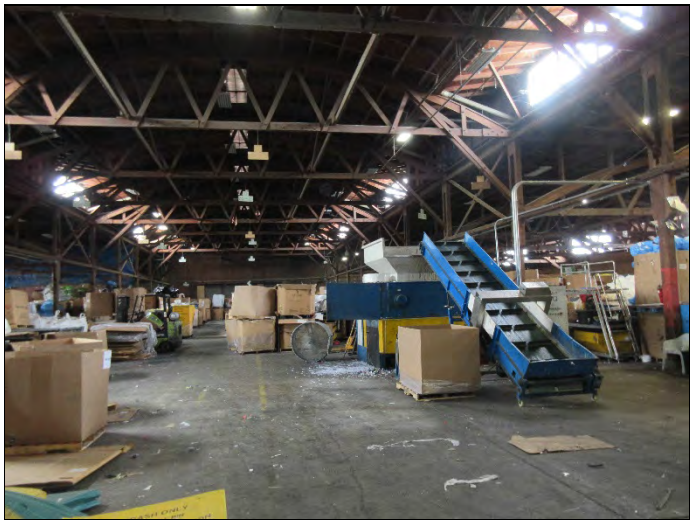
50. View of recycling facility (Kerozak).

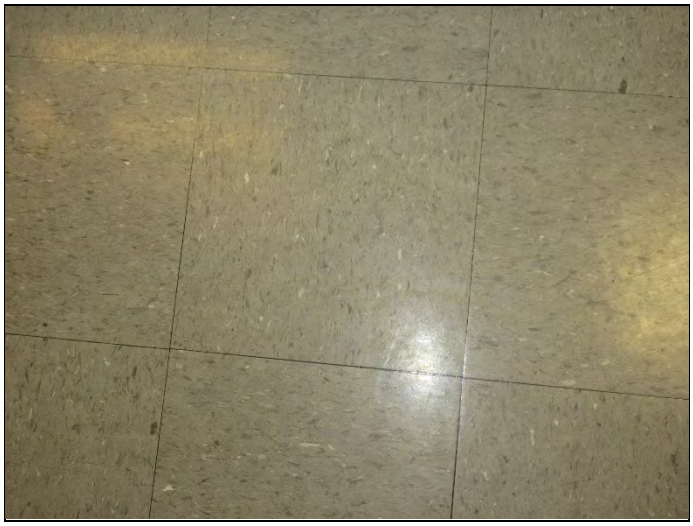
65. View of typical floor tiles located on the subject property.

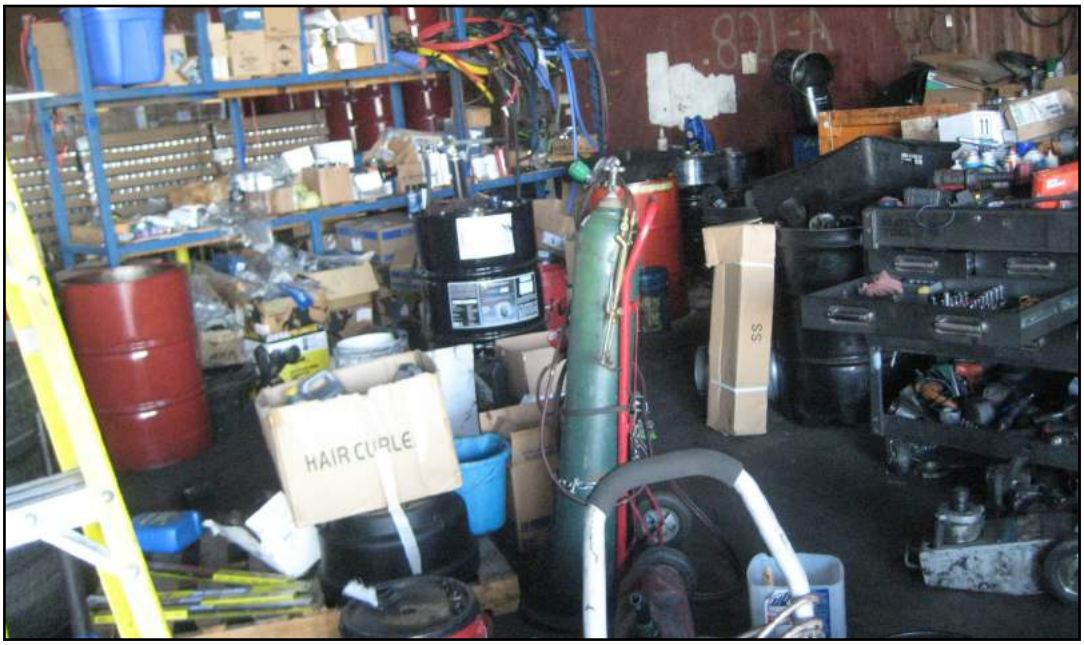
Photo 20—Maintenance area in northern portion of Freightco Express, 821 A.

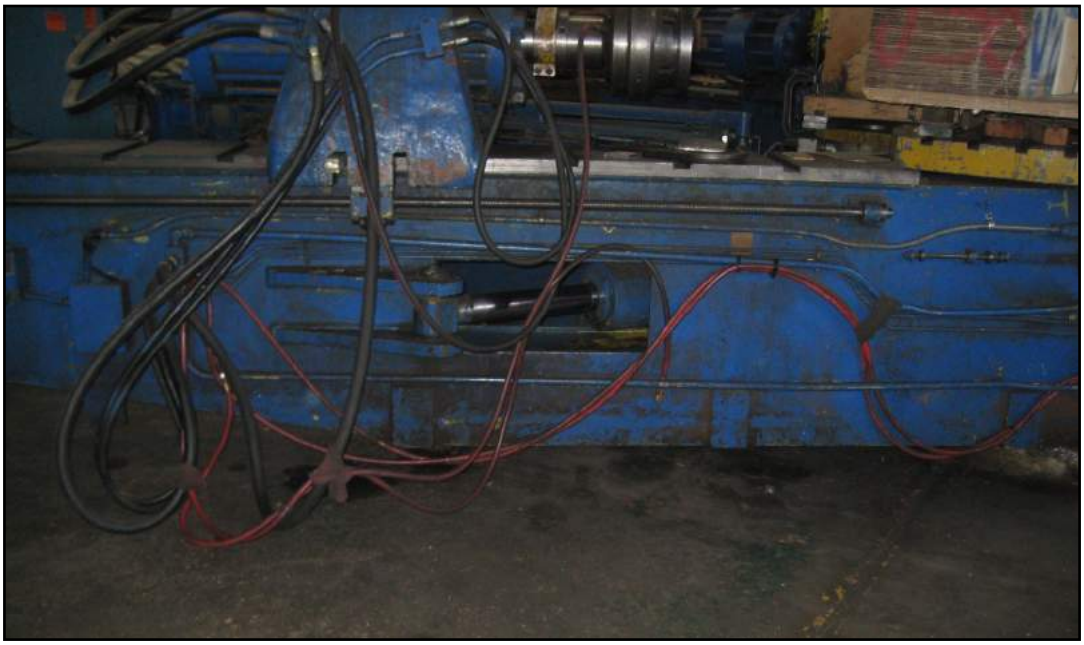
Photo 24—One of four stretch form presses in Curvetech, 821 B; hydraulic oil stains on concrete.
