Phase I Environmental Site Assessment of the Bloomington Business Park - Block 1 Properties, Bloomington, San Bernardino County, California

RG Bloomington LLC
c/o Rockefeller Group Development Corporation

Project Number: 60620647

June 2021

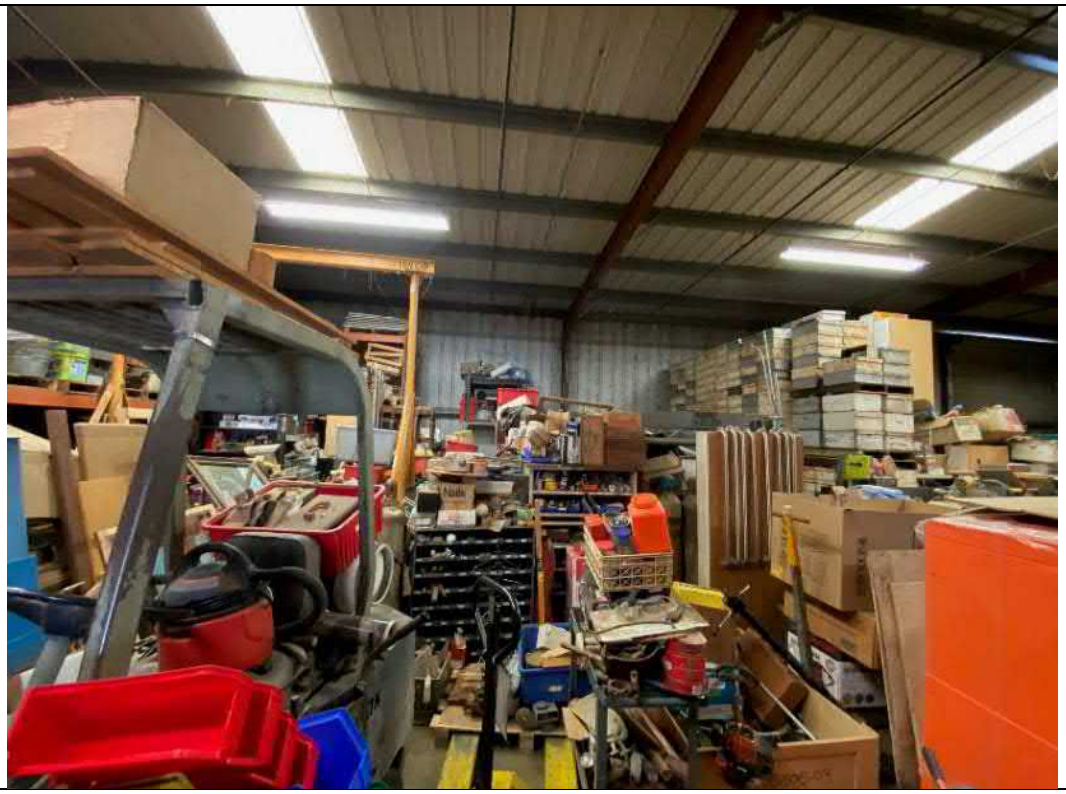
Interior view of the shop/storage garage located in the western portion of Site No. 30.
