PHASE II ENVIRONMENTAL SITE ASSESSMENT
MERIDIAN – WEST CAMPUS UPPER PLATEAU

ALL OR PORTIONS OF RIVERSIDE COUNTY APNS:
276-170-001, -007, 294-020-001
297-090-001, -002, -003, -006, -007, -008, -009
297-080-002, -003, -004, -005

Project No. 13226.003

January 17, 2022

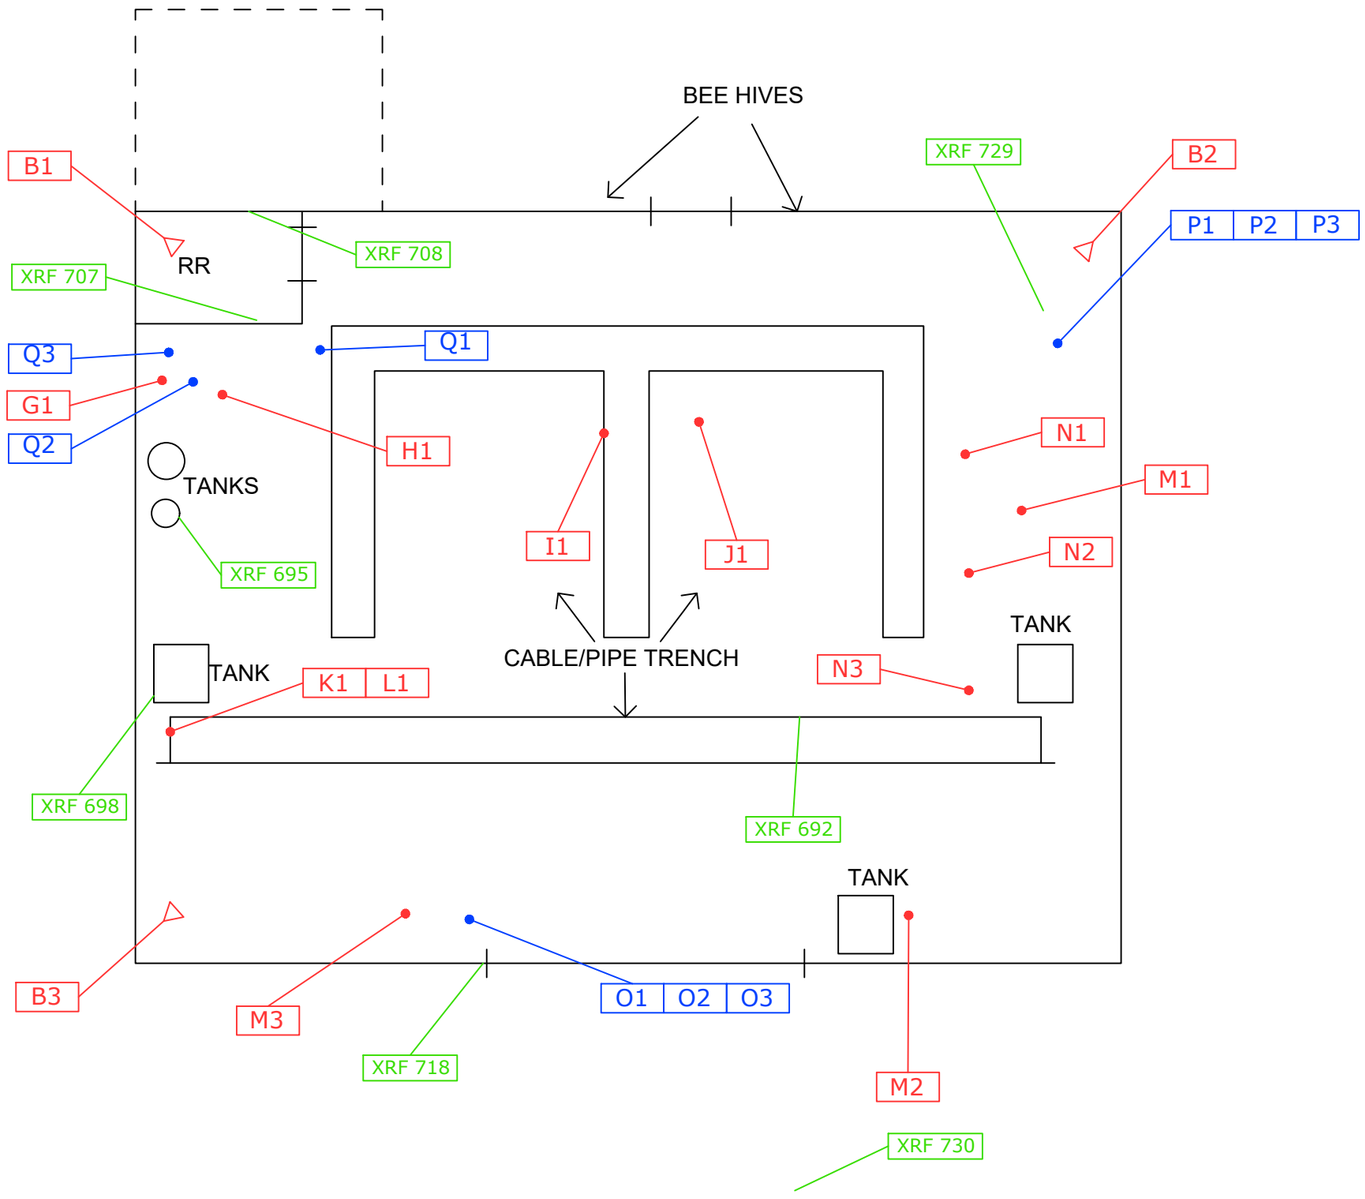
SITE 1
BUILDING 1 (FORMER SHOP BUILDING THAT HAS EXTENSIVE FIRE DAMAGE)
ACM AND LCP SAMPLING LOCATIONS

1. Building 1 (former shop building that has extensive fire damage)
2. Building 2 (former shop building North of Building 1)
3. Building 3 (currently partly occupied by a pyrotechnics company)

1. Due to the fire-damaged condition of Building 1, only the exterior of the building, excluding the roof, was investigated and tested during this investigation. The structure will require some sort of structural stabilization before an assessment of environmental hazards inside the building can be undertaken in a safe manner.
