PHASE I ENVIRONMENTAL SITE ASSESSMENT REPORT

Parcel B – Rohr Inc, a Collins Aerospace Company
850 Lagoon Drive
Chula Vista, California 91910

Report Date: February 12, 2021
Partner Project No. 20-302755.1

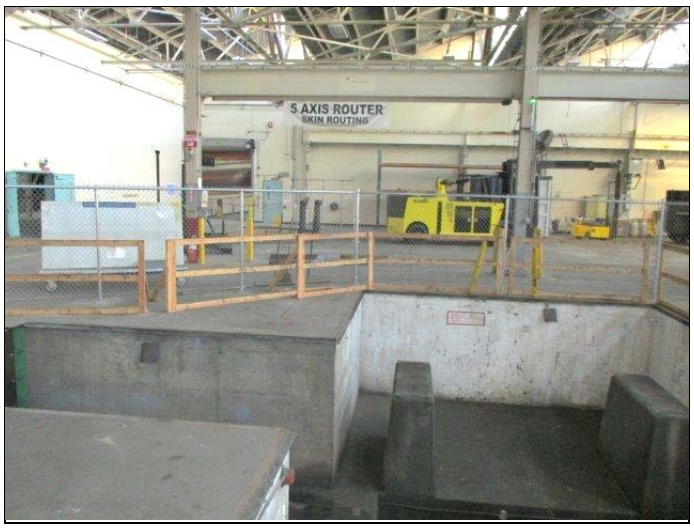
20. View of deep mechanical pit inside Building 1

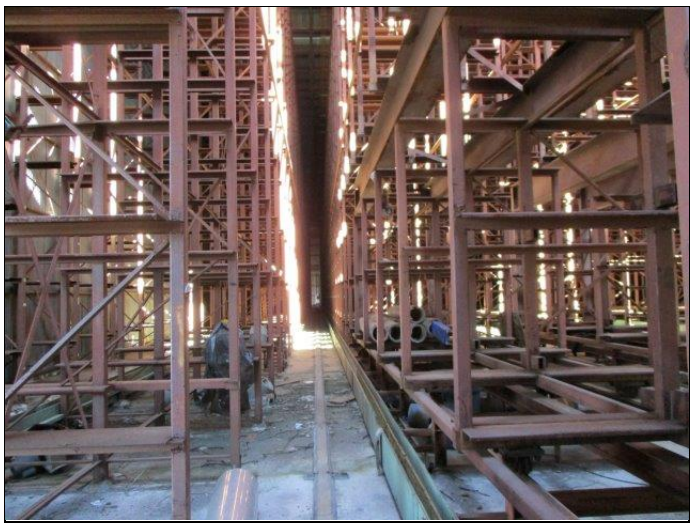
30. View of floor trench on the west side of Building 1 in a sandblast room looking west

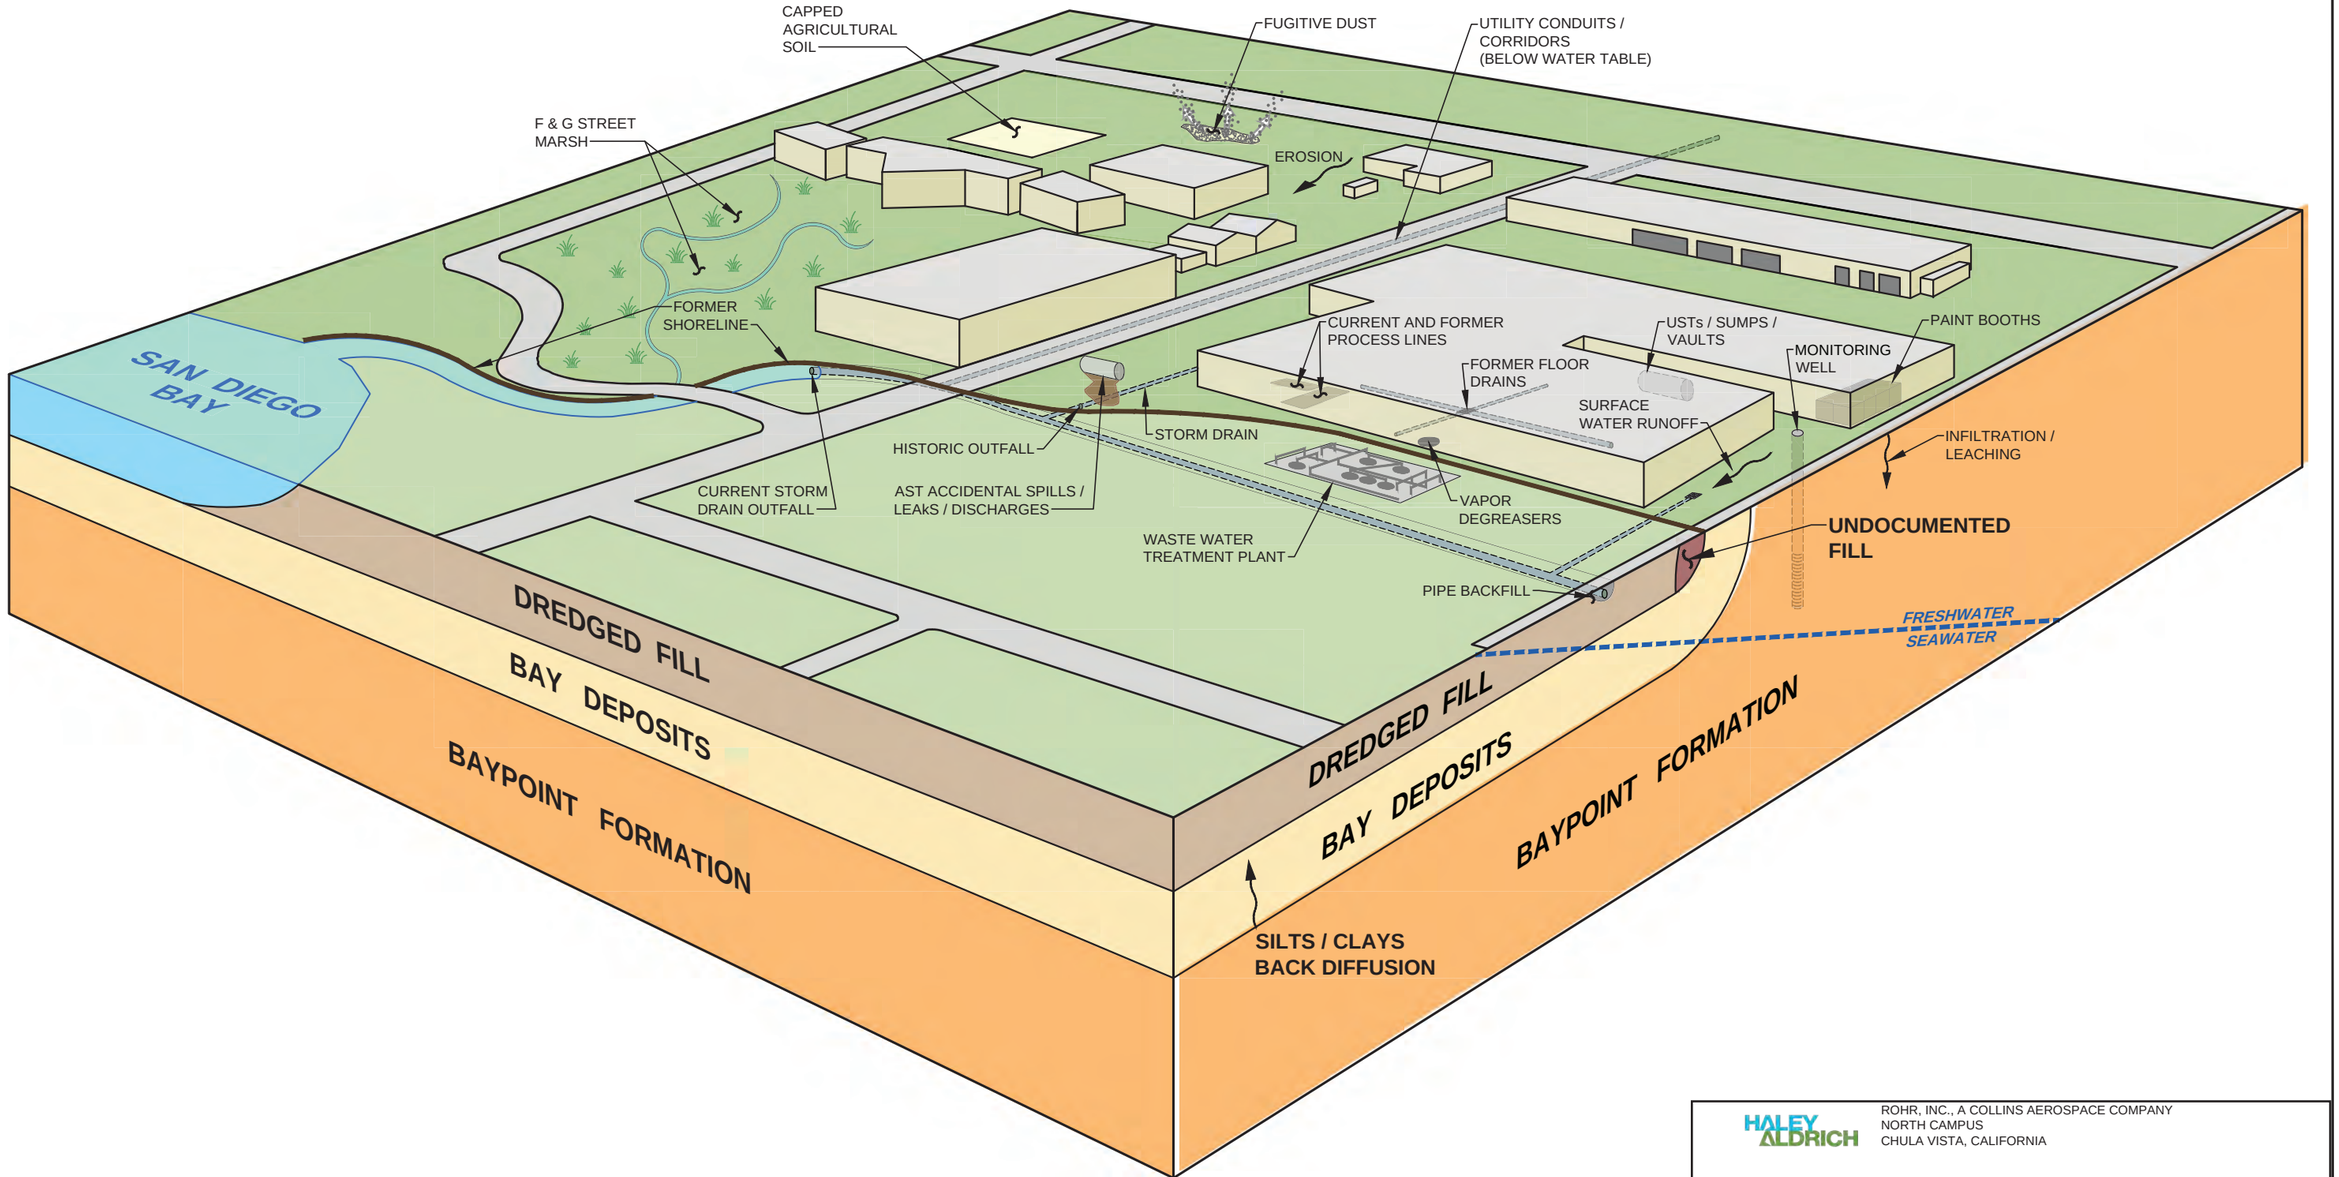
FIGURE 3

Investigation has identified certain VOCs (primarily TCE), metals, and TPH in soil in specific areas that are above the GPLs as shown on Figure 3 and in the table below. The GPL for total PCBs is 130 milligrams per kilogram. The PCB concentrations in soil have been compared to the commercial/industrial California Department Toxic Substances Control-Screening Levels (DTSC-SLs). Those PCB mixtures that have been detected in soil above their respective DTSC-SLs are also noted on Figure 3 and in the table below. Those chemicals of potential concern (COPCs) that have been found in soil above GPLs include the following:
