REPORT OF PRELIMINARY GEOTECHNICAL INVESTIGATION

Davidson Residential Development
811-827 Coast Boulevard South
La Jolla, California

JOB NO. 20-12787
24 September 2020

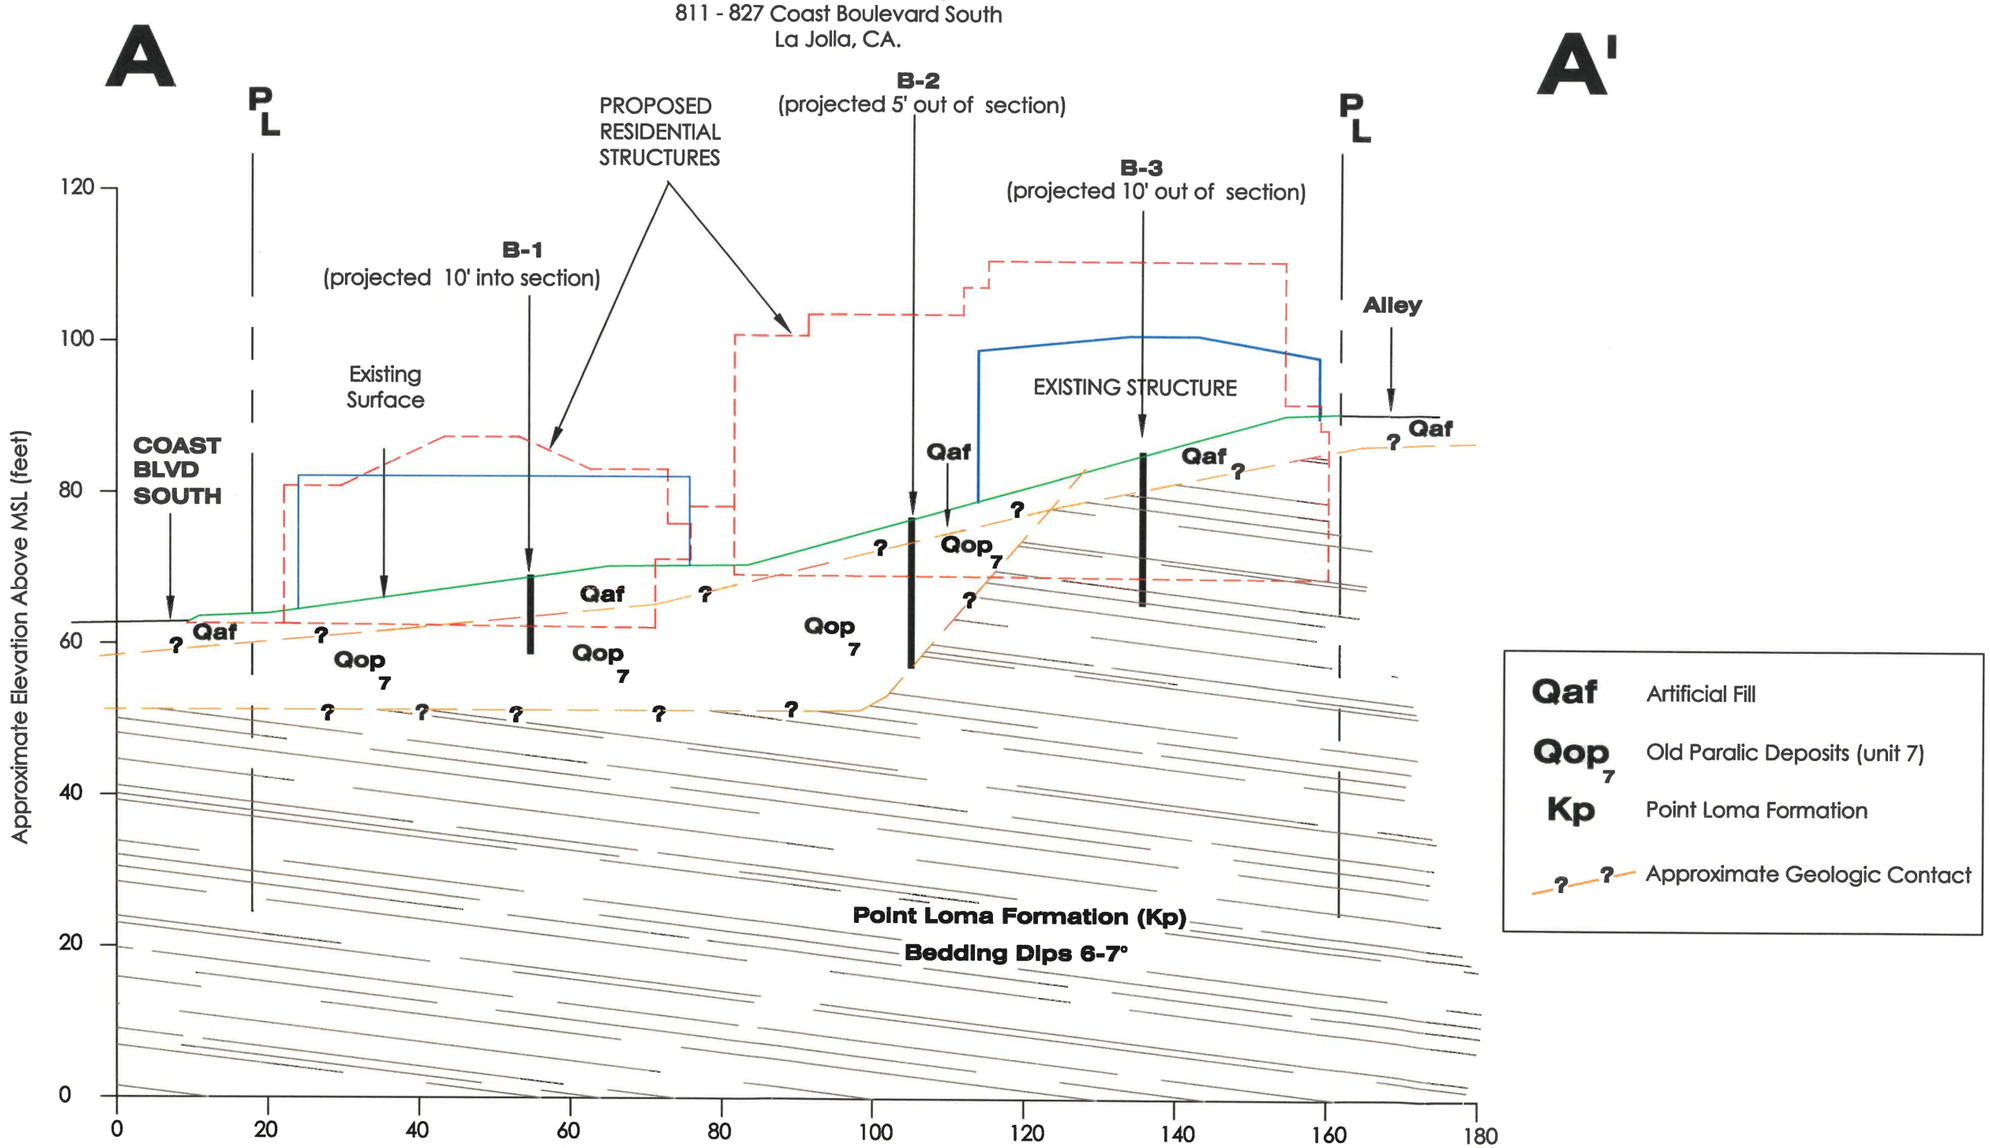
CROSS SECTION A-A'

Regional geologic structure was corelated by using information obtained in our exploratory borings and the mapped geology of the La Jolla area. The geologic contact between the Old Paralic Deposits and the Point Loma Formation is an unconformity. The basal contact of the Old Paralic Deposits is near horizontal, at an elevation of approximately 52 feet above MSL in the northwestern portion of the site. The inland edge of the marine terrace bench occurs in the eastern area of the site, where the Point Loma formation was observed to be directly underlying the fill soils. For greater understanding of the geologic structure, refer to Figure Nos. IIb-c, the Geologic Cross Sections.

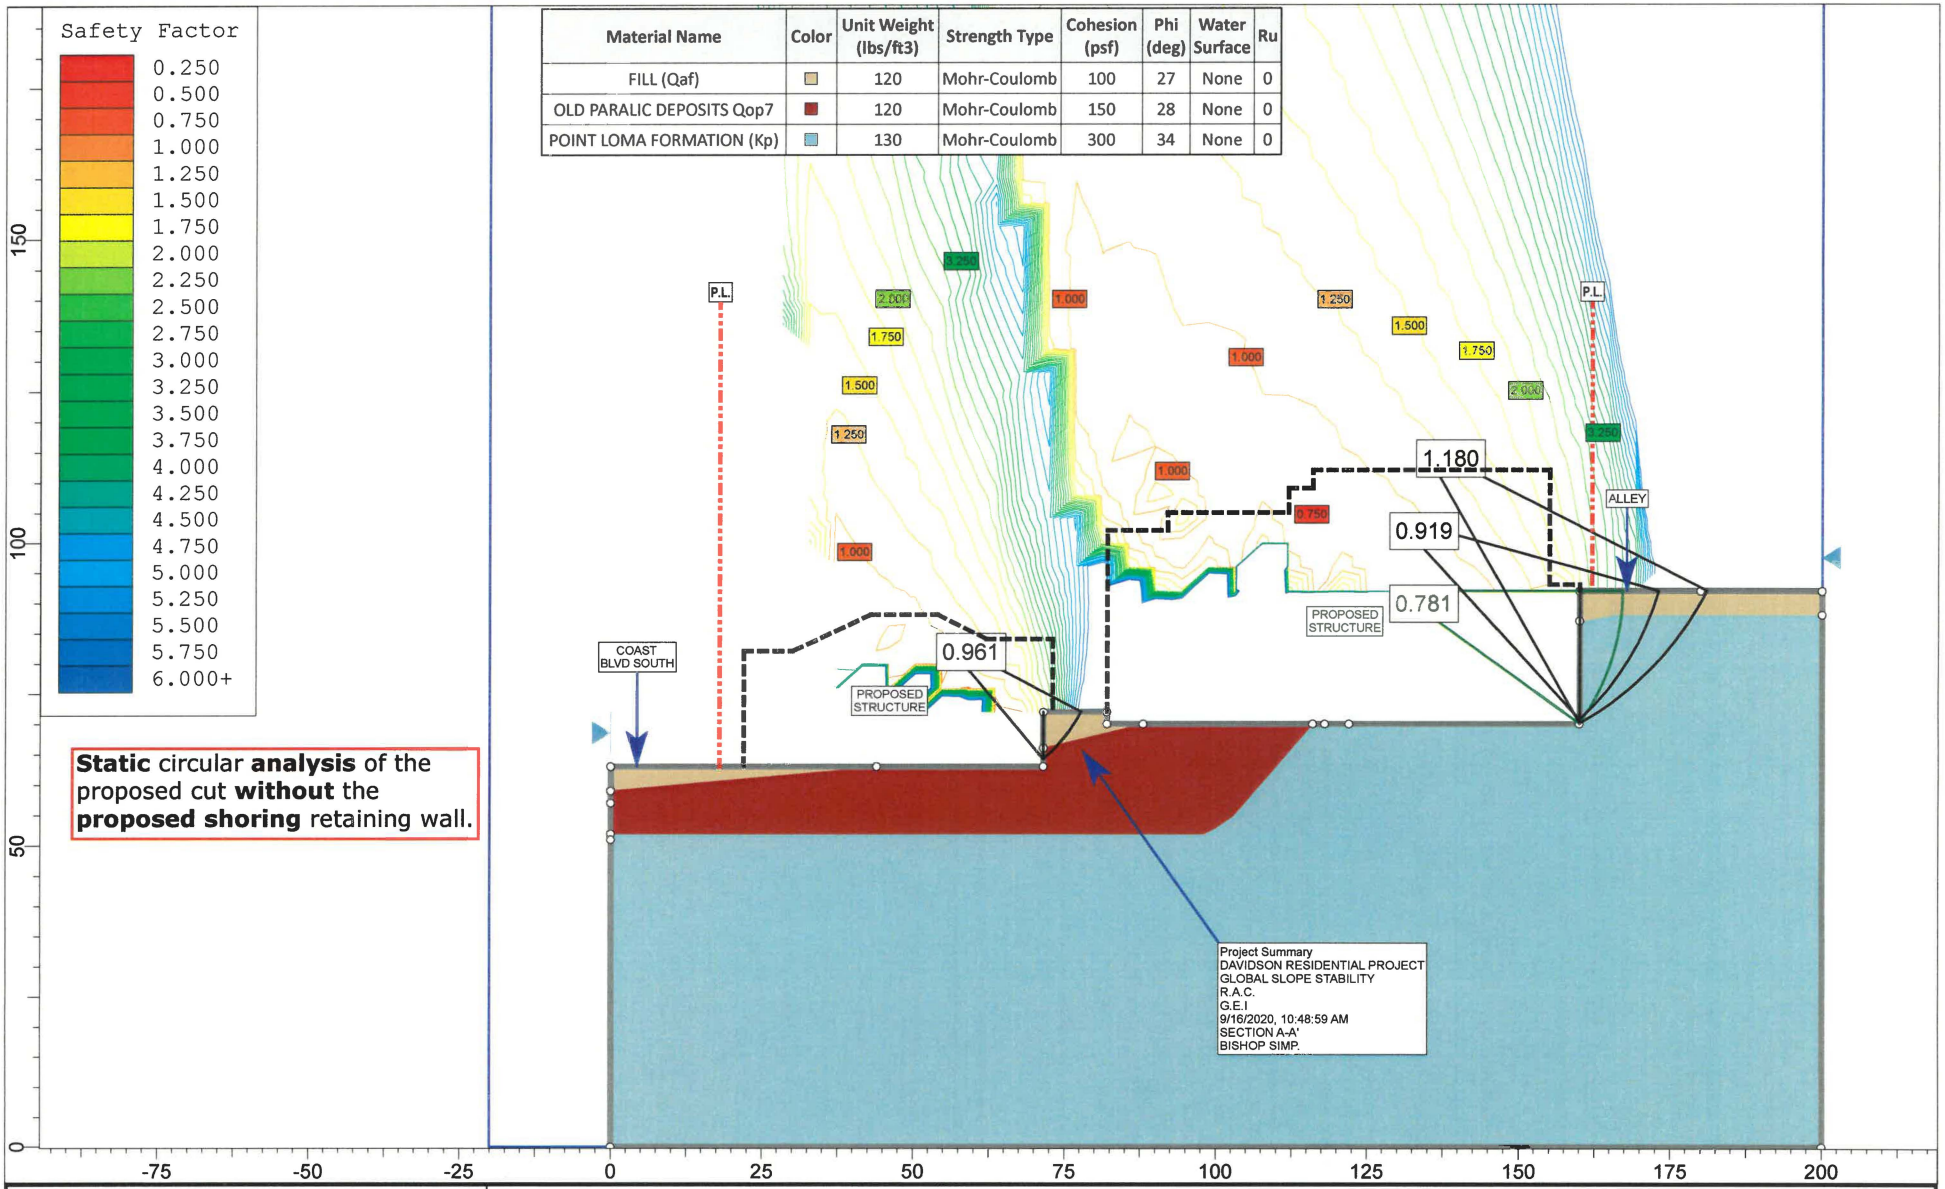
Static circular **analysis** of the proposed cut **without** the **proposed shoring** retaining wall.

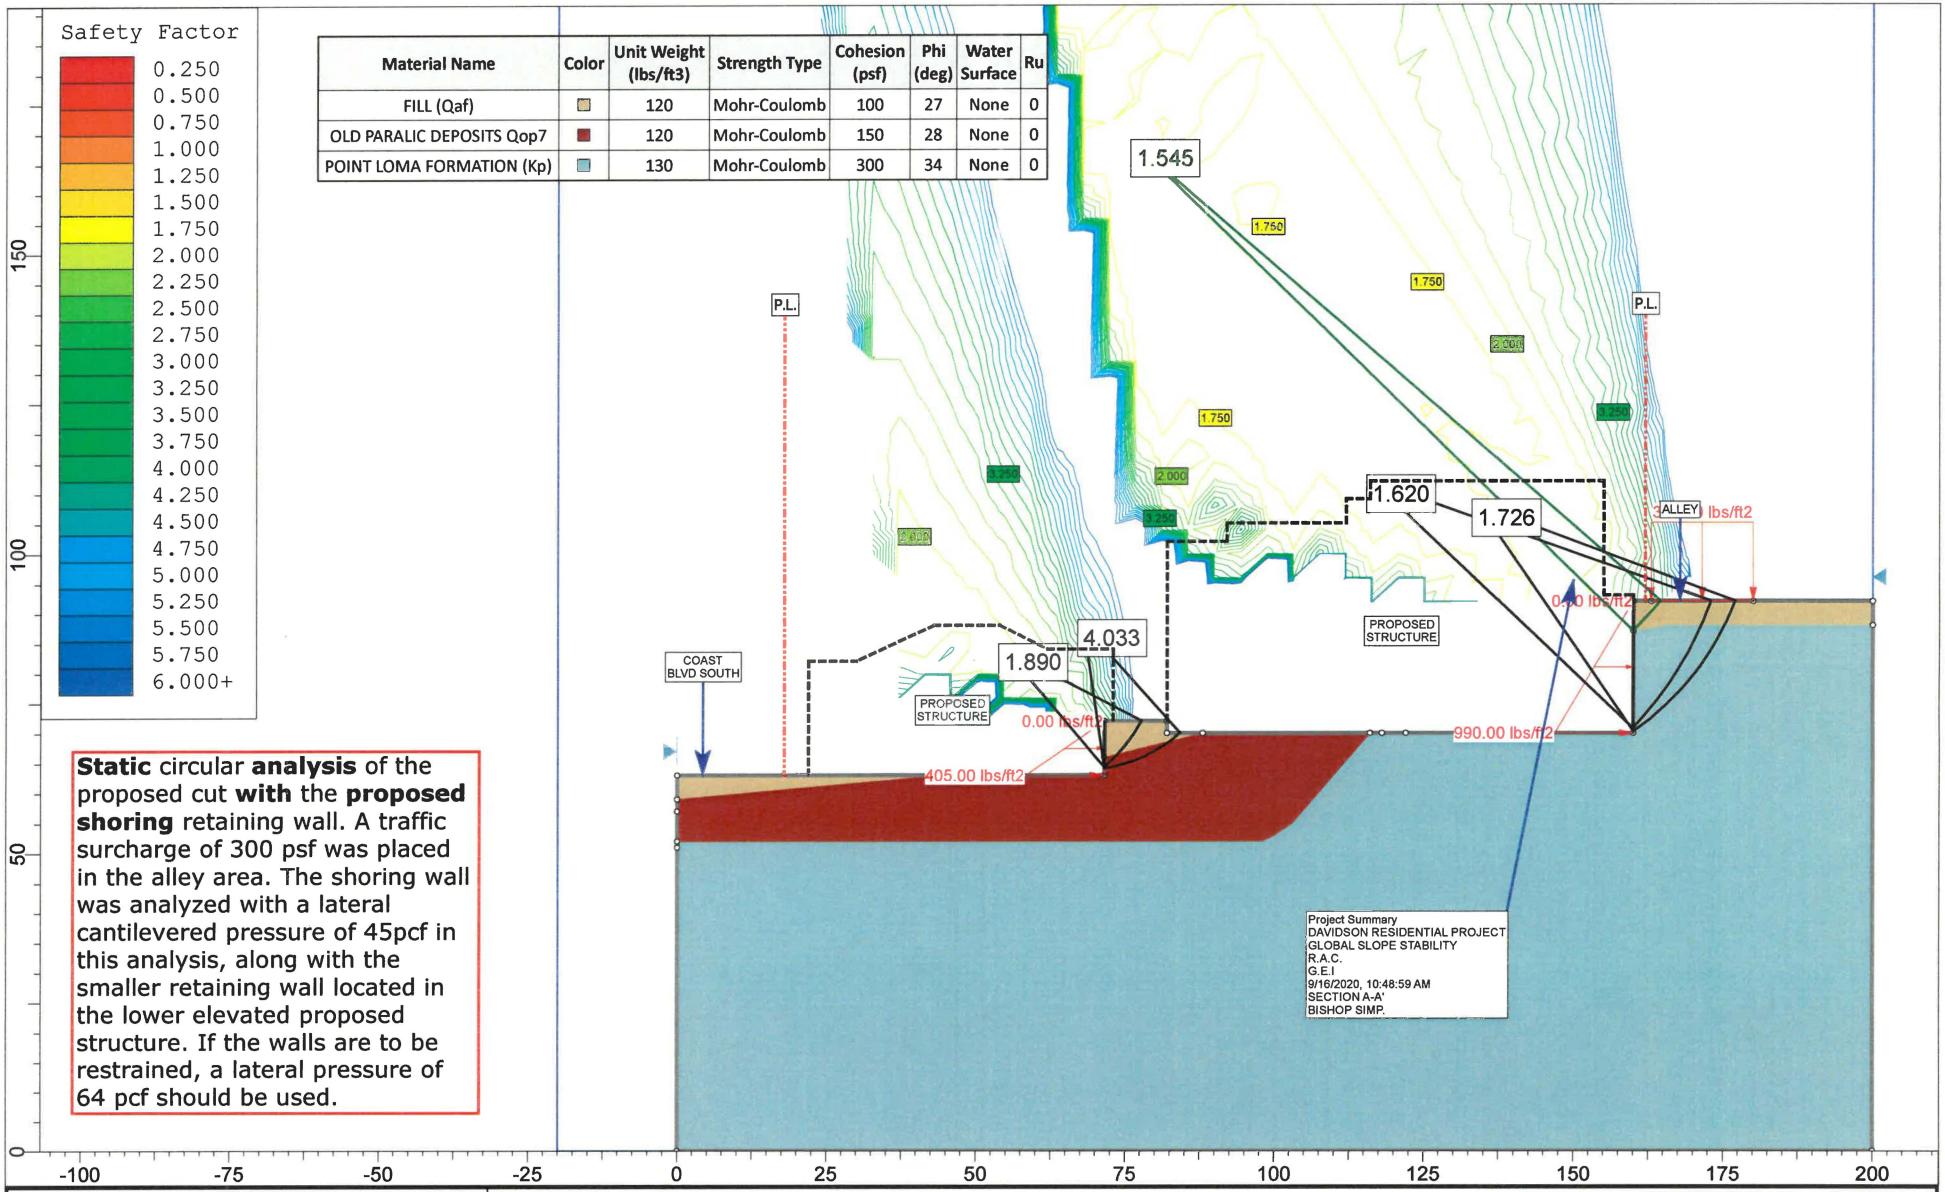
Static circular **analysis** of the proposed cut **with** the **proposed shoring** retaining wall. A traffic surcharge of 300 psf was placed in the alley area. The shoring wall was analyzed with a lateral cantilevered pressure of 45pcf in this analysis, along with the smaller retaining wall located in the lower elevated proposed structure. If the walls are to be restrained, a lateral pressure of 64 pcf should be used.

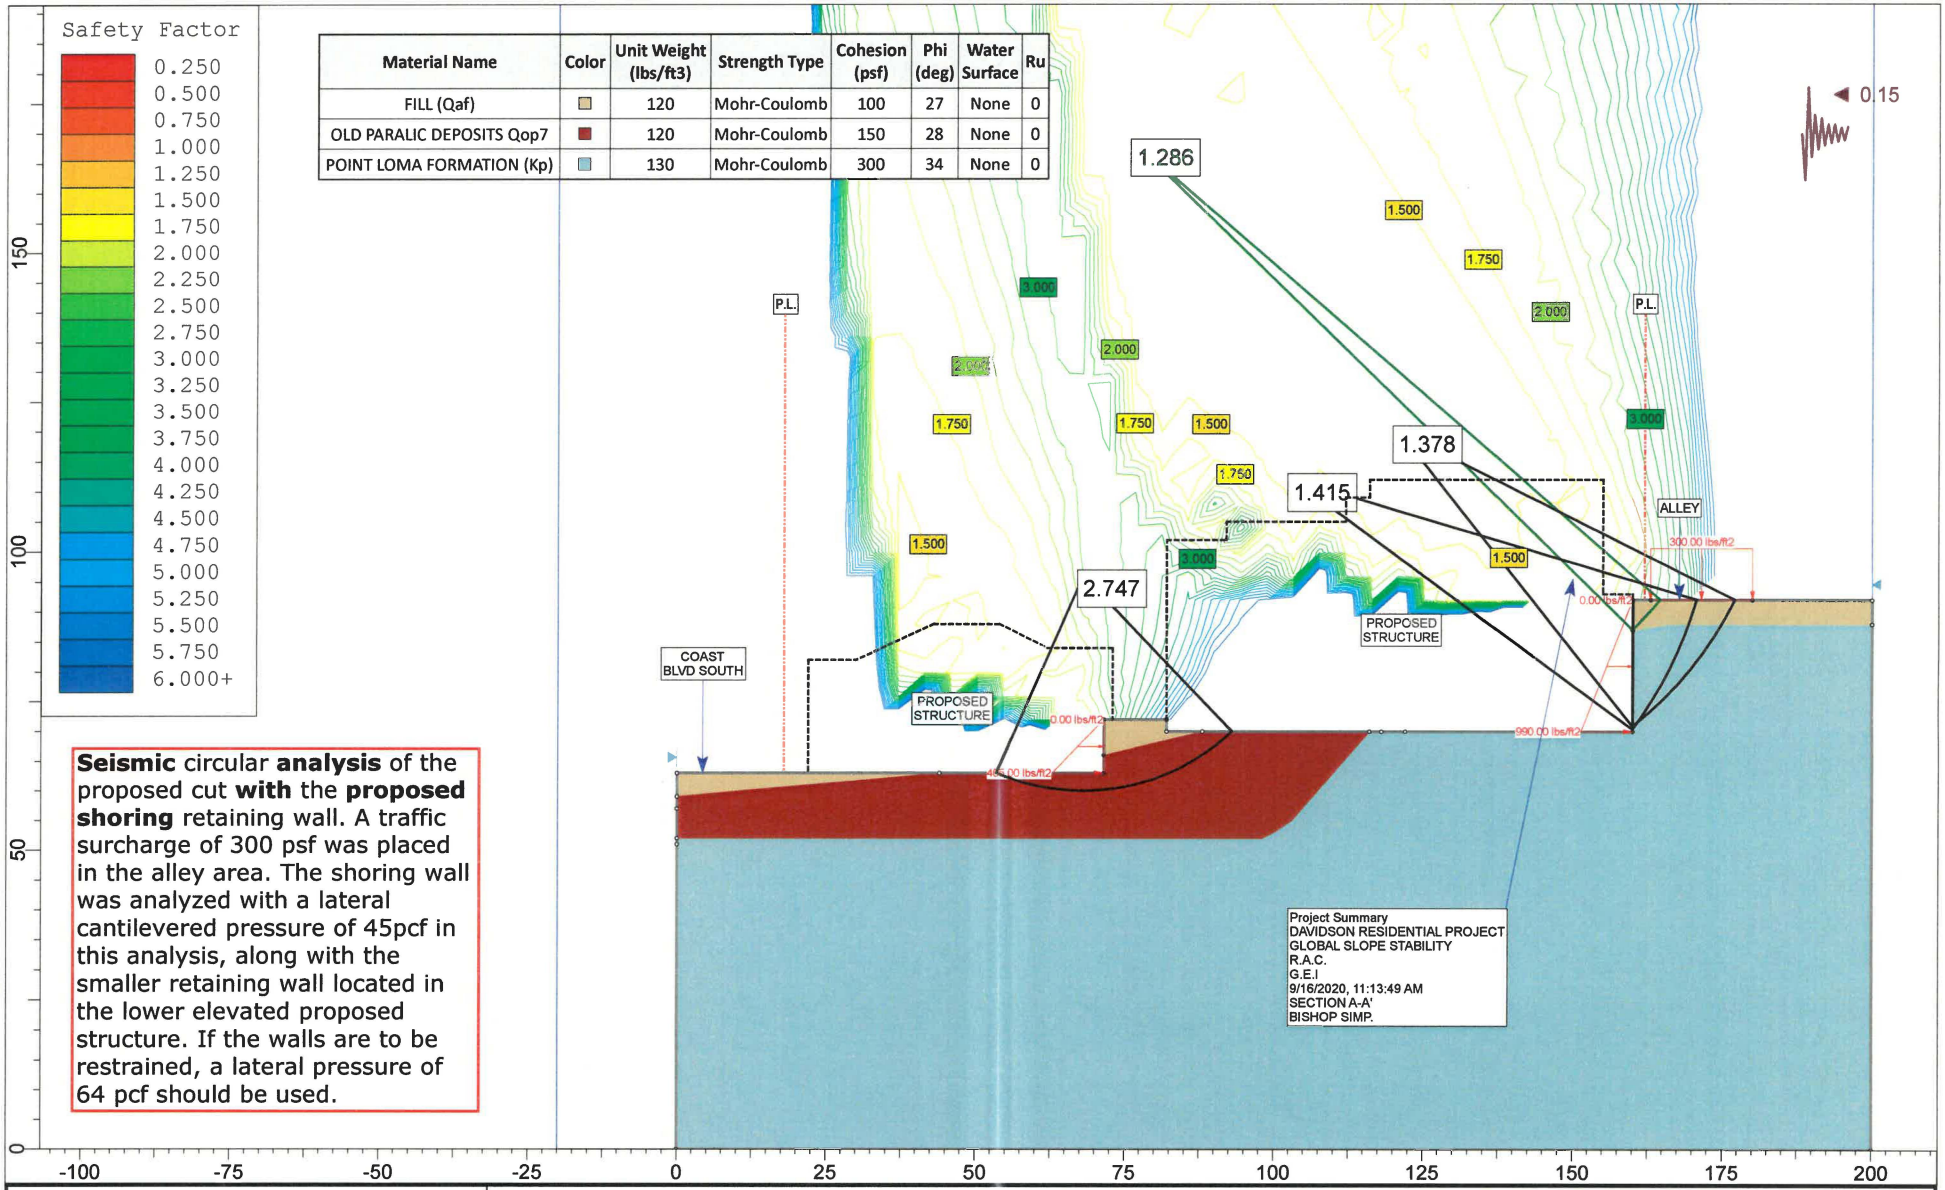
Seismic circular **analysis** of the proposed cut **with** the **proposed shoring** retaining wall. A traffic surcharge of 300 psf was placed in the alley area. The shoring wall was analyzed with a lateral cantilevered pressure of 45pcf in this analysis, along with the smaller retaining wall located in the lower elevated proposed structure. If the walls are to be restrained, a lateral pressure of 64 pcf should be used.

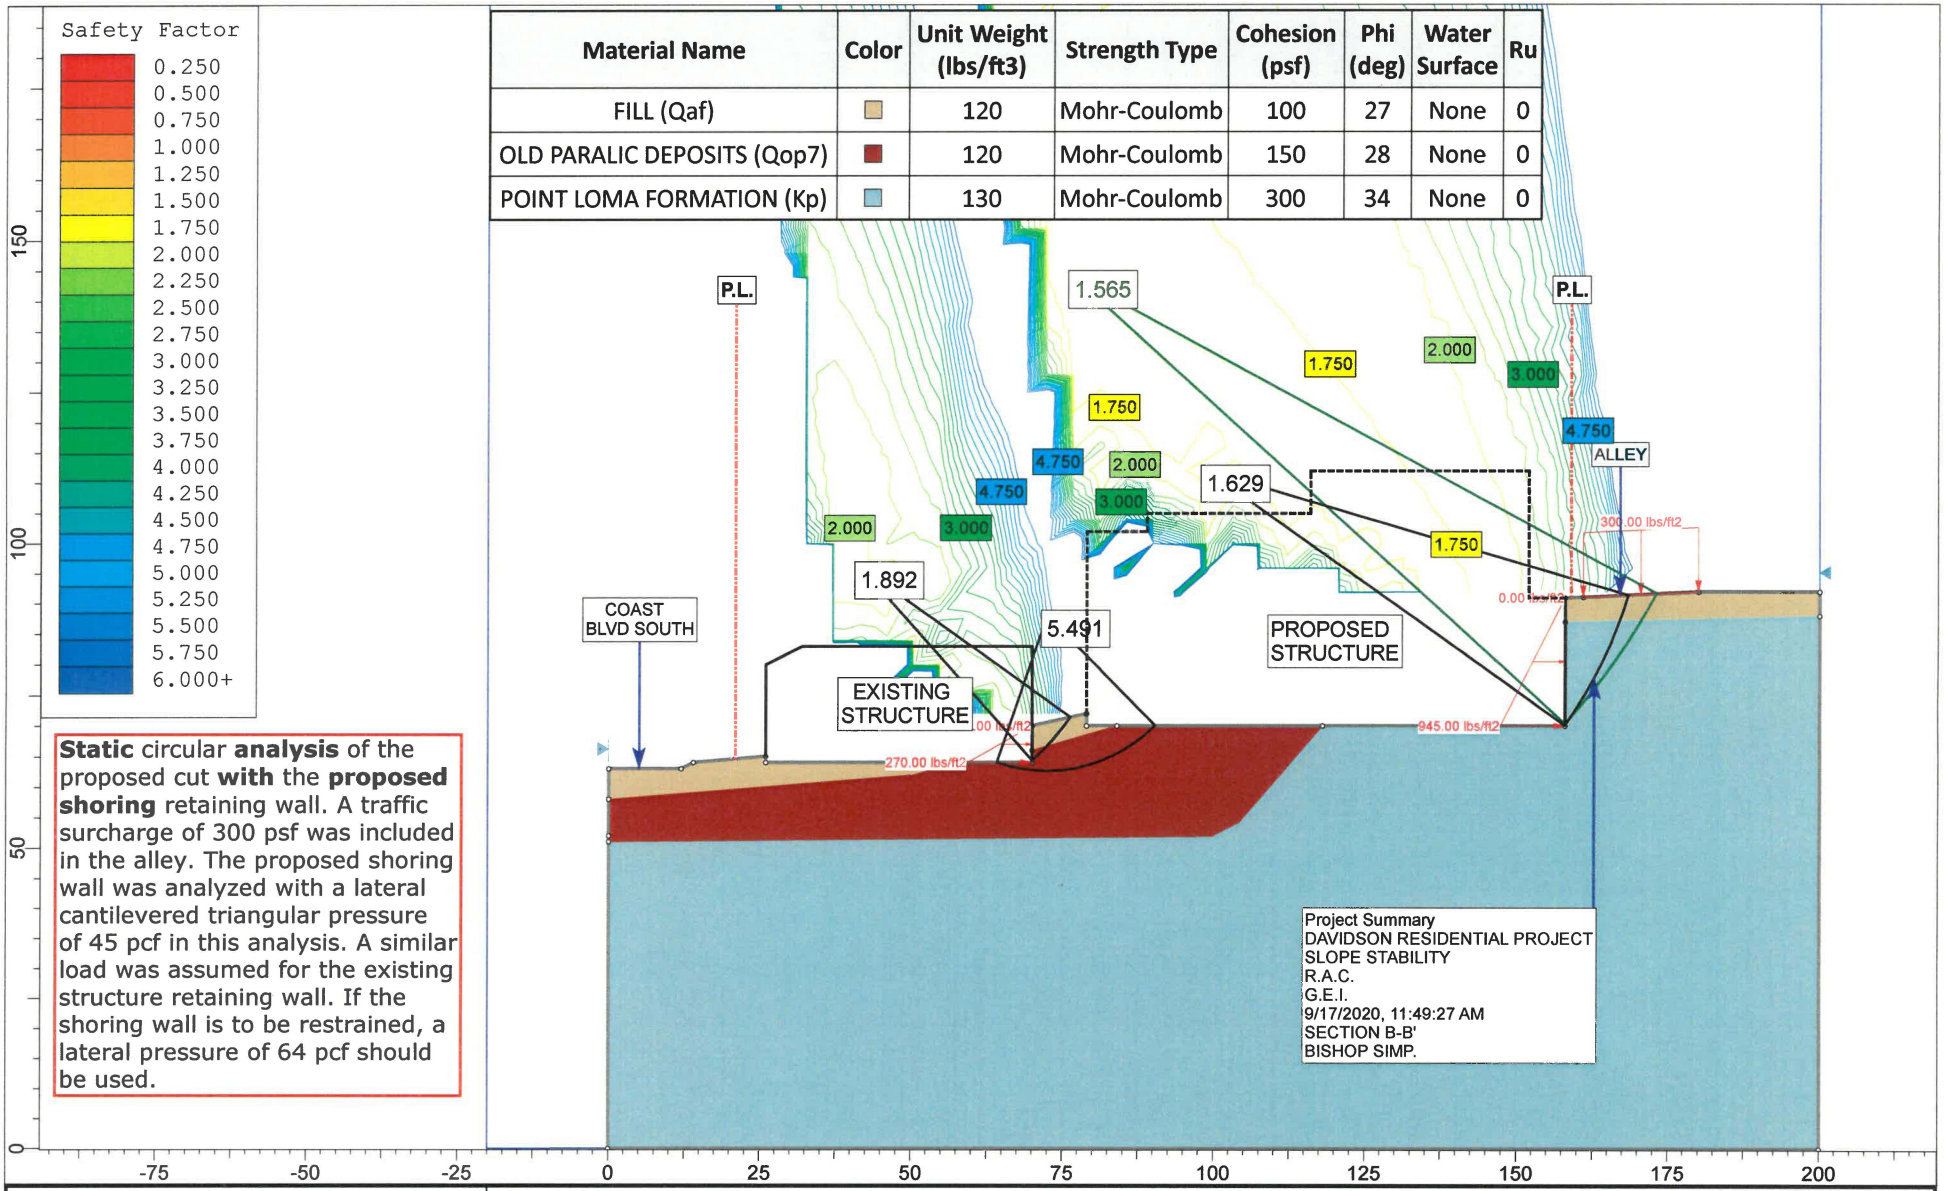
Static circular **analysis** of the proposed cut **with** the **proposed shoring** retaining wall. A traffic surcharge of 300 psf was included in the alley. The proposed shoring wall was analyzed with a lateral cantilevered triangular pressure of 45 pcf in this analysis. A similar load was assumed for the existing structure retaining wall. If the shoring wall is to be restrained, a lateral pressure of 64 pcf should be used.

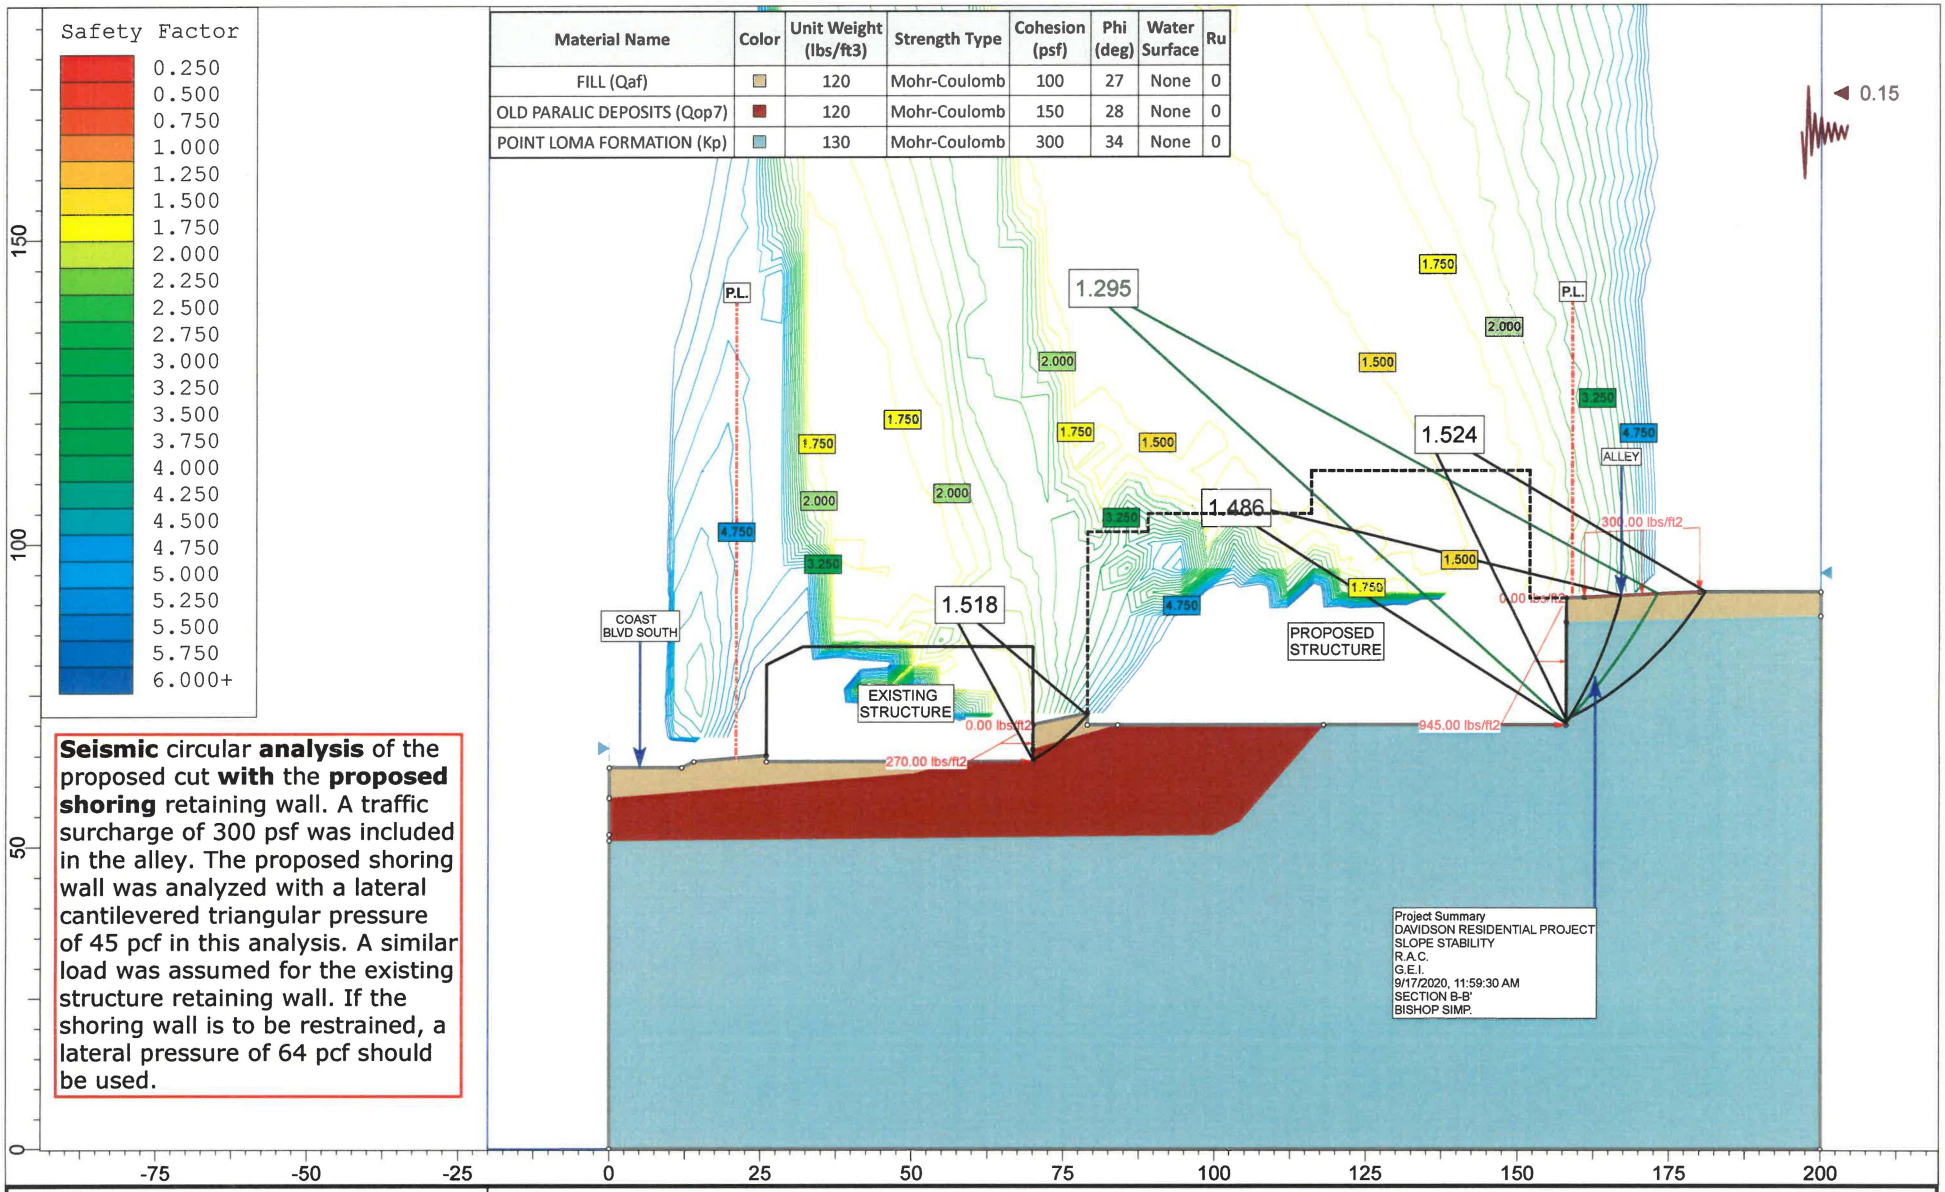
Seismic circular **analysis** of the proposed cut **with** the **proposed shoring** retaining wall. A traffic surcharge of 300 psf was included in the alley. The proposed shoring wall was analyzed with a lateral cantilevered triangular pressure of 45 pcf in this analysis. A similar load was assumed for the existing structure retaining wall. If the shoring wall is to be restrained, a lateral pressure of 64 pcf should be used.
