ENVIRONMENTAL SITE ASSESSMENT

918 RICH AVENUE
SAN JOSE, CALIFORNIA

EIS, Inc. PROJECT #2103-1

February 16, 2020

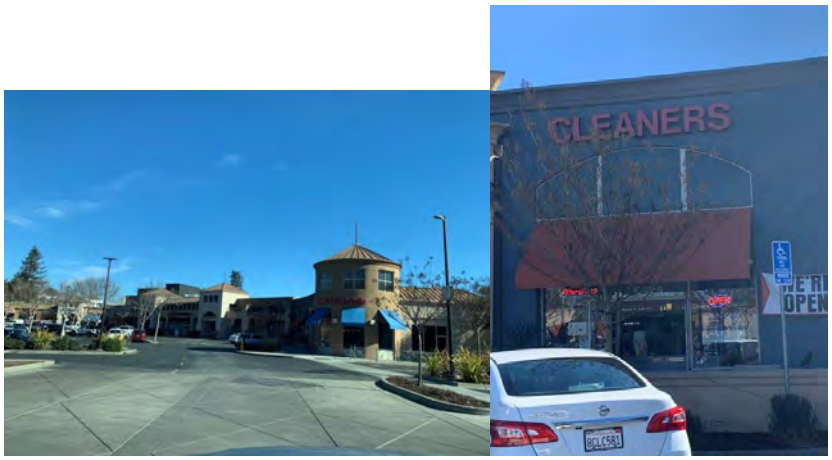
Project No. 2103-1	**Description**	View of northwestern adjoining commercial shopping center (left) and dry-cleaner in northwestern adjoining commercial shopping center (right).	**10**
	Name	918 Rich Avenue, Mountain View, California	**Photo Date** February 4, 2021
