PHASE I AND II ENVIRONMENTAL SITE ASSESSMENT REPORT

985 O'Brien Drive
1001 to 1015 O'Brien Drive
1320 Willow Road
Menlo Park, California

Farallon PN: 2333-008

September 10, 2021

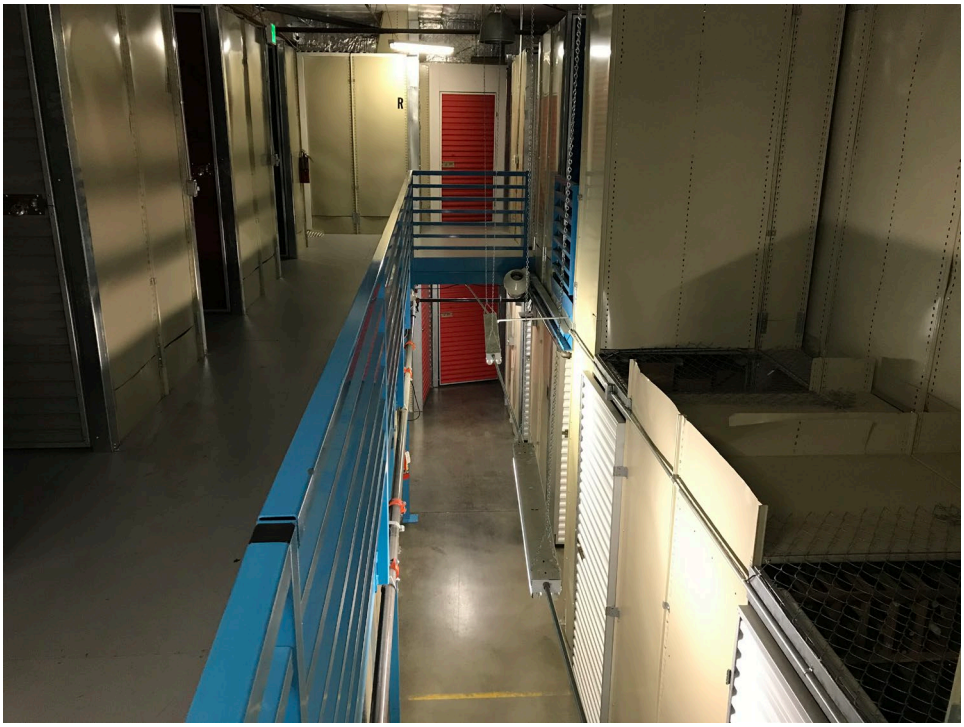
Photograph 12: Vehicle storage area at 1320 Willow Road.
