PHASE I ENVIRONMENTAL SITE ASSESSMENT

THE SHOPS AT TANFORAN
1122-1198 EL CAMINO REAL
AND 300 TANFORAN PARK
SAN BRUNO, CALIFORNIA

Date:
February 3, 2025

Project Number:
1690022506_CONV-006

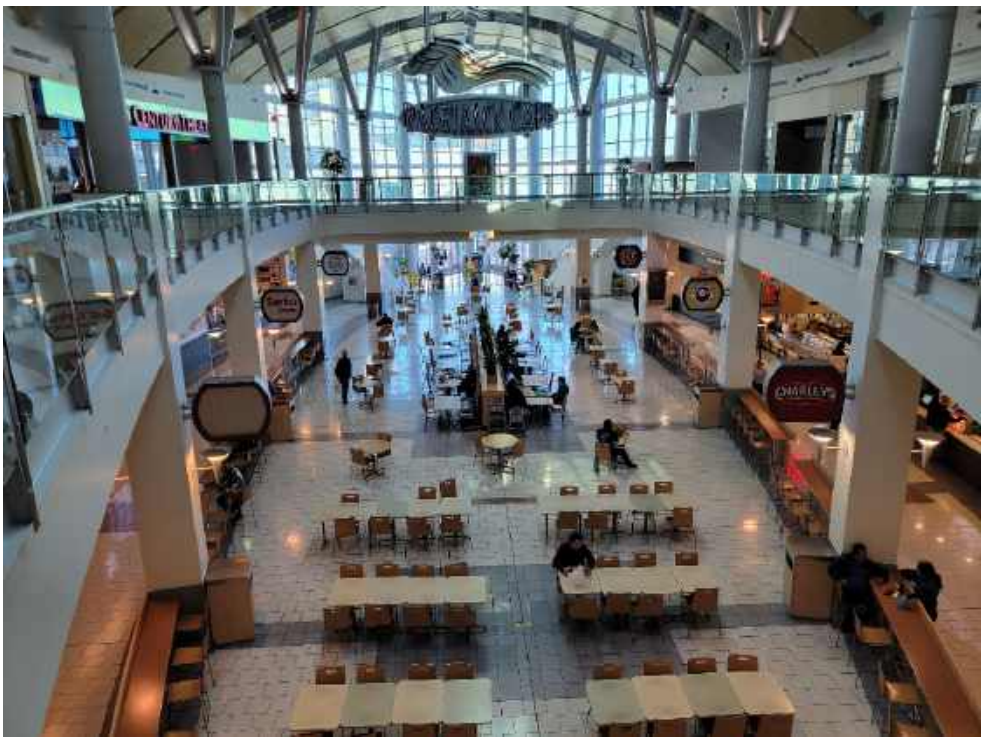
Photo 10: Interior photo showing the food court on the ground floor and shops on the upper floor.

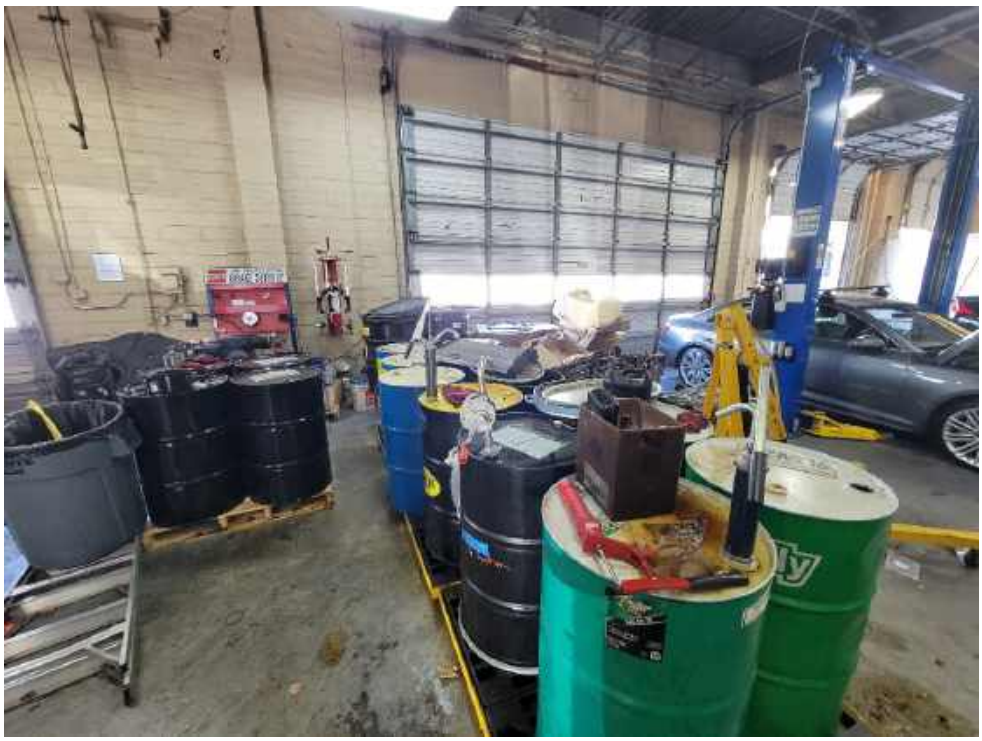
Photo 16: Product (oil and transmission fluid) drums and waste drums (used oil, used oil filters, used transmission fluid, aerosol cans) in the Hyundai automotive service building.

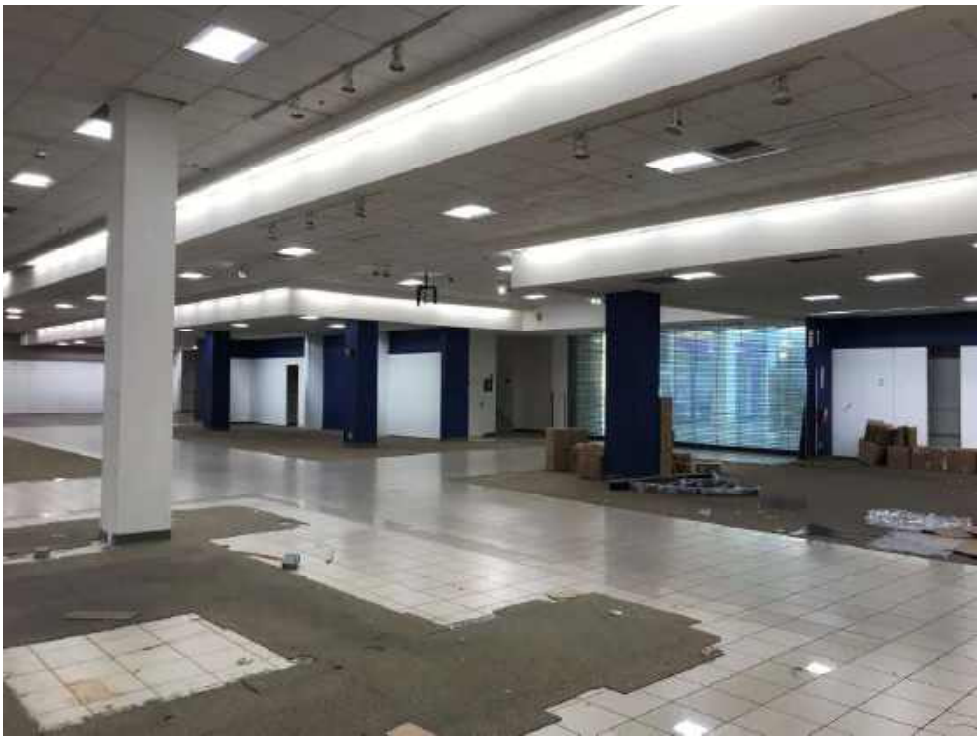
Photo 3: View of a vacant area of the Sears department store building.
