BLUFF RETREAT EVALUATION REPORT

PRC 421 DECOMMISSIONING PROJECT
GOLETA, SANTA BARBARA COUNTY, CALIFORNIA

Project No. 2102-0251

AUGUST 2021

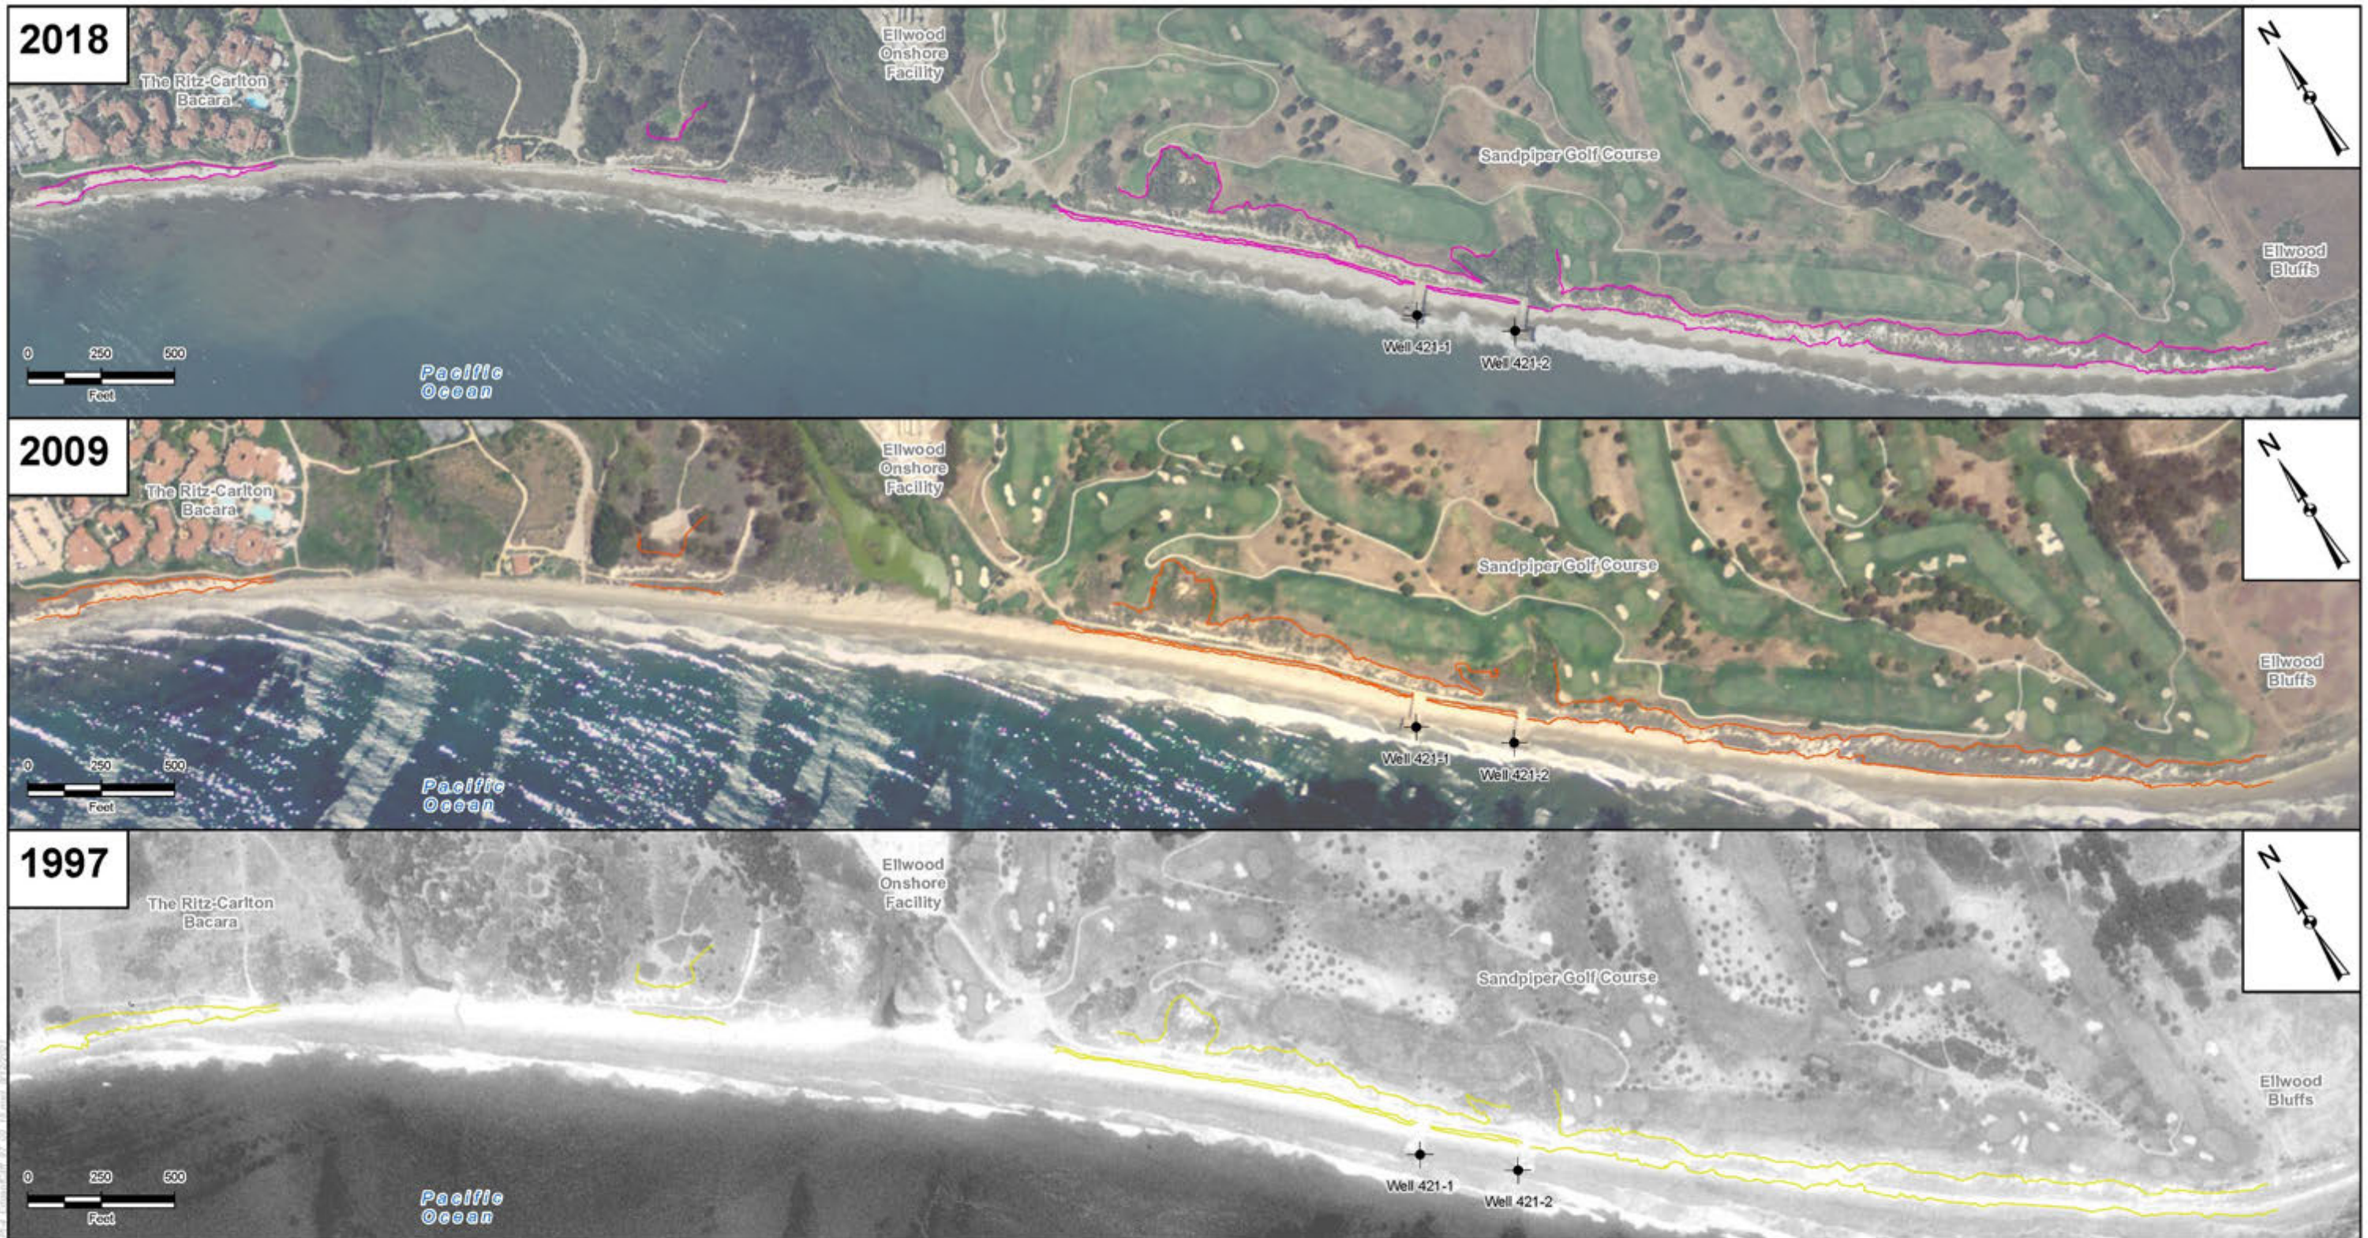
PLATE 4

Light-detection and range (LiDAR) elevation data was obtained for the years of 2018, 2009, and 1997 (Table 1). The LiDAR data was collected via aircraft using laser scanning technology to capture coordinate location data (northing, easting, and elevation data) as a point cloud. The point cloud data was interpolated by the data collection agencies and provided to Padre as polyline feature contour data delineating the coastal bluff at the Project Site. The crest and toes of bluff were delineated in geographic information systems (GIS) software from the contour LiDAR data for each data set (Plate 4).

It should be noted that a 1997 aerial photograph of sufficient quality for analysis was unavailable for use at the time of this study; however, a 1994 aerial photograph was available from Google Earth Pro that generally agreed with the geometry of the 1997 crest and toe of coastal bluff; it was used as background imagery for display purposes (Plate 4).
