LINDBERG GEOLOGIC CONSULTING
David N. Lindberg, CEG
Post Office Box 306
Cutten California 95534
(707) 442-6000

August 31, 2022

Project No: 0481.00

Subject: Hydrologic Isolation of Existing Well from Surface Waters, Well Number One
2238 Run Down Acres Lane, Bridgeville, APN: 210-054-008, WCR2022-005784

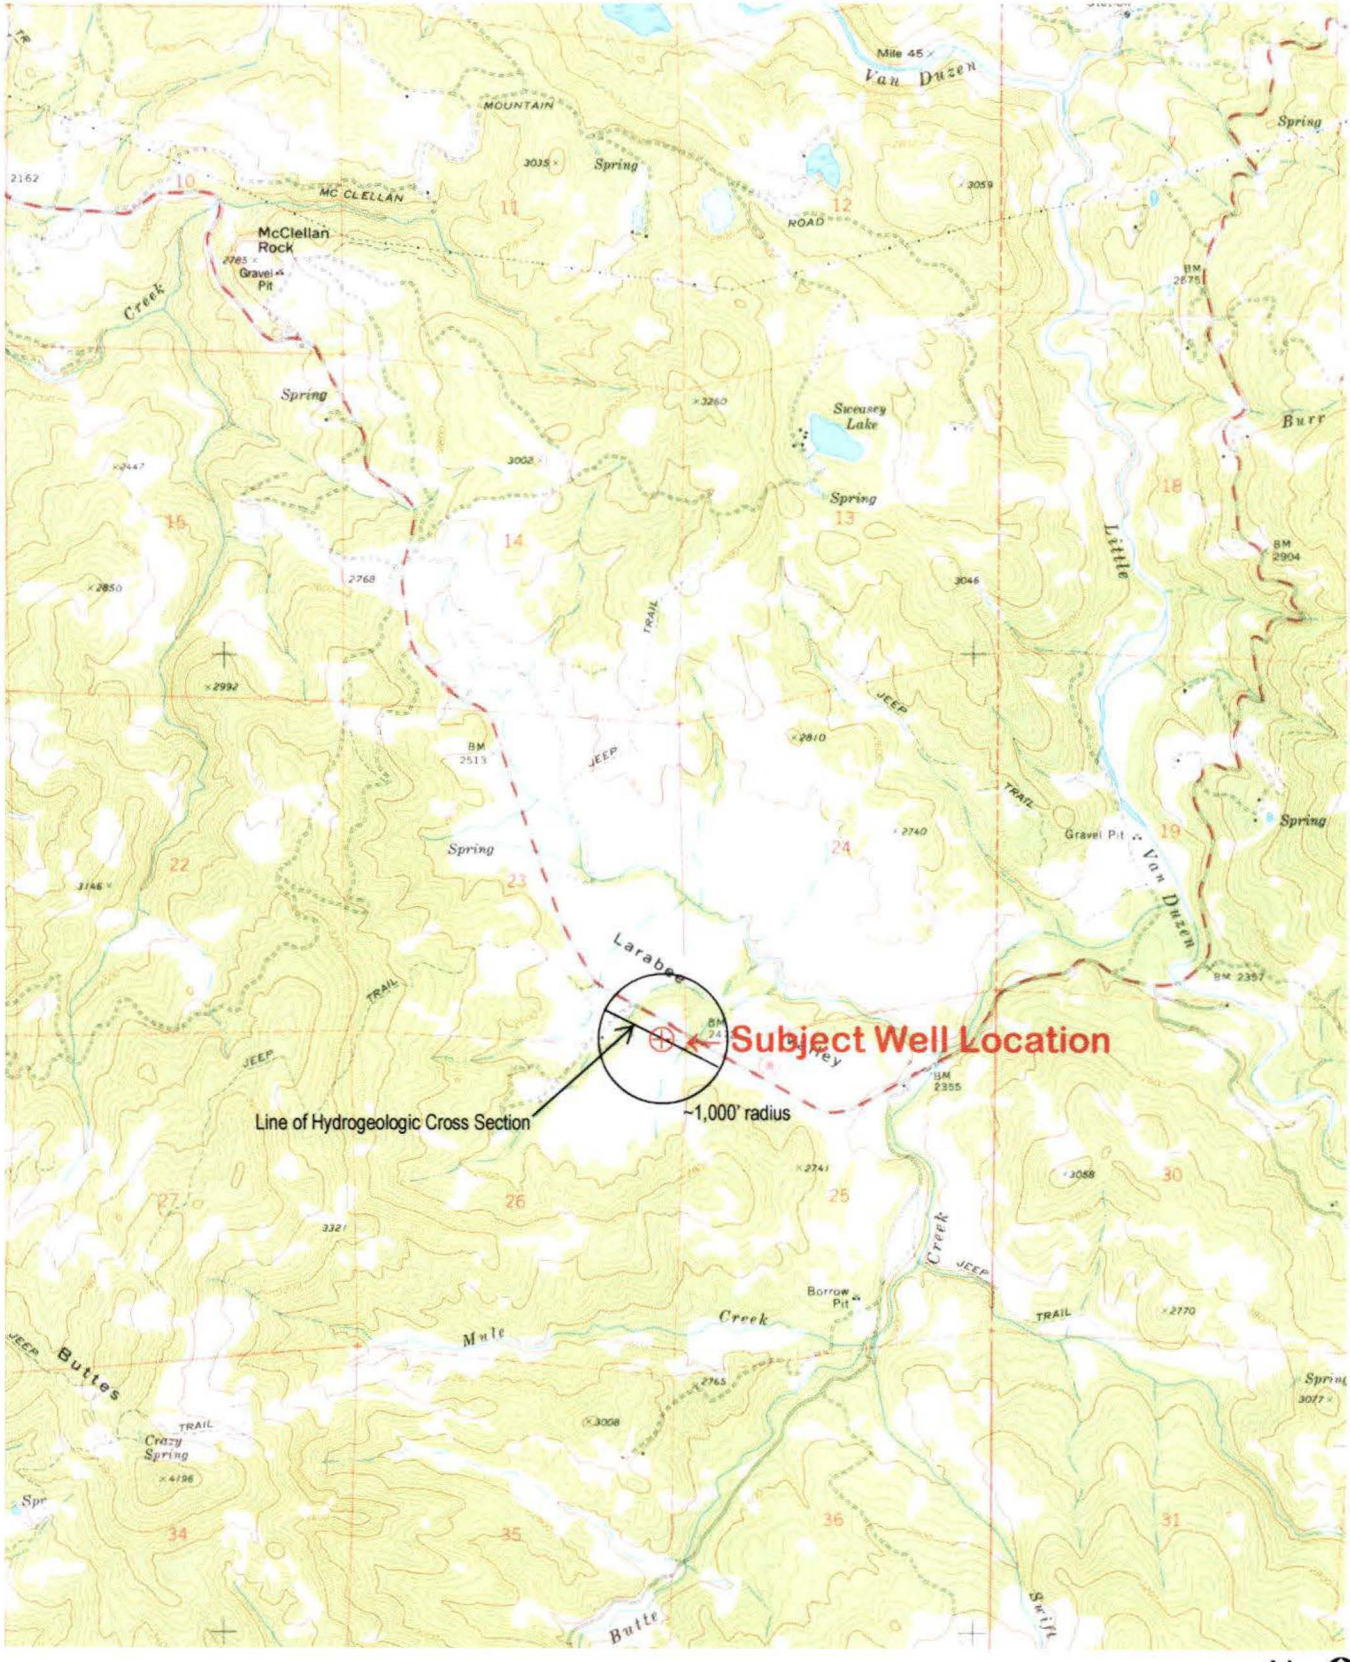
The Humboldt County WebGIS shows two ephemeral tributaries of Butte Creek, the nearest is more than 310 feet southeast of the well, while the other ephemeral stream is more than 640 feet northwest of the well (Figure 1). The property owner reported that both ephemeral streams are dry by mid-July. As stated, based on interpolation from the USGS "Larabee Valley, Calif." (1977), topographic quadrangle map (Figure 1), and the Humboldt County WebGIS, the well site elevation is 2,485 feet. The elevation of the ephemeral watercourse to the southeast is approximately 2,475 feet and the elevation of the ephemeral watercourse to the northwest is also approximately 2,475 feet. The well bottom elevation of the well is approximately 2,305 feet, making the nearest ephemeral watercourses 170 feet higher than the total depth of the well.

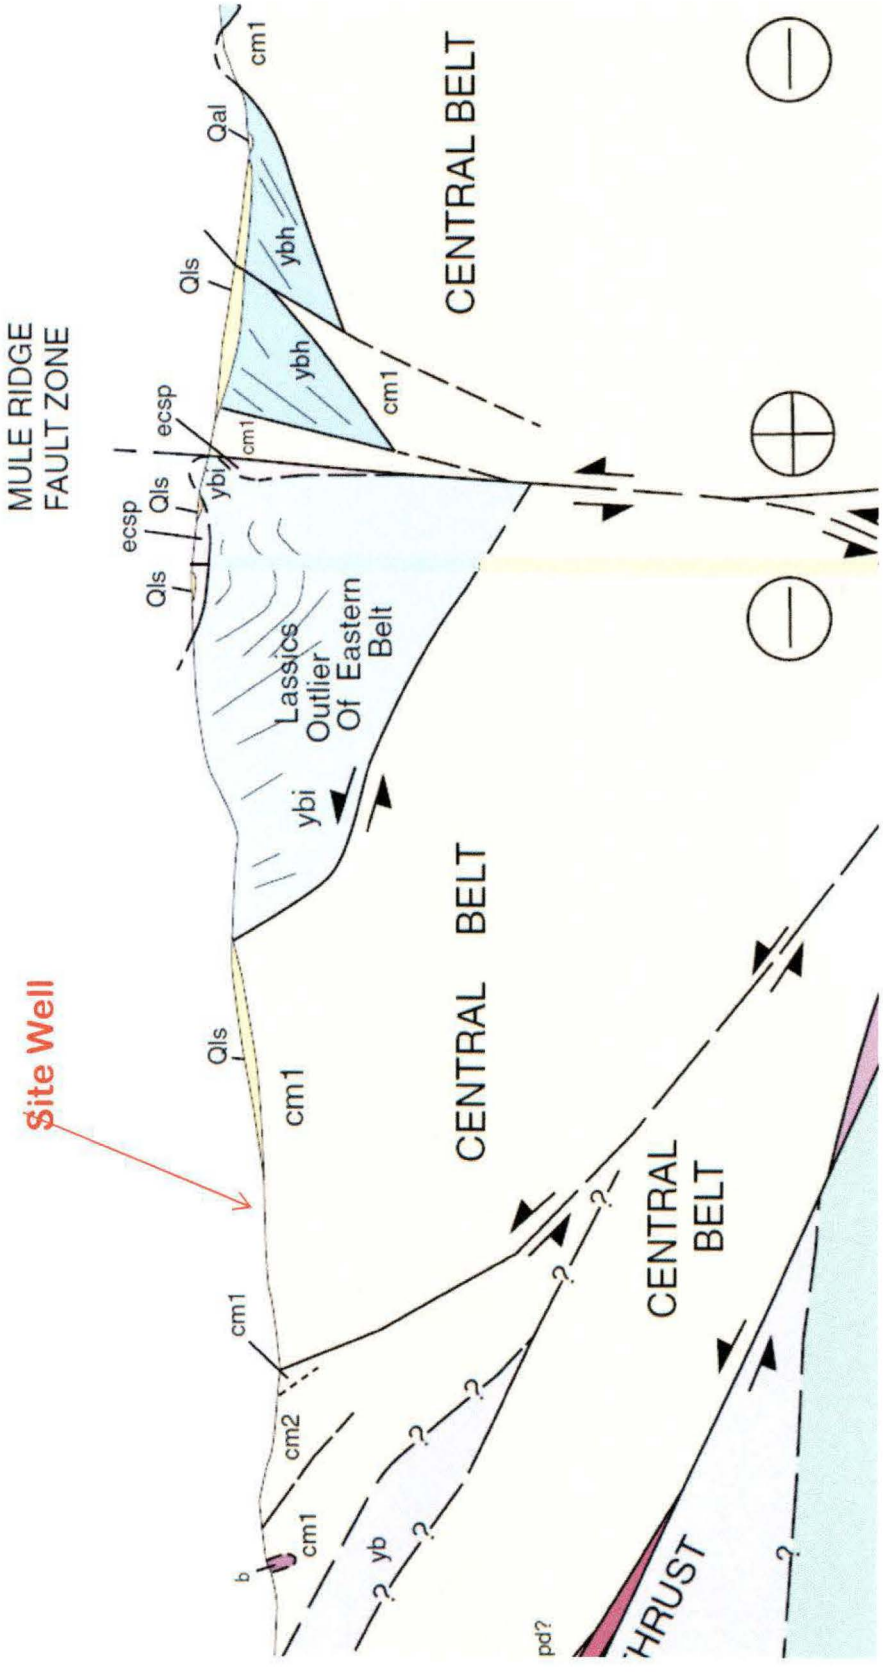
A geologic cross section of the area after McLaughlin et al., (2000) shows the structural and stratigraphic relationships between the regional geologic units (Figure 5). The central belt mélange is shown dipping east and bounded by thrust fault plane contacts. On-site, no dip of the rock units could be observed because they are mantled with soil and fluvial alluvium and obscured by vegetation. We interpret the faults in the subsurface to be hydrologic boundaries of reduced permeability (due to grinding and shearing along the fault planes), effectively separating units of the Franciscan Complex from each other hydrologically and limiting groundwater flow between these fault-bound units.

In this vertically exaggerated (~2x) cross section, the view is looking down slope toward the northeast. Groundwater flow in the cross section is away from the viewer, or into the page. Groundwater is presumed to flow from recharge areas in the higher ground to the southwest, to the northeast toward Larabee Valley and the unnamed tributary of Butte Creek. Bedrock subgrade is presumed to be composed of abundantly fractured Broken Formation (cb1) of the Central Belt of the Franciscan Complex. These deposits are one of several components of the Central Belt Franciscan Complex. Groundwater is envisioned as flowing through fractured zones in the Broken Formation. Fractures are interpreted to be the primary preferential flow paths for groundwater in this area.

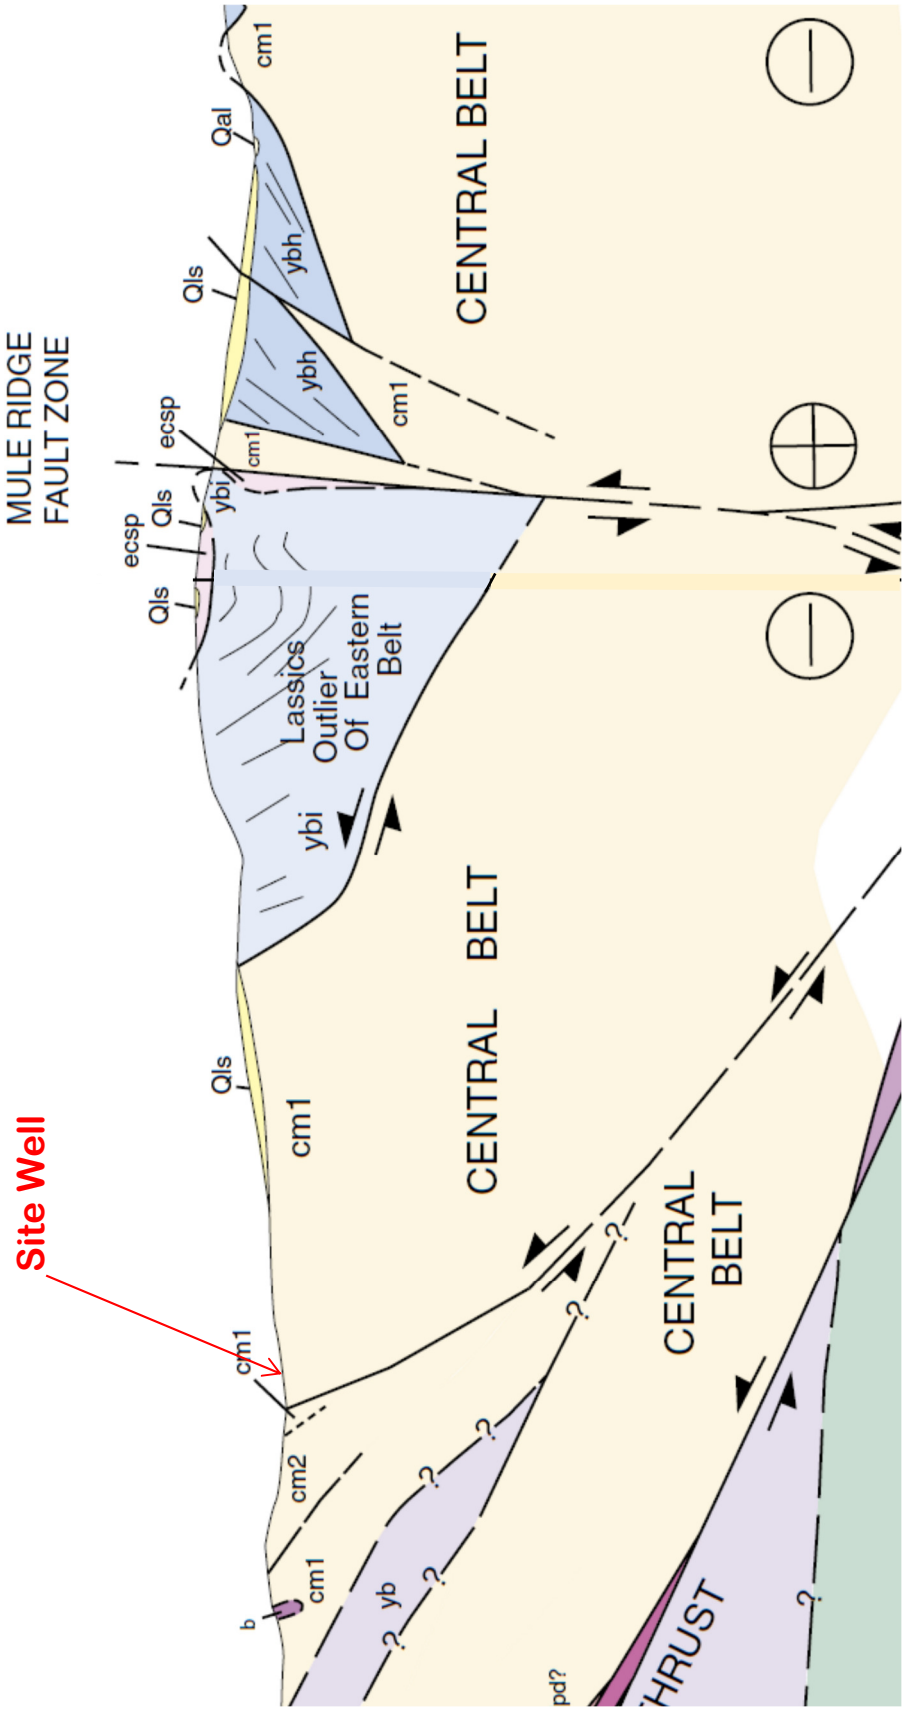
In this vertically exaggerated (~2x) cross section, the view is looking down slope and toward the northeast. Groundwater flow in the cross section is away from the viewer, or into the page. Groundwater is presumed to flow from recharge areas in the higher ground to the southwest, to the northeast toward Larabee Valley and the unnamed tributaries of Butte Creek. Bedrock subgrade is mapped by McLaughlin et al. (2000) as composed of abundantly fractured Broken Formation (cb1) of the Central Belt of the Franciscan Complex. Broken Formation is one of several components of the Central Belt Franciscan Complex. Groundwater is envisioned as flowing through fractured zones in the Broken Formation. Fractures are interpreted to be the primary permeability and providing preferential flow paths for groundwater in this area.

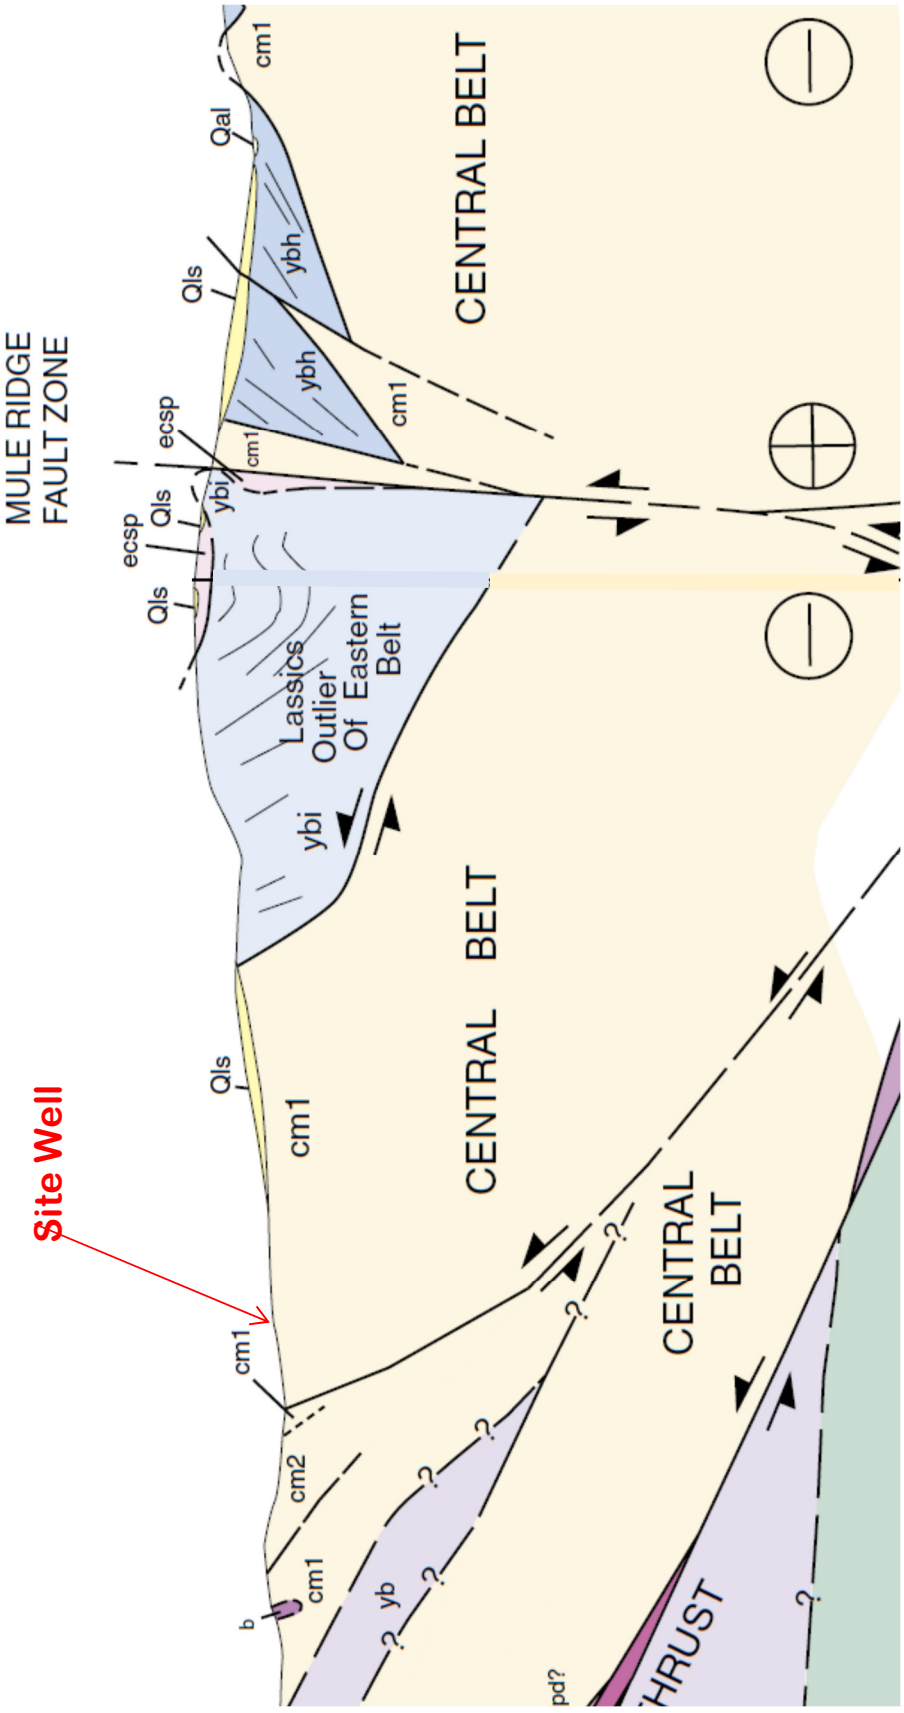
In this vertically exaggerated (~2x) cross section, the view is looking down slope toward the northeast. Groundwater flow in the cross section is away from the viewer, or into the page. Groundwater is presumed to flow from recharge areas in the higher ground to the southwest, to the northeast toward Larabee Valley and unnamed tributaries of Butte Creek. Bedrock subgrade is presumed to be composed of abundantly fractured Broken Formation (cb1) of the Central Belt of the Franciscan Complex. The Broken Formation deposits are one of several components of the Central Belt Franciscan Complex. Groundwater is envisioned as flowing through fractured zones in the Broken Formation. Fractures are interpreted to be the primary preferential flow paths for groundwater in this area.

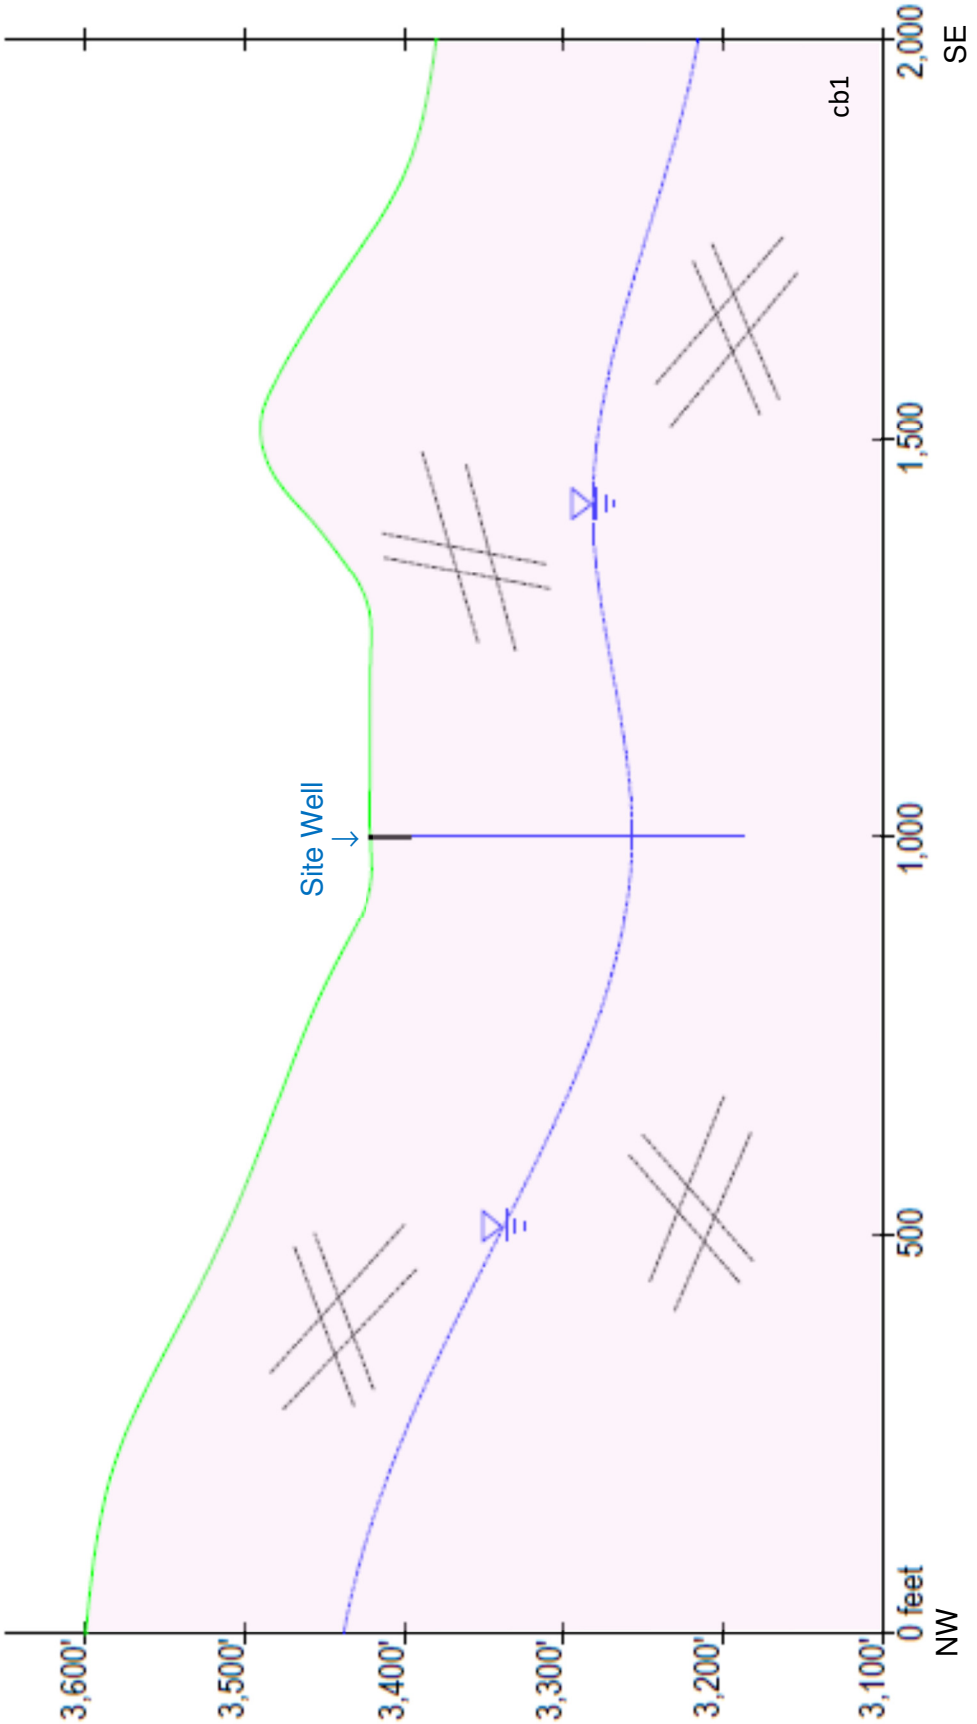
In this vertically exaggerated (~2x) cross section, the view is looking down slope and toward the northeast. Groundwater flow in this cross section is away from the viewer, or into the page. Groundwater is presumed to flow from recharge areas in the higher ground to the southwest, to the northeast toward Larabee Valley and unnamed tributaries of Butte Creek. Bedrock subgrade is mapped by McLaughlin et al. as composed of abundantly fractured Broken Formation (cb1) of the Central Belt of the Franciscan Complex. Broken Formation is one of several components of the Central Belt Franciscan Complex. Groundwater is envisioned as flowing through fractured zones in the Broken Formation. Fractures are interpreted to be the primary permeability and providing preferential flow paths for groundwater in this area.

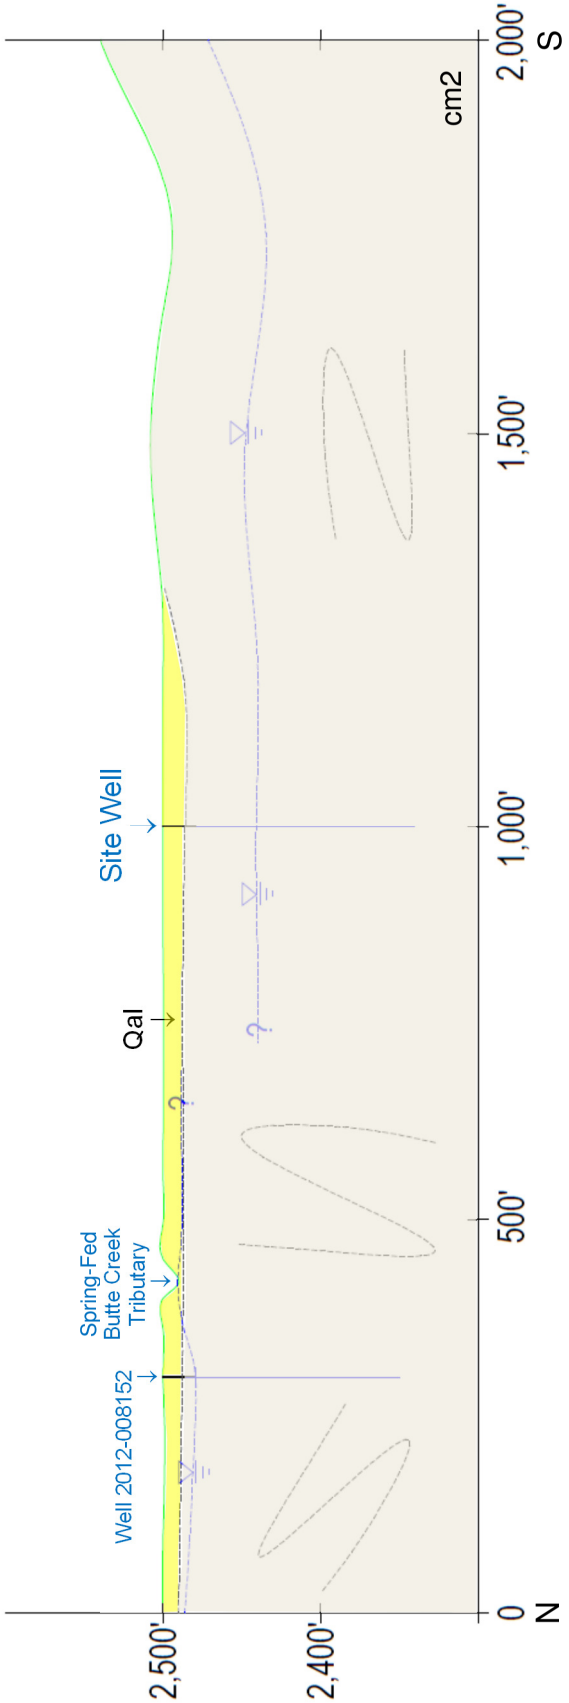
In this vertically exaggerated (~2x) cross section, the view is looking down slope and toward the east. Groundwater flow in this cross section is away from the viewer, or into the page. Groundwater is presumed to flow from recharge areas in the higher ground to the southwest, to the northeast toward Larabee Valley and unnamed tributaries of Butte Creek. Bedrock subgrade is mapped by McLaughlin et al. as composed of mélange (cm2) of the Central Belt of the Franciscan Complex. Mélange is one of several components of the Central Belt Franciscan Complex. Groundwater is envisioned as flowing through fractured zones in the metasandstone portion of the mélange. Fractures are interpreted to be the primary permeability and providing preferential flow paths for groundwater in this area. Differing water levels in the Site Well and well 2012-008152, indicate that they likely encountered different aquifers.
