PHASE I ENVIRONMENTAL SITE ASSESSMENT

Atascadero State Hospital Buffer Land – Phase I
Specific Portion – Paseo Paloma Project – Phase II
El Camino Real & San Rafael Road
Atascadero, CA 93422

Project No. 631049368

May 22, 2026

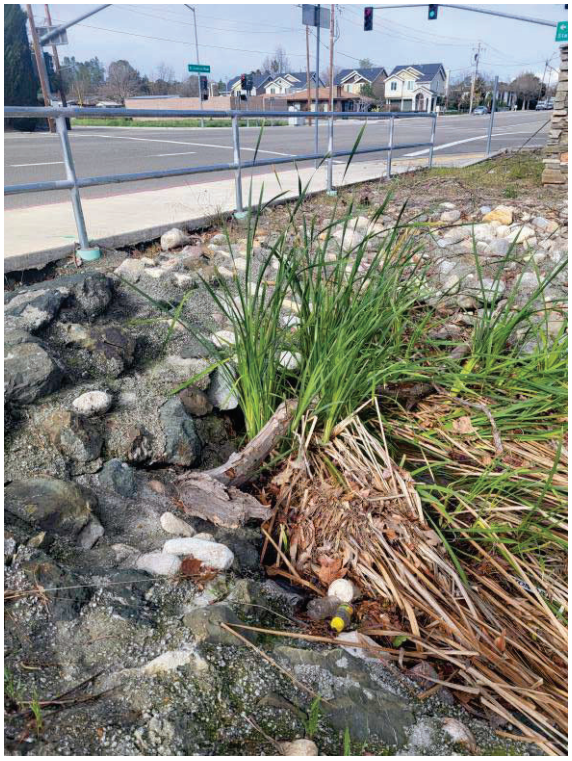
NW corner of the subject parcel at El Camino Real and San Rafael Rd. where stormwater and runoff flow into culverts running beneath El Camino Real.

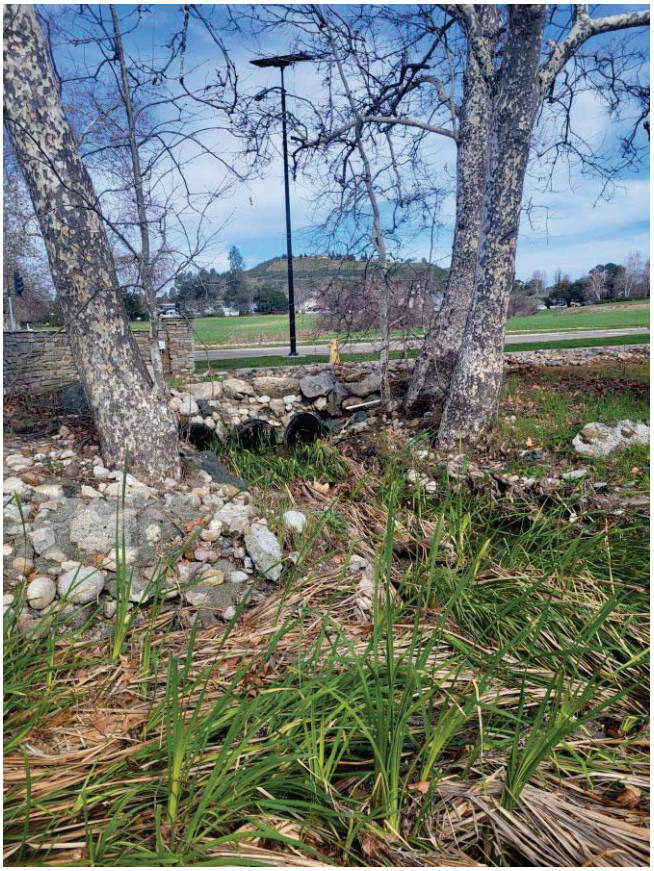
Photograph No 8

NW corner of the subject parcel at El Camino Real and San Rafael Rd. where stormwater and runoff flow into culverts running beneath El Camino Real.

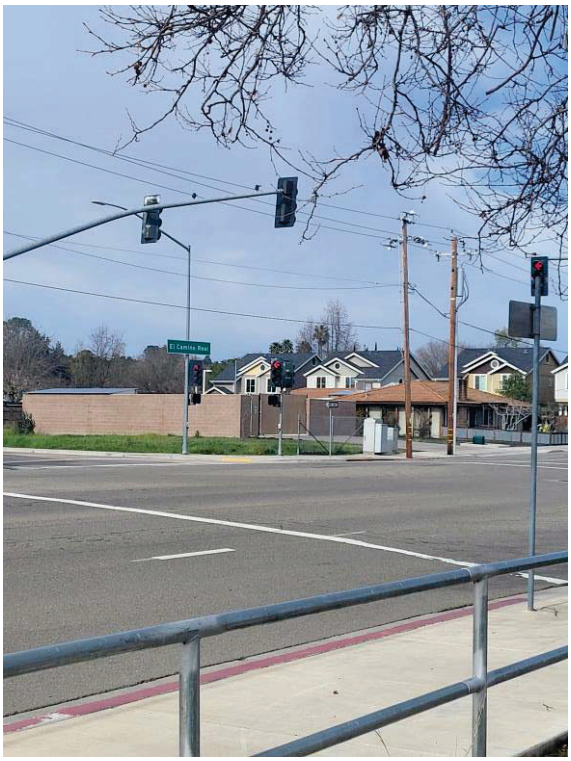
Lift Station; corner of El Camino Real and San Rafael Ct.; across from subject property
