Phase I Environmental Site Assessment

PHASE 1
ENVIRONMENTAL SITE ASSESSMENT

Undeveloped 18.39 Acre Parcels of Land
South Side of Alessandro Boulevard
Moreno Valley, California

Project 24-1851

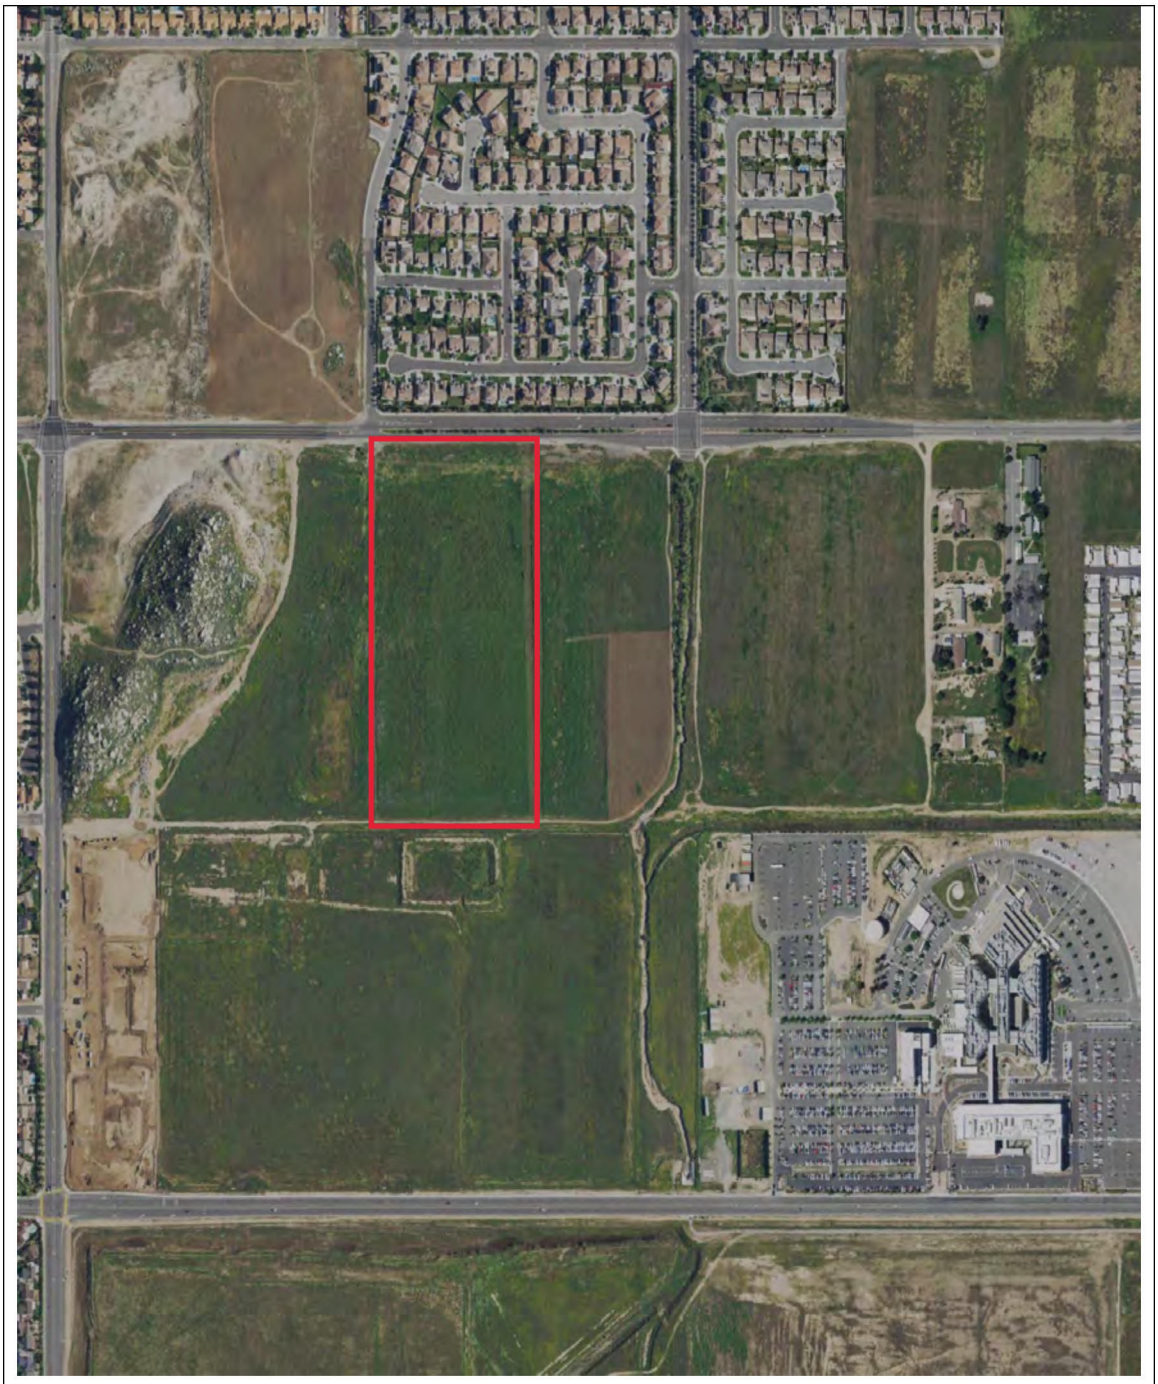
Hayden Environmental	2012 AERIAL PHOTOGRAPH Subject Property: Two Parcels on Alessandro Boulevard; Moreno Valley, California	↑ **NORTH**
JOB NUMBER: 24-1851	Date: 5/21/24	FIGURE: C-5

- An aerial photograph taken in **2012** showed the Subject Property and the adjoining properties to the east and west to be undeveloped, with no evidence of activity observed. The adjoining property to the north, across Alessandro Boulevard, was shown to have been developed with single family residences. In the adjoining area to the south was a dry reservoir and an undeveloped area. The structures to the southwest had been demolished. A small creek was shown to the east and a rocky hill was shown to the west. A large medical facility was shown to the southeast. Residences and a mobile home park were shown to the east. Much of the area to the south shown to be undeveloped. Tracts of single family residences were shown to the northeast, west, southwest, north and northwest. A copy of this aerial photograph can be seen as Figure C-5 in Appendix C.
