Tree Inventory Report

**Hope Village Residential Development Project Site,
Los Angeles, California
800 North Main Street – 1081 North Vignes Street
Los Angeles Council District 14**

March 7, 2024

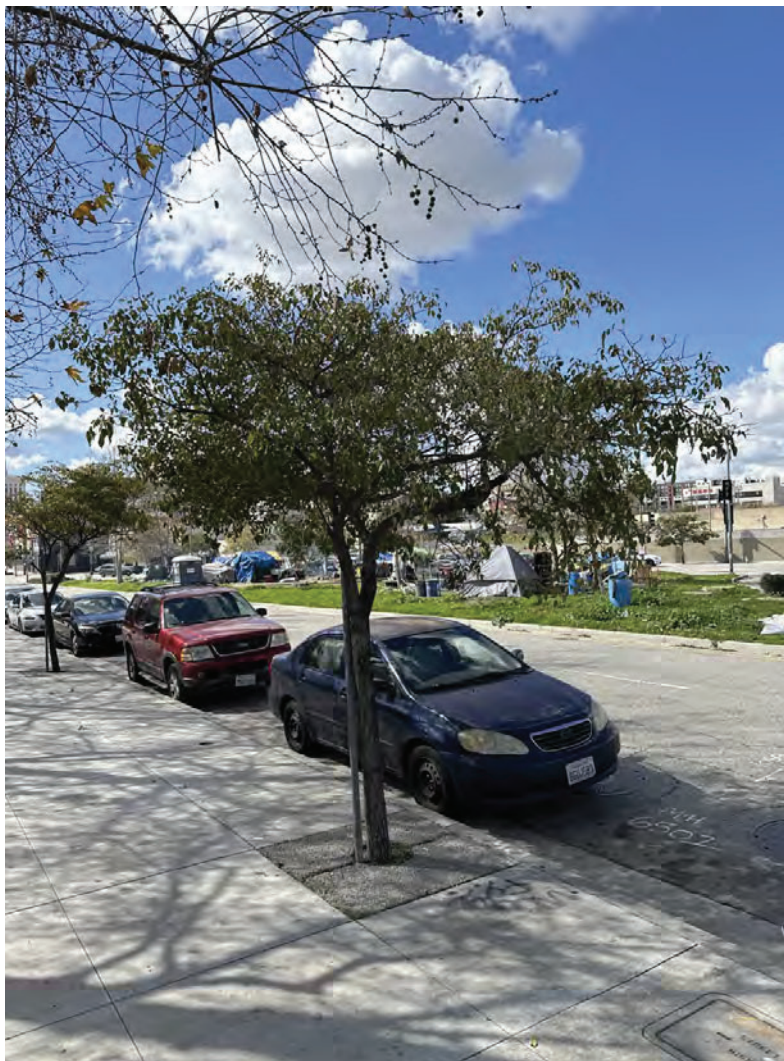
Photo 69. View of Tree 80

79	London plane tree <i>Platanus x hispanica</i>	Planted	street tree	Non-Protected	1	10.9	-	-	-	10.9	35	25	3	3	Preserve	N/A	N/A	N/A	Concrete cutout by street. Graffiti. Trunk wounds. Past pruning.
80	pink trumpet tree <i>Handroanthus heptaphyllus</i>	Planted	street tree	Non-Protected	1	5.6	-	-	-	5.6	10	15	2	2	No Impact	N/A	N/A	N/A	Concrete cutout. Wound damage. Graffiti. Leaf blight.
81	pink trumpet tree <i>Handroanthus heptaphyllus</i>	Planted	street tree	Non-Protected	1	4.5	-	-	-	4.5	10	10	2	2	No Impact	N/A	N/A	N/A	Concrete cutout. Wound damage. Graffiti. Leaf blight.
82	pink trumpet tree <i>Handroanthus heptaphyllus</i>	Planted	street tree	Non-Protected	1	3.9	-	-	-	3.9	10	5	2	2	No Impact	N/A	N/A	N/A	Concrete cutout. Wound damage. Graffiti. Leaf blight.
83	pink trumpet tree <i>Handroanthus heptaphyllus</i>	Planted	street tree	Non-Protected	1	4.2	-	-	-	4.2	12	12	3	3	No Impact	N/A	N/A	N/A	Concrete cutout. Wound damage. Graffiti. Leaf blight.
