## 142-150 EAST SANTA CLARA STREET HISTORIC TREATMENT REPORT

SAN JOSE, CALIFORNIA  
[20053]

PREPARED FOR:  
BAYVIEW DEVELOPMENT GROUP

December 3, 2021

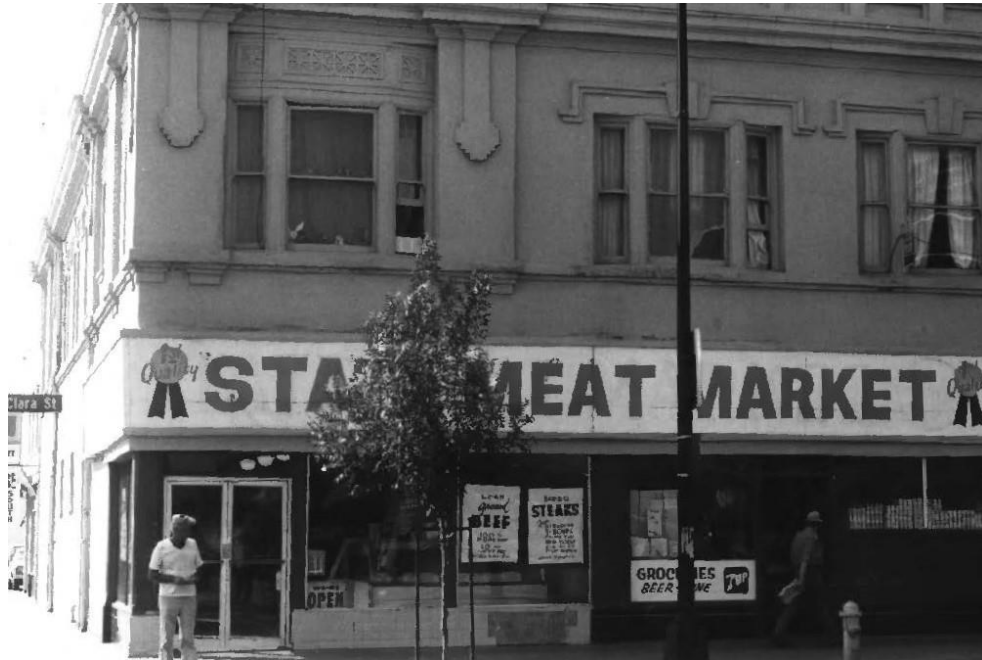
Though the original location of the storefront entries is not documented in building permit history or historic photographs identified to date, it is apparent through review of historic photographs that the entrance to unit 150 was at one time immediately adjacent to the northeast corner of the building (**Figure 3**). By 2005, this entrance had been centered within the storefront for its commercial unit (**Figure 4**).

Figure 3. Detail from ca. 1980 photograph of subject building with entrance at corner of storefront nearest South 4th Street. Source: National Register documentation for the Downtown Commercial Historic District.

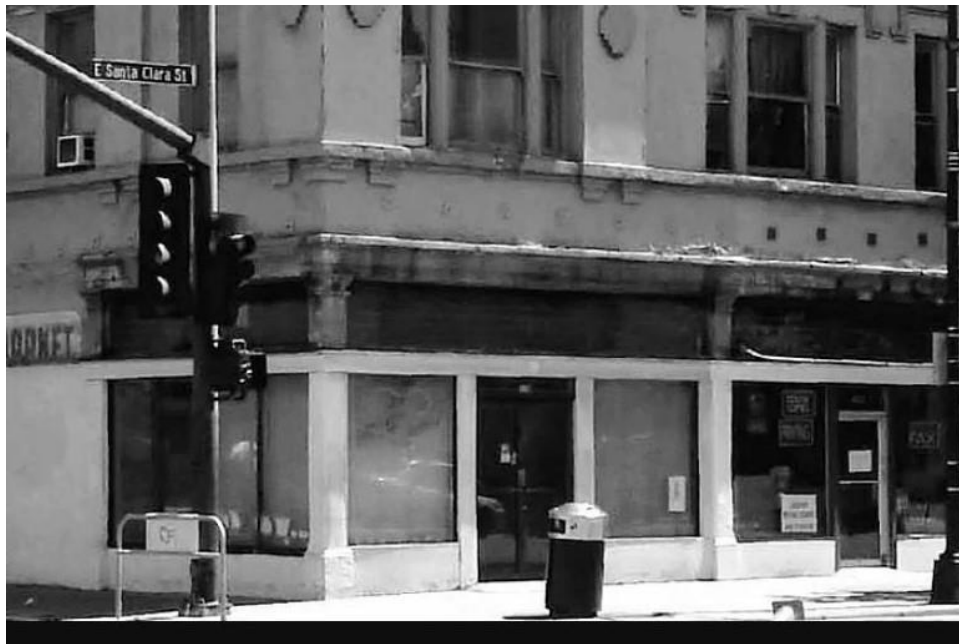
Figure 4. Detail from undated pre-2005 photograph of subject building with entrance centered in northeast storefront. Source: M. Sandoval Architects, Inc.
