## Preliminary Arborist Report

Bellarmino College Preparatory  
960 W. Hedding Street  
San Jose, CA

Kier & Wright  
3350 Scott Boulevard, Building 22  
Santa Clara, CA

**August 30, 2022**

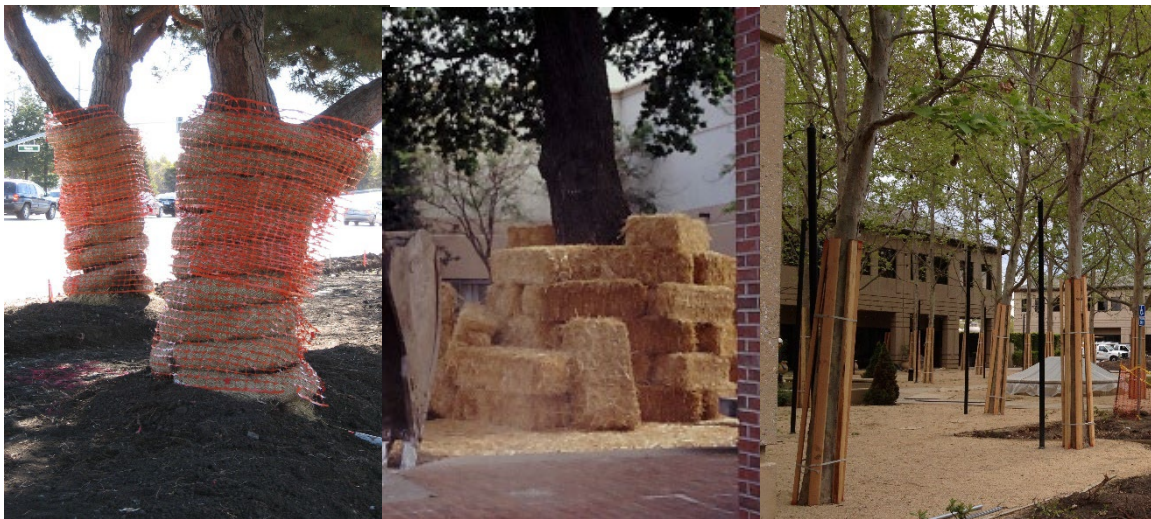
4. Where demolition must occur close to trees, such as removing curb and pavement, install temporary trunk protection devices such as winding silt sock wattle or wood planks around trunks or stacking hay bales around tree trunks to a height of approximately 5'. Any low branches that are within the work zone should also be protected. Remove trunk protection after demolition is completed and install protective fence at the limits of the tree protection zone. Do not retain wattling around tree trunks for more than 2-3 weeks to avoid damaging trunks from excess moisture.
