**FAULT STUDY
PROPOSED WAREHOUSE DEVELOPMENT**

NEC Todd Avenue and 10th Street

Azusa, California

Project No.: **22G144-2**

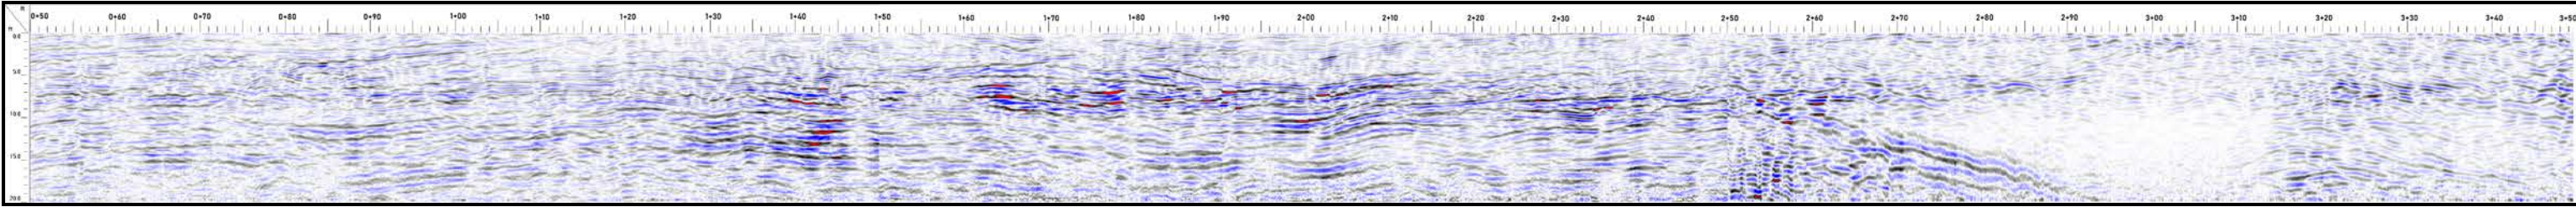
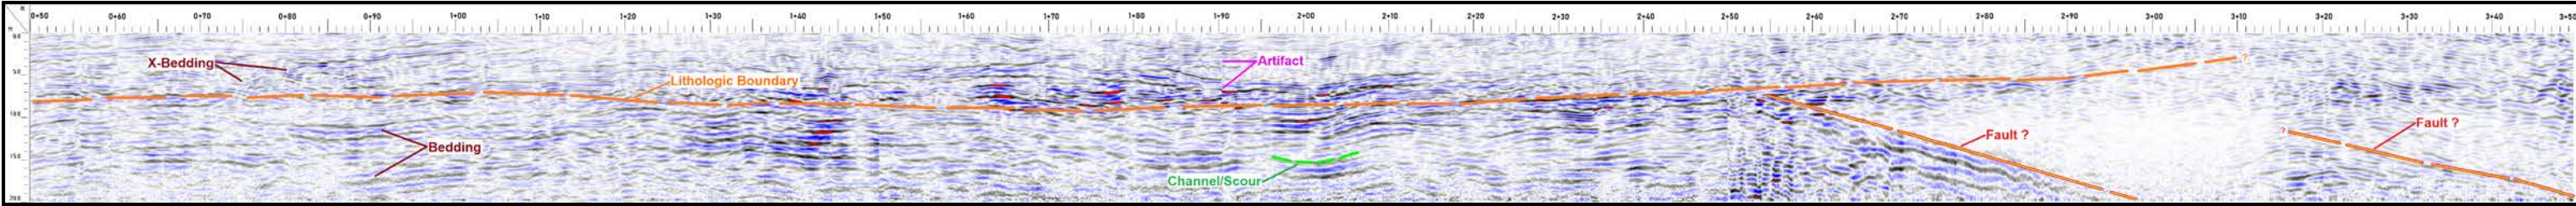
SURVEY LINE GPR-1

The field survey consisted of performing two survey traverse lines (GPR-1 and GPR-2) along the bottom of the existing exploratory trench excavation (see survey photographs, Plate 3), as presented on Plates 1 and 2. Both traverses started at a distance of 50 feet from the beginning of each exploratory trench FT-1 and FT-2 at Station 0+50, due to the sloping nature of the trench ends. GPR-1 was extended a total of 300 feet along the bottom of Exploratory Trench FT-1 ending at Station 3+50 where the trench ramp began to slope steeply upwards. GPR-2 was extended a total of 200 feet along the bottom of Exploratory Trench FT-1 ending at Station 2+50 also where the trench ramp began to slope steeply upwards. Upon completion of these traverses, the images were reviewed in the field for quality control purposes.

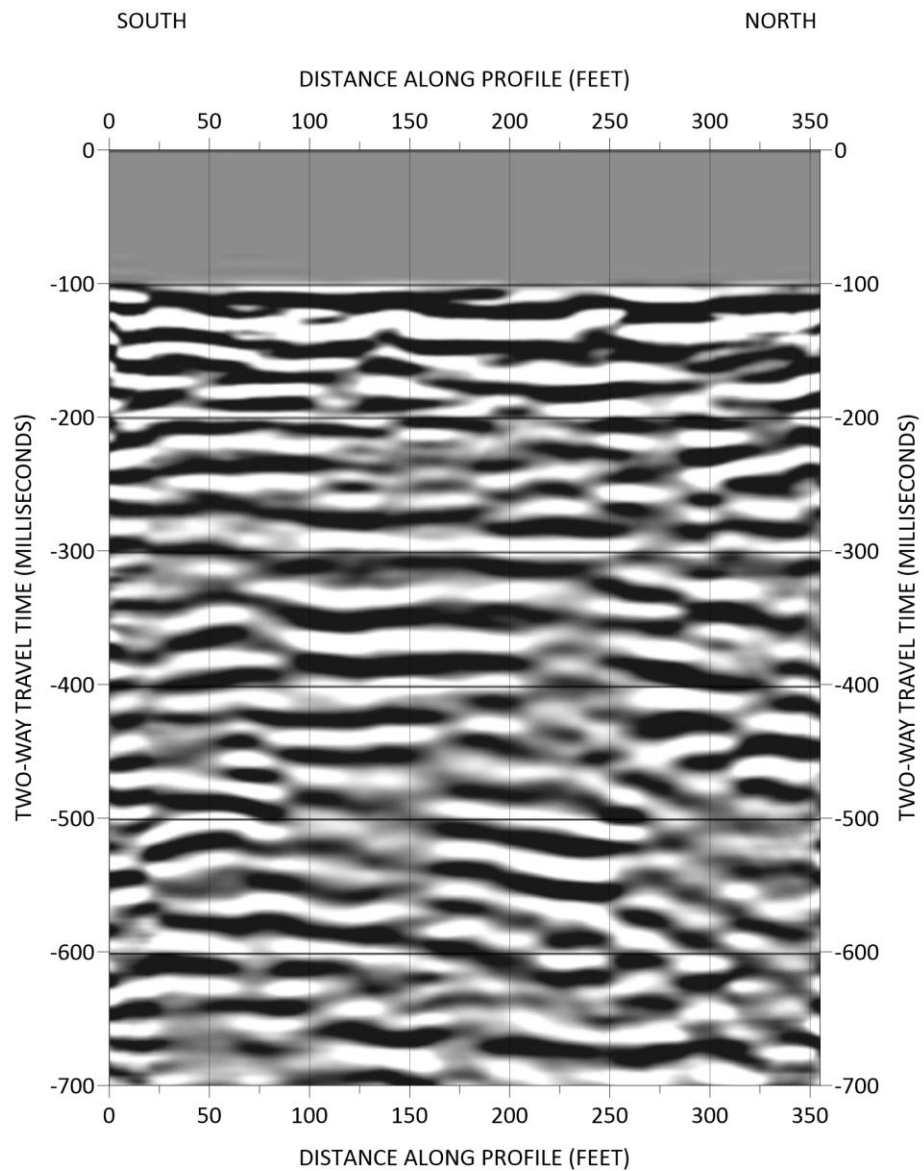
Appendix Figure 2 – Seismic Line Relative Trace Amplitude

- Uninterpreted, P-wave migrated, enhanced trace amplitude seismic sections with post-stack processing (spectral balancing and trace equalization). Referred to as Relative Amplitude section in Figure 2. This is a common presentation of seismic reflection data.

Figures 2, 4 and 5 show seismic events in the travel time data interpreted as being caused by lithologic interfaces with significant impedance contrast (reflectors). There is some ~20 millisecond anticlinal displacement in some of the events at the southern end of the line, projecting to the surface at our profile distance of ~50-75 feet, but this feature does not clearly extend through the shallower reflection events. As this feature is not imaged in the shallow time-section, it could be caused by a structure out of plane or oblique to the survey line and we cannot determine this attitude of the feature without parallel survey lines.

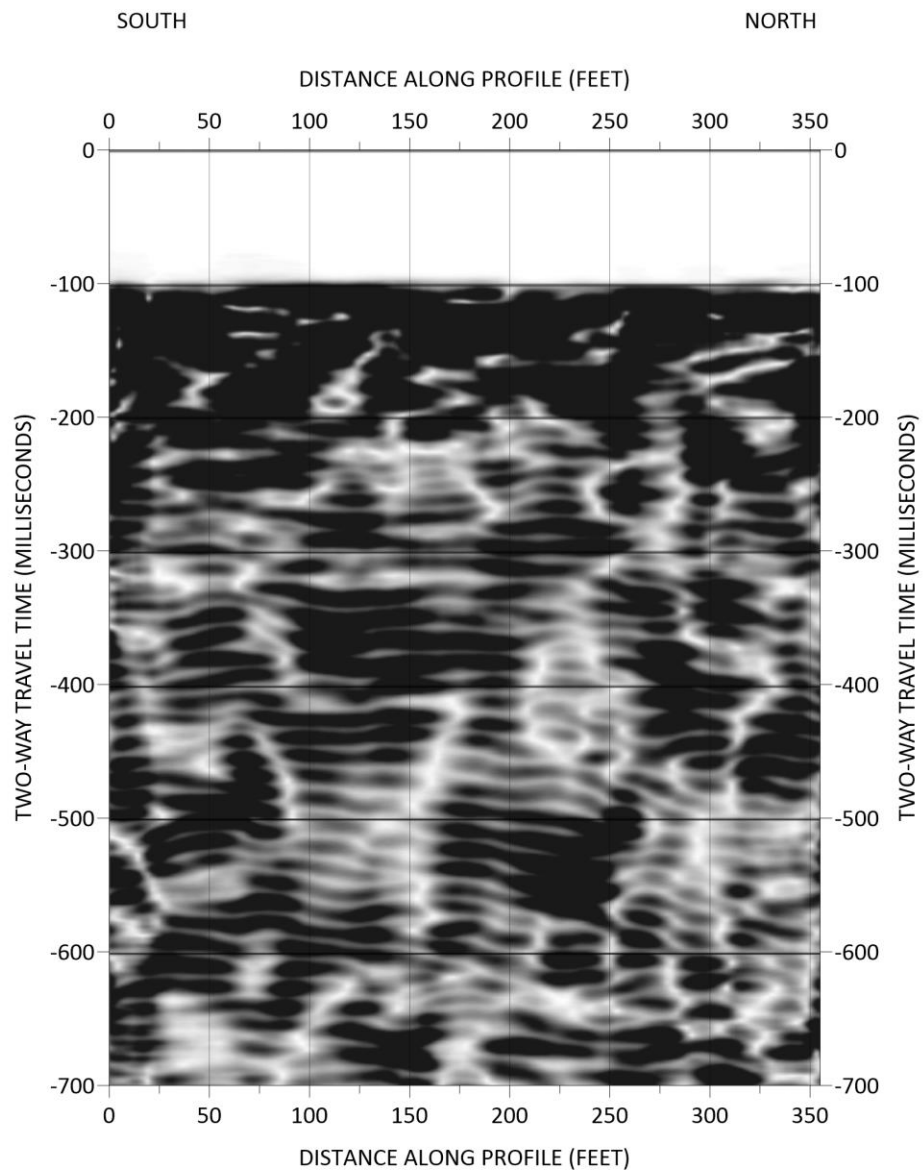
Appendix Figure 3 – Seismic Line Signal Envelope

- Uninterpreted, P-wave migrated, enhanced amplitude envelope seismic sections with post-stack processing (spectral balancing and FX predictive deconvolution). Referred to as Signal Envelope section in Figure 3. Amplitude Envelope generally depicts the energy level of the seismic signal. It is the “signal” where the seismic wave is the carrier. Many faults or discontinuities show a change in this attribute from one side to the other.

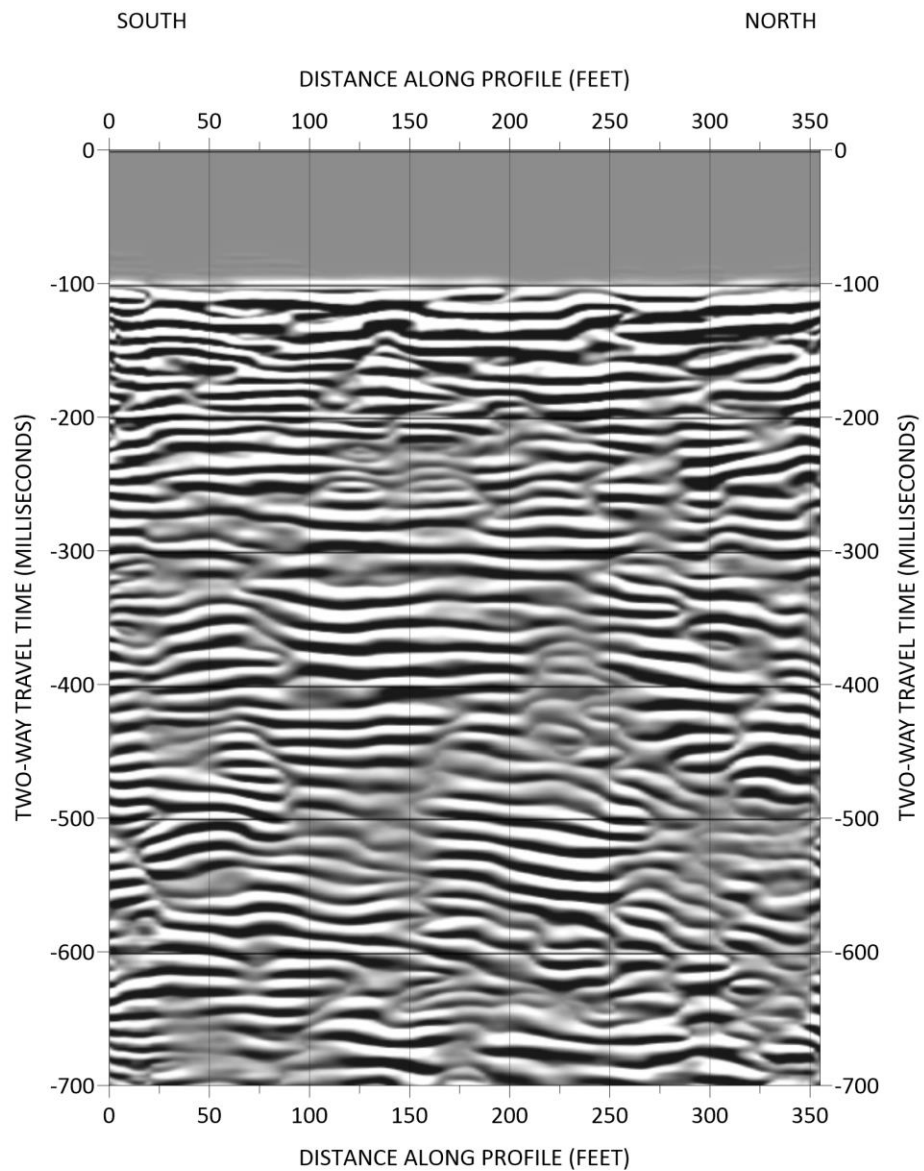
Appendix Figure 4 – Seismic Line Pseudo-Relief

- Uninterpreted, P-wave migrated, enhanced trace amplitude seismic sections with post-stack processing (spectral balancing and FX predictive deconvolution). Referred to as pseudo relief section in Figure 4. Pseudo relief attributes are used to promote easier interpretation of structural features – in particular, faults and horizons. The RMS amplitude of the trace signal is calculated, and an inverse Hilbert transform is applied across a user-defined window of samples (3 was used for this project, a smoothing scalar less than half the period of the wavelet at a reflector). The pseudo-relief attribute is popular for adding apparent texture to a flat 2D cross-section of often overloading polarity reversals and signal characters.
