Hazardous Building Material Survey Long Beach City College – Liberal Arts Campus Veterans Stadium and Ticket Booth Structures 4901 East Carson Street Long Beach, California 90808

Long Beach Community College District 4901 East Carson Street – G21 | Long Beach, California 90808

May 9, 2024 | Project No. 210407005

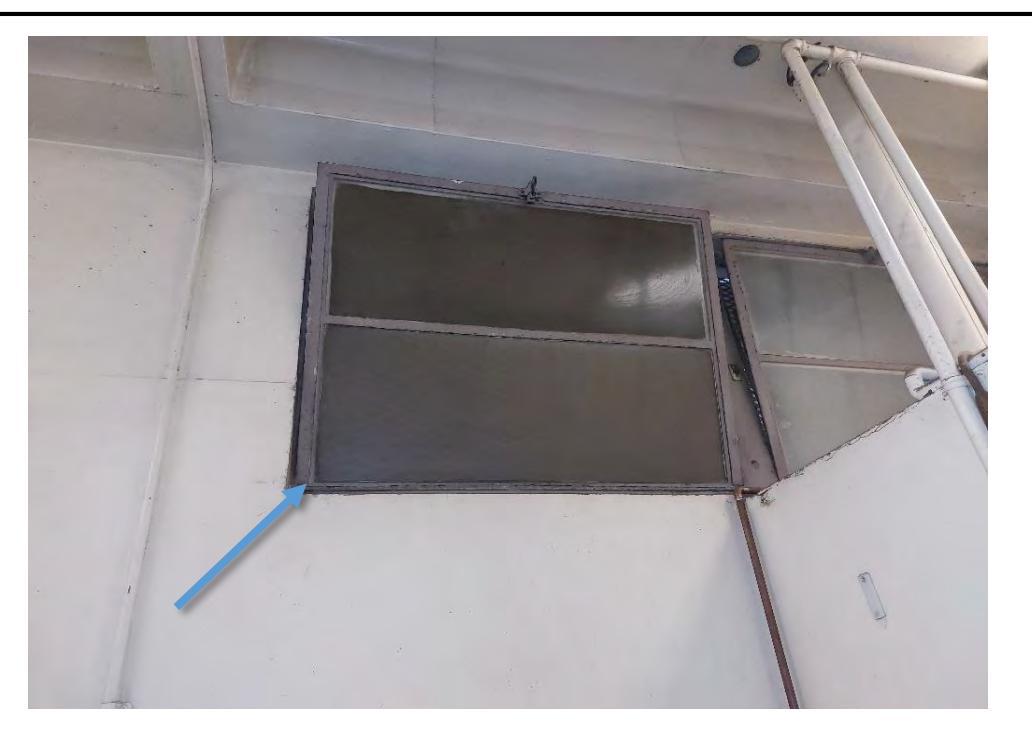
Photograph 17: View of the PCB sample location of the window putty on the exterior windows.

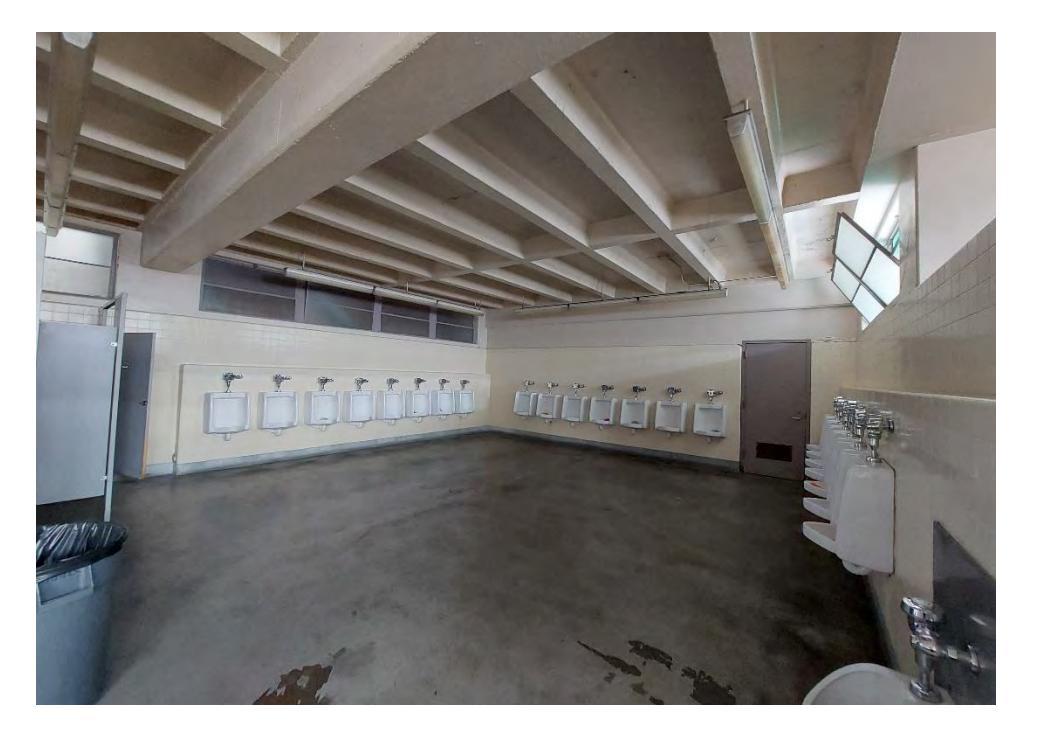
Photograph 18:

Representative view of the PCB sample location of the caulking associated with the sinks, toilets, and urinals throughout.

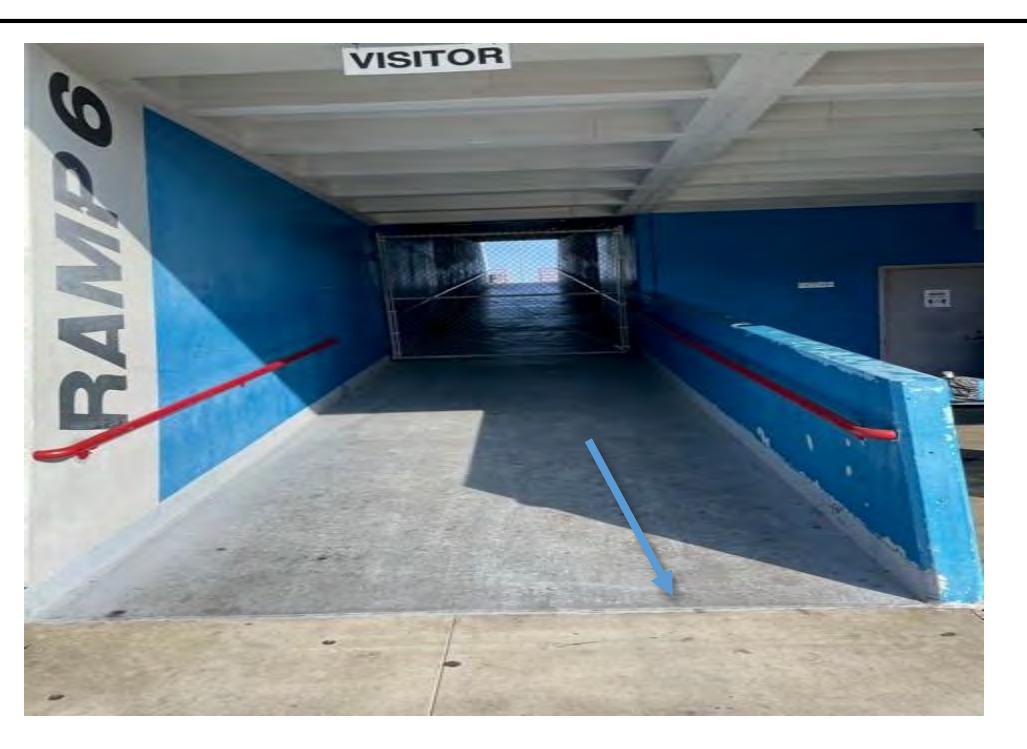
Photograph 19:

Representative view of the PCB sample location of the caulking associated with the exterior expansion joints (ramps and stadium seating throughout.

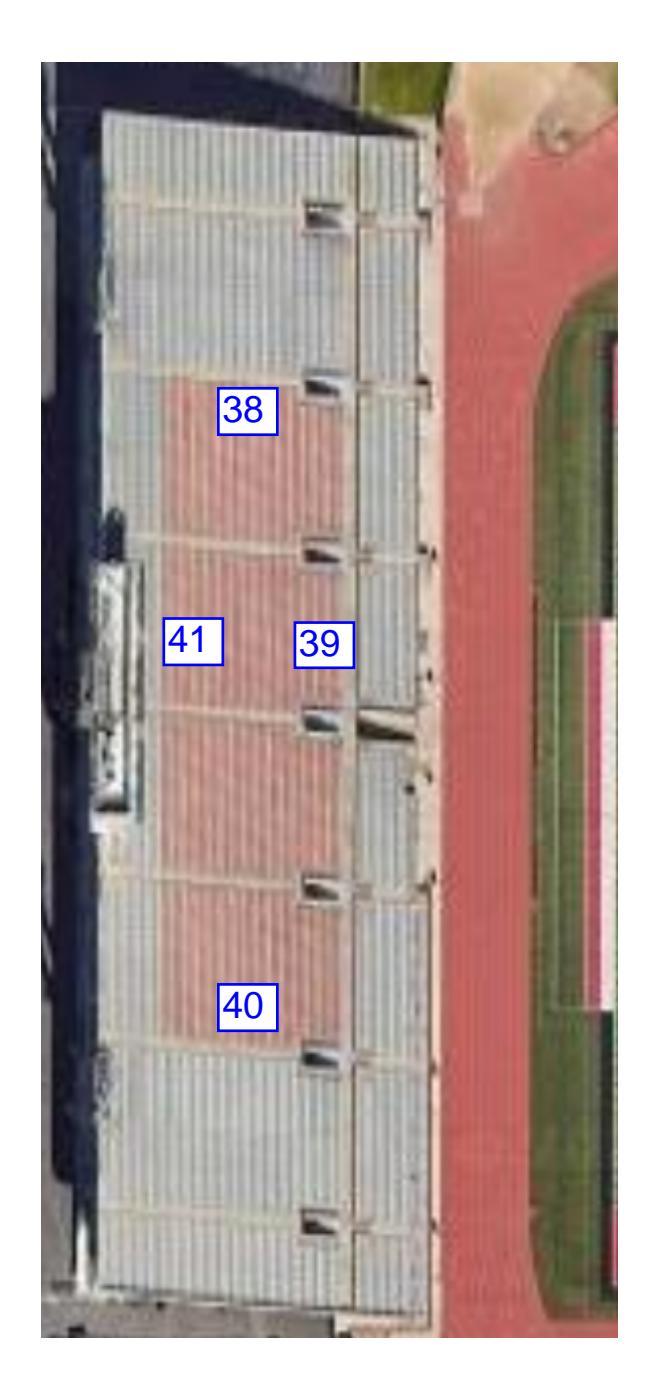
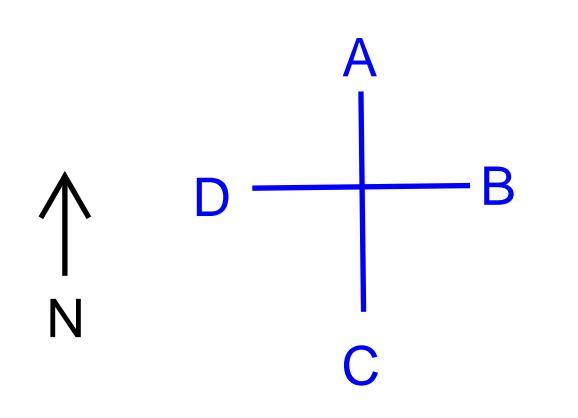
Field

Positive XRF scan location
