Tree Inventory Report

RE: Revised Arborist Report for Development on a Portion of Sunset Las Palmas Studio at 6650 W. Romaine in Los Angeles, Ca (APN 5532-014-039)

ARBORIST LETTER REPORT

Sunset Las Palmas Studio

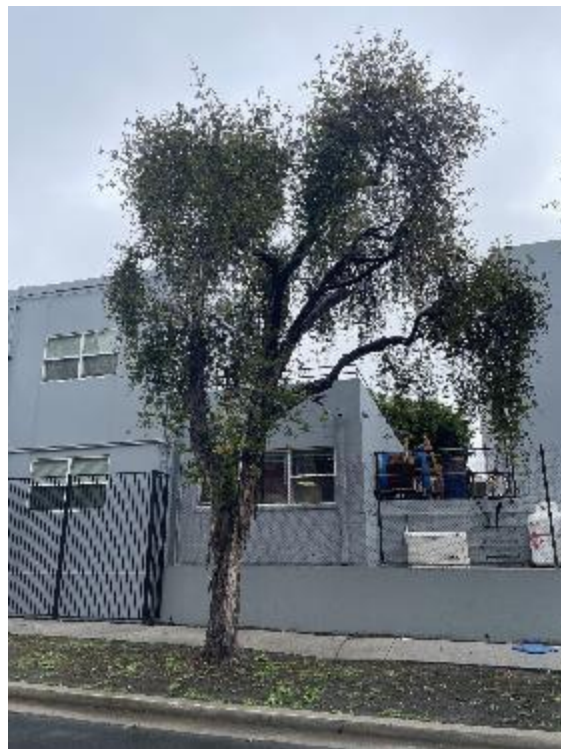
Tree 23

Based on the entitlement landscape plan and root zone calculations, three (3) trees (#22, #23, and #43) would require removal to allow for a new driveway installation. In addition, trees 3, 4, 5 (along Barton Ave) and trees 18, 19, 20, 21, 24, 25, 26 and 27 (along N. Las Palmas Ave.) are proposed for removal based on the site development plans and anticipated sidewalk and roadway dedication and improvements areas. . As shown in Appendix D, only tree 18 has moderate priority for preservation, while all other trees adjacent to the site are not recommended for preservation. Based on development plans, trees 37, 38, 39, 40, 41, and 42 (along Romaine St) could remain in place even during and after construction and because there are not sidewalk and roadway dedications and improvements anticipated in this area. However, note that all the trees along Romaine St are identified in this report as trees not recommended for preservation due to the existing condition of the trees. If any trees are to be retained, especially along Romaine St, then specific tree protection measures may be required for those trees immediately adjacent to the construction area or that may be impacted by demolition, new sidewalk features, or new footings/utilities for buildings or structures. Trees NP-1 - NP-4 will be removed during grading and will not require permitting or replacement per ordinance. Any trees removed would be replaced in accordance with the applicable tree replacement ratios and applicable ordinances.

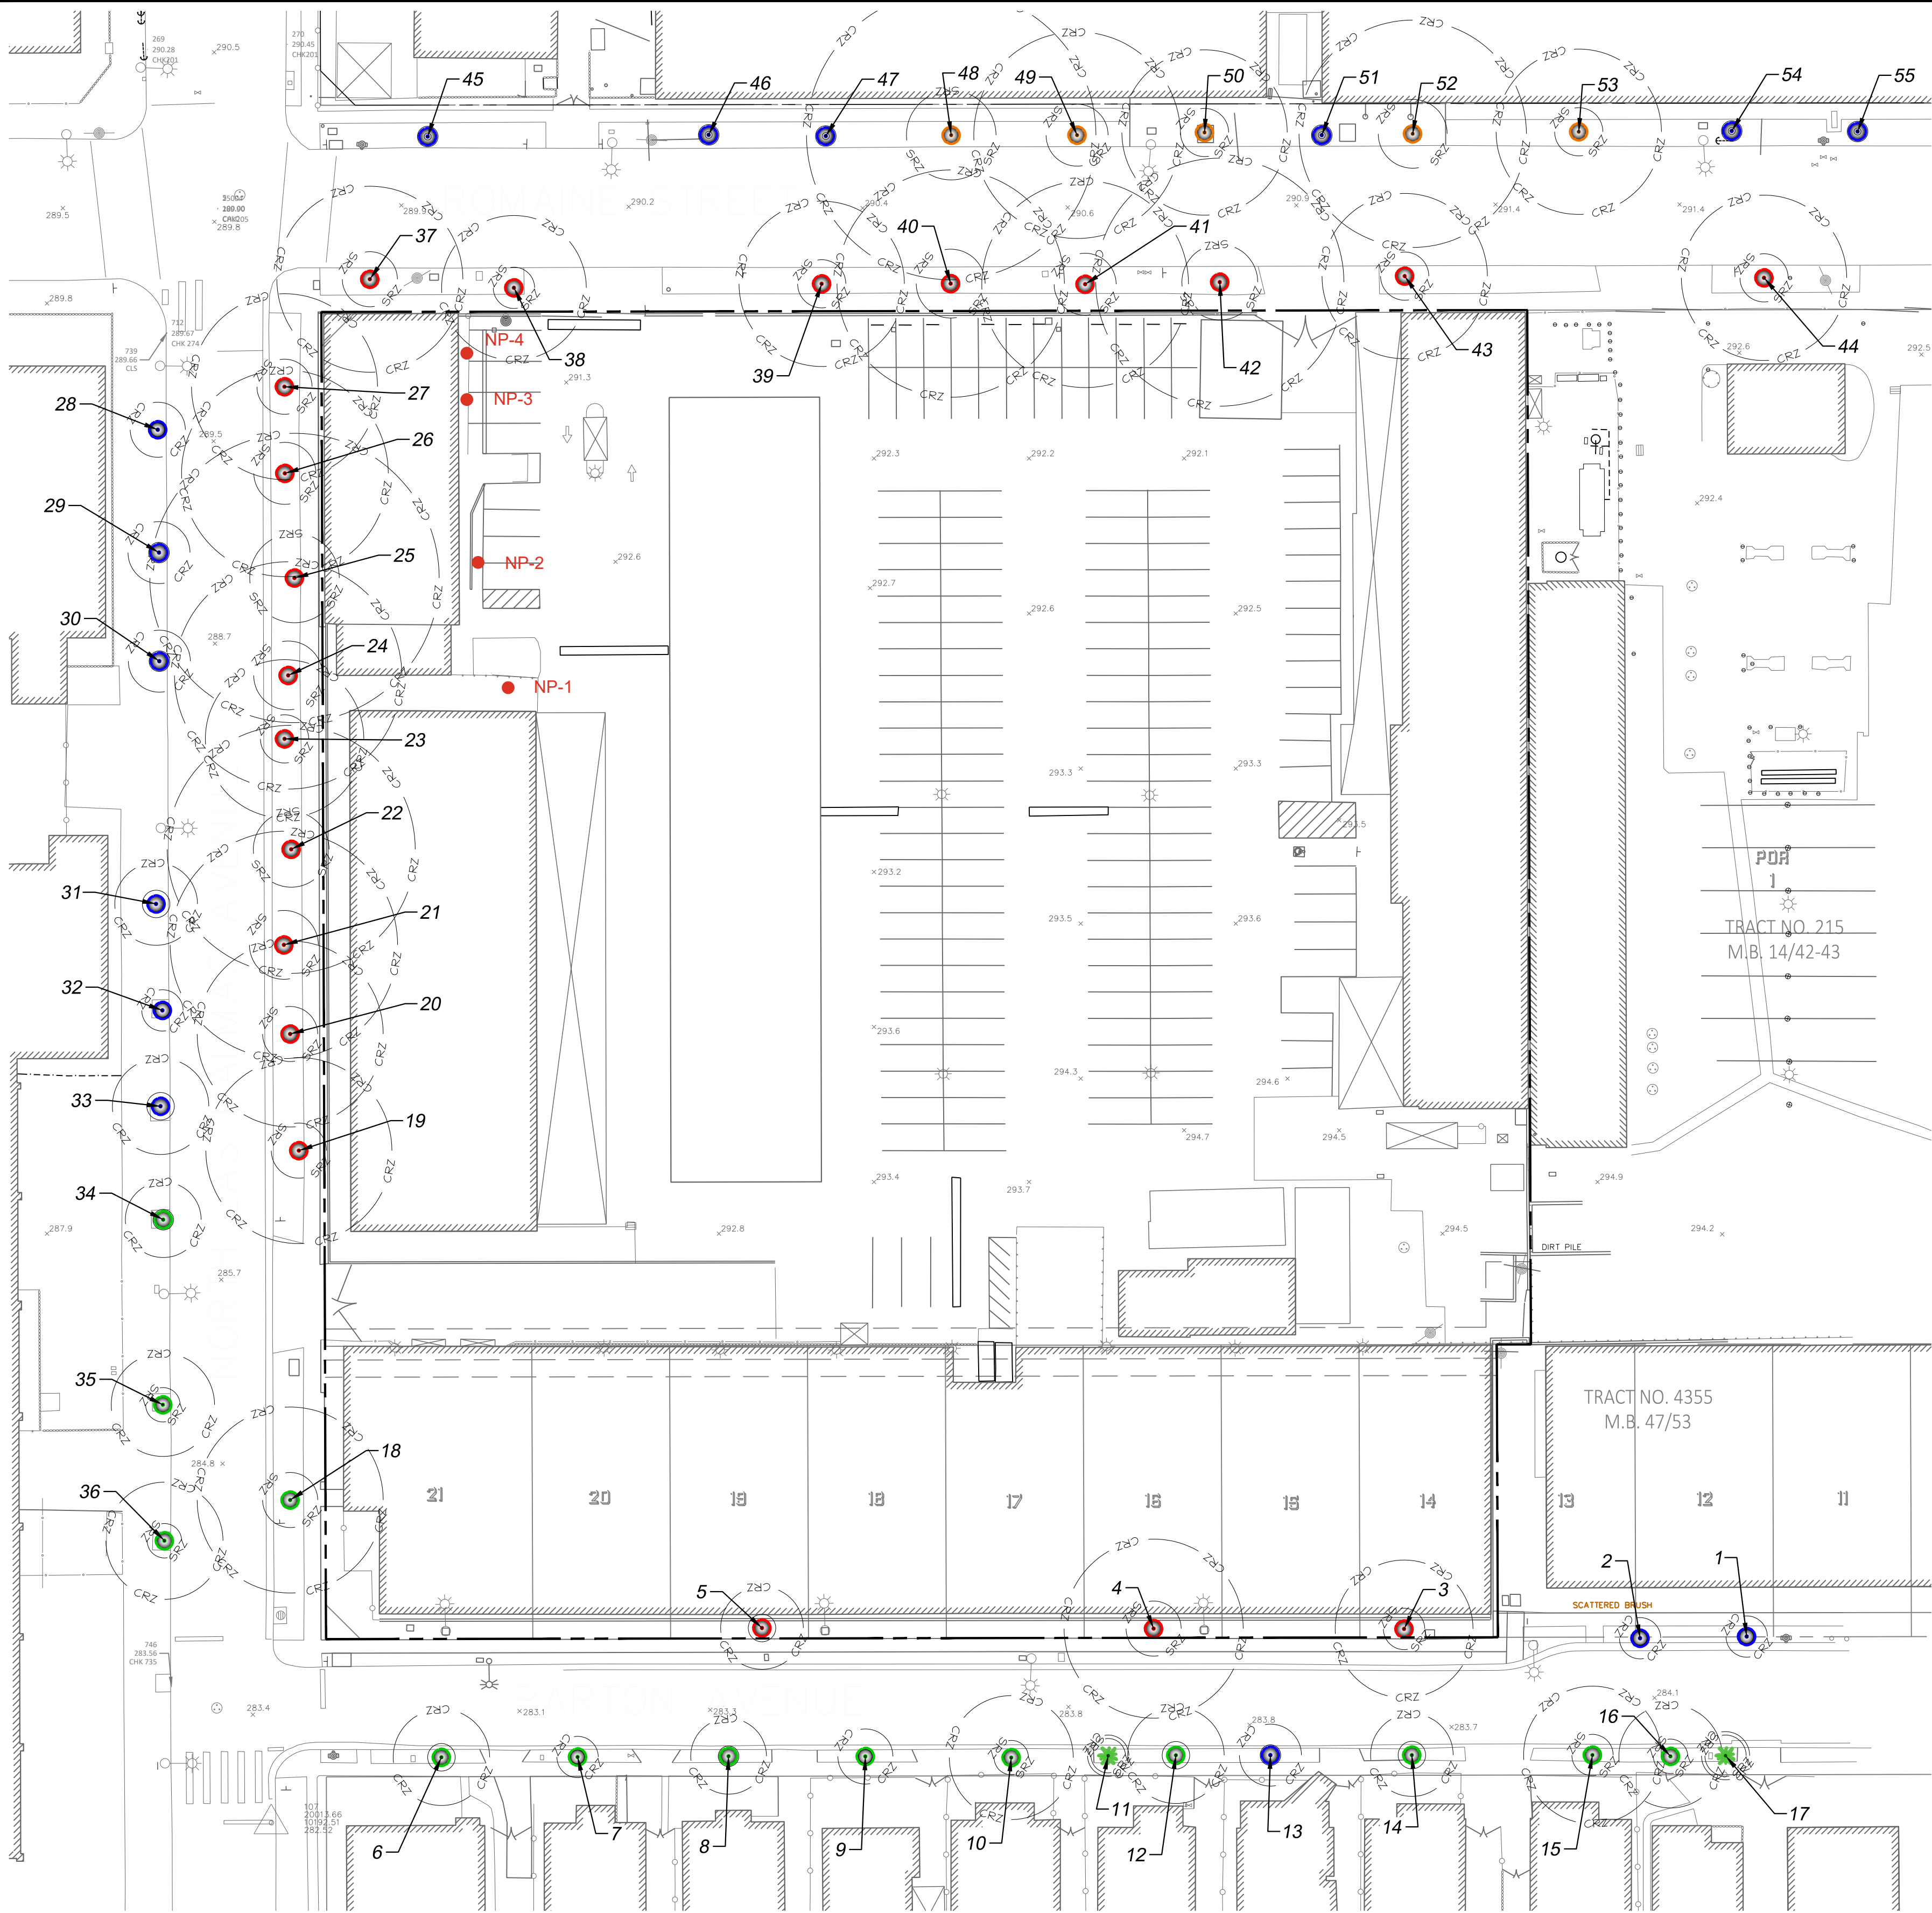
Appendix D Maps of Tree Location and Current Conditions

21	22	bottlebrush, red	Callistemon citrinus	30%	Poor		14	30	1	10	33	4		Basal Decay, Trunk Decay, Included Bark/Weak Union, Co-Dominant Stems
22	24	bottlebrush, red	Callistemon citrinus	30%	Poor		14	30	1	11	36	4		Basal Decay, Trunk Decay, Included Bark/Weak Union, Co-Dominant Stems
23	15	bottlebrush, red	Callistemon citrinus	30%	Poor		14	30	1	7	23	4		Basal Decay, Trunk Decay, Included Bark/Weak Union, Co-Dominant Stems, Serious Decline
24	22	bottlebrush, red	Callistemon citrinus	30%	Poor		14	30	1	10	33	4		Basal Decay, Trunk Decay, Included Bark/Weak Union, Co-Dominant Stems
25	28	bottlebrush, red	Callistemon citrinus	30%	Poor		14	30	1	13	42	4		Basal Decay, Trunk Decay, Included Bark/Weak Union, Co-Dominant Stems
26	20	bottlebrush, red	Callistemon citrinus	30%	Poor		14	30	1	9	30	4		Basal Decay, Trunk Decay, Included Bark/Weak Union, Co-Dominant Stems
27	18	bottlebrush, red	Callistemon citrinus	30%	Poor		14	30	1	8	27	4		Basal Decay, Trunk Decay, Included Bark/Weak Union, Co-Dominant Stems

37	18	bottlebrush, red	Callistemon citrinus	30%	Poor		10	35	1	8	27	4		Excessive Lean, Trunk Decay, Included Bark/Weak Union, Co-Dominant Stems, Mechanical Damage, Stressed, Broken Limbs
38	14	bottlebrush, red	Callistemon citrinus	15%	Critical		10	35	1	6	21	4		Excessive Lean, Trunk Decay, Included Bark/Weak Union, Co-Dominant Stems, Mechanical Damage, Stressed, Broken Limbs
39	16	bottlebrush, red	Callistemon citrinus	30%	Poor		10	25	1	7	24	4		Trunk Decay, Included Bark/Weak Union, Co-Dominant Stems, Mechanical Damage, Stressed
40	22	bottlebrush, red	Callistemon citrinus	30%	Poor		13	25	1	10	33	4		Trunk Decay, Included Bark/Weak Union, Co-Dominant Stems, Mechanical Damage, Stressed
41	20	bottlebrush, red	Callistemon citrinus	30%	Poor		13	30	1	9	30	4		Trunk Decay, Included Bark/Weak Union, Co-Dominant Stems, Mechanical Damage, Stressed
42	24	bottlebrush, red	Callistemon citrinus	15%	Critical		13	30	1	11	36	4		Trunk Decay, Included Bark/Weak Union, Co-Dominant Stems, Mechanical Damage, Stressed, Broken Limbs

43	16	bottlebrush, red	Callistemon citrinus	30%	Poor		8	20	1	7	24	4		Trunk Decay, Included Bark/Weak Union, Co-Dominant Stems, Mechanical Damage, Stressed, Broken Limbs
44	16	bottlebrush, red	Callistemon citrinus	30%	Poor		8	20	1	7	24	4		
45	2	crapemyrtle, common	Lagerstroemia indica	95%	Excellent		2	12	1	1	3	1	California Pepper / Schinus molle	Root Damage/Decay, Basal Decay, Trunk Decay, Mechanical Damage, Broken Limbs
46	2	crapemyrtle, common	Lagerstroemia indica	95%	Excellent		2	12	1	1	3	1	California Pepper / Schinus molle	Excessive Lean, Root Damage/Decay, Basal Decay, Trunk Decay, Mechanical Damage
47	2	crapemyrtle, common	Lagerstroemia indica	95%	Excellent		2	12	1	1	3	1	California Pepper / Schinus molle	Root Damage/Decay, Trunk Decay, Mechanical Damage
48	28	California pepper	Schinus molle	50%	Fair		15	35	1	13	42	3		
49	20	California pepper	Schinus molle	50%	Fair		13	35	1	9	30	3		
50	16	California pepper	Schinus molle	50%	Fair		12	30	1	7	24	3

51	2	crapemyrtle, common	Lagerstroemia indica	95%	Excellent		2	12	1	1	3	1		
52	22	California pepper	Schinus molle	60%	Fair		12	30	1	10	33	3		Root Damage/Decay, Basal Decay, Trunk Decay, Mechanical Damage
53	16	California pepper	Schinus molle	60%	Fair		12	30	1	7	24	3		Root Damage/Decay, Basal Decay, Trunk Decay, Mechanical Damage
54	2	crapemyrtle, common	Lagerstroemia indica	95%	Excellent		2	2	1	1	3	1		
55	2	crapemyrtle, common	Lagerstroemia indica	95%	Excellent		2	2	1	1	3	1		
112	2	crapemyrtle, common	Lagerstroemia indica	95%	Excellent		2	12	1	1	3	1		
113	2	crapemyrtle, common	Lagerstroemia indica	95%	Excellent		2	12	1	1	3	1		
114	2	crapemyrtle, common	Lagerstroemia indica	80%	Good		2	12	1	1	3	1	Damaged canopy
