FAULT HAZARD EVALUATION
PROPOSED COMMERCIAL DEVELOPMENT
PARCELS APN 283-280-020, 283-180-001
TEMESCAL CANYON ROAD
COUNTY OF RIVERSIDE, CALIFORNIA
RIVERSIDE COUNTY GEOLOGIC REPORT # 18195

CTE JOB NO.: 40-3640G

FEBRUARY 25, 2019

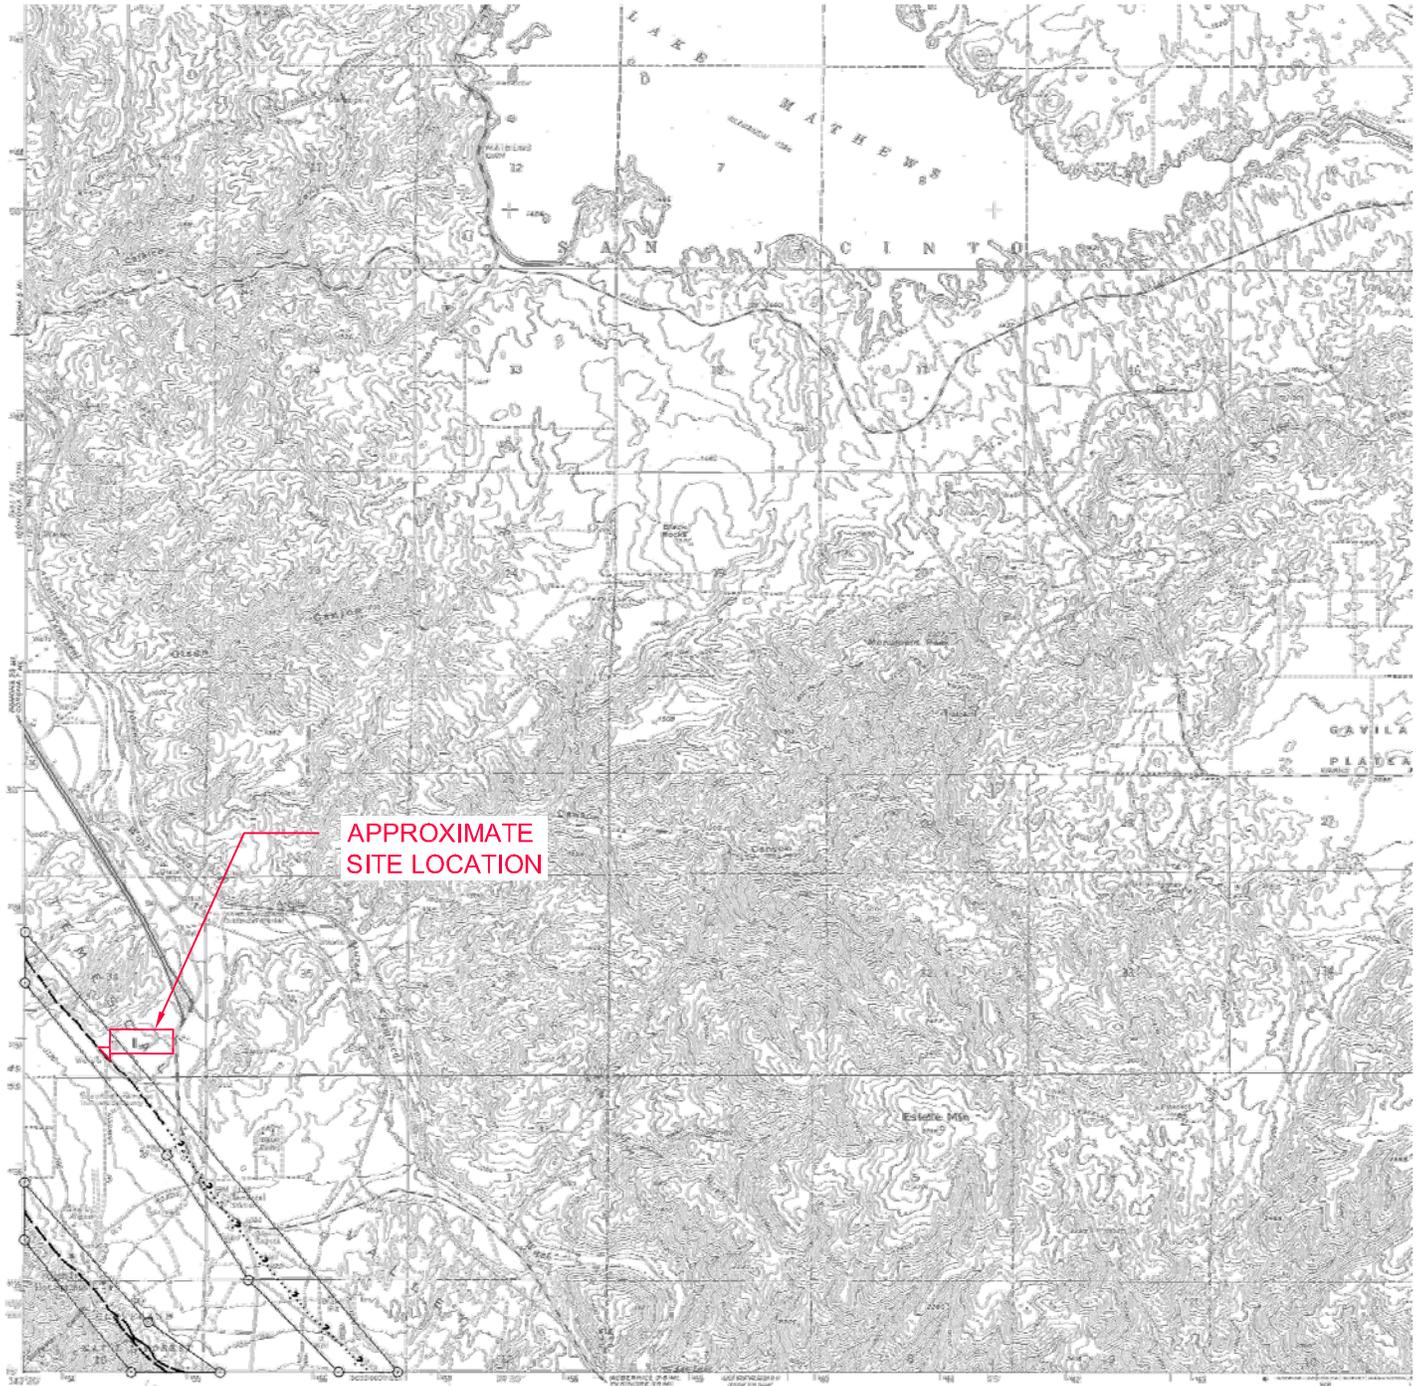
CTE SOUTH Construction Testing & Engineering, South <small>Inspection Testing Geotechnical Environmental & Construction Engineering Civil Engineering Surveying</small>	SCALE: 1"~5000'	DATE: 2/19
	CTE JOB NO.: 40-3640G	FIGURE: 2

Construction Testing and Engineering, South, Inc. (CTE), has completed the requested fault hazard evaluation for the proposed Commercial Warehouse Development, located on Parcels APN 283-280-020, & 283-180-001, on Temescal Canyon Road, County of Riverside, California (Figure 1). As shown on Figures 2 and 3, the western parcels of the site fall within the boundaries of the State of California Alquist-Priolo Earthquake Fault Zone (formerly referred to as Special Study Zones) for the Glen Ivy North Fault within the Lake Matthews 7.5 minute quadrangle, and within the boundaries of the County of Riverside Fault Zone. The subject site is located within the geological structural domain characterized by greater Elsinore Fault Zone along the segment referred to as the Glen Ivy North Fault, which is south of the Chino and Whittier Fault segments, and extends to approximately eight kilometers south of Lake Elsinore. (Smith, 1978)

As shown on Figures 2 and 3, the AP–Zone and Riverside County Fault Zone boundary encompasses APN 283-280-020 and transects the southwest portion of APN 283-180-001. The fault evaluation focused on the area between Lawson Road and the northeastern boundary of the AP and County of Riverside Fault Zones. This work has been performed in general accordance with the terms of CTE proposal R18056REV, dated July 12, 2018.

Mathews 7.5 Minute Quadrangle (1980), is approximately located in on the southwest edge of the parcel 283-280-020, along Lawson Road. The northeasterly boundary of the AP- Zone is approximately 540 feet northeast of the mapped fault location dissecting parcel 283-180-001 diagonally in the northwest direction (Figure 3). A Fault Hazard evaluation conducted by LLA, 1998, on parcel number 283-280-020, supported a relocation of the Glen Ivy North fault and subsequent adjustment of the fault setback zone, which was approved by the Riverside County Planning Department 1998, but is not reflected in the AP- Zone maps because the Lake Mathews AP- Zone Map has not been revised subsequent to the 1998 report.
