Site Management Plan

(Tier 2, High Risk)

WDID-1_12CC415333

Humboldt County

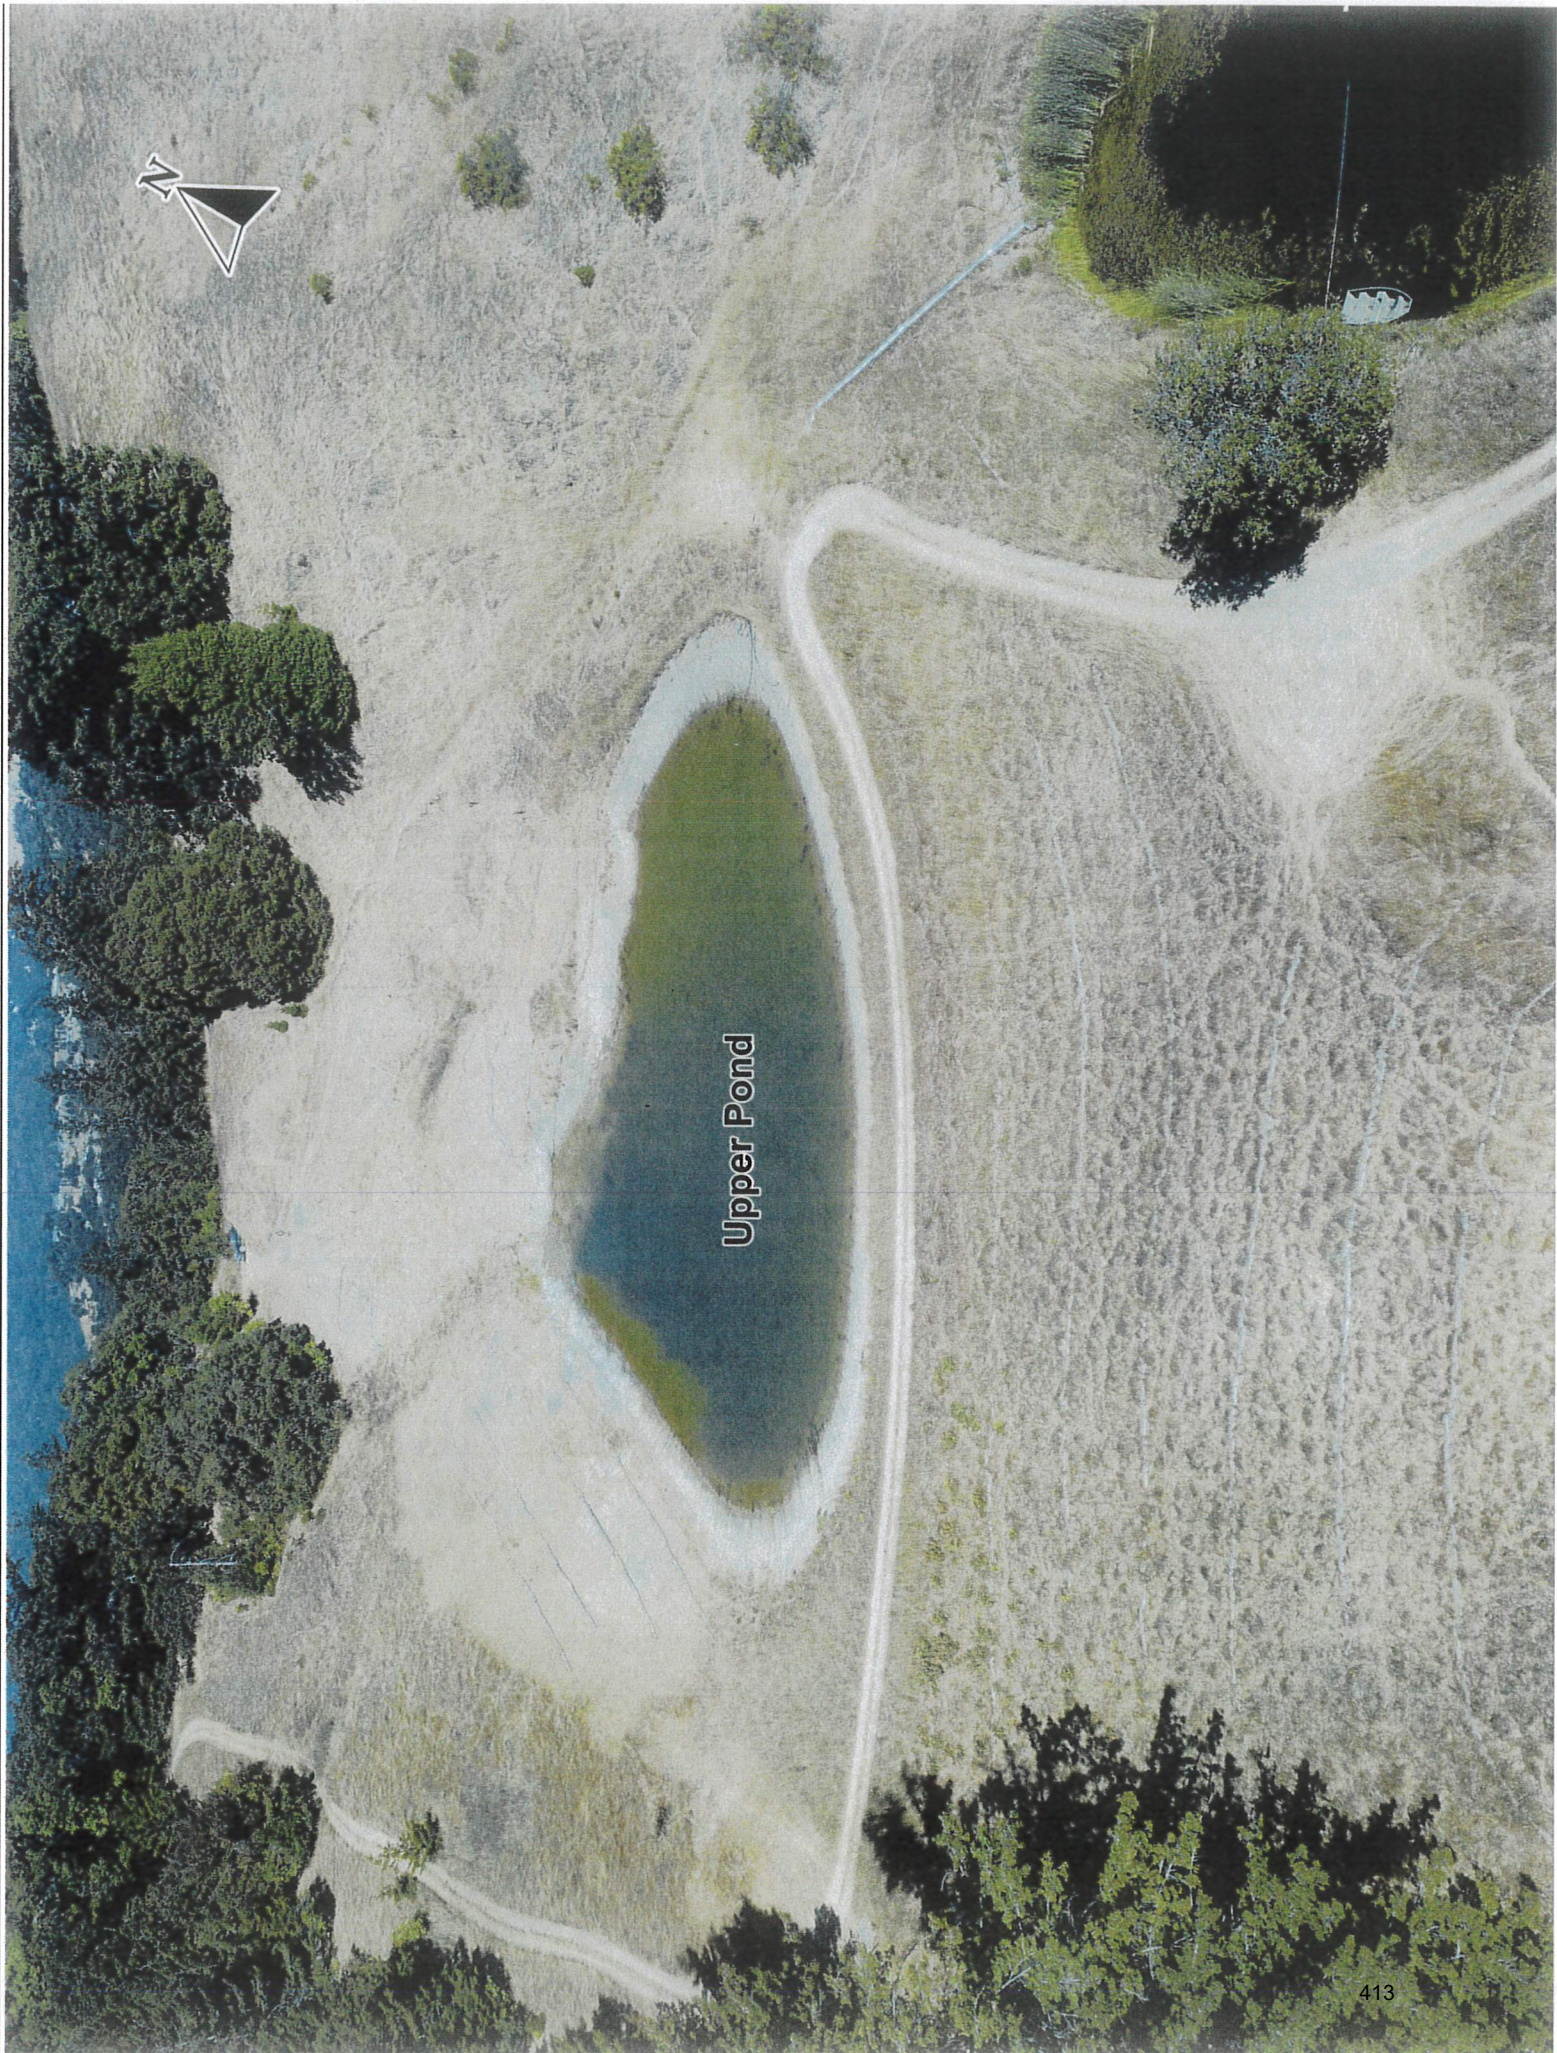
Upper Pond

Runoff from compacted and graded cut-slope collecting into swale feature creating overland flow

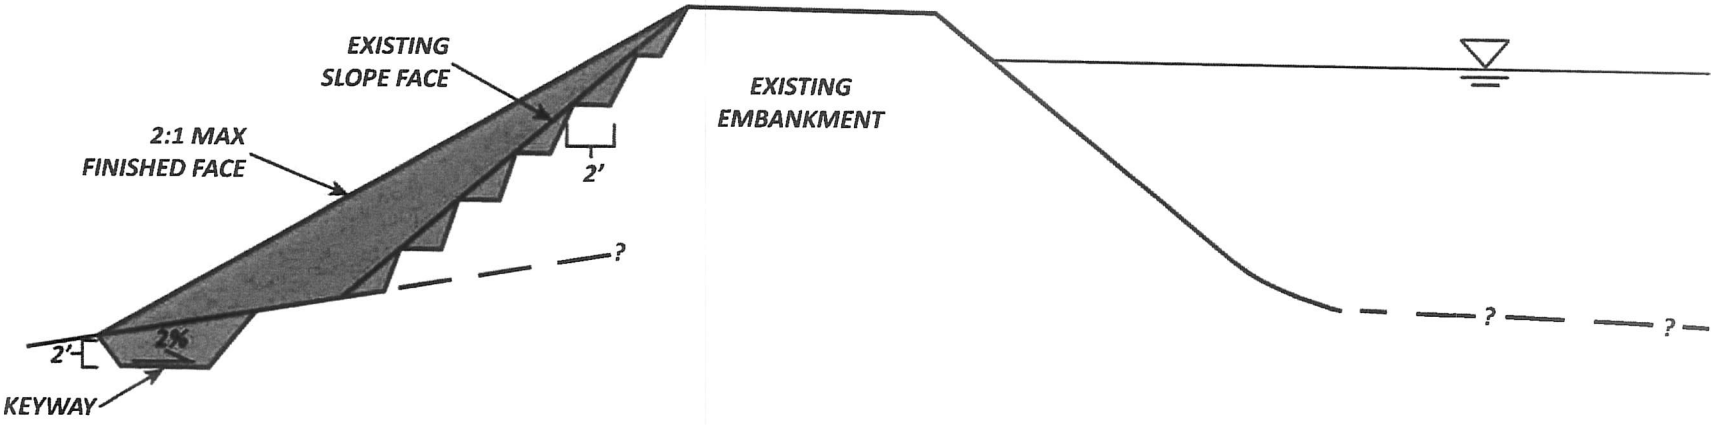
A) ADD FILL TO THE EXISTING OUTBOARD SLOPE FACE TO CREATE 2:1 SLOPE

- For any subgrade area to receive fill, scarify the upper 12 inches of exposed subgrade soils, moisture-condition to a uniform moisture content of at least 2 percent above optimum, and compact to at least 90 percent relative compaction.

- Place embankment fill materials in horizontal layers no greater than 8 inches in loose thickness, moisture-condition to a uniform moisture content at least 2 percent above optimum, and compact to at least 90 percent relative compaction.

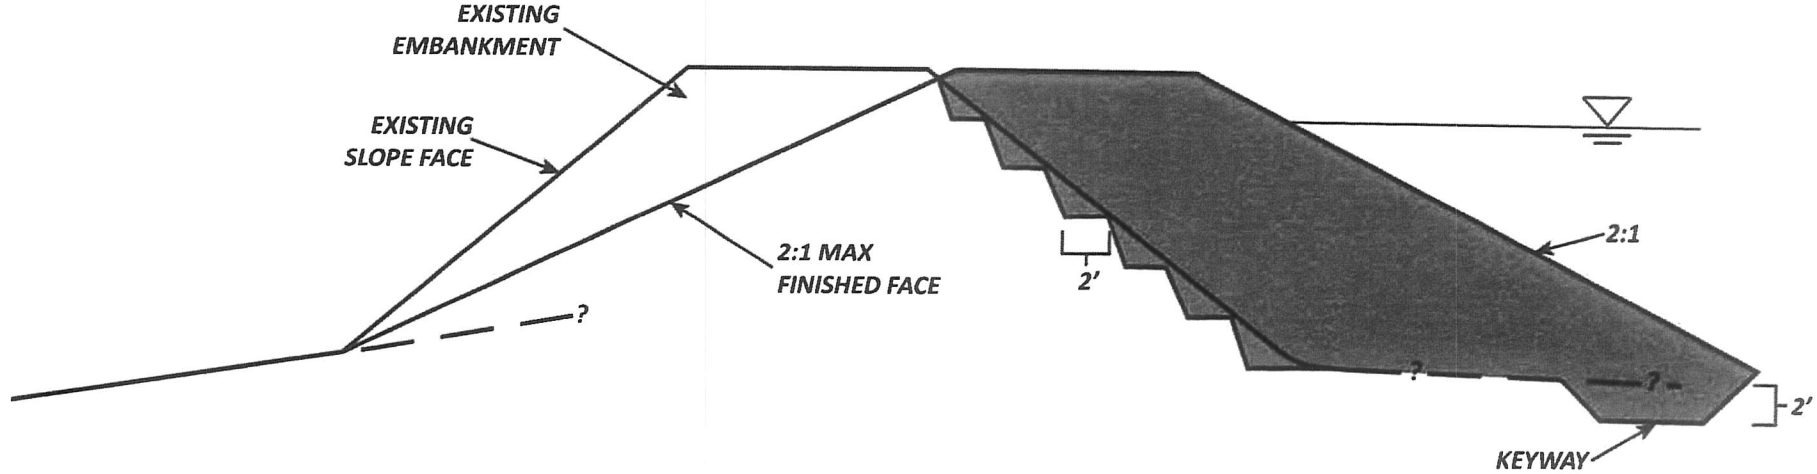
B) LAY EXISTING OUTBOARD SLOPE FACE BACK TO CREATE 2:1 SLOPE; ADD FILL TO INBOARD FACE

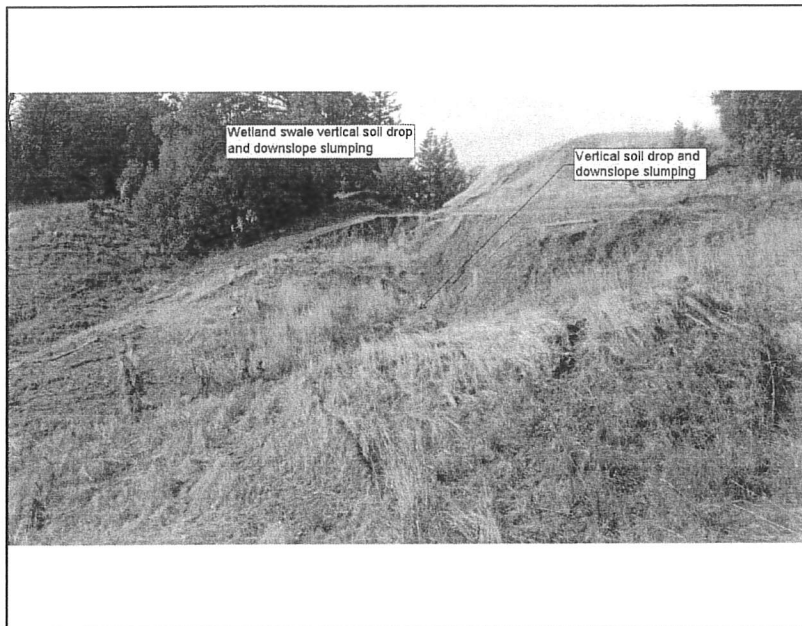
Photograph 3. Photograph taken January 10, 2019 of the landslide areas above Reservoir 1. No bed and bank features that would constitute streams were present.

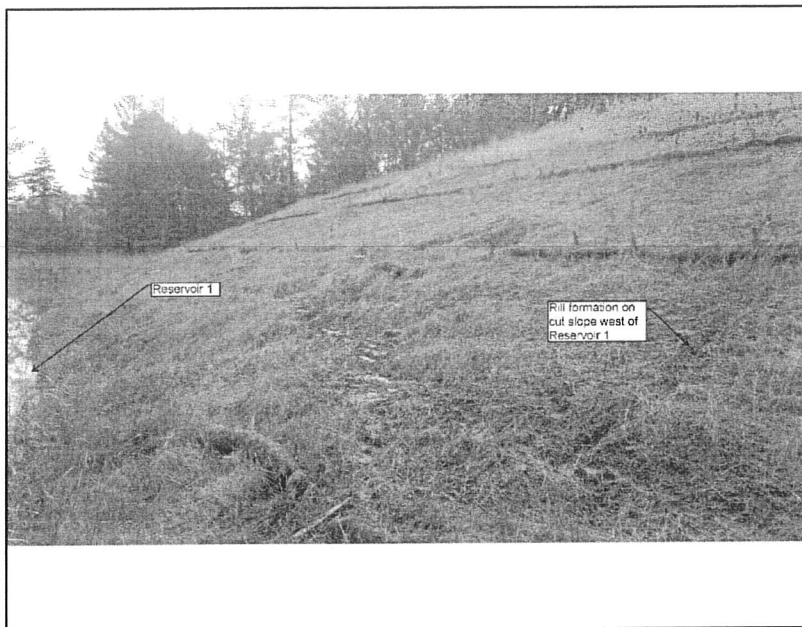
Photograph 4. The cut slope on the west side of Reservoir 1. Rills have formed, but nothing meeting the definition of stream was present.

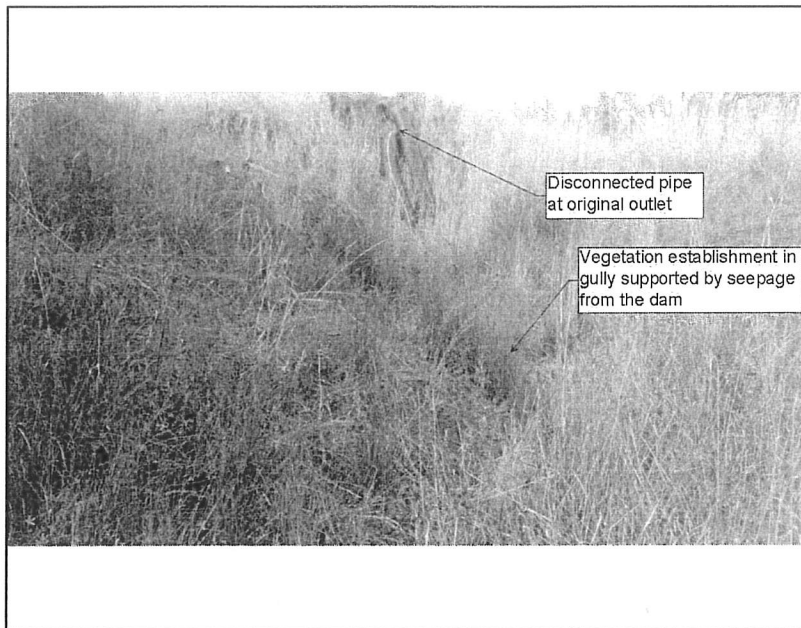
Photograph 6. Gully below Reservoir 2 eroded by outfall from the reservoir from the drain pipe separating. A new outlet on the east side of the reservoir was installed. Seepage from the bottom of the reservoir is becoming established

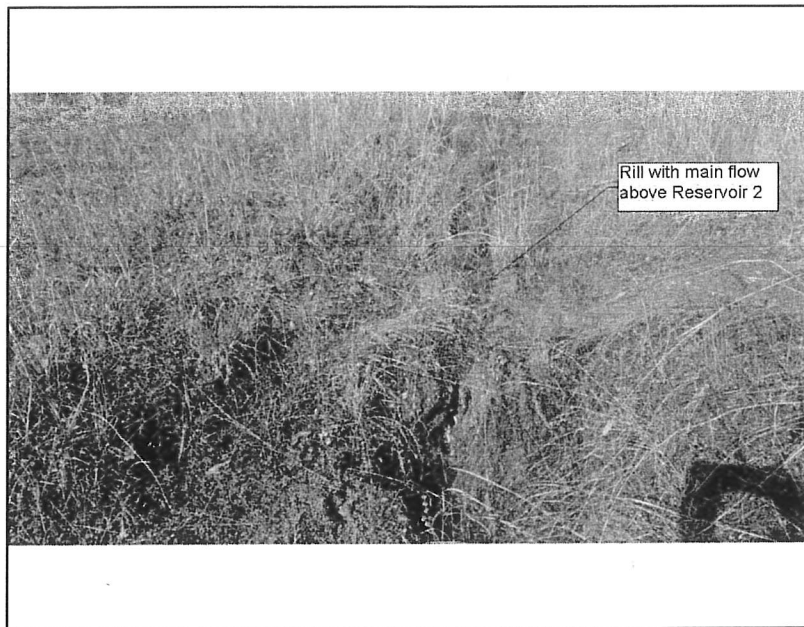
Photograph 7. The main rill from the area above Reservoir 2. No bed and back is present which precludes calling this feature a stream.

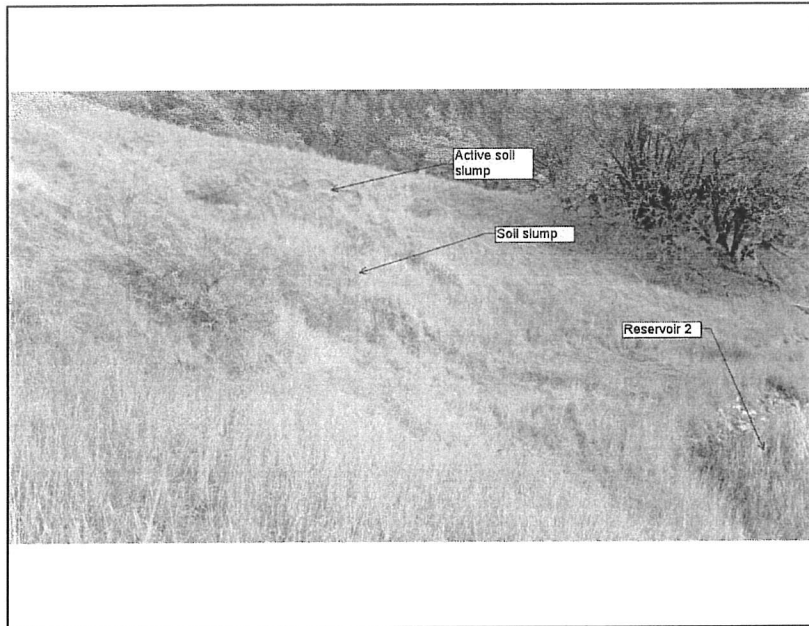
Photograph 8. The area above Reservoir 2 is a landslide area that is still somewhat active as indicated by soil slumping and recent active soil slumping.

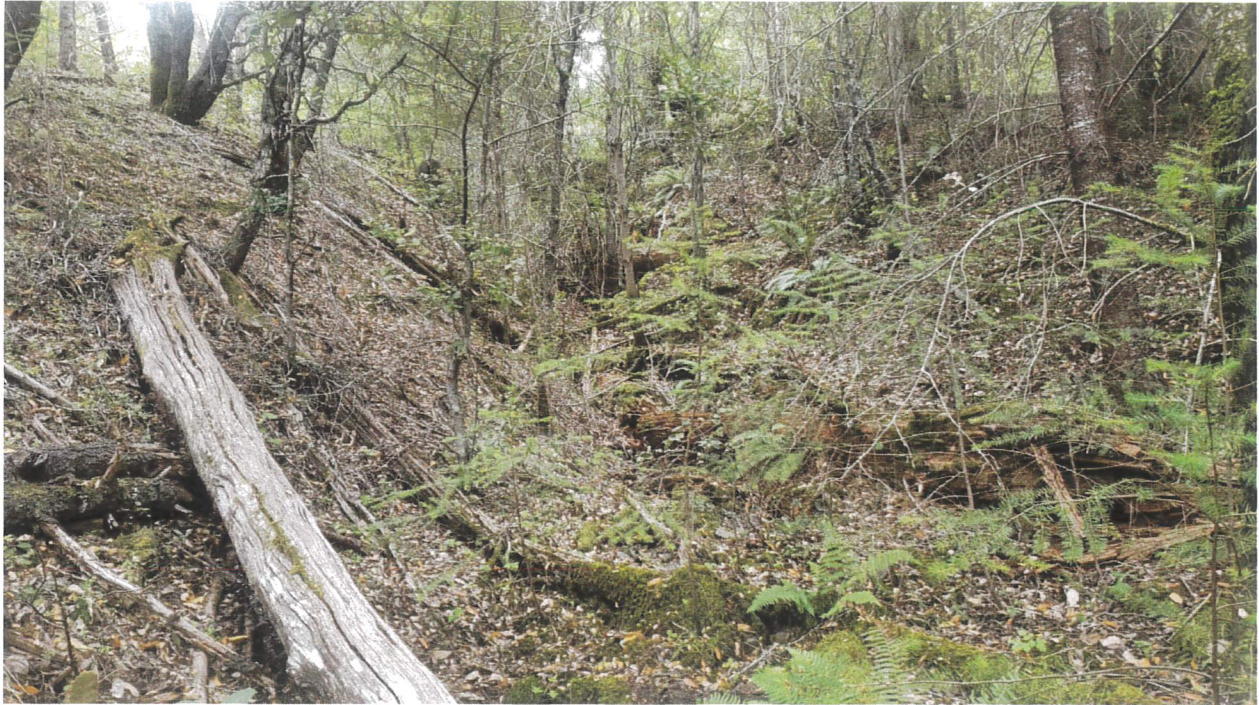
Undefined watercourse at Site 13 looking up stream.

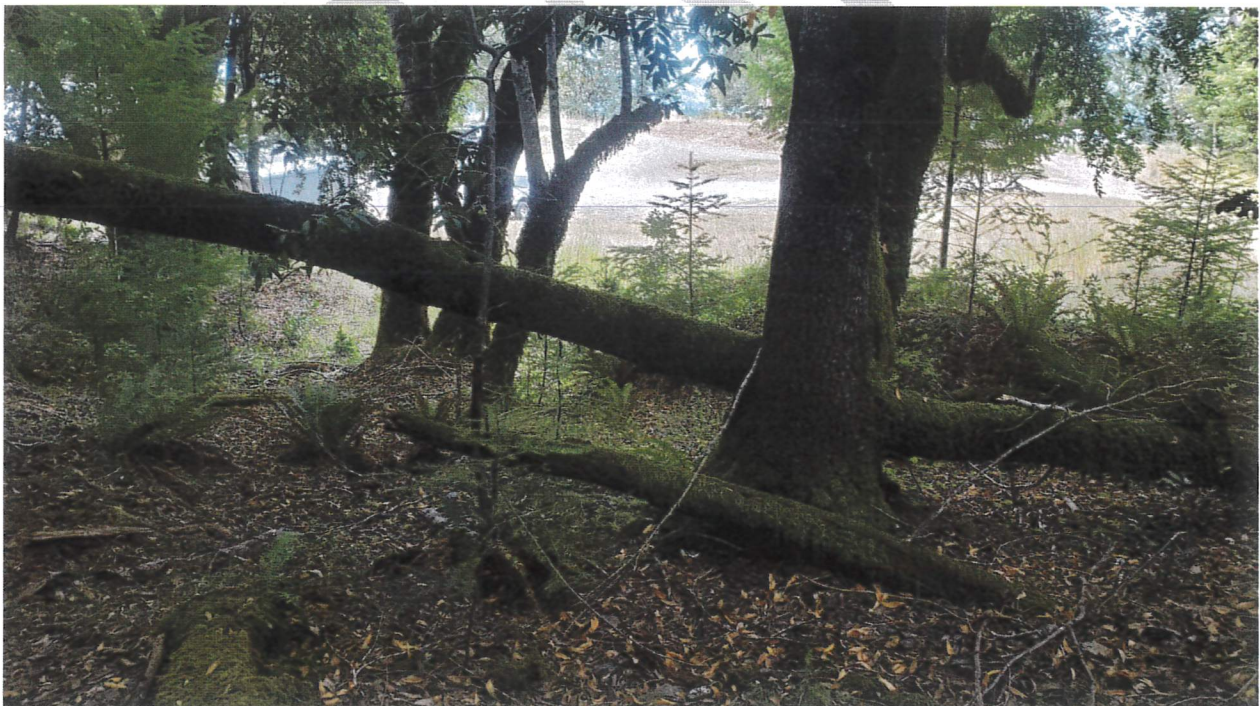
Undefined watercourse at Site 13 looking downstream. The watercourse terminates at the edge of the tree line.

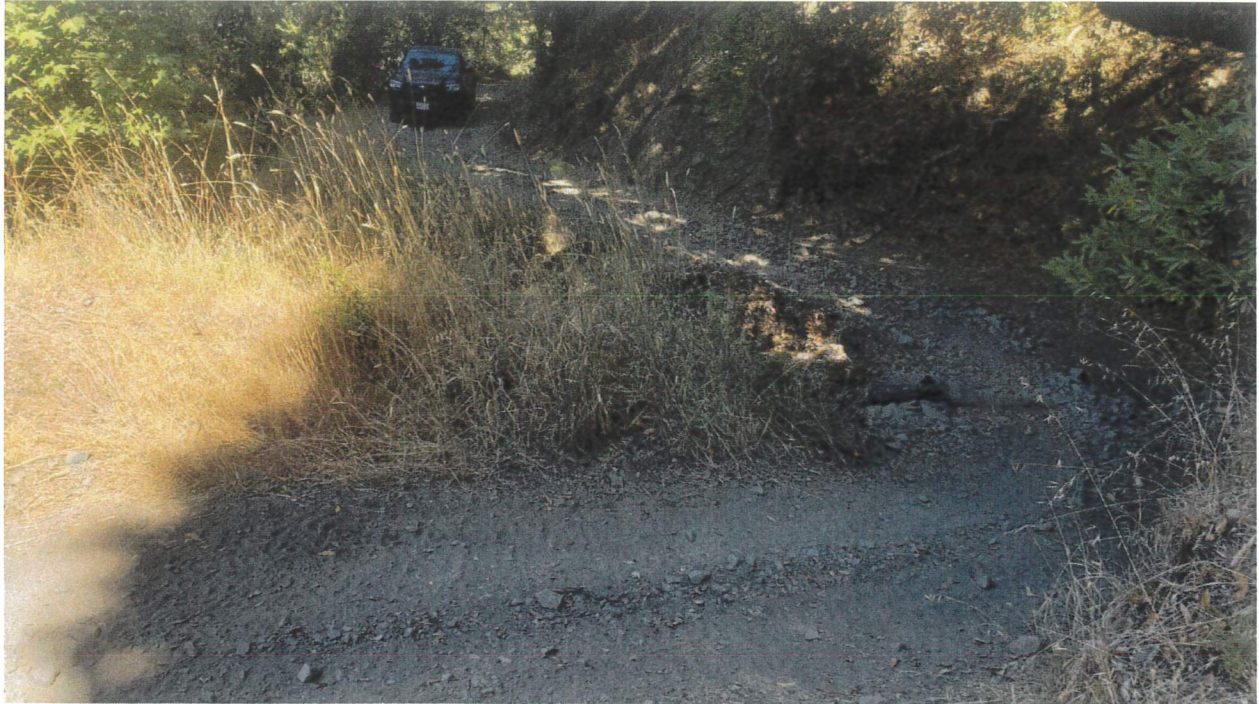
Photograph of the watercourse crossing at Site 16. This crossing is to be upgraded to a culverted crossing and the road approaches rocked to the garden parking area immediately to the left out of frame of this photograph.

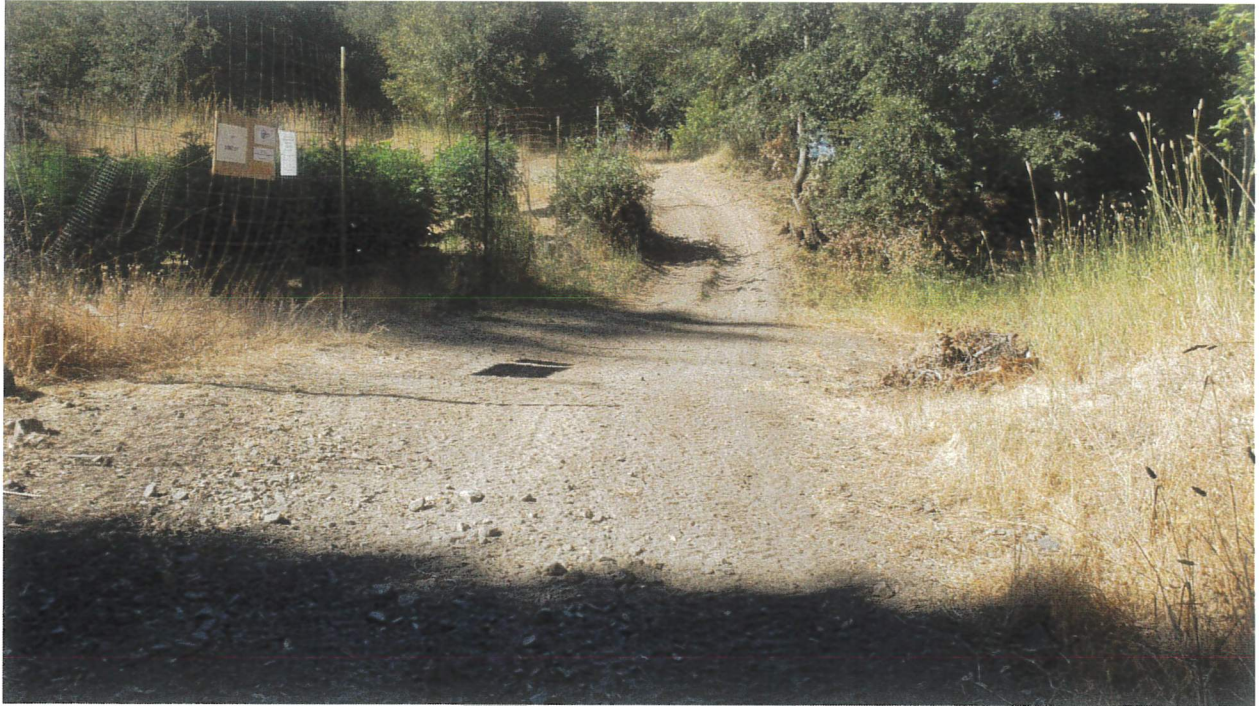
Photograph of Cultivation Area B's parking area. This area is to be rocked and staked straw wattles are to be installed to the right of the road along the brush line above the watercourse.

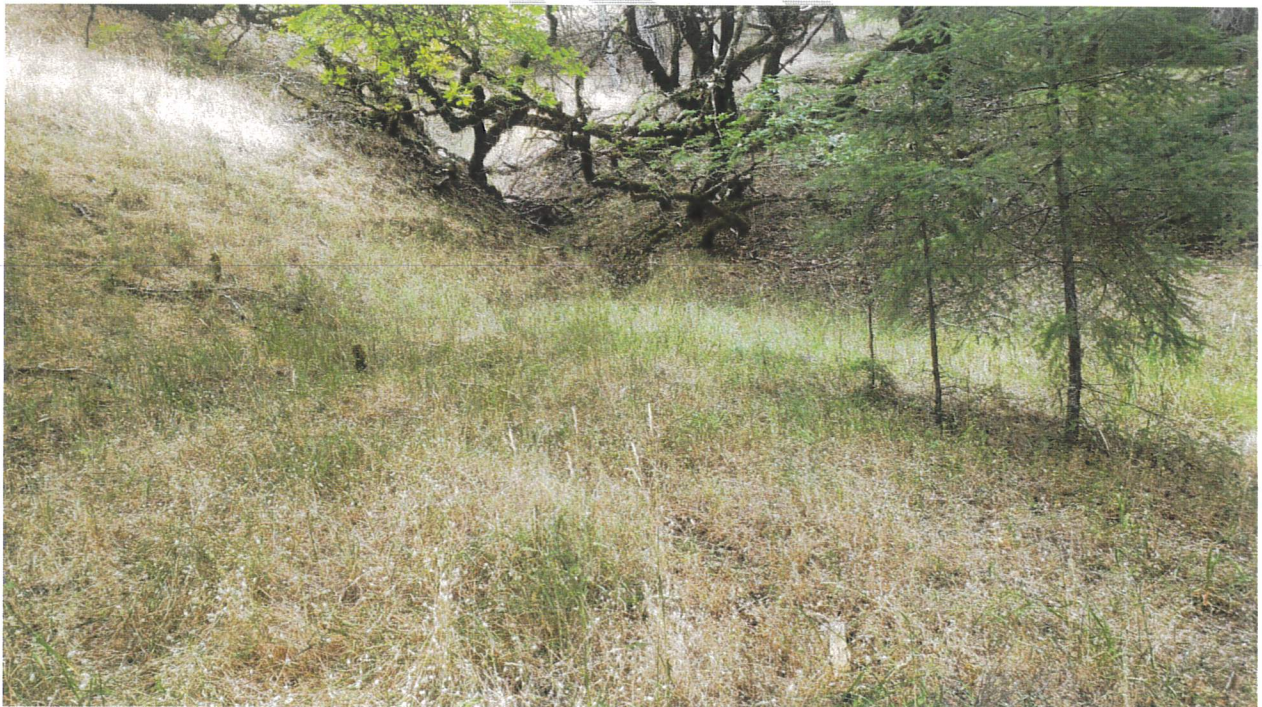
Looking upstream at the diverted watercourse at Site 21. Historically the watercourse drained to the right of the photograph behind the sapling trees to the right. Bed load delivery during large storm events has created an alluvial fan that has diverted the watercourse towards the position of where the photograph was taken.

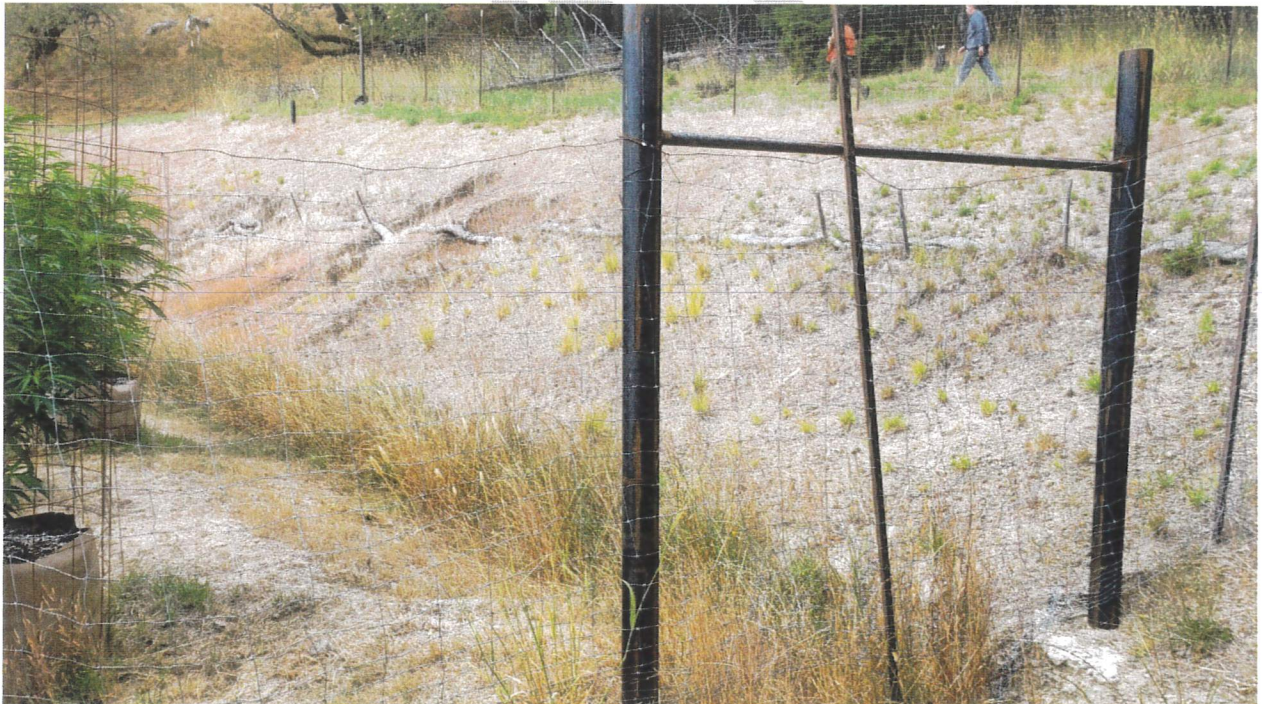
Looking at the drainage ditch along the northeastern side of Cultivation Area A. The diverted watercourse from Site 21 is draining over the cut bank and causing the erosion of the cutbank as scene in this photograph.

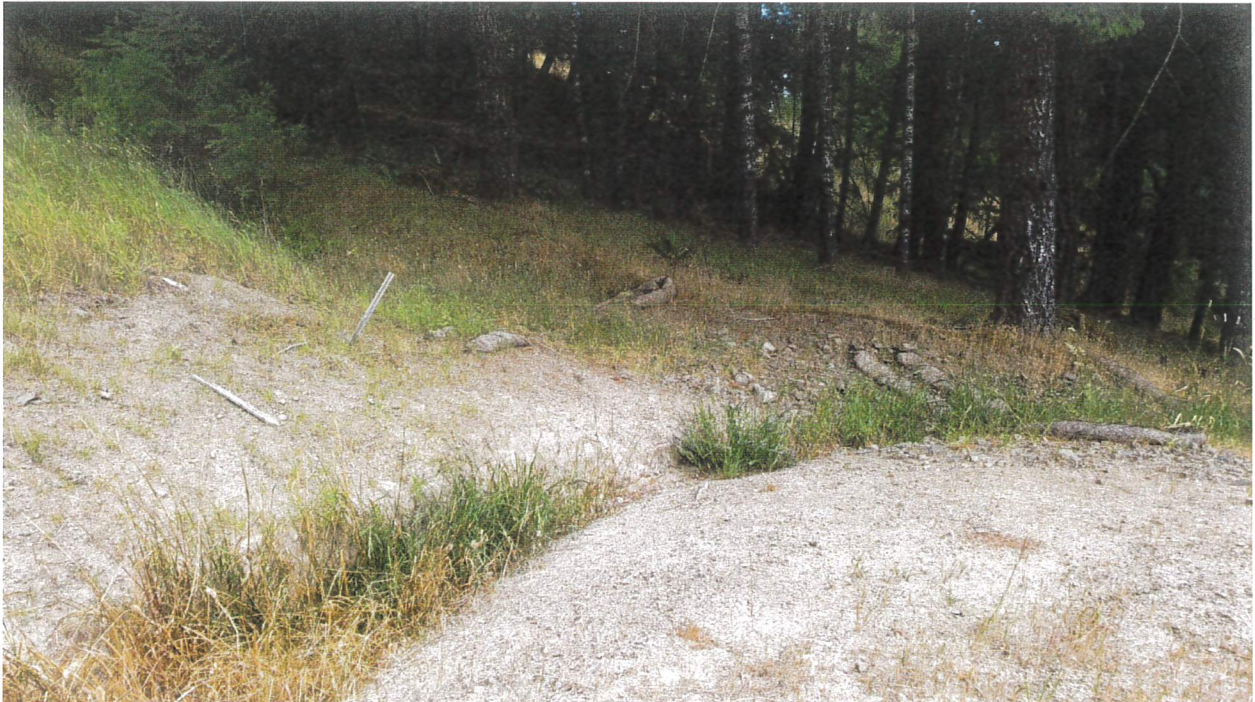
The drainage ditch then drains into the head of a Class III watercourse. The re-alignment of the watercourse at Site 21 will have the watercourse drain into the channel located at the base of the sapling trees in the upper left of the photo.

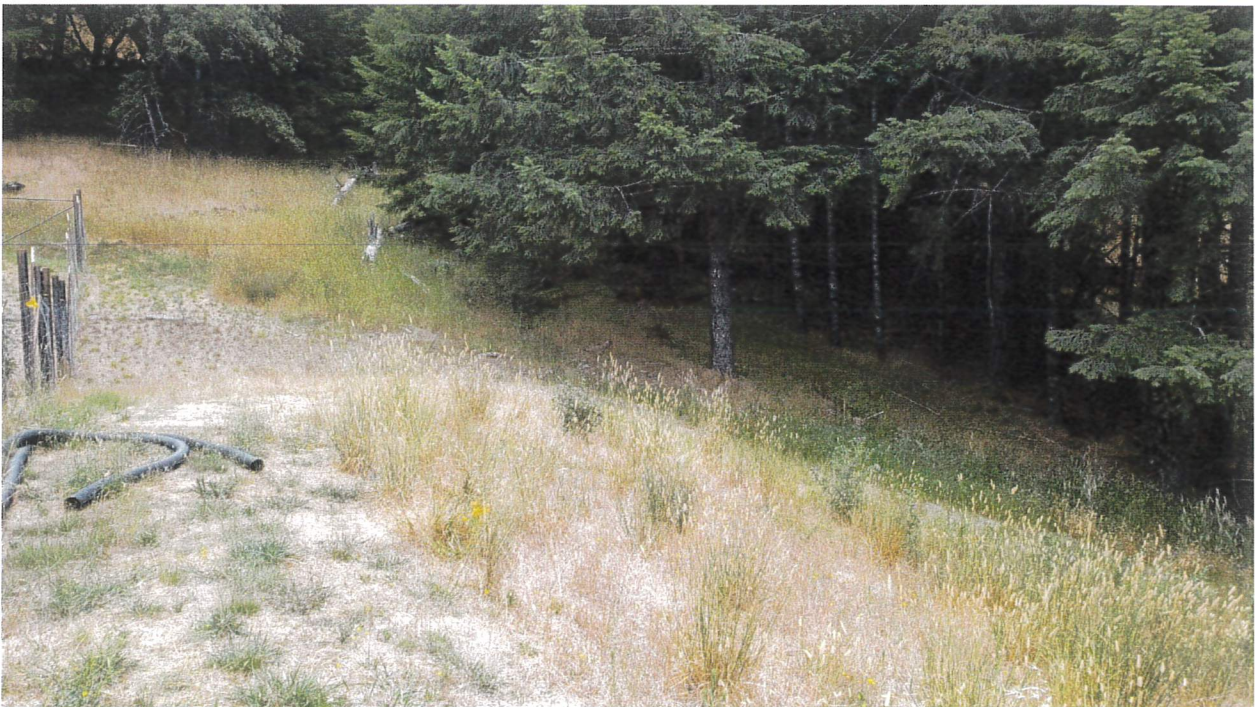
Photo looking at the outlet of the drainage ditch previously shown in the photo above. The Class III watercourse is located approximately center left of the photo where the flagging tied to trees is located along the tree line.

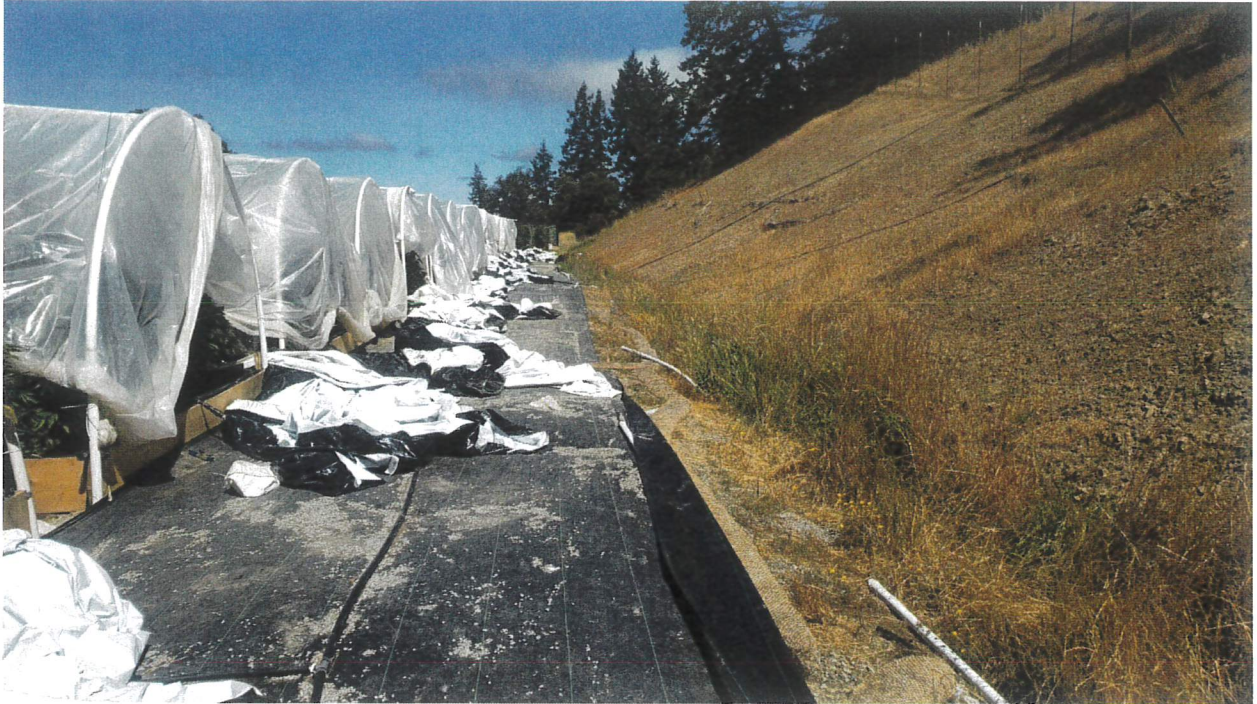
Photograph of the drainage ditch along the northeastern edge of Cultivation Area A. This photograph was taken looking northwest. Note the well vegetated ditch, straw wattles, graveled surface, and weed matting all used to slow and capture surface runoff from the cultivation area.

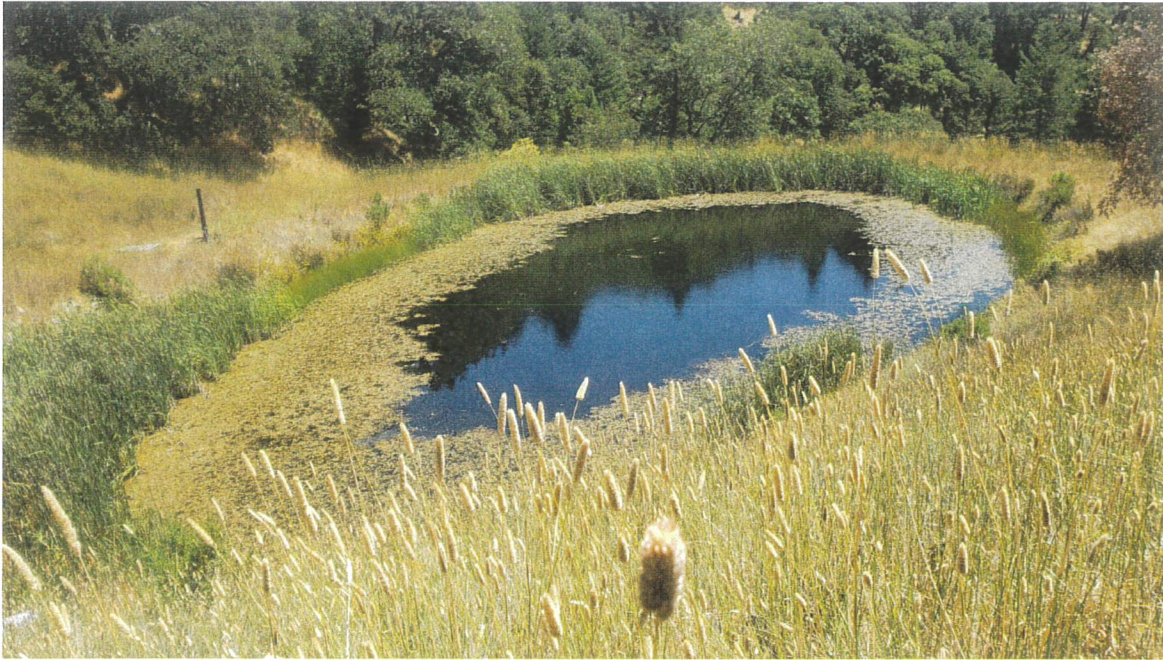
Photograph of the Lower Pond (on-stream). The primary spillway (Site 38) is located along the left side of the pond in the photograph and the secondary spillway (Site 39, to become the primary spillway) is located to the right. The overflow spillway from the Upper Pond is located in the left-hand corner of the photograph.

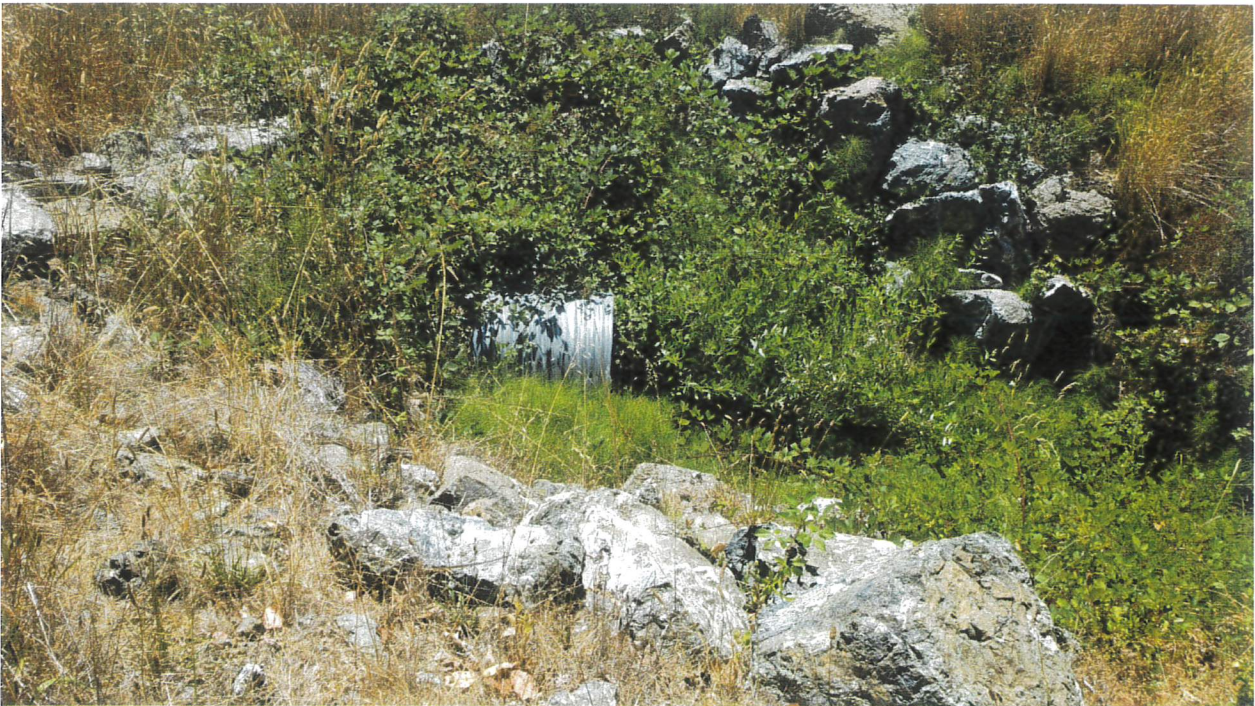
Photograph of the inlet of the watercourse crossing at Site 61.

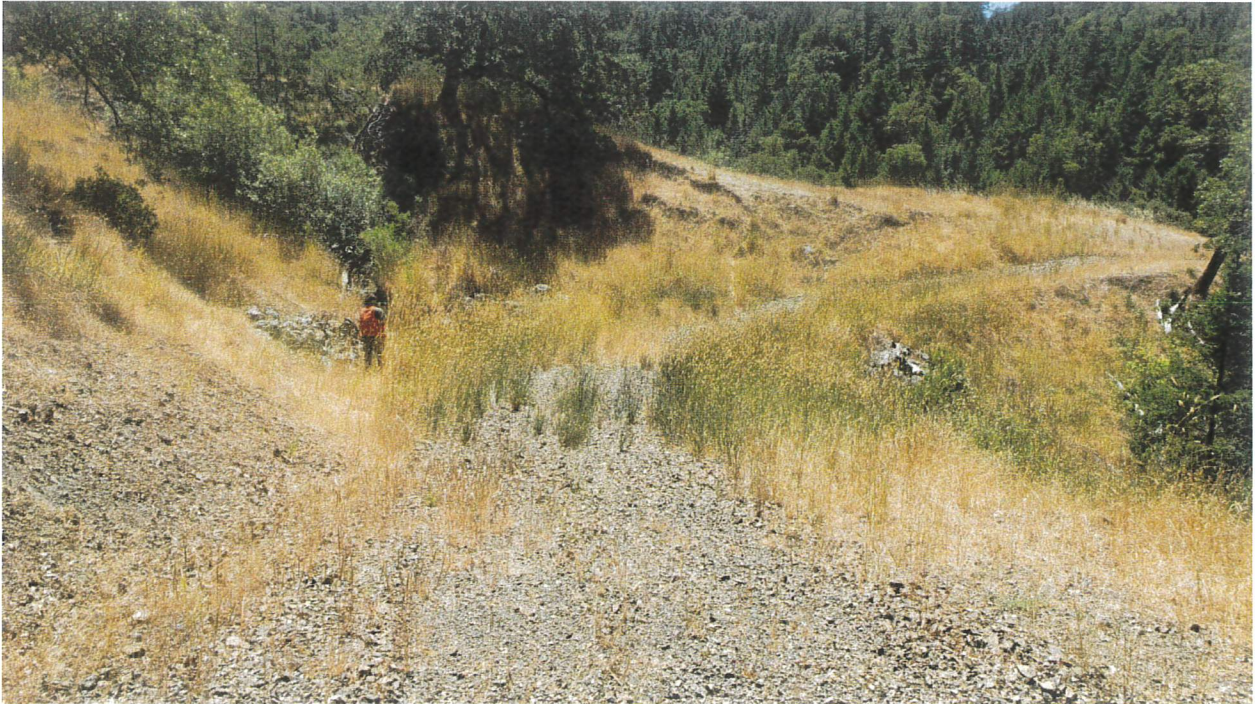
Photograph of the outlet of the watercourse crossing at Site 61.

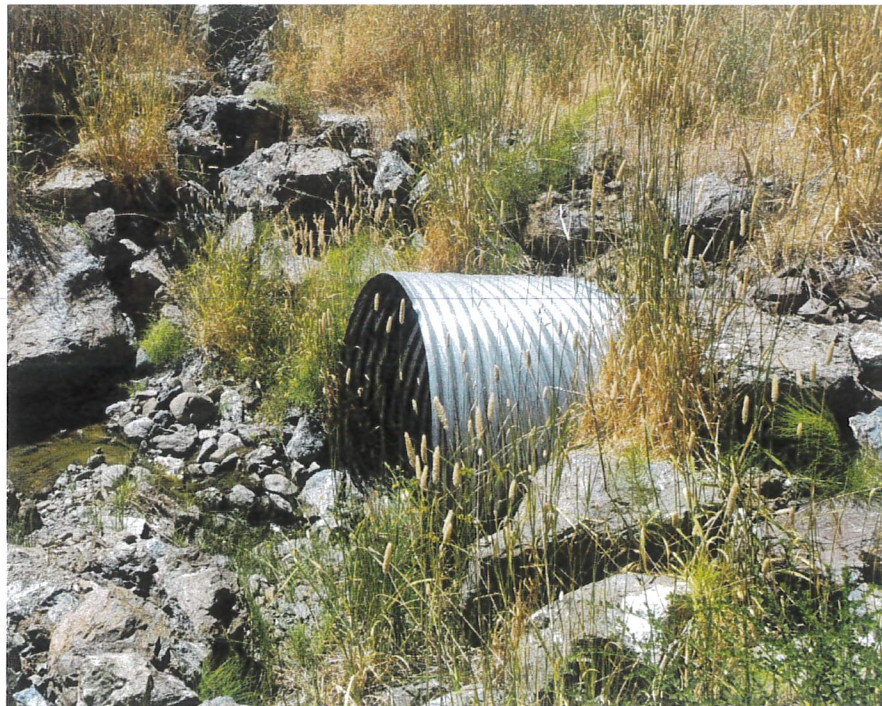
Photograph of the watercourse crossing at Site 69.

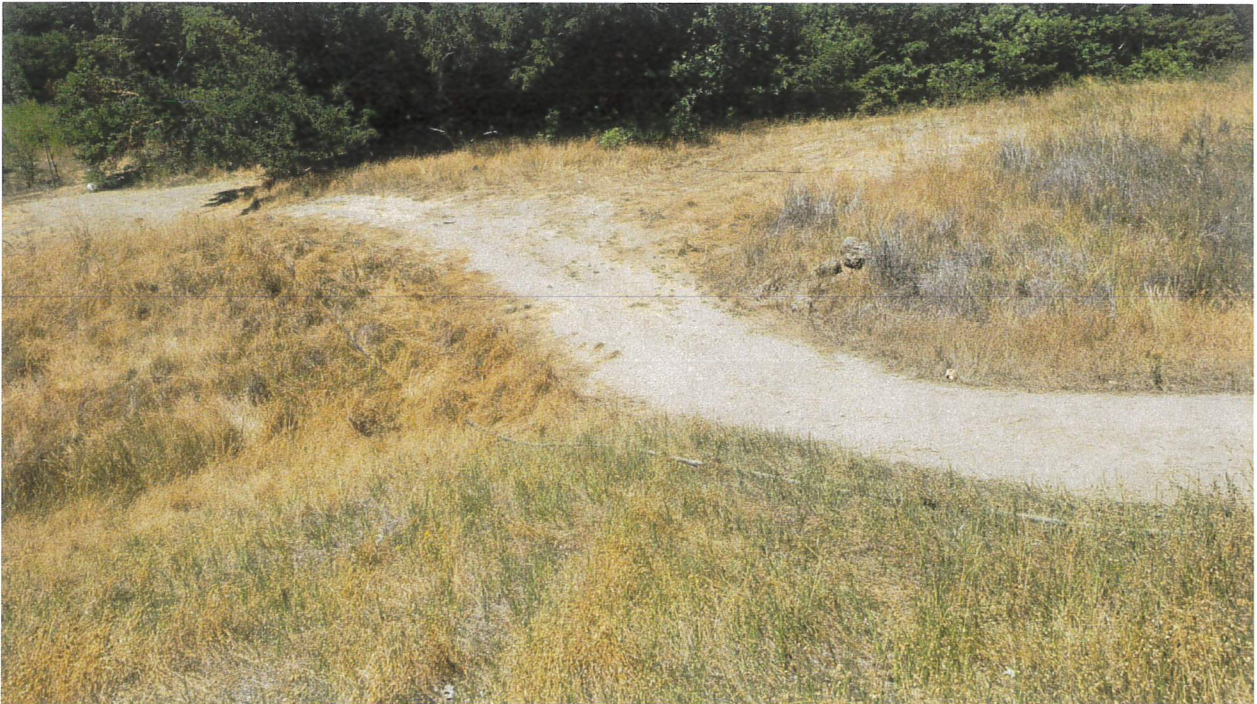
Photograph of the trail at Site 71 to be water barred and abandoned after the removal and relocation of Cultivation Area F.

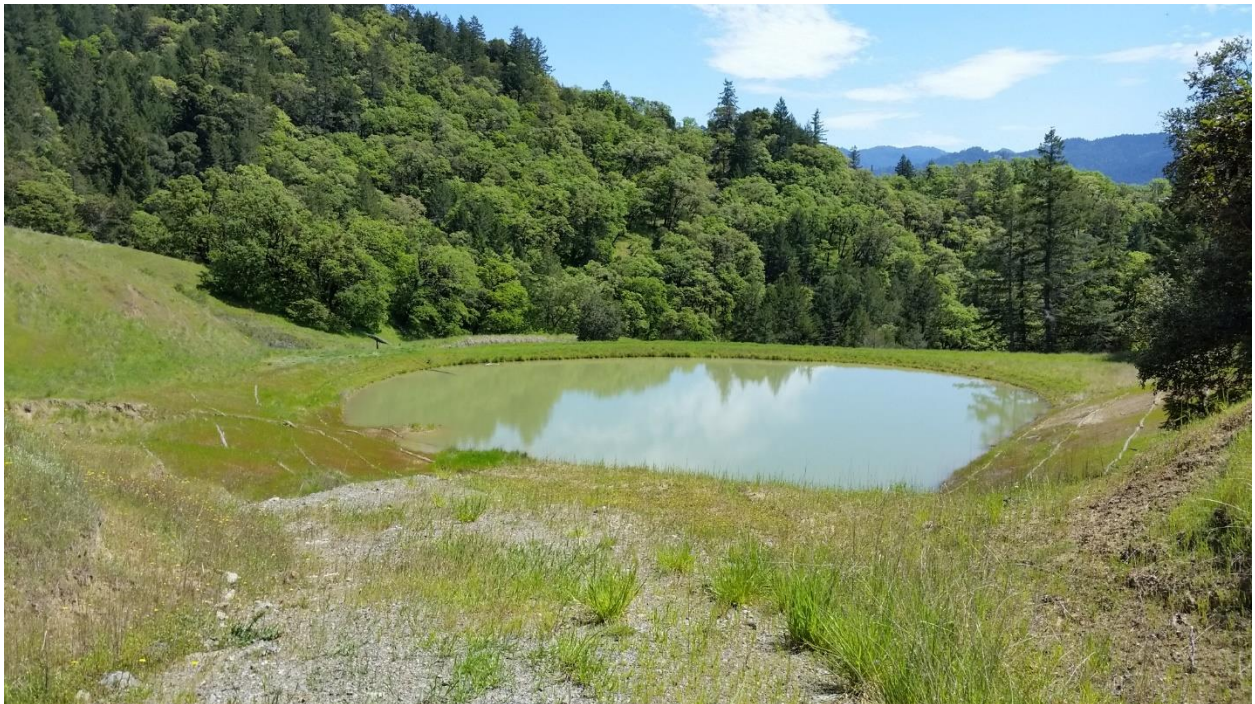
As part of the permitting process the landowner has been instructed to either remove or improve stability of the Upper Pond, constructed in 2016 (Photo 2) prior to record-setting winter precipitation when some minor bank failure occurred. The landowner is planning to improve the stability of land around this pond and utilize the water for cannabis irrigation.

Photo 2. Upper Pond needing removed or improved

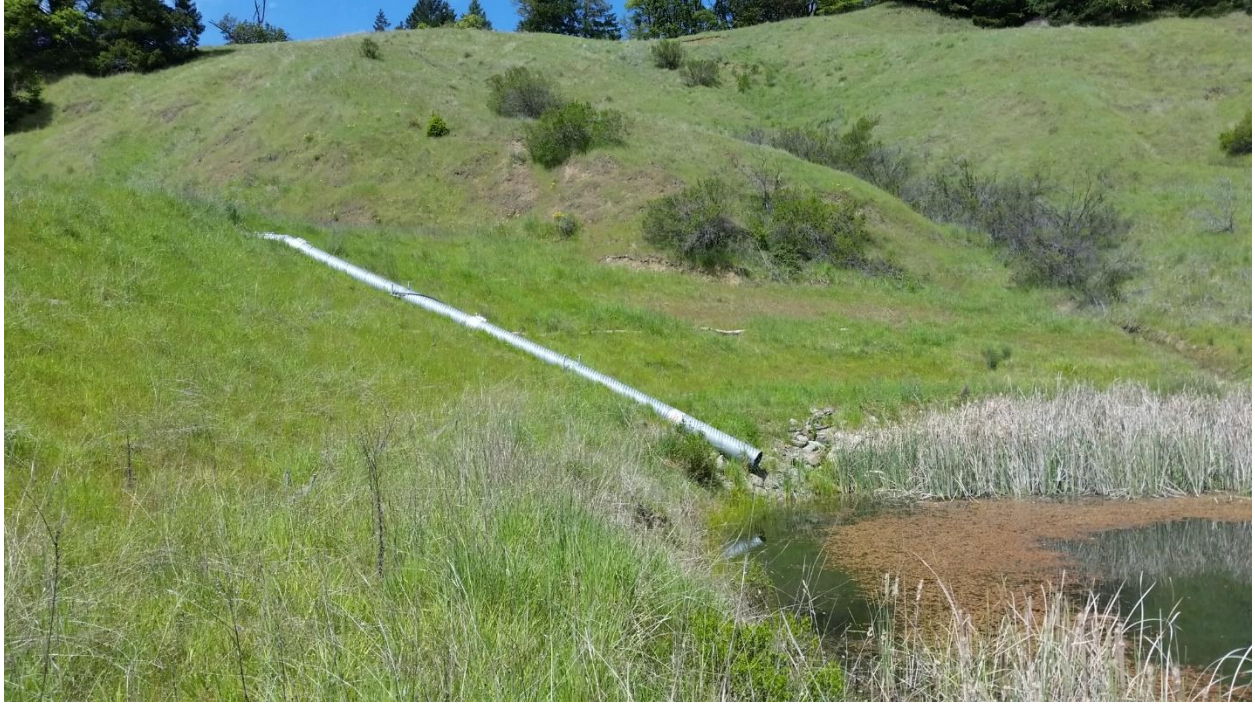
Photo 3. Culvert connected Upper Pond with Lower Pond
