Site Management Plan

(Tier 2, High Risk)

WDID-1_12CC415333

Humboldt County

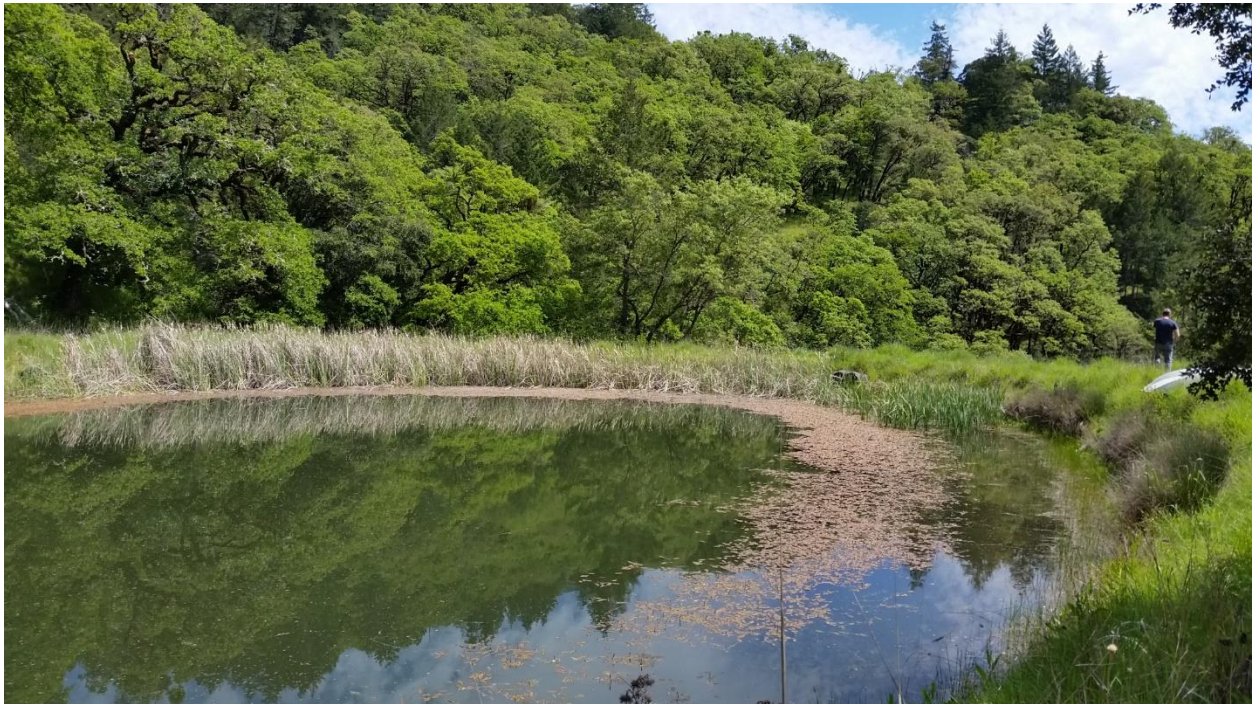
The Lower Pond, constructed around 2006, is connected to the upper pond via a culvert (Photo 3). The earthen dam (Photo 4) at the end opposite where the culvert enters from the Upper Pond has had some issues, apparent by the erosion around the two outlet culverts (Photo 5) which deposit into a Class II drainage. The landowner, who has been instructed to either mitigate or remove this pond, is planning to improve the stability of land around this pond.

Photo 4. View of Lower Pond looking toward Class II and cattails with nesting red-winged blackbirds; person to right standing above culverts in the following picture.

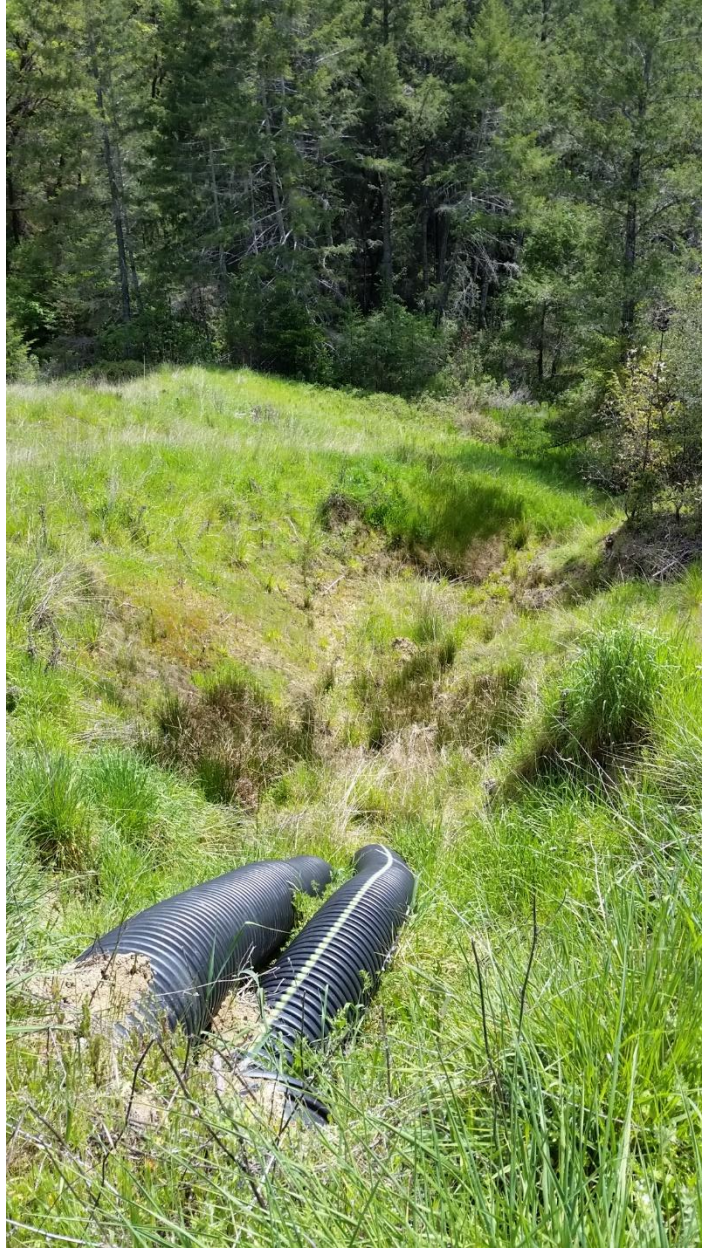
Photo 5. View of culverts behind earth dam of Lower Pond and erosion, with Class II drainage below

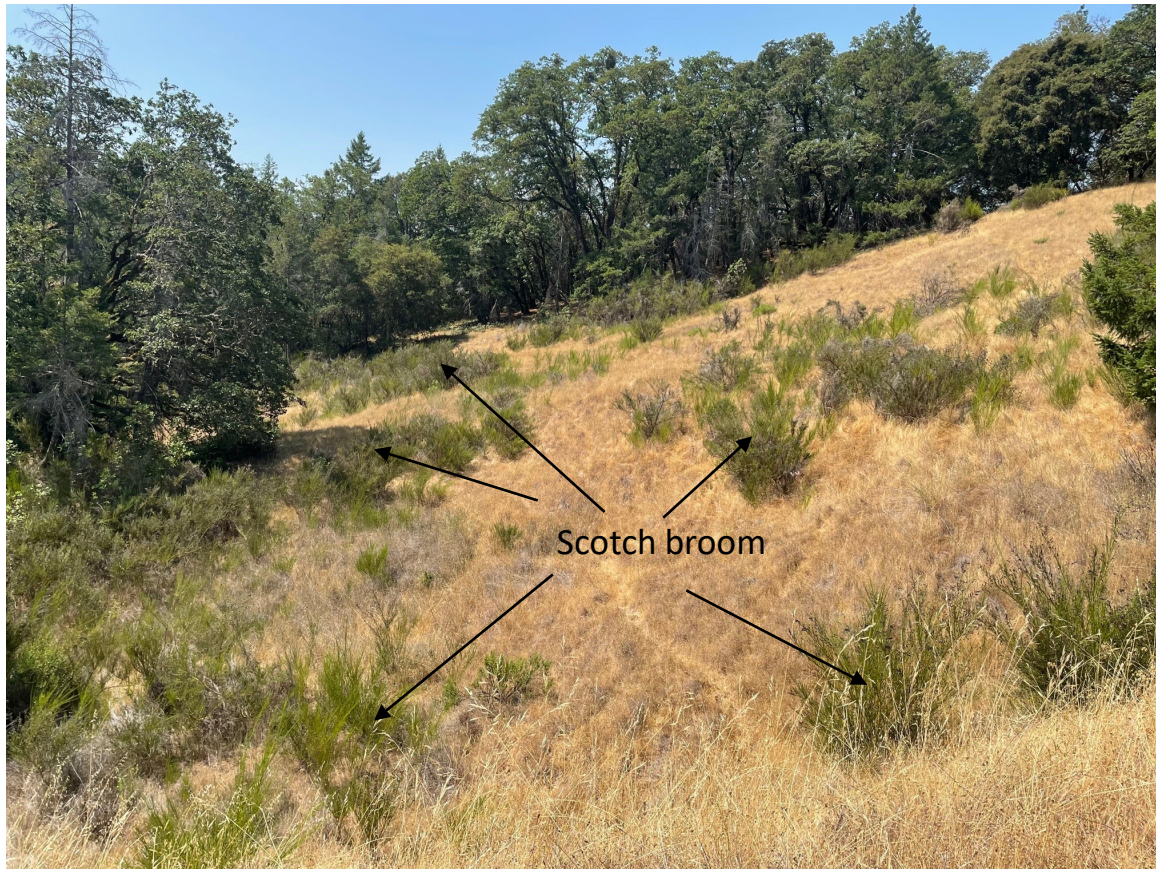
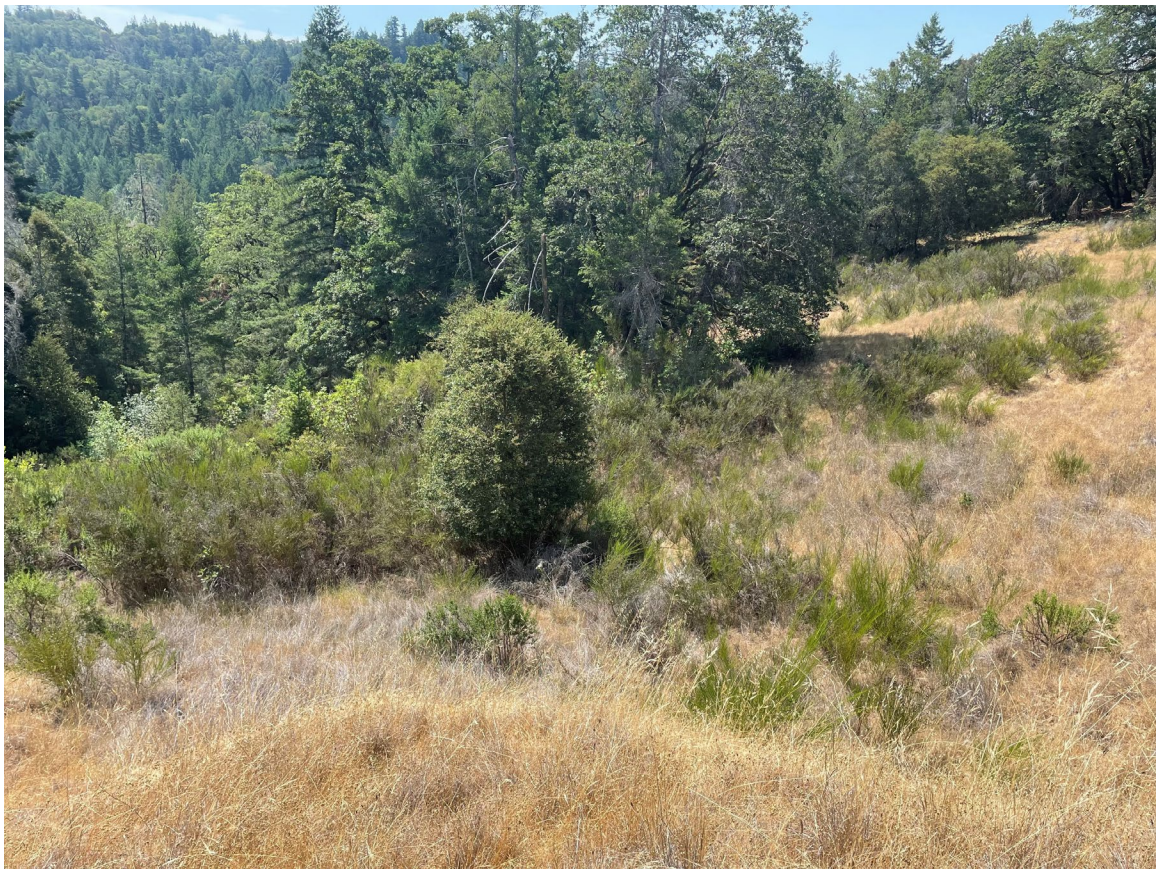
Photos of the potential mitigation area shown in Figure 6. The site has relatively high cover of California oatgrass (*Danthonia californica*) and purple needlegrass (*Stipa pulchra*) with an infestation of Scotch broom (*Cytisus scoparius*).

It is recommended Scotch broom, French broom, yellow starthistle, and Himalayan blackberry be controlled to prevent further spread. Information on control of these species can be found at:

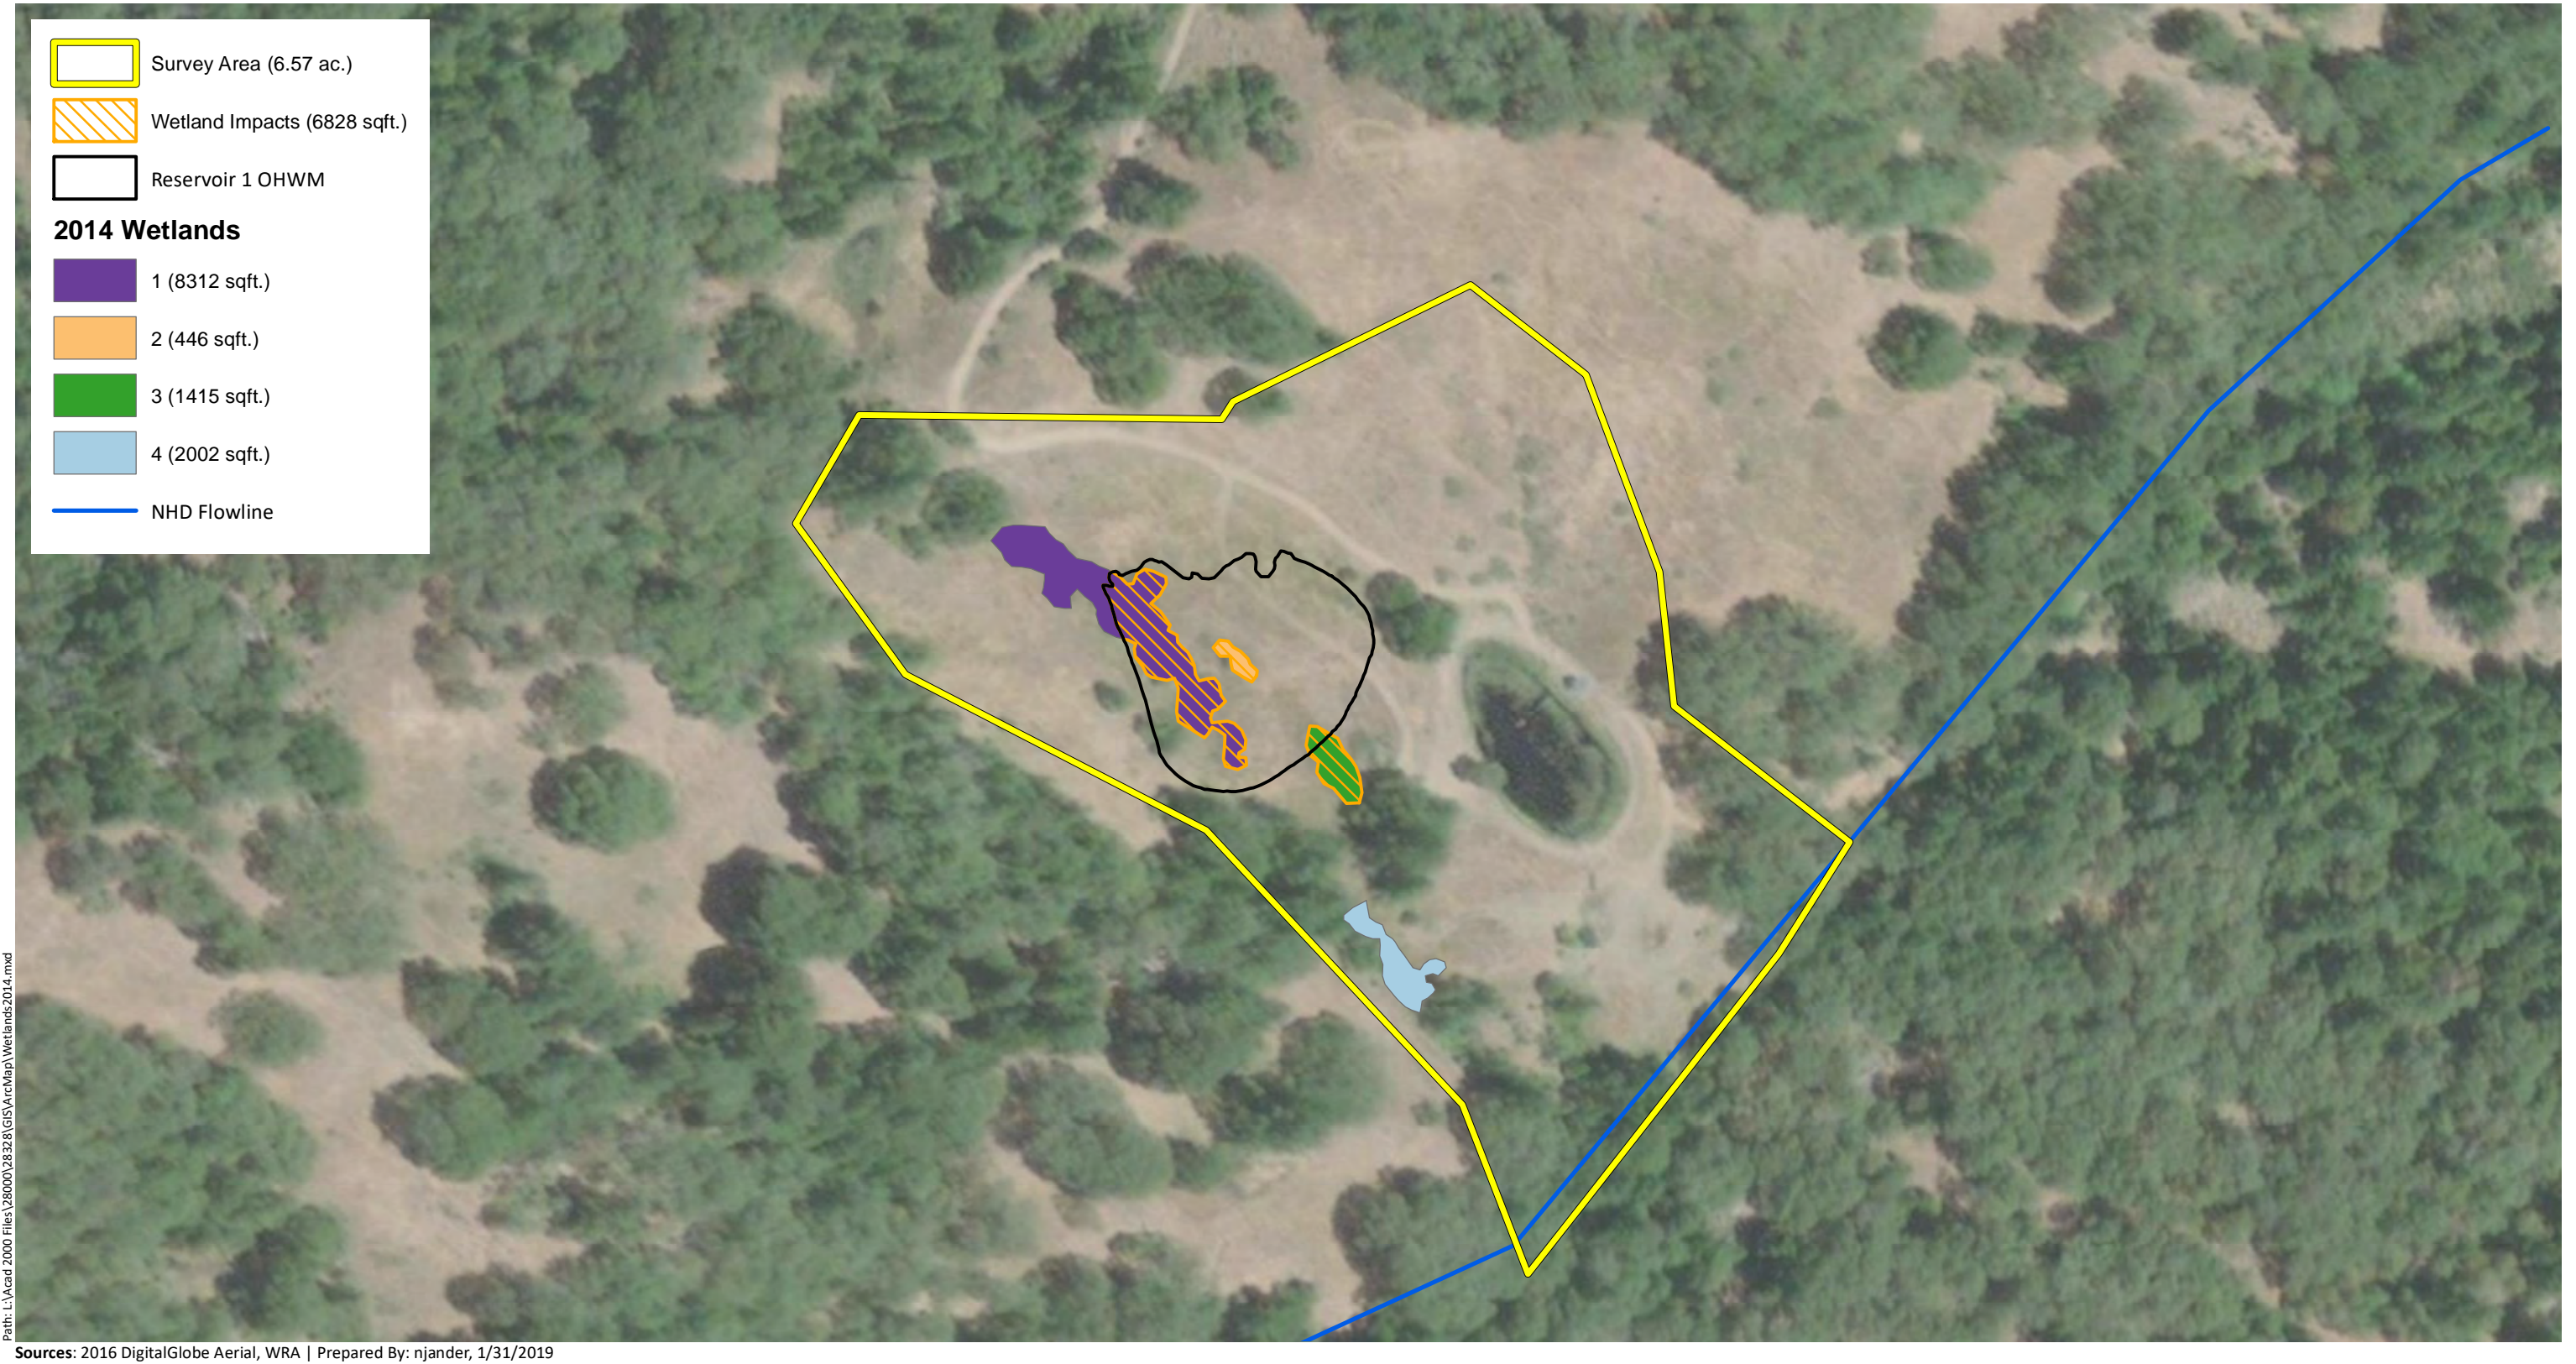
Figure 3. Wetlands Delineation

Sampling results of the January 10, 2018 wetlands delineation indicate that wetlands conditions are present in a specific area around Reservoir 1 and that a small amount of wetlands conditions may have extended into the area now occupied by Reservoir 1 prior to construction, but not to the extent speculated by the NCRWQCB Inspection Report, which suggested wetlands area of up to 87,000 sq. ft. was disturbed by creation of Reservoir 1. Results of the wetland delineation are provided in Table 1 and wetland delineation data forms with recorded sample data are provided in Appendix A. The location where each wetland delineation sample was taken is shown in Figure 2.

The seep wetland currently associated with SP-03 likely continued downslope and into the area now occupied by Reservoir 1 (Figure 3). The location and area that may have met wetlands conditions was estimated through interpretation of graphic signatures on historic aerial photographs, and comparison with areas meeting wetlands parameters, such as at SP-03 and SP-09. This comparison methodology was conducted using NAIP 2014 aerial photography because photographic signatures appeared to best represent potential wetlands areas on this photograph over other photographs. Based on this analysis, the location and extent of potential wetlands is shown in Figure 3, with an estimated wetlands impact of 6,828 square feet (0.17 ac). The topography that existed in the area of Reservoir 1 prior to its creation had a reduced slope as compared to the seep wetland that still exists upslope of the reservoir to the northwest. Because the slope gradient became more gradual in the area where the reservoir was created it is likely the water seeping downslope slowed and saturated soil creating a wetlands meadow feature, and did not continue farther toward the south. Therefore, there would have been no connection of the wetlands to the unnamed creek to the south.

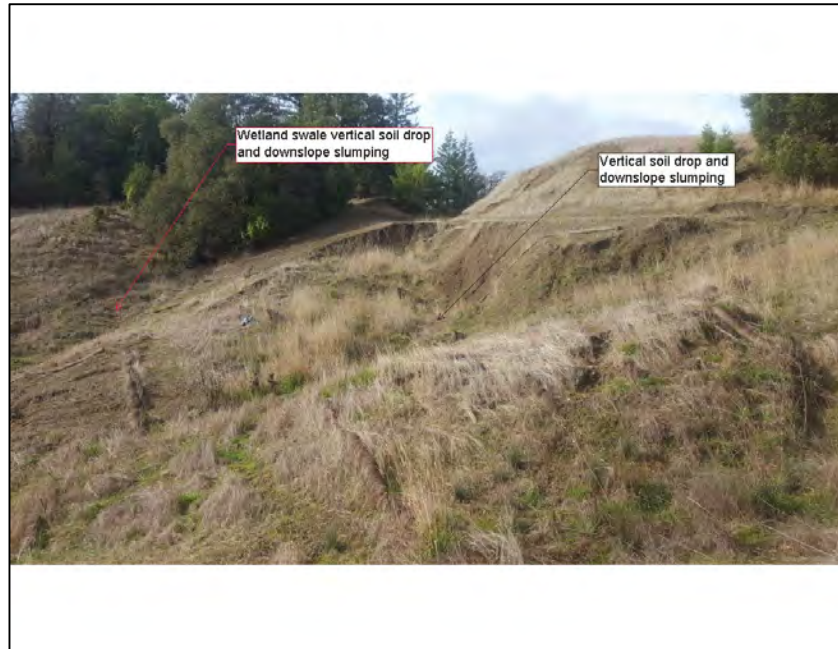
Photograph 3. Photograph taken January 10, 2019 of the landslide areas above Reservoir 1. No bed and bank features that would constitute streams were present.

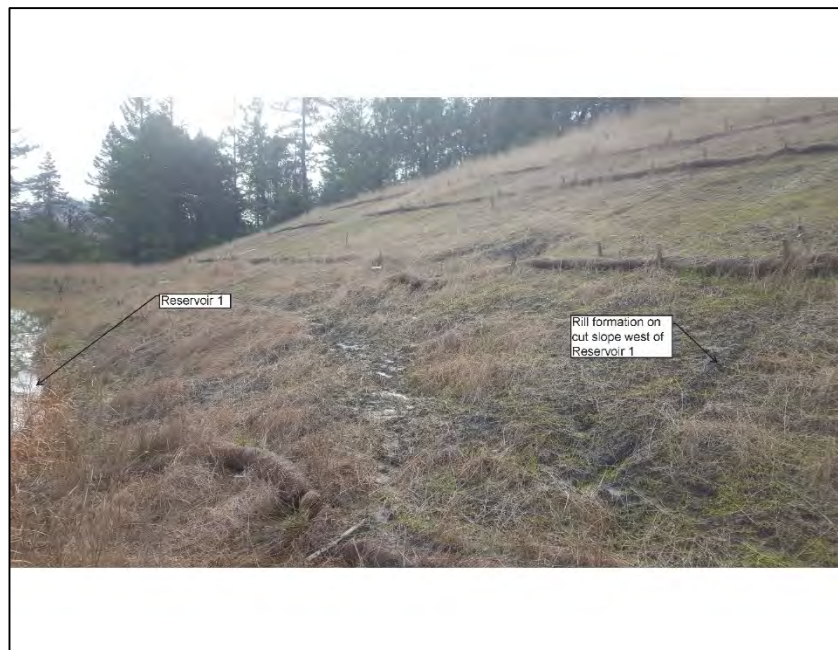
Photograph 4. The cut slope on the west side of Reservoir 1. Rills have formed, but nothing meeting the definition of stream was present.

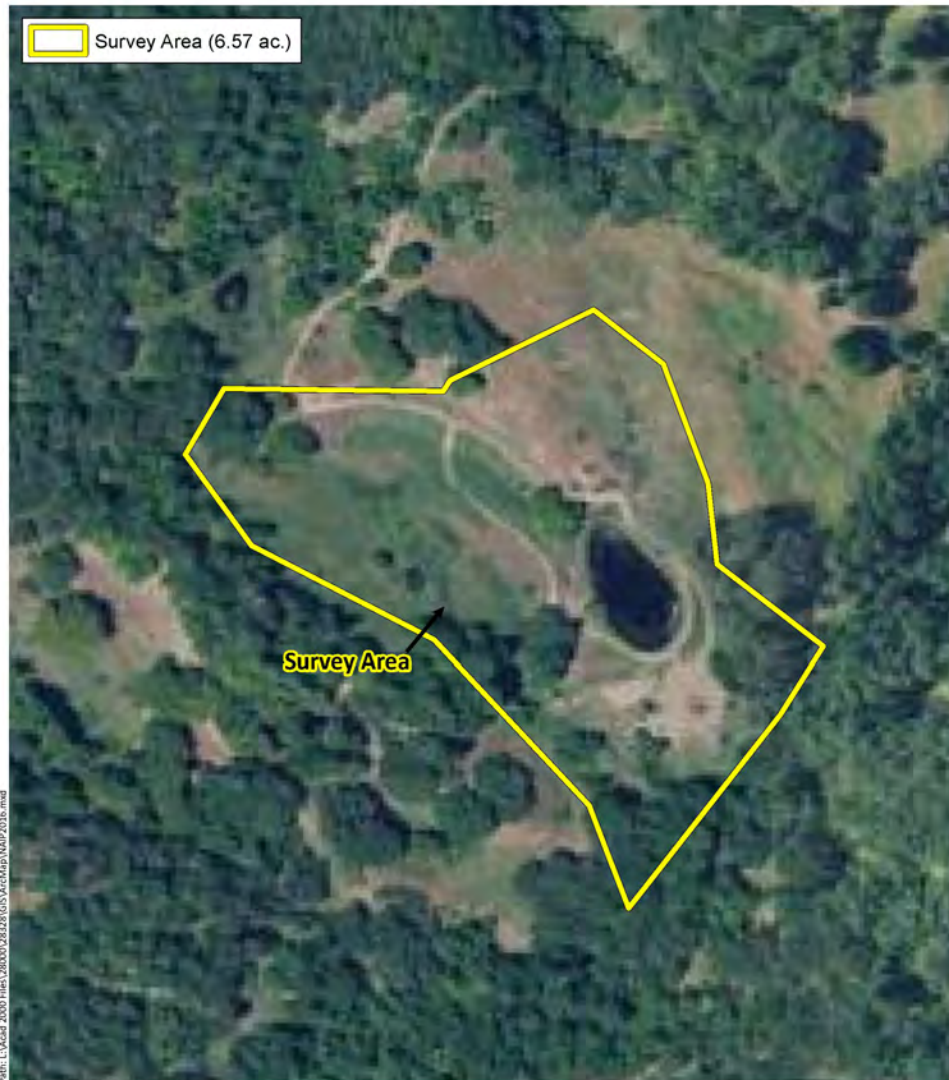
Photograph 5. 2016 NAIP Imagery

photograph (Photo 5). However, this estimate was not based on comparison with direct wetland delineation evidence. The darker green coloration that appears in the area of the created reservoir on that photograph also appears generally in other areas of the photograph and cannot be uniformly assumed to determine wetlands. Moreover, in order to reach 87,000 square feet of wetlands impacts, the entire concave landform from ridge top to below where the reservoir was created would have needed to meet wetlands conditions; as shown in Figure 4, the entire area meeting wetlands conditions is an impossibility. As further evidence that not all green areas in the NAIP 2016 aerial photograph should be considered as representing wetlands, the farm road in the photograph that makes a wide “S” curve through the eastern side of the area would not, from a practical purpose, be placed by a landowner to pass through a wetland because access to areas would be blocked.

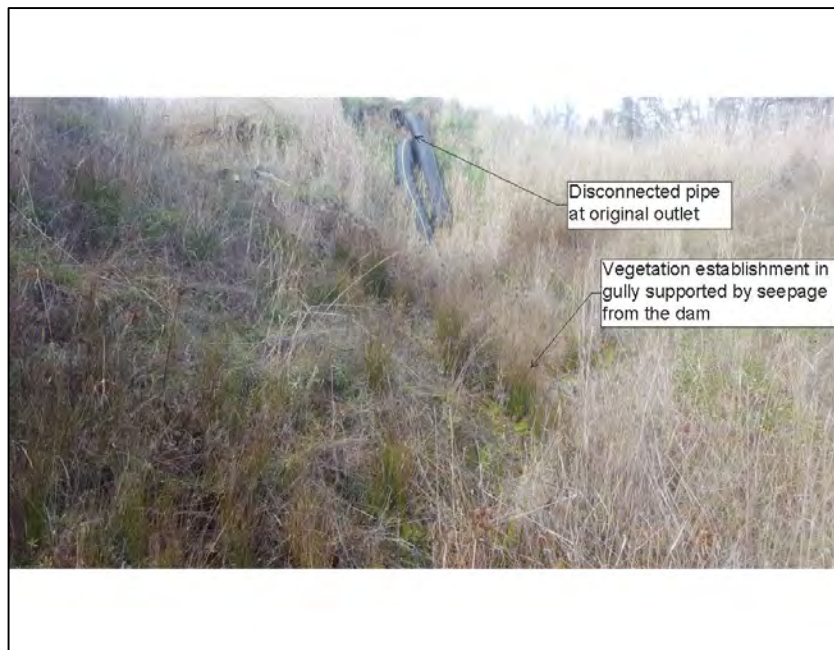
Photograph 6. Gully below Reservoir 2 eroded by outfall from the reservoir from the drain pipe separating. A new outlet on the east side of the reservoir was installed. Seepage from the bottom of the reservoir is becoming established

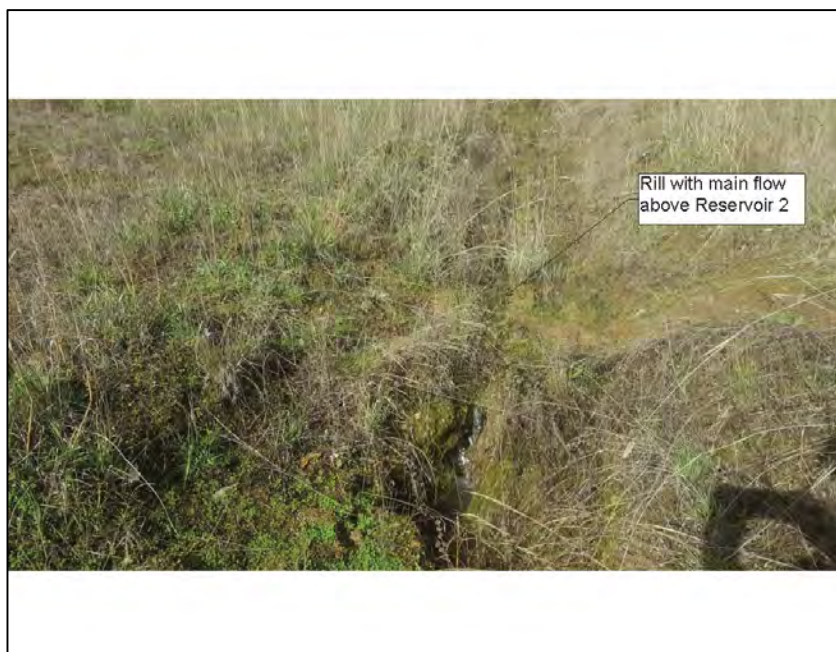
Photograph 7. The main rill from the area above Reservoir 2. No bed and back is present which precludes calling this feature a stream.

Photograph 1 taken in 2005 shows that the landform that has existed above the reservoir before it was built was a steep escarpment to the top of the ridge line with erosion gullies extending downslope with no bed and bank (Photo 7). Observations also made during the January 10, 2019 site visit indicate that the soil slumping still occurs (Photo 8) and the landslide is still active. Therefore, soil erosion and gully formation is continuing. The lack of tree cover in the area above the reservoir is further indication that landslide activity is frequent enough to preclude establishment of trees that are present in adjacent, more stable areas. Shrub vegetation observed leading up the central erosion gully is coyote brush (*Baccharis pilularis*), an upland species and an indication that the flow in the gully is ephemeral with conditions too dry to support riparian species, such as willow. All of these conditions are indicative that the drainage is an erosion feature does not meet requirements to be a recognized watercourse. Therefore, Reservoir 2 is not an in-stream impoundment.

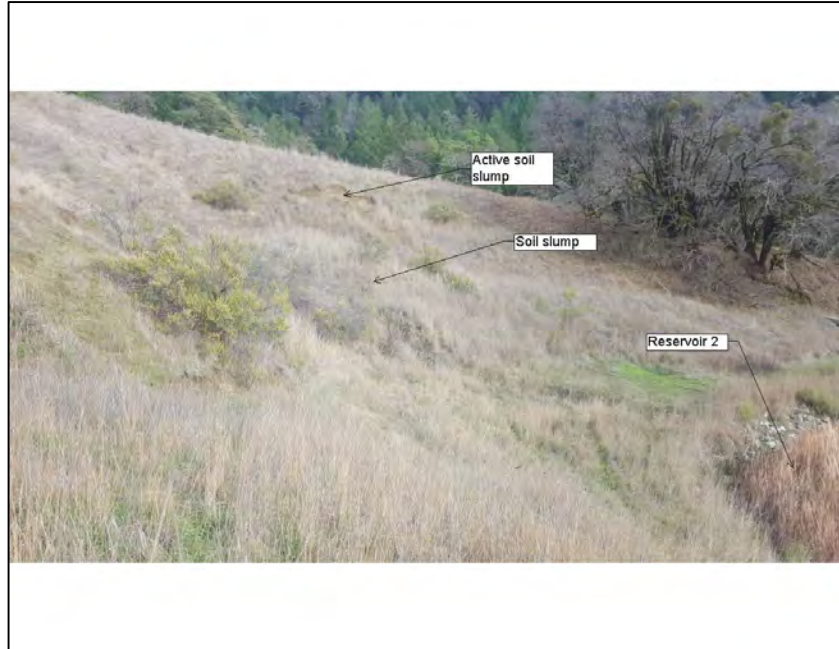
Photograph 8. The area above Reservoir 2 is a landslide area that is still somewhat active as indicated by soil slumping and recent active soil slumping.
