February 24, 2020

Subject: Landslide Hazard Evaluation, Chappellet Vineyard
APN's 032-010-076 and 032-010-094

Subject: Response to comments on Chappellet Vineyards Landslide Hazard Evaluation associated with #P20-00271-ECPA Sage Canyon Road: APNs 032-560-022 and -033

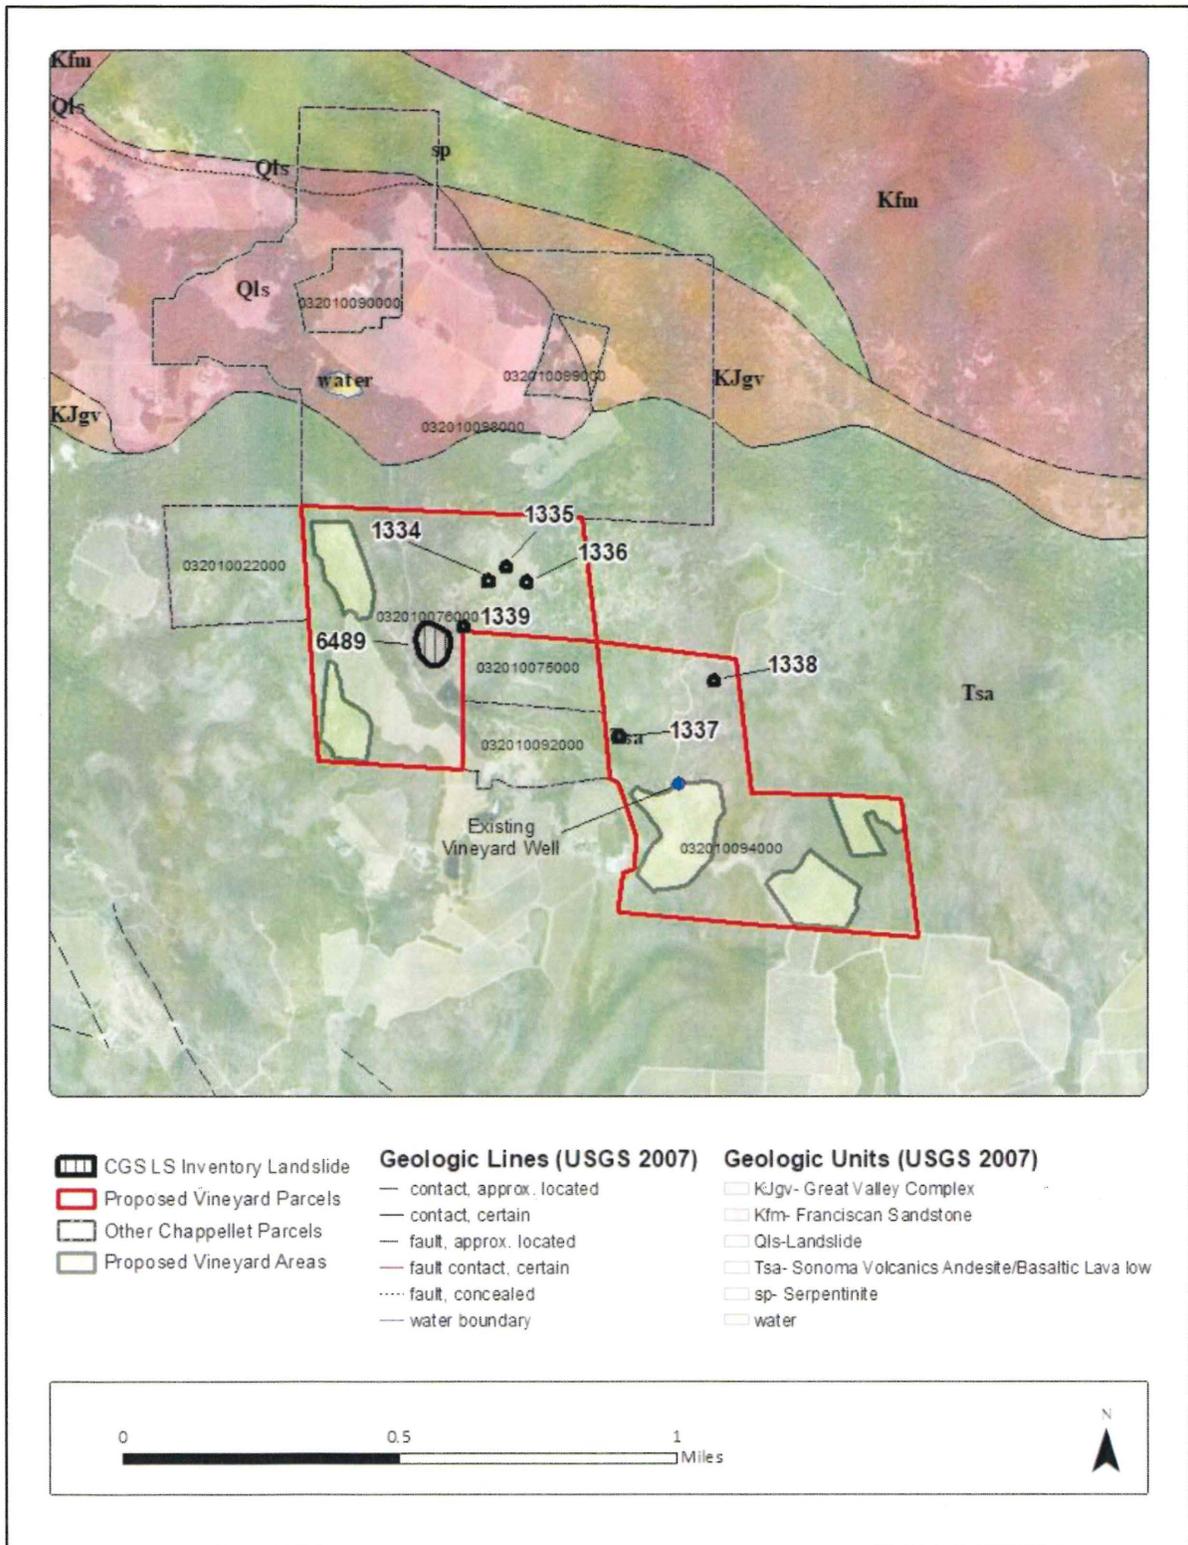
Figure 1. Surficial geology of the project parcel (Graymer et al., 2007).

In the northern project parcel I visited all five mapped landslides and assessed their classification, activity and stability. The extents of landslides 1334, 1335, 1336 and 1339 were adjusted as shown by the black and white dashed polygons in Figure 1. Landslides 1334 and 1335 appear to be offset to the northwest slightly and are part of a single feature; 1339 was smaller than the USGS mapped extent. The extent of landslide 6489 was not changed, and a previously unmapped probable historic debris slide landslide (OEI 1) was observed. None of the landslides observed were active or present a hazard to the project or project infrastructure. In the southern project parcel at the locations of the two mapped landslides both sites had exposed bedrock, boulders and cobbles; however, no evidence of active or historic slope movement was observed.

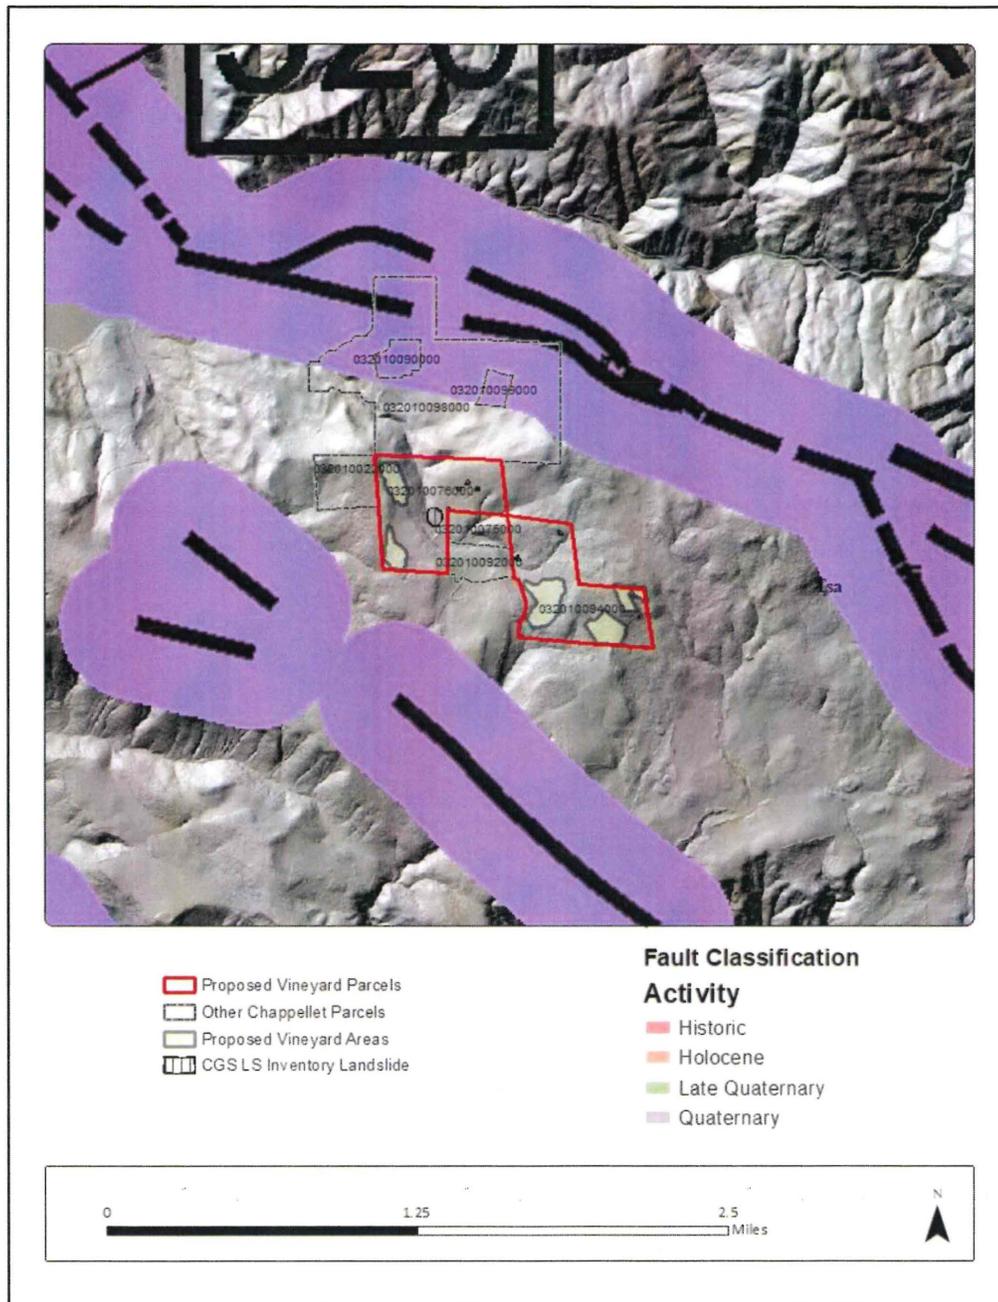
A series of northwest by southeast-tending Quaternary faults are mapped near the project parcels within about 0.5 miles to the northeast and southwest of the project site (Figure 2). The site is 18 miles northwest of the nearest active fault, the Green Valley Fault.

Figure 2. Faults near the project parcels from California Geological Survey Fault Activity Map of California (2010).

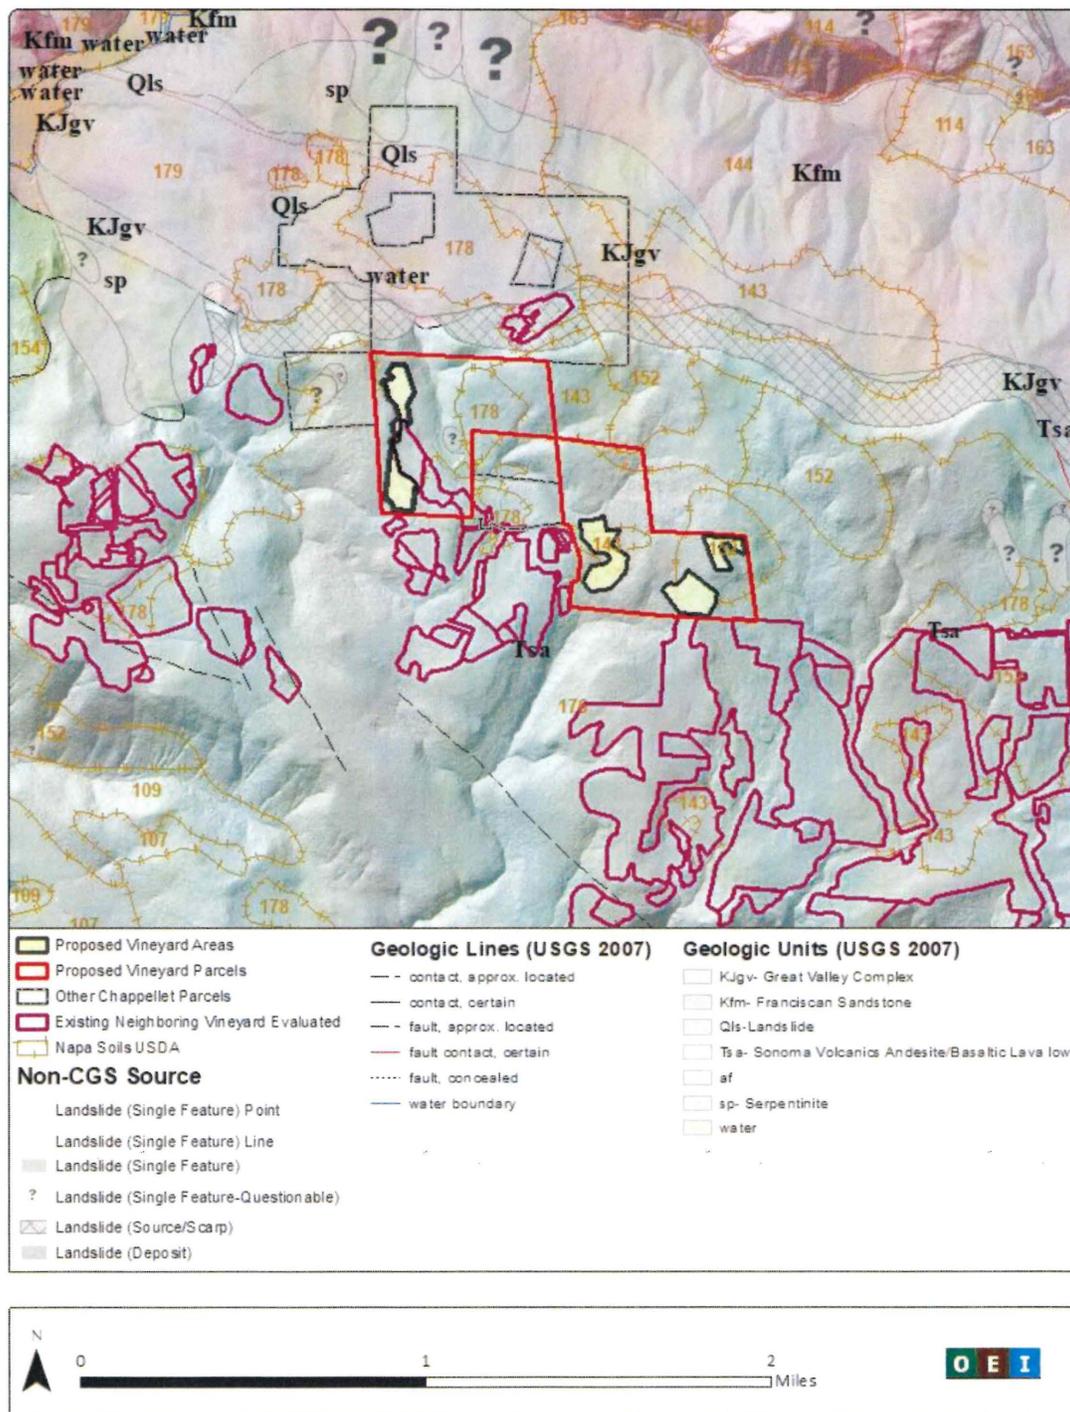
Aerial and LiDAR Imagery. Finally, aerial imagery and recent LiDAR topographic data were reviewed for the Pritchard Hill area, particularly those areas with developed vineyards with in soils and geology similar to the project area. Figure 1 shows existing vineyard areas where this additional review was made in and around vineyards where rock removal and soil ripping has occurred. Available aerial imagery on Google Earth covering the period between 2002 and the present did not reveal any evidence of landslides in these

areas. Further review of hillshade terrain maps and slope gradient maps derived from recent 2018 LiDAR data collected by USGS¹ did not reveal any landslides or unstable slopes in areas located on nearby upland plateaus and rounded ridgetops within the Tsa bedrock unit (Figure 1). Slopes across all vineyard areas are generally less than 30% per county requirements and therefore it is not surprising that no evidence of landslides or unstable slopes were remotely identified. Anomalous steeper slopes near vineyard areas were always associated with piles of rock removed from the adjacent fields.

Figure 1. Project site with proposed vineyard areas, geology, soils and previously mapped landslides.
