Pre-Demolition Hazardous Building Materials Survey
845 Santa Fe Drive
Encinitas, California
APN: 260-132-23-00

October 13, 2023 | Project No. 109721001

Subject: Pre-Demolition Hazardous Building Materials Survey
845 Santa Fe Drive
Encinitas, California 92024
San Diego County APN: 260-132-23-00

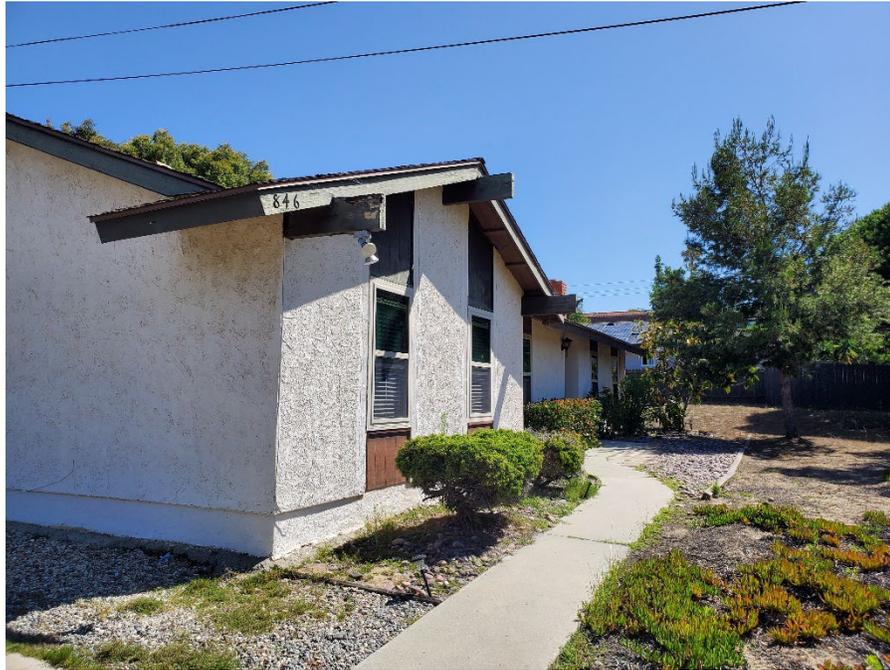
Photograph 1: View of the Residence, facing east-northeast. Typical stucco exterior walls and shingle roofing is visible.

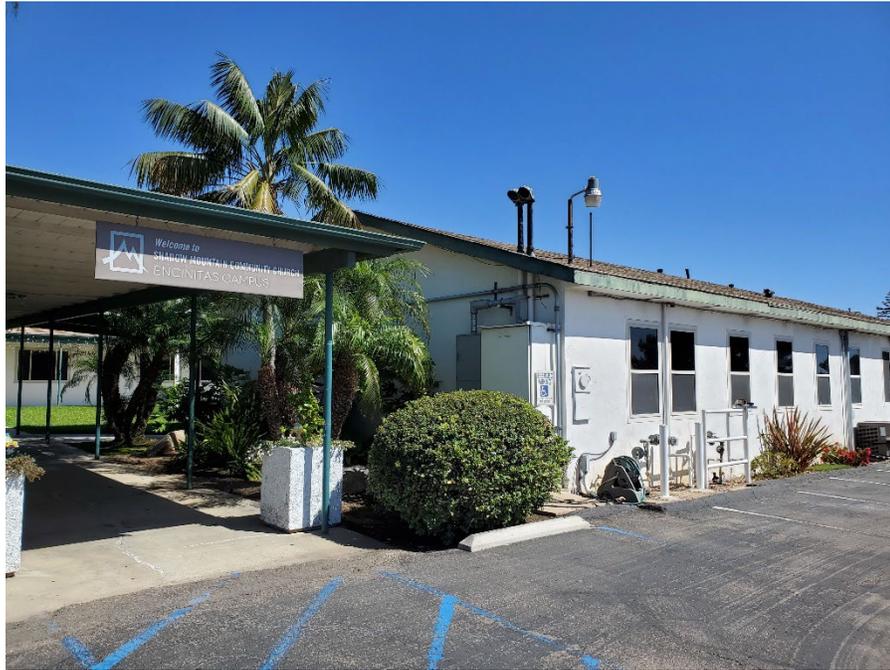
Photograph 7: View of the Office Building of the church, facing southeast.

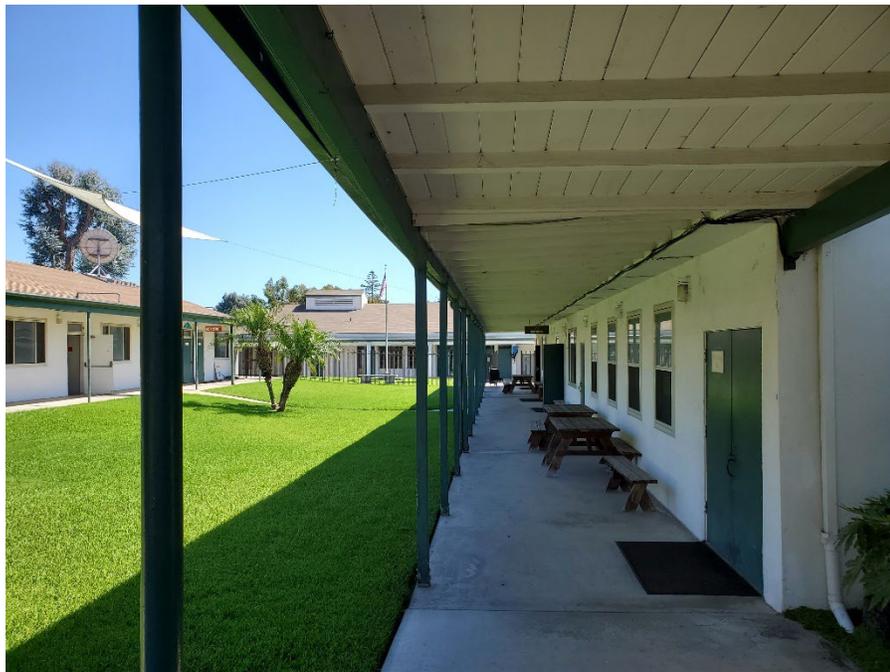
Photograph 8: View of the church-related buildings, facing south: the Office is on the right, the Church is on the left, and the Preschool is in the background. Typical stucco exterior walls are visible, as well as the wood overhang/walkway.

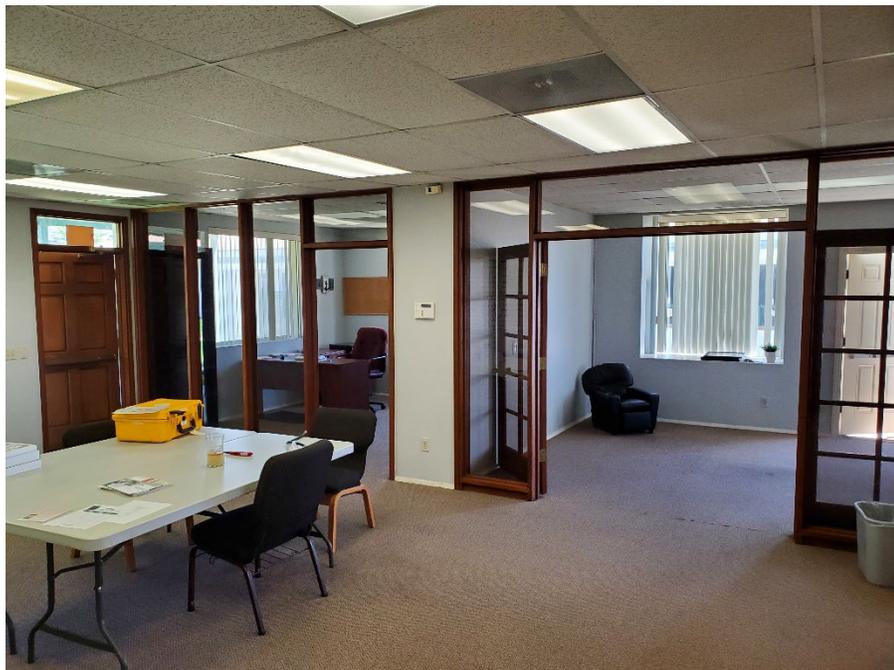
Photograph 10: View of southern portion of the Office Building. Typical acoustic panel ceilings, drywall walls, and carpet floors are visible.

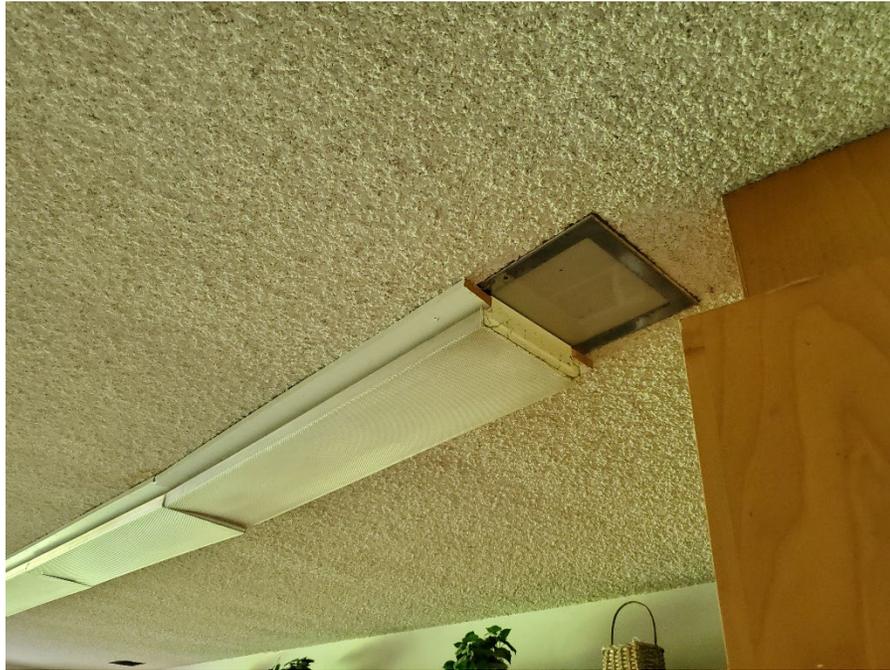
Photograph 13: View of double lighting fixtures in the Kitchen of the Office Building.

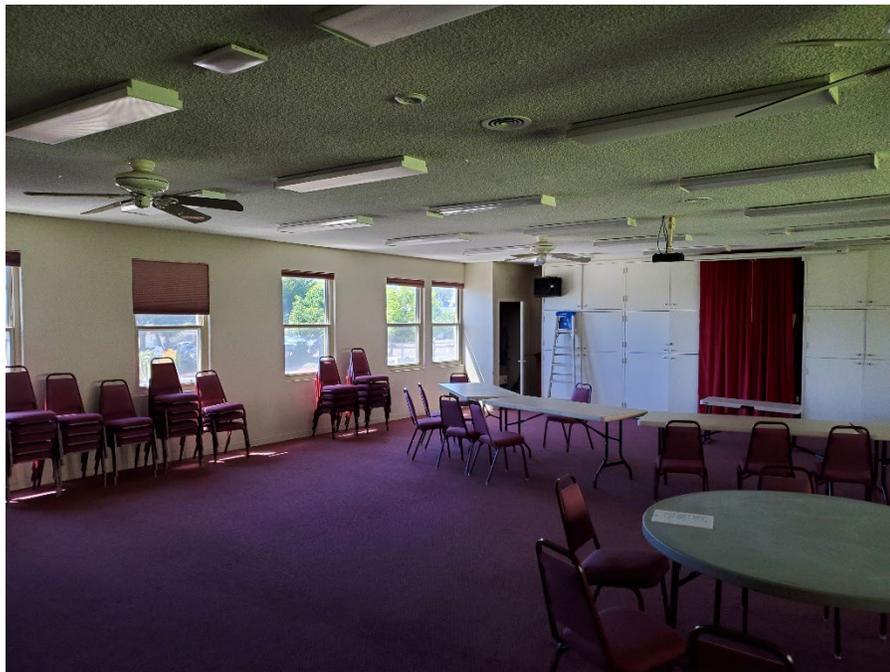
Photograph 14: View of Community Hall of the Office Building. The Communication Closet is visible on the far side of the room.

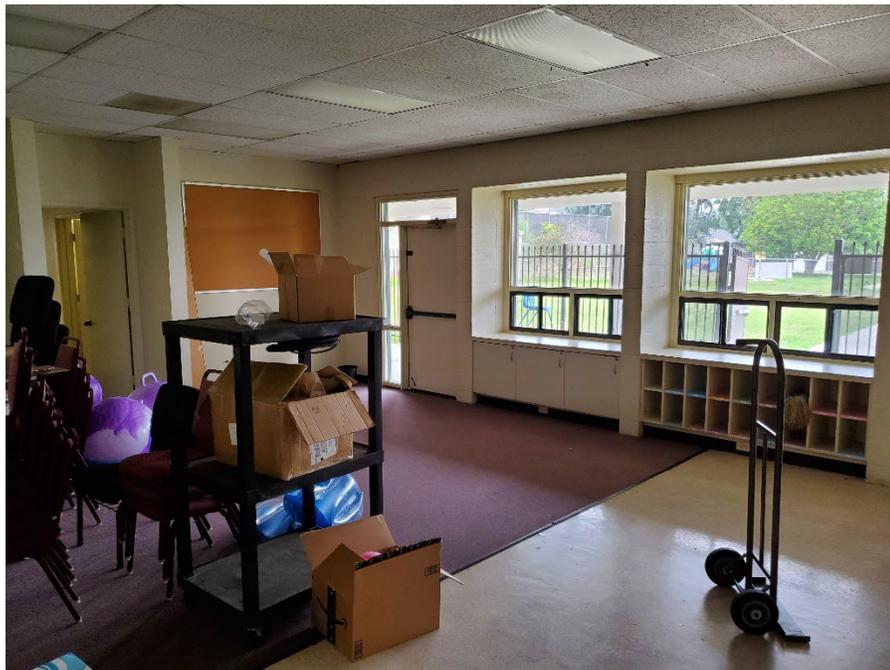
Photograph 16: View of typical Classroom in the Preschool Building. Typical acoustic panel ceiling, drywall and concrete masonry unit walls, and carpet and vinyl sheet floors are visible.

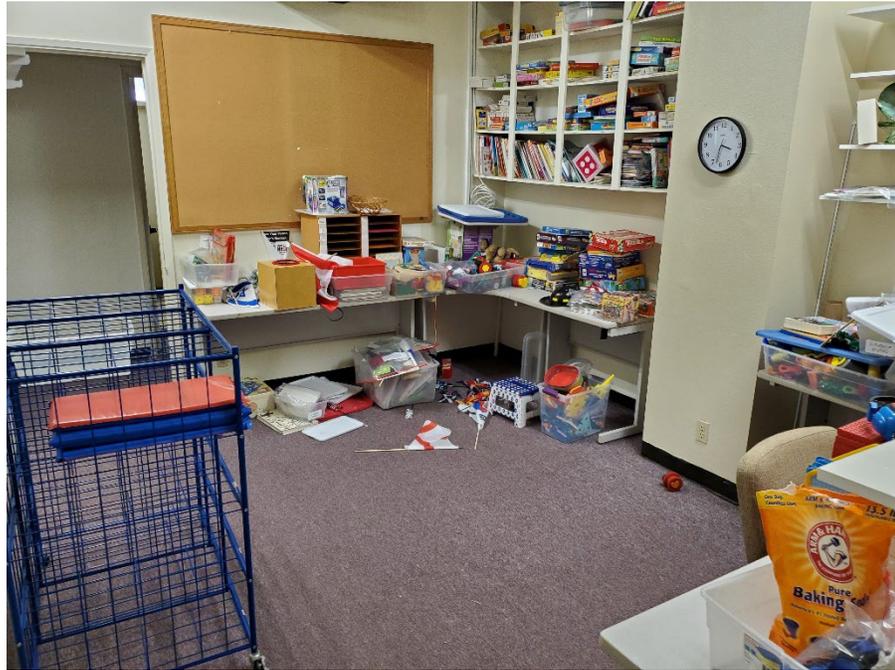
Photograph 17: View of typical Storage Room in the Preschool Building.

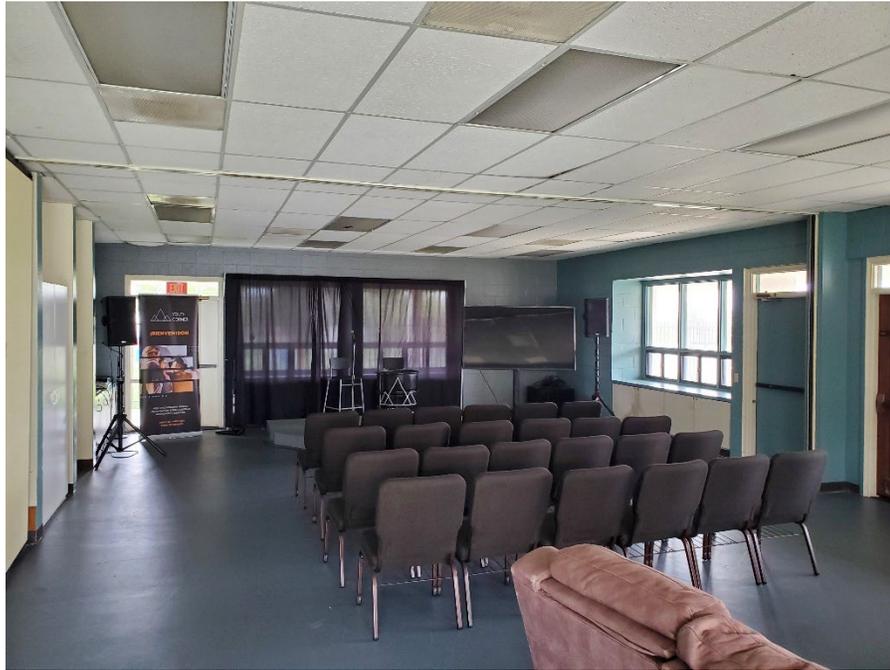
Photograph 19: View of the Bible Study Room of the Preschool Building.

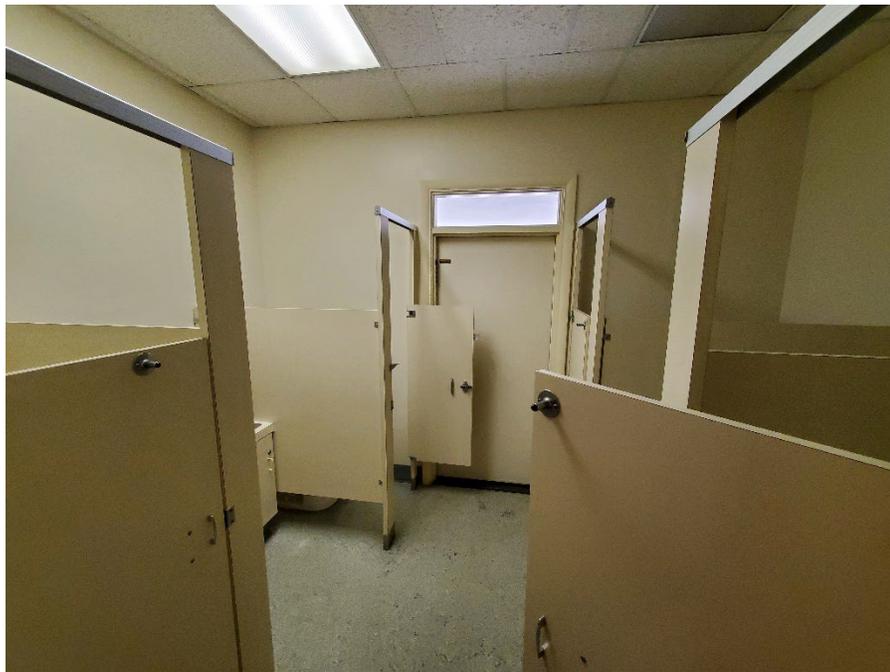
Photograph 20: View of typical restroom in the Preschool Building.
