# Tree Survey and Arborist Report

*for an approximate 8.3-acre Site*

*Located at 333 Garrison St. Oceanside, CA, within the County of San Diego*

*Report Date: March 27, 2024*

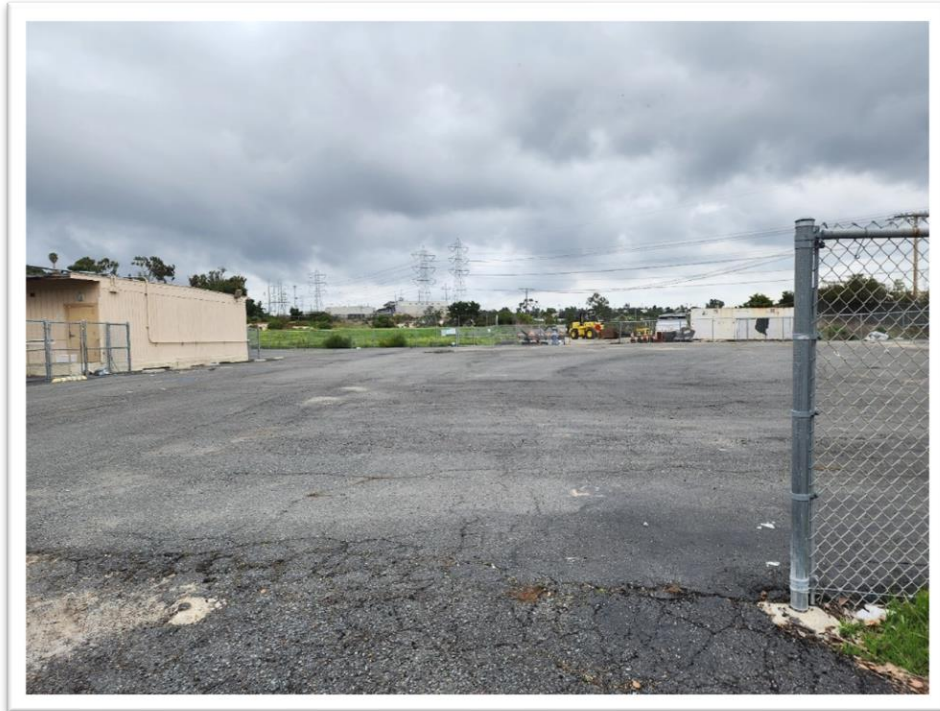
Plate 1. This is an eastern view of a paved area within the central portion of the site, with a field in the background, composed of ruderal vegetation.

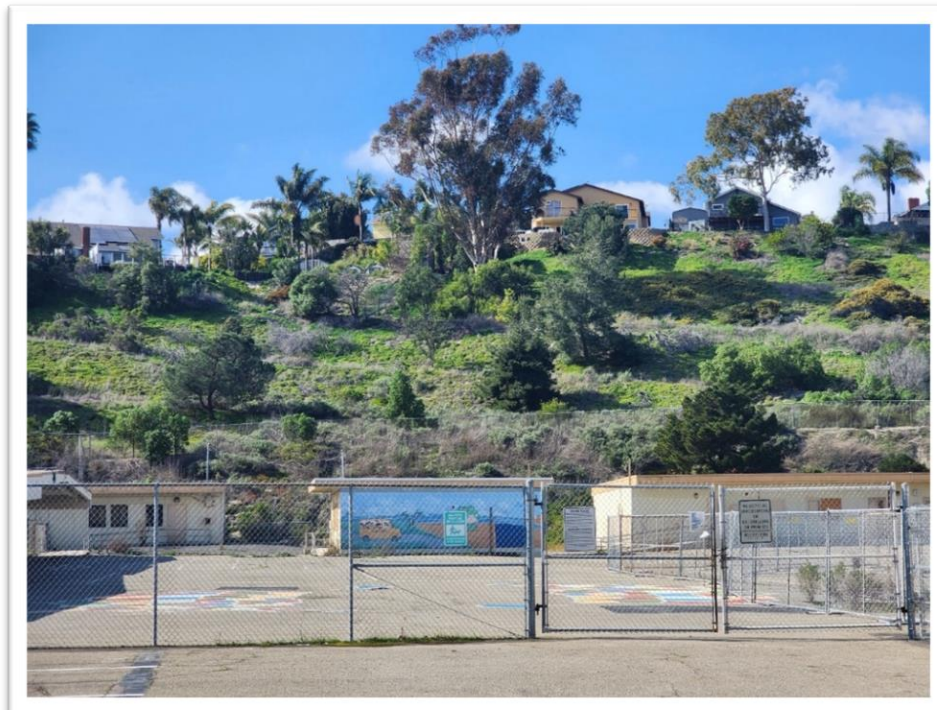
Plate 2. This is a northern view at the terrace just beyond the pavement showing ornamental vegetation with relic native plants seen sporadically on the lower hillside.
