### Tree Inventory Report

**CITY OF LOS ANGELES PROTECTED TREE REPORT  
THE STAR  
6061, 6063, 6069 & 6087 W. SUNSET BOULEVARD  
LOS ANGELES, CA 90028**

**APRIL 3, 2025**

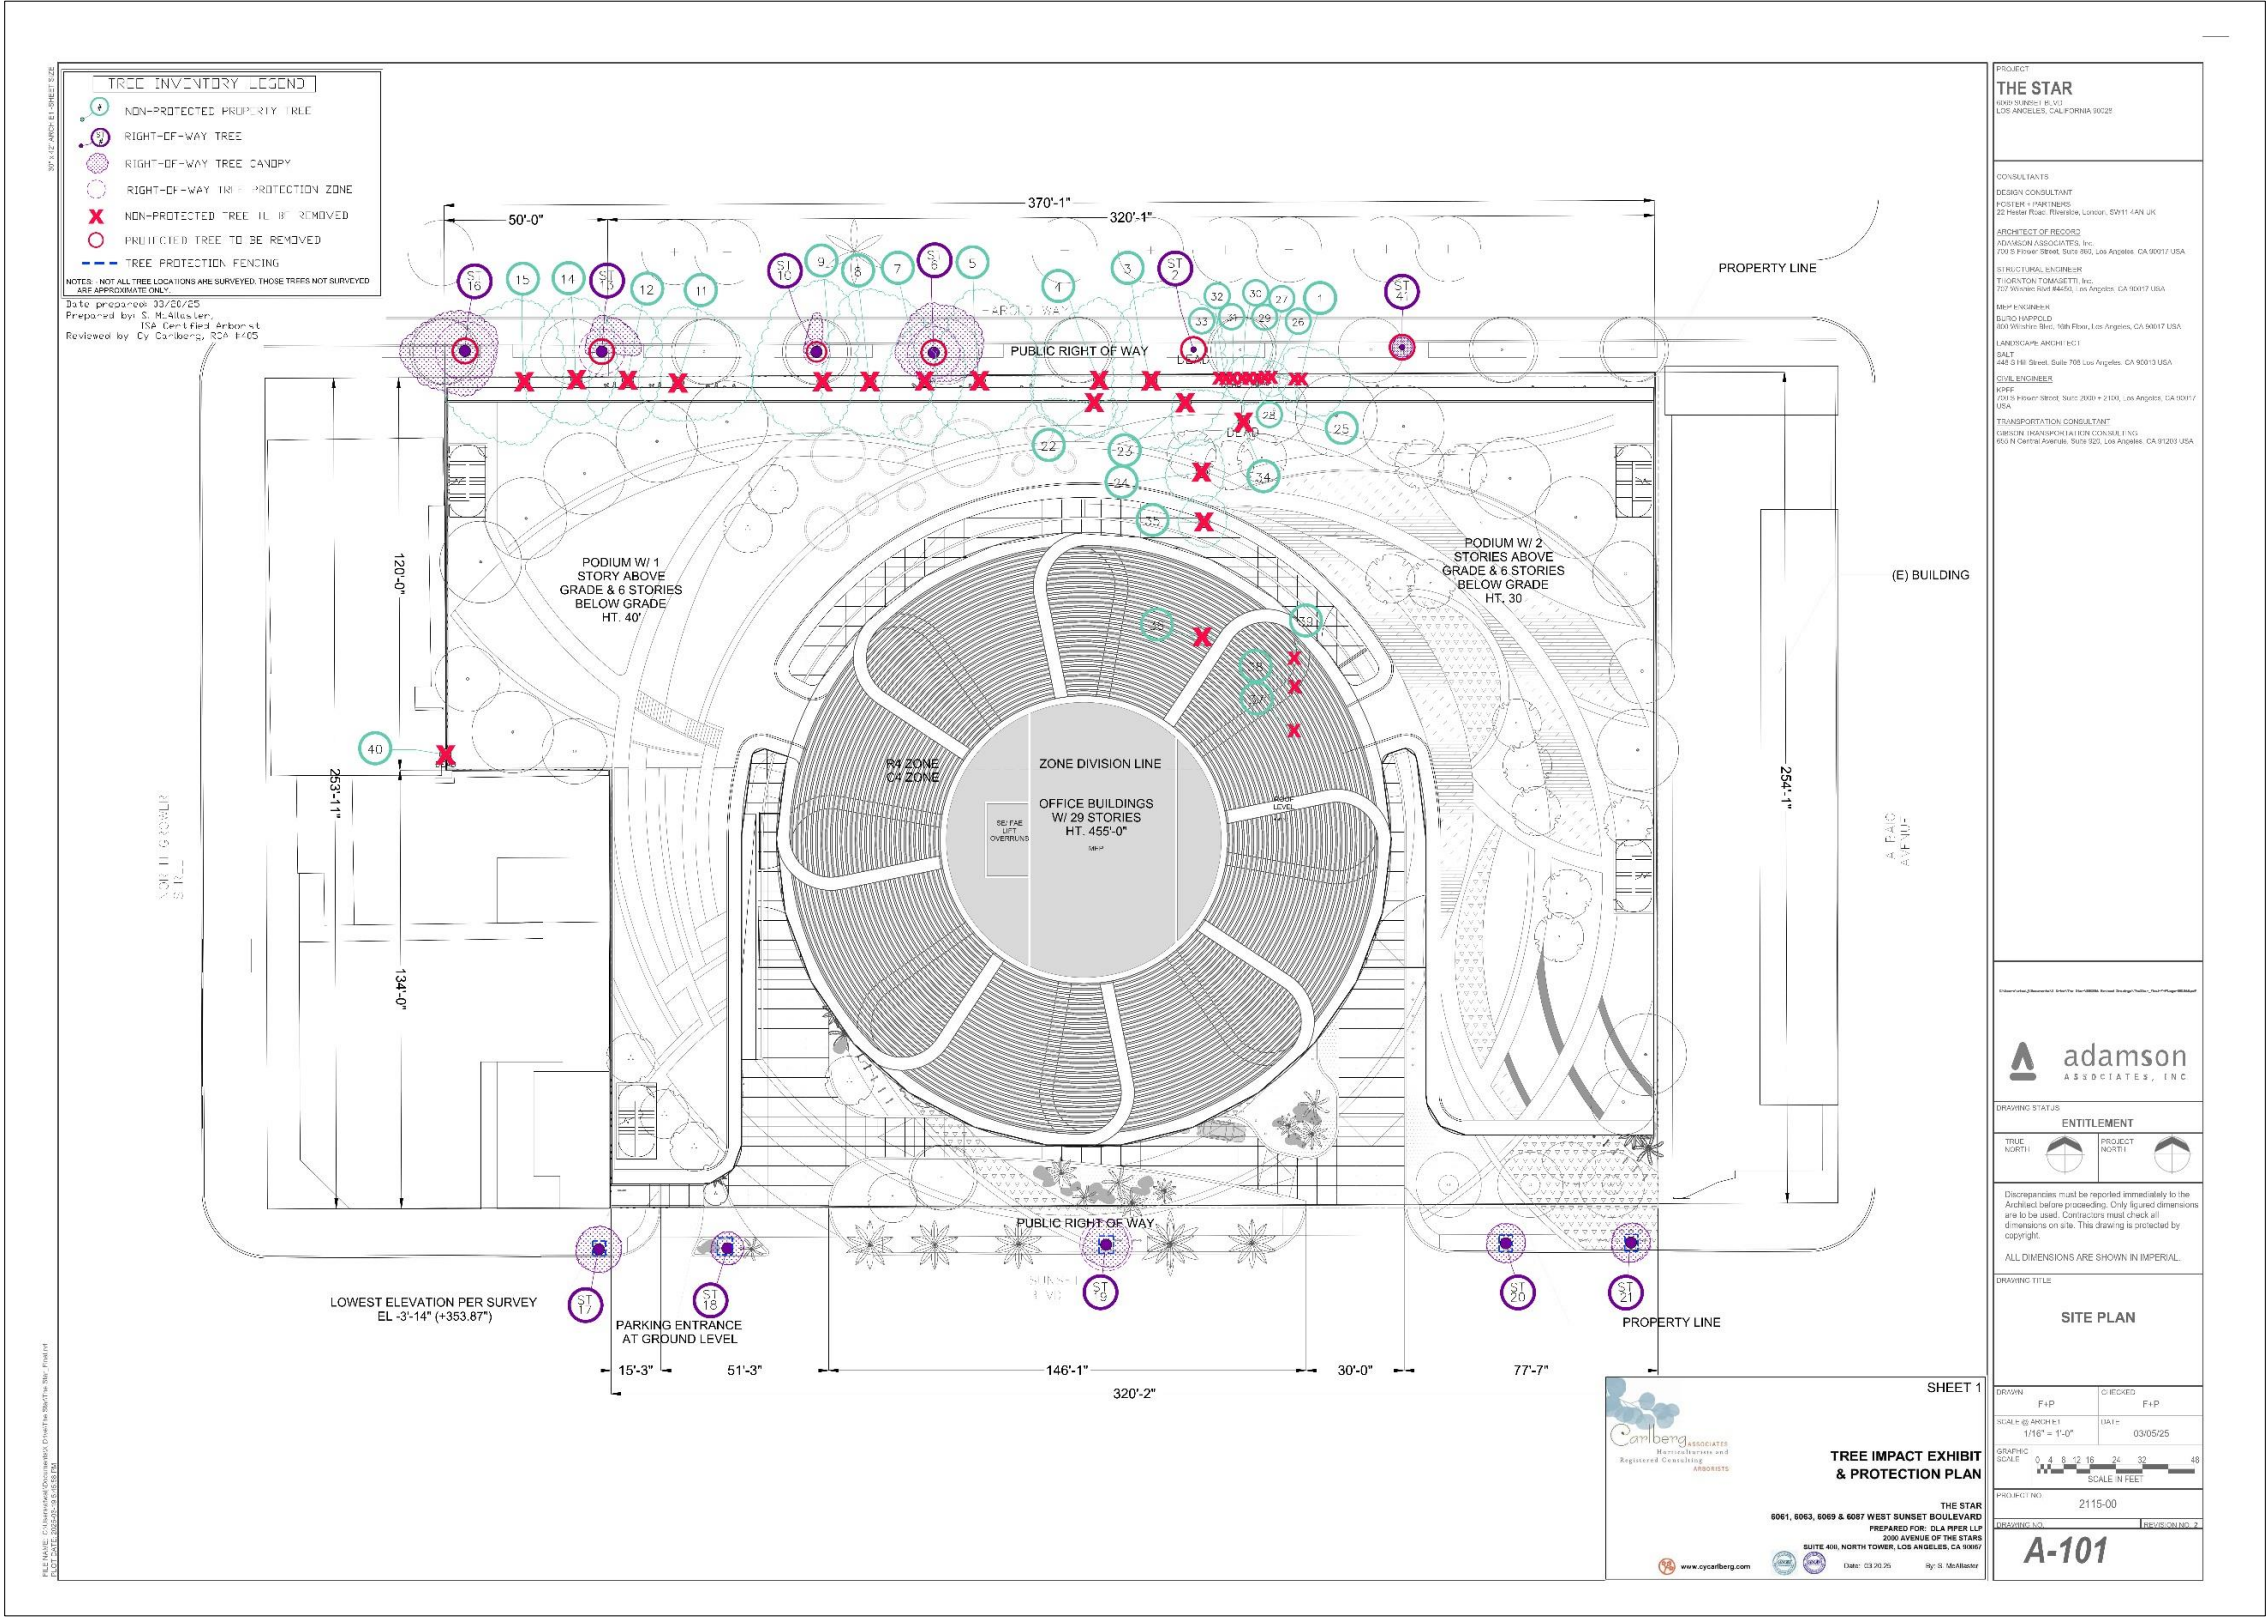
EXHIBIT D – REDUCED COPY OF THE TREE IMPACT EXHIBIT (NOT TO SCALE, 11” X 17” SHEET)

Trees to be preserved or removed, along with the proposed location of recommended protective fencing, are illustrated on the reduced and full-sized copies of the Tree Impact Exhibit and Protection Plan.

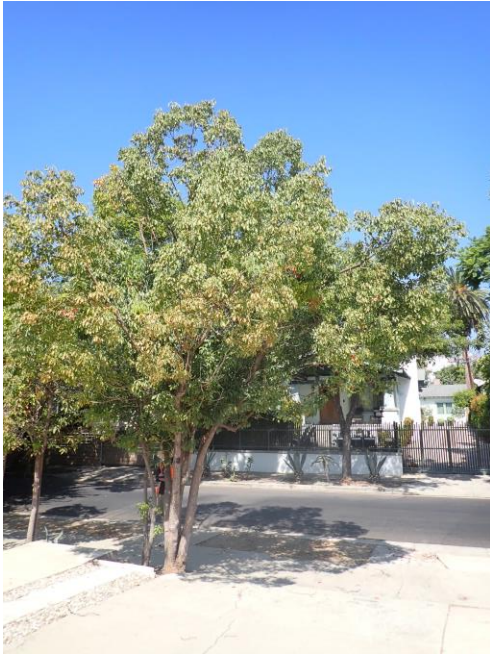
Street Tree no. 2 (ST2) is recommended for removal because it is standing dead, therefore has hazardous risks.

Tree ST2 (Protected) – pink trumpet tree (*Handroanthus impetiginosus*) facing southwest

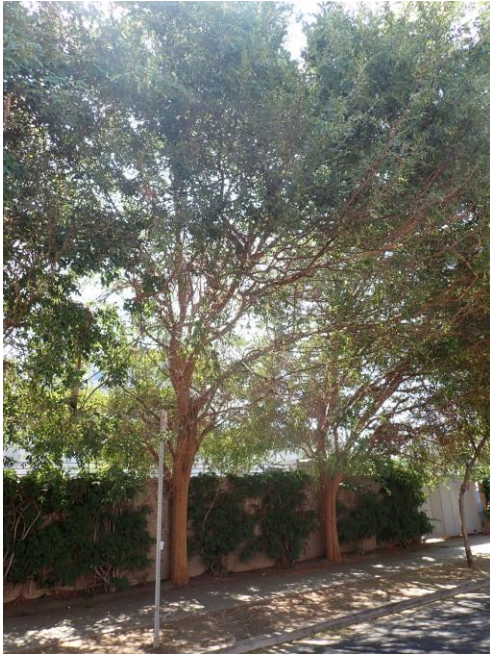
Street Tree no. 6 (ST6) is recommended for removal due to its poor structural condition. The tree has extensive dieback and has been shaded out over the years by adjacent Chinese elm trees that have almost fully engulfed the canopy.

Tree ST6 (Protected) – pink trumpet tree (*Handroanthus impetiginosus*) facing southwest

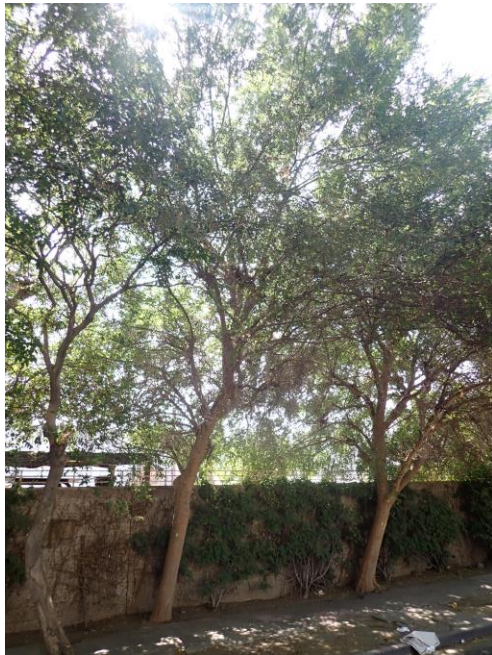
Street Tree no. 13 (ST13) is recommended for removal due to its poor structural condition. The tree has a large amount of damage at the trunk's base, extensive dieback and has been shaded out over the years by adjacent Chinese elm trees that have almost fully engulfed the canopy.

Tree ST13 (Protected) – pink trumpet tree (*Handroanthus impetiginosus*) facing southwest
