## Preliminary Arborist Report

### Haker Bucknall Multi-Purpose Building San Jose, CA

**PREPARED BY:**  
HortScience | Bartlett Consulting  
2550 Ninth Street, Suite 112  
Berkeley, CA 94710

**January 2025**

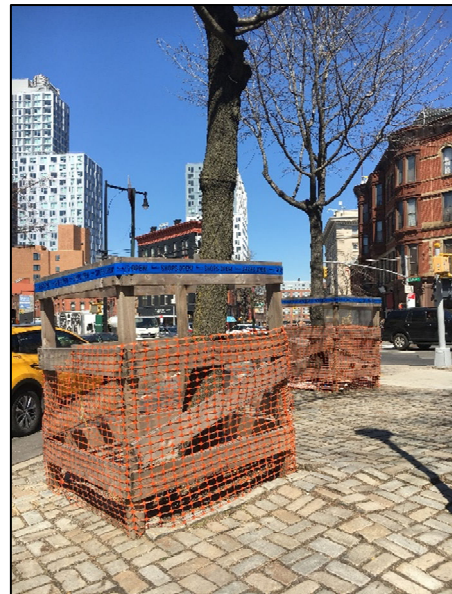
**Figure 1:** An example of trunk protection measures in the public right-of-way.

1. The demolition contractor shall meet with the Consulting Arborist before beginning work to discuss work procedures and tree protection.
2. Fence all trees to be retained to completely enclose the **Tree Protection Zone** prior to demolition, grubbing, or grading. Fences are to remain in place until all construction is completed.
3. The 21 *Street Trees* in the public right-of-way will require trunk protection during demolition of the existing hardscape and construction of the renovated sidewalk. This may be created by enclosing the entire planter in 6-foot-tall wooden fencing wrapped in orange snow fencing (Figure 1).
