## Preliminary Arborist Report

**3521 Homestead Road  
Santa Clara, CA**

**PREPARED FOR:**  
PulteGroup, Inc.  
4511 Willow Road  
Suite 8  
Pleasanton, CA 94588

**November 2024**

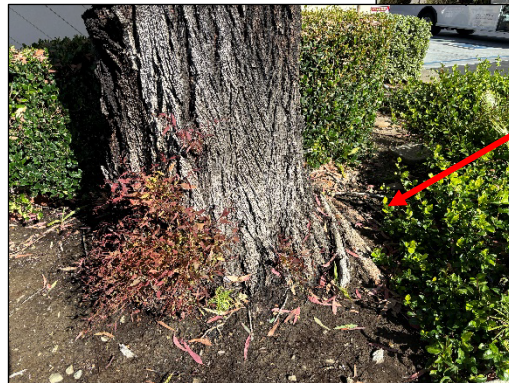
Mature red ironbarks #166 and 167 grew in separate planters between a driveway and building. Tree #166 was in poor condition with a crook at 6 feet, poor structure, a high crown, and history of branch failure (Photo 5). Tree #167 was in fair condition and vigorous with poor structure, extensive epicormic growth, and a dense crown. Extensive girdling roots were amassed on the east side of the base (Photo 6).

**Photo 6:** Red ironbark #167 had a dense vigorous crown and girdling roots (inset).
