January 13, 2025

## **TREE ASSESSMENT, PROTECTION, AND MITIGATION PLAN**

**Job Location: 1 HOT SPRINGS RD., Santa Barbara, CA 93108**

Bill Spiewak Consulting Arborist

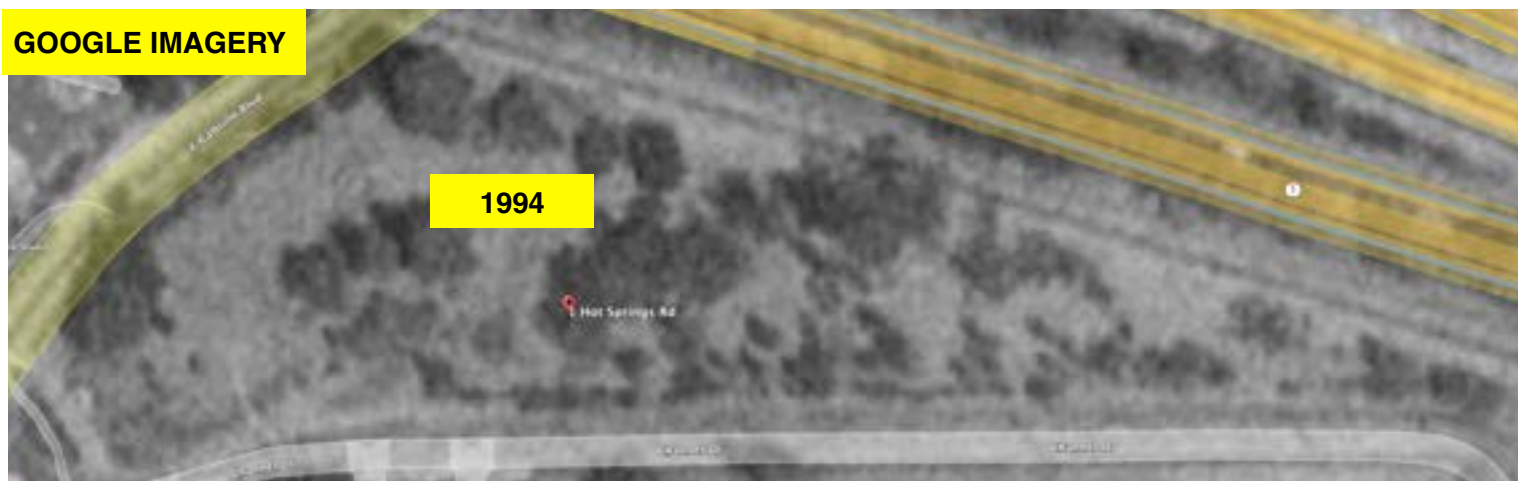
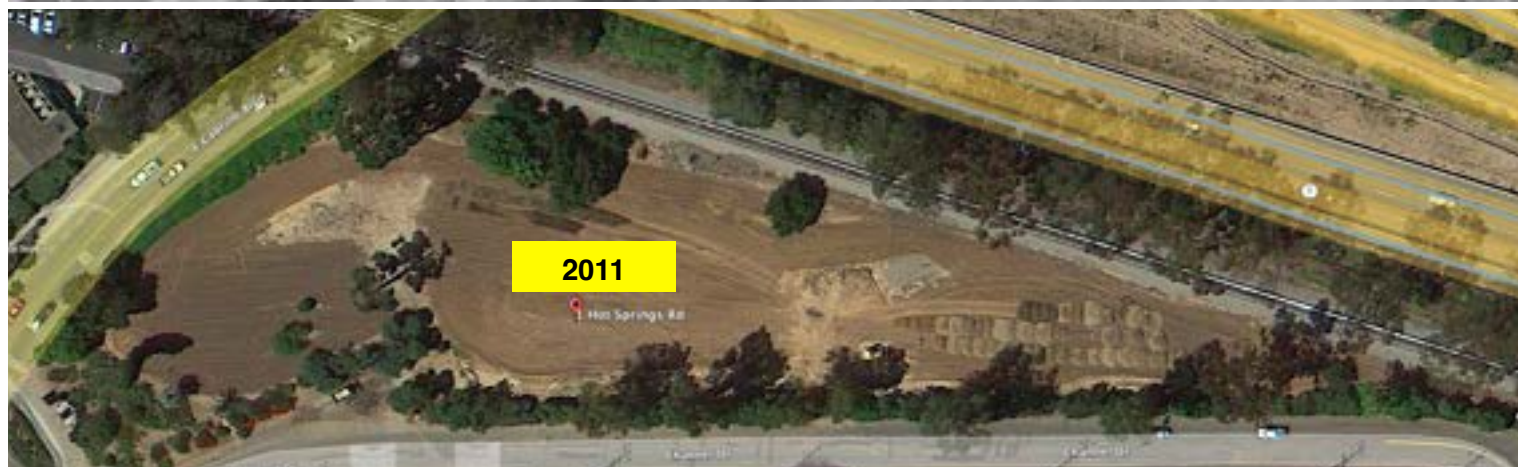
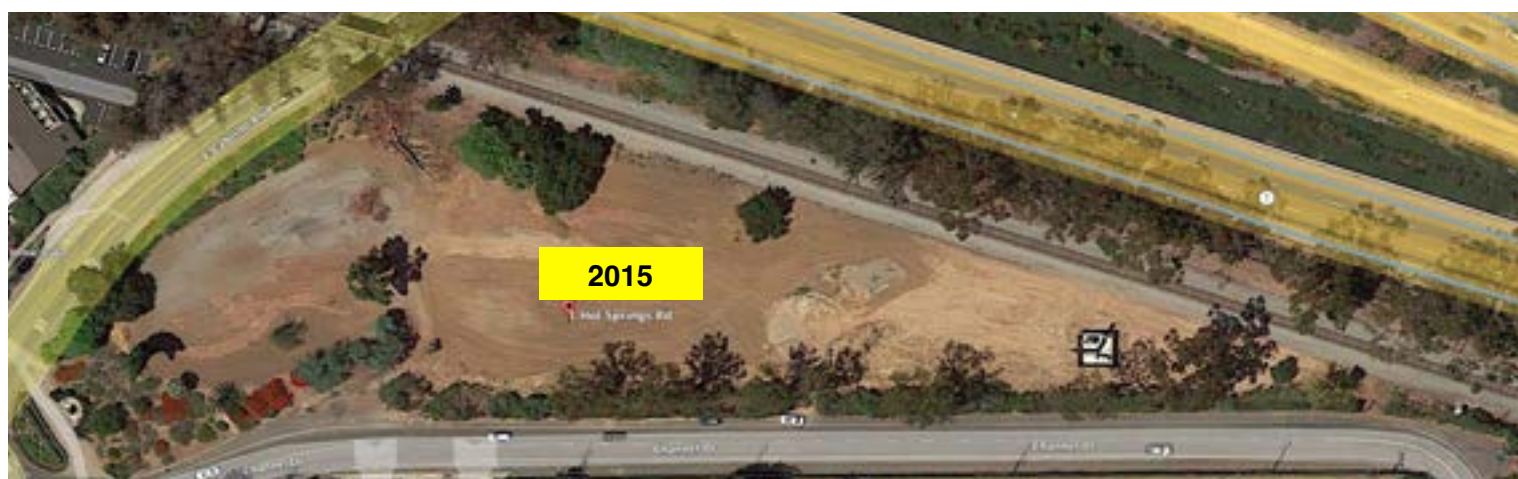
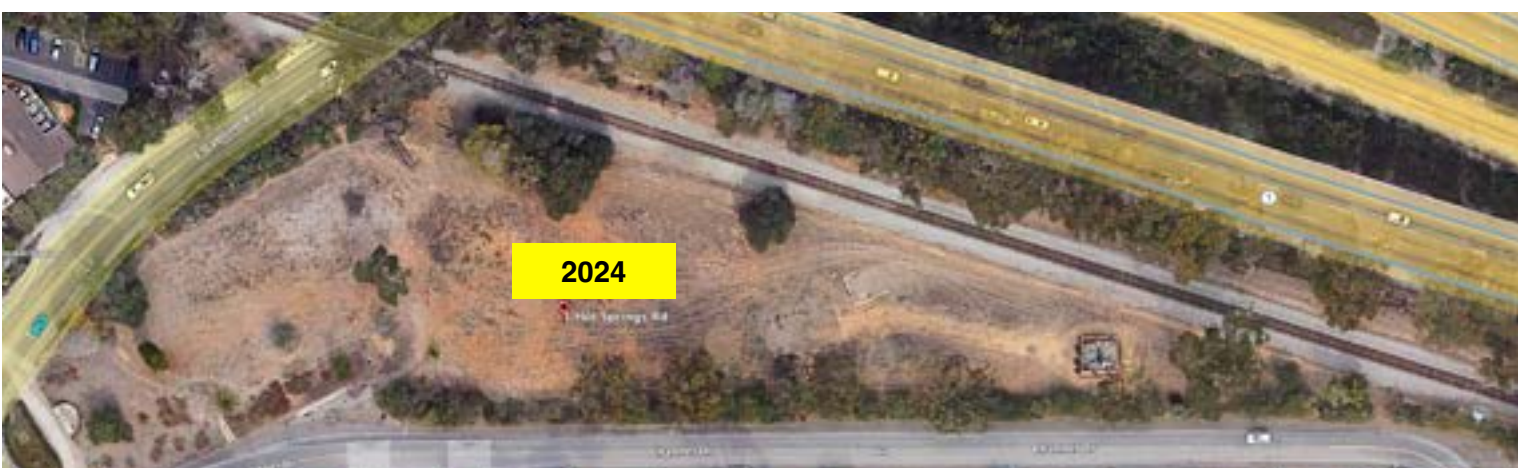
GOOGLE IMAGERY

3. A review of the 2015 topographical site plan and historical *Google Earth* imagery shows a degradation of the site (loss of trees) over the past 30 years.

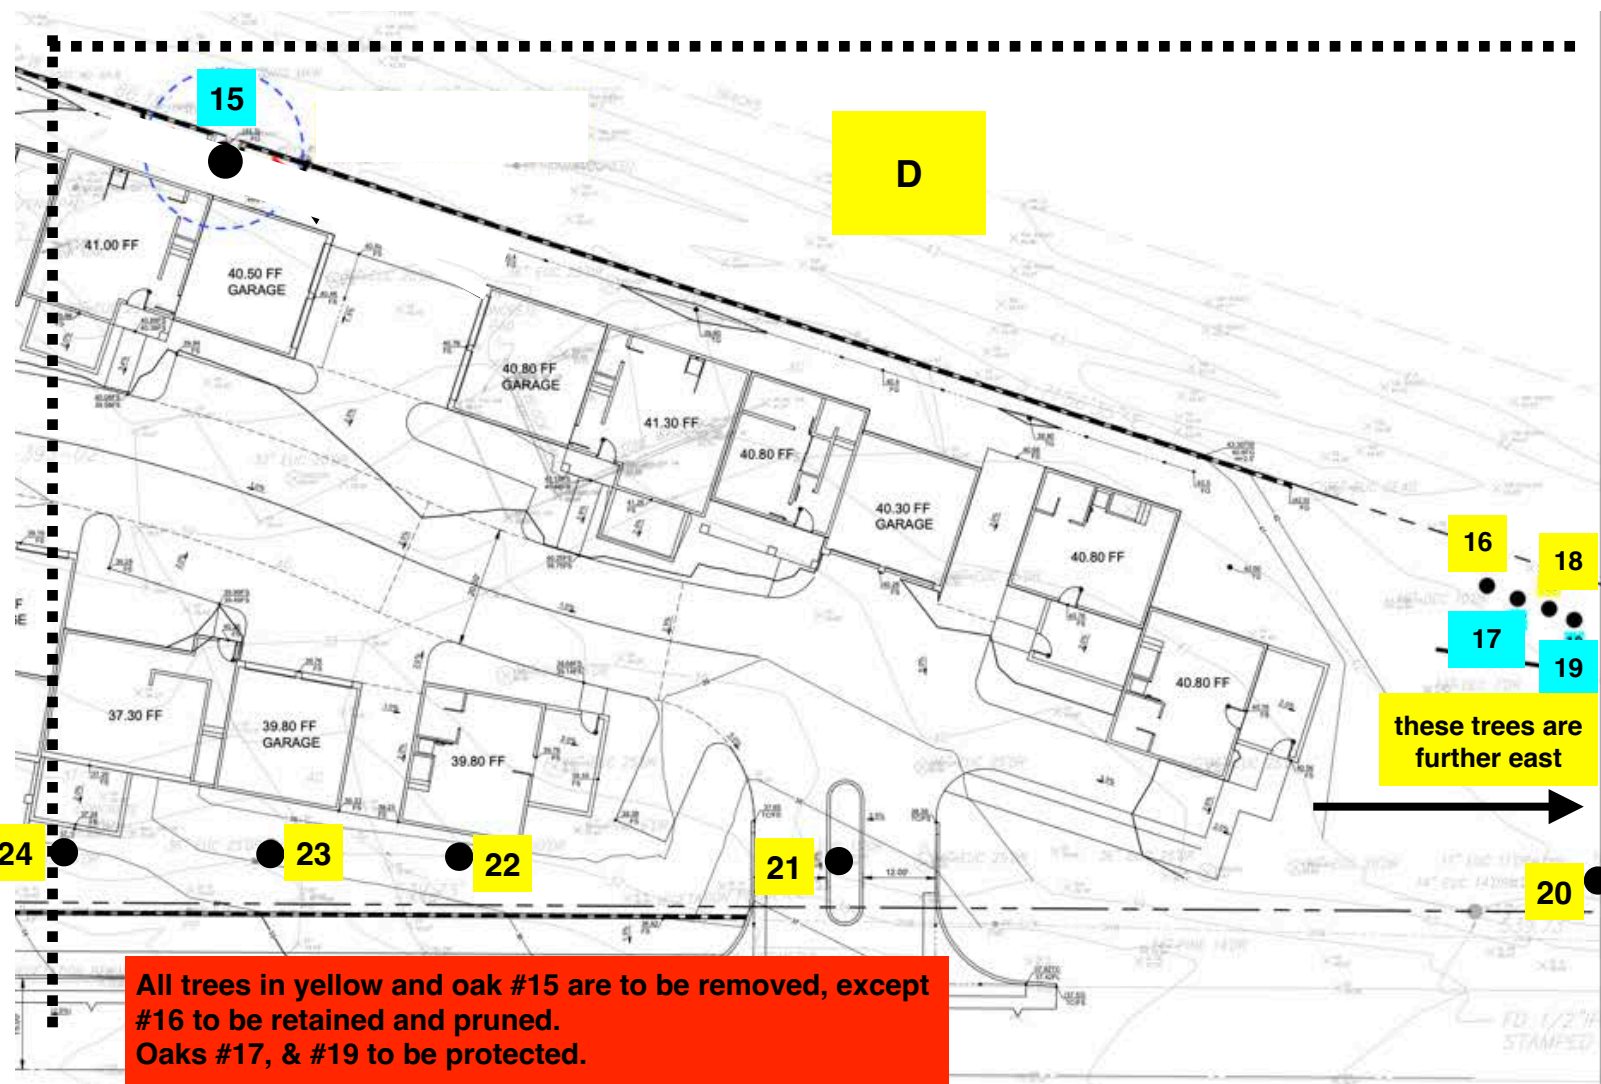
All trees in yellow are to be removed.
