# Geotechnical Evaluation S-7 Sewer Lift Station Rehabilitation Long Beach Water Department Long Beach, California

July 15, 2022 | Project No. 211941001

**Ninyo & Moore**  
Geotechnical & Environmental Sciences Consultants

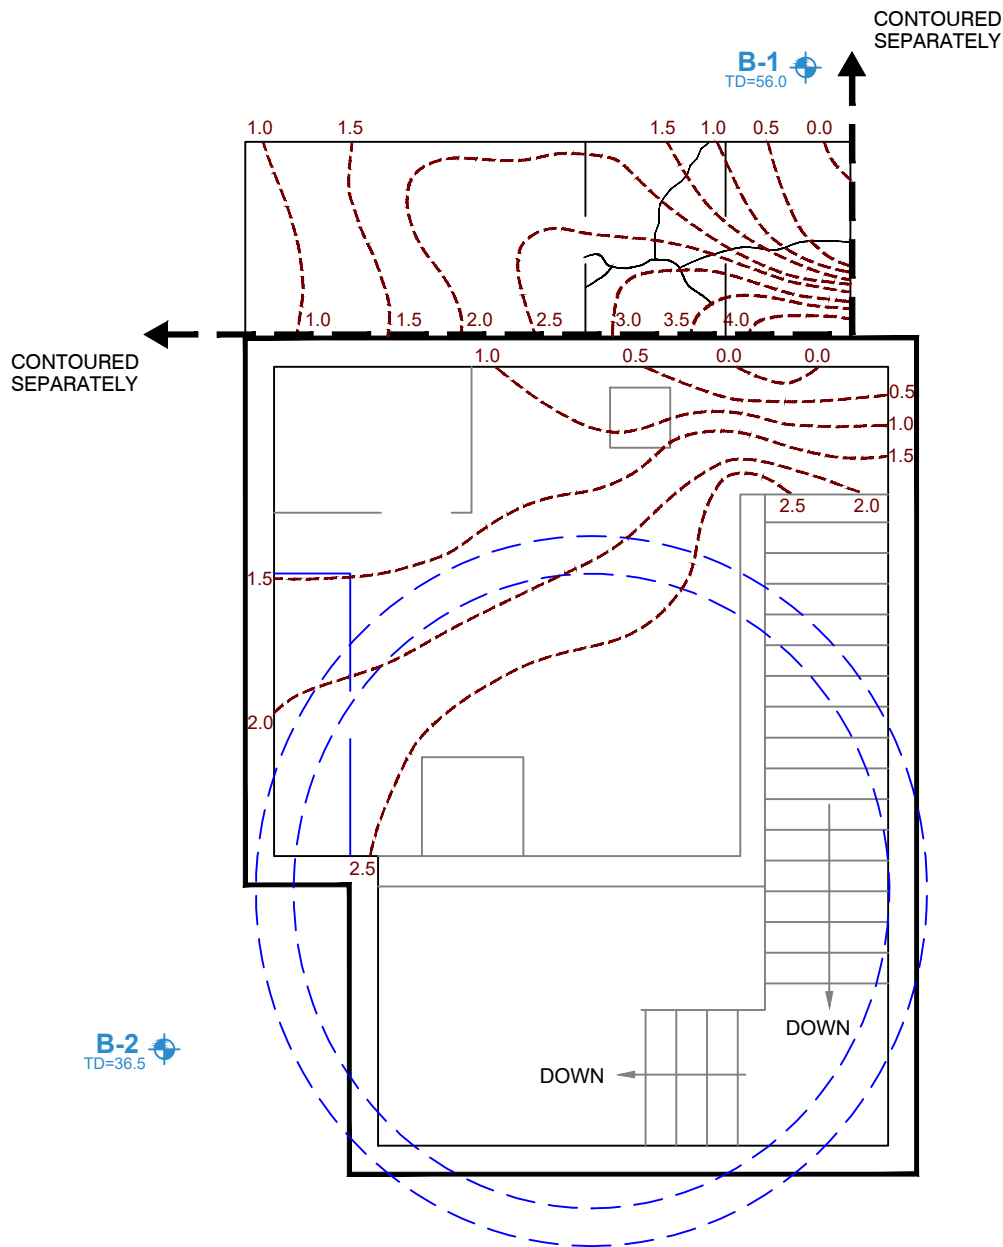
FIGURE 3

On May 16, 2022, elevation measurements were taken on the upper interior floor and exterior sidewalk slab of the S-7 lift station. The upper interior floor and exterior sidewalk slab were contoured separately. The results of the surveys performed are presented on Figure 3. The relative low area of the upper interior floor in the survey is indicated by the 0.0-inch contour line near the south corner of the building, at the doorway. The relative high area of the upper interior floor is indicated by the 2.5-inch contour line at the northwest side of the floor. The relative low area of the exterior sidewalk slab in the survey is indicated by the 0.0-inch contour line at the south corner of the slab. The relative high area of the exterior sidewalk slab is indicated by the 4.0-inch contour line at the northwest corner of the slab.

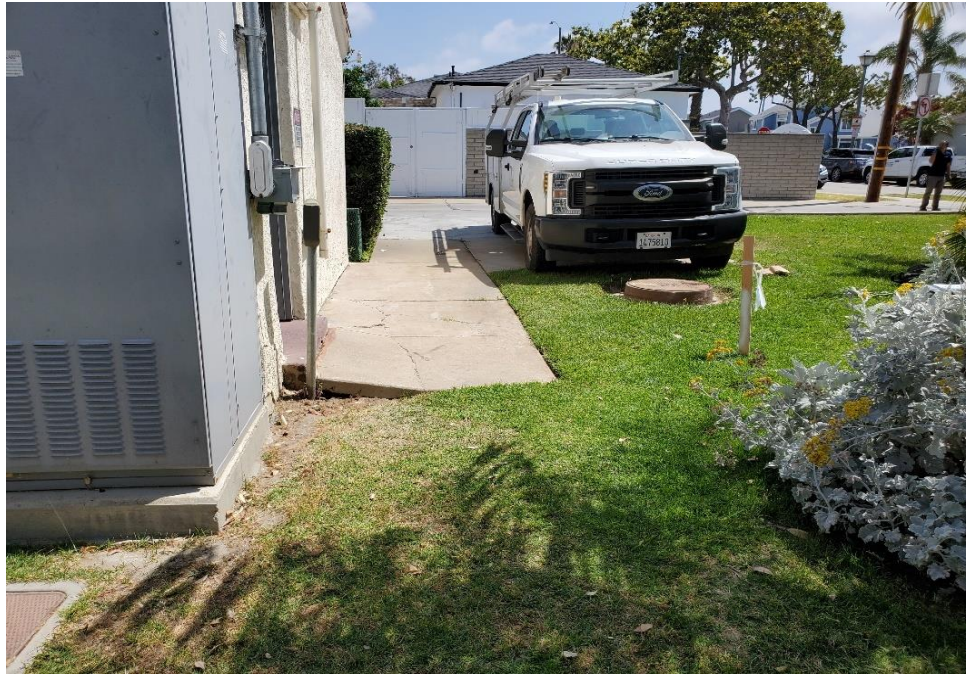
Geotechnical reconnaissance of the subject site was performed by Ninyo & Moore on May 16, 2022. Selected photographs of the site conditions are included in Appendix C. Exterior distress features generally consisted of settlement of the sidewalk slab on the south side of the lift station (Photographs 1 through 3), vertical and horizontal separation of the sidewalk slab from the building (Photographs 4 through 6), a ½-inch-wide crack on the south corner of the building (Photographs 7, 9, and 10), vertical separation between the sidewalk and the ground surface (Photographs 7 and 8), and settlement of the ground surface on the north side of the property (Photographs 11 and 12). Interior distress features generally consisted of a ¼-inch-wide horizontal crack on the upper floor of the lift station, above the doorway on the southeast wall (Photographs 13 and 14), and a horizontal crack extending approximately halfway across the southwest wall of the upper floor (Photographs 15 and 16). We also observed the crack noted by VCA engineers in their structural assessment, located on the interior wall dividing the wet well and stairway wall. Based on discussions with DRP, no cracks or structural issues have been observed within the sump of the lift station.

**Photograph 1:** Southeast side of S-7 sewer lift station, looking northeast.

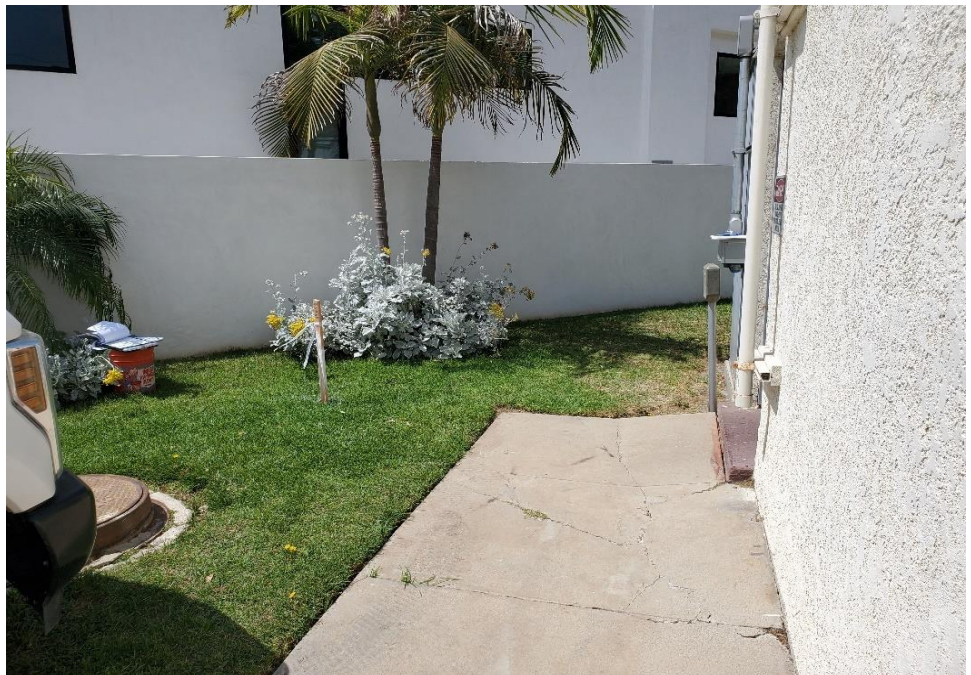
**Photograph 2:** Southeast side of S-7 sewer lift station, looking southwest.

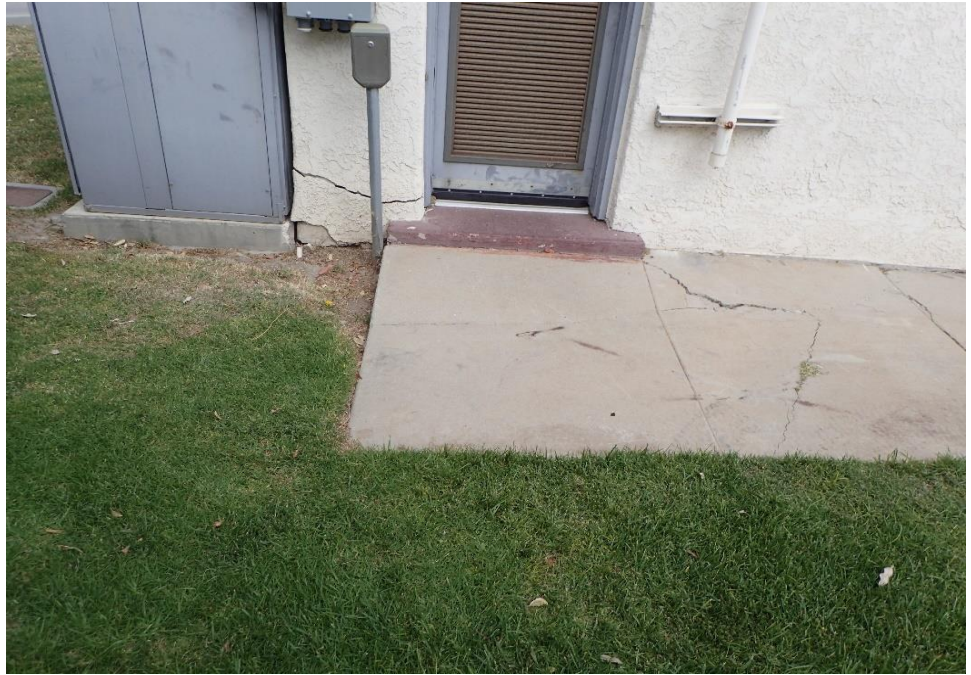
**Photograph 3:** Southeast side of S-7 sewer lift station, looking northwest.
