GeoSolve, Inc.®
Geoscience Solutions rather than Status-Quo

Project No. 2022-15
June 9, 2022

Subject: Former St. Mark's Episcopal Church Property
1957 Pruneridge Avenue
APN 303-03-025
Santa Clara, California
PHASE II ENVIRONMENTAL SITE ASSESSMENT

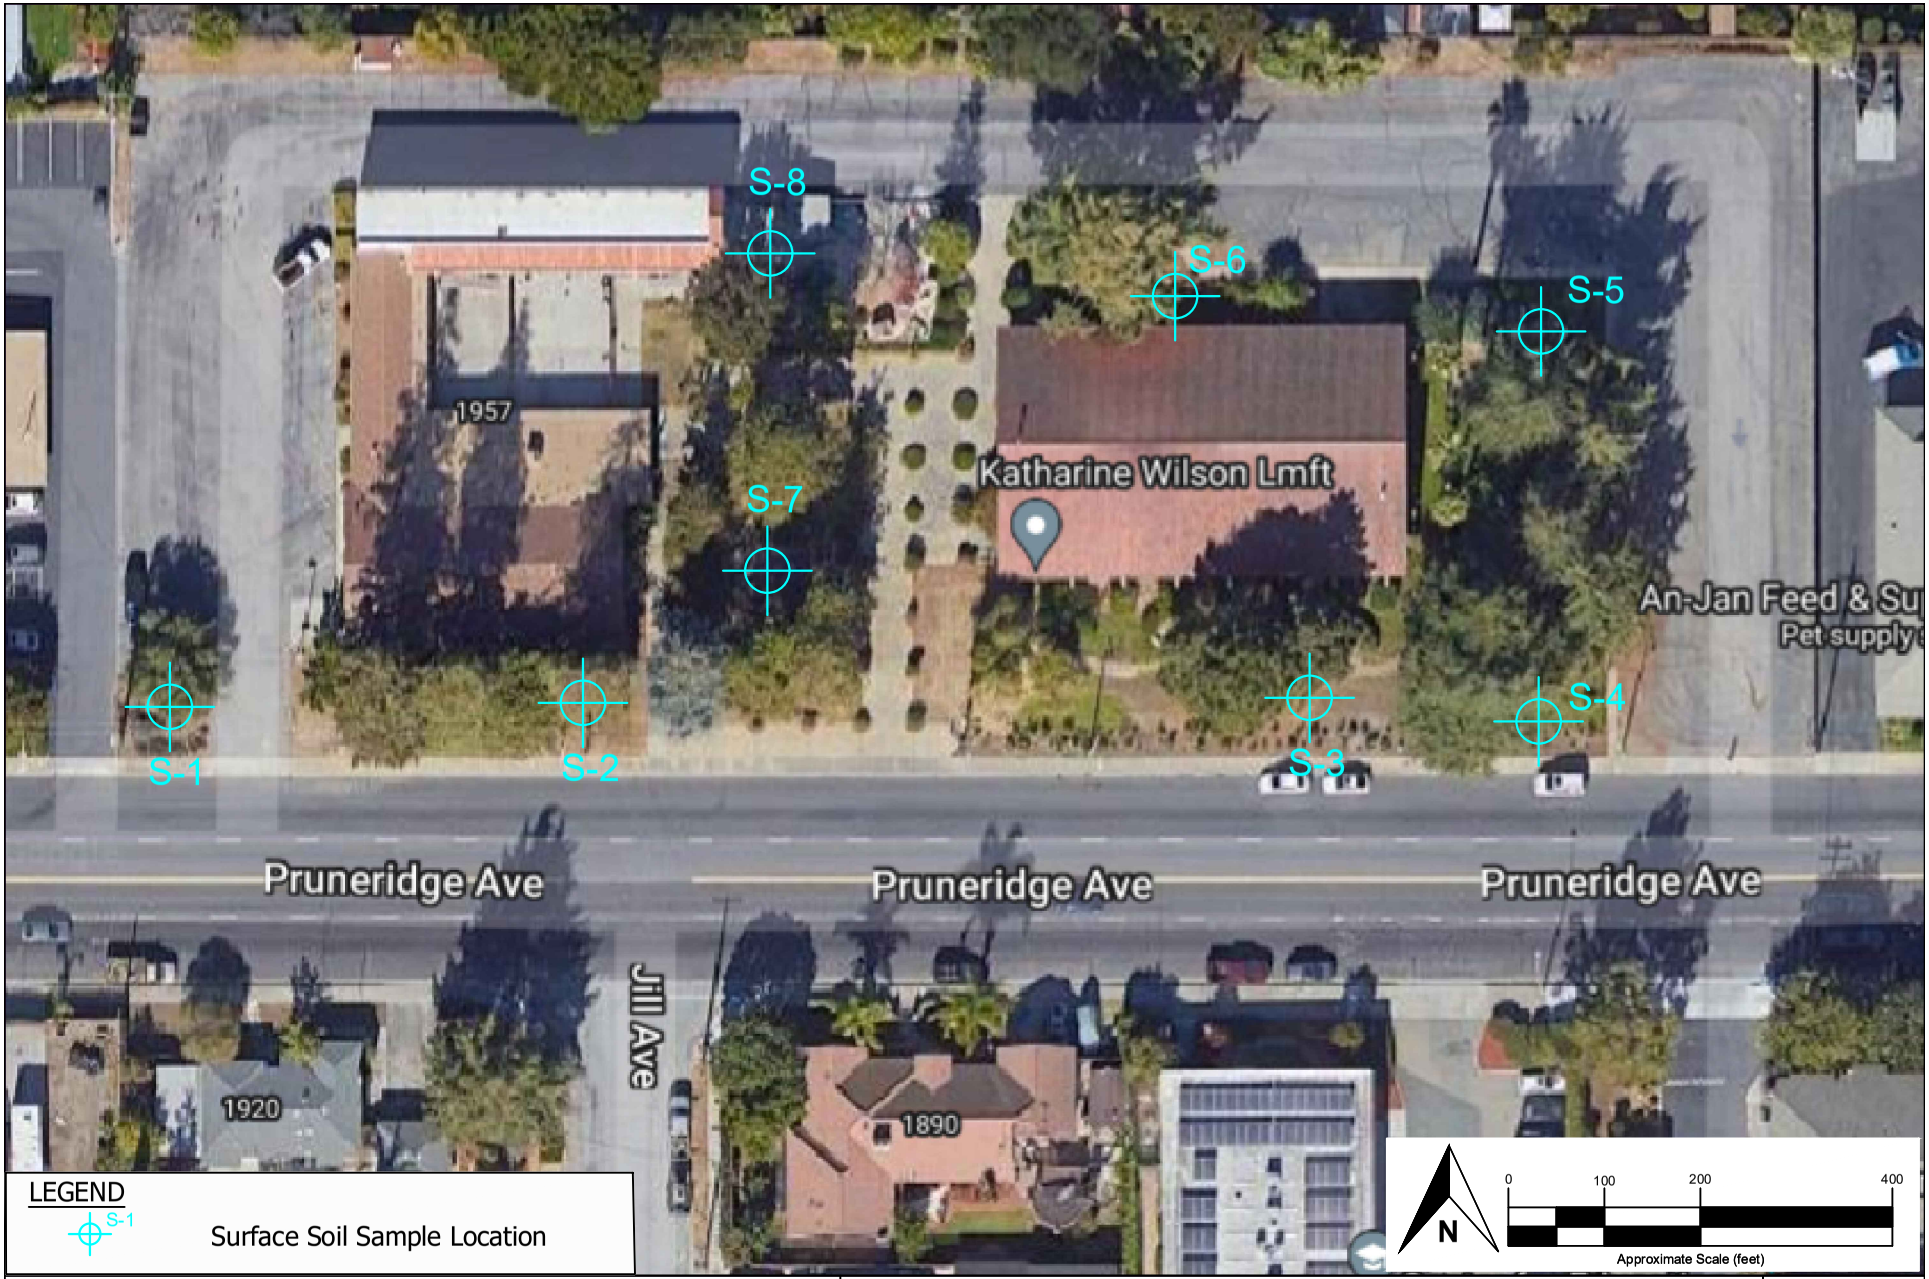
Figure No.
2

On May 26, 2022, a ***GeoSolve, Inc.*** field geologist visited the subject site and collected eight surficial soil samples (S-1 through S-8) from approximately 0.5-foot below ground surface (bgs) using laboratory supplied glass jars, which were sealed, labeled, and placed within a pre-chilled ice chest for temporary storage. Soil samples S-1 through S-8 were delivered under chain-of-custody documentation to McCampbell Analytical, Inc., a State-certified hazardous waste testing laboratory (No. 1644) for analysis. Soil samples S-1 through S-8 were analyzed for organochlorine pesticides and arsenic using Environmental Protection Agency (EPA) Methods SW846/SW3550B/3640Am/3630Cm/SW8081A and SW3050B/SW6020. The location of soil samples S-1 through S-8 are shown on Figure 2.
