## Geology and Soils Technical Memorandum

**To:** Kara Peterson; San Diego State University  
**From:** Perry Russell, Dudek  
**Subject:** SDSU Imperial Valley Off-Campus Center – Calexico, Affordable Student Housing Project – Geology and Soils Technical Memorandum  
**Date:** December 12, 2024  
**cc:** Sarah Lozano, Mollie Brogdon; Dudek, Michael Haberkorn; Gatzke Dillon & Ballance  
**Attachments:** A – Figures  
B – Geotechnical Report

**REPORT OF GEOTECHNICAL INVESTIGATION  
STUDENT RESIDENCE HALL  
SAN DIEGO STATE UNIVERSITY  
IMPERIAL VALLEY CAMPUS  
CALEXICO, CALIFORNIA**

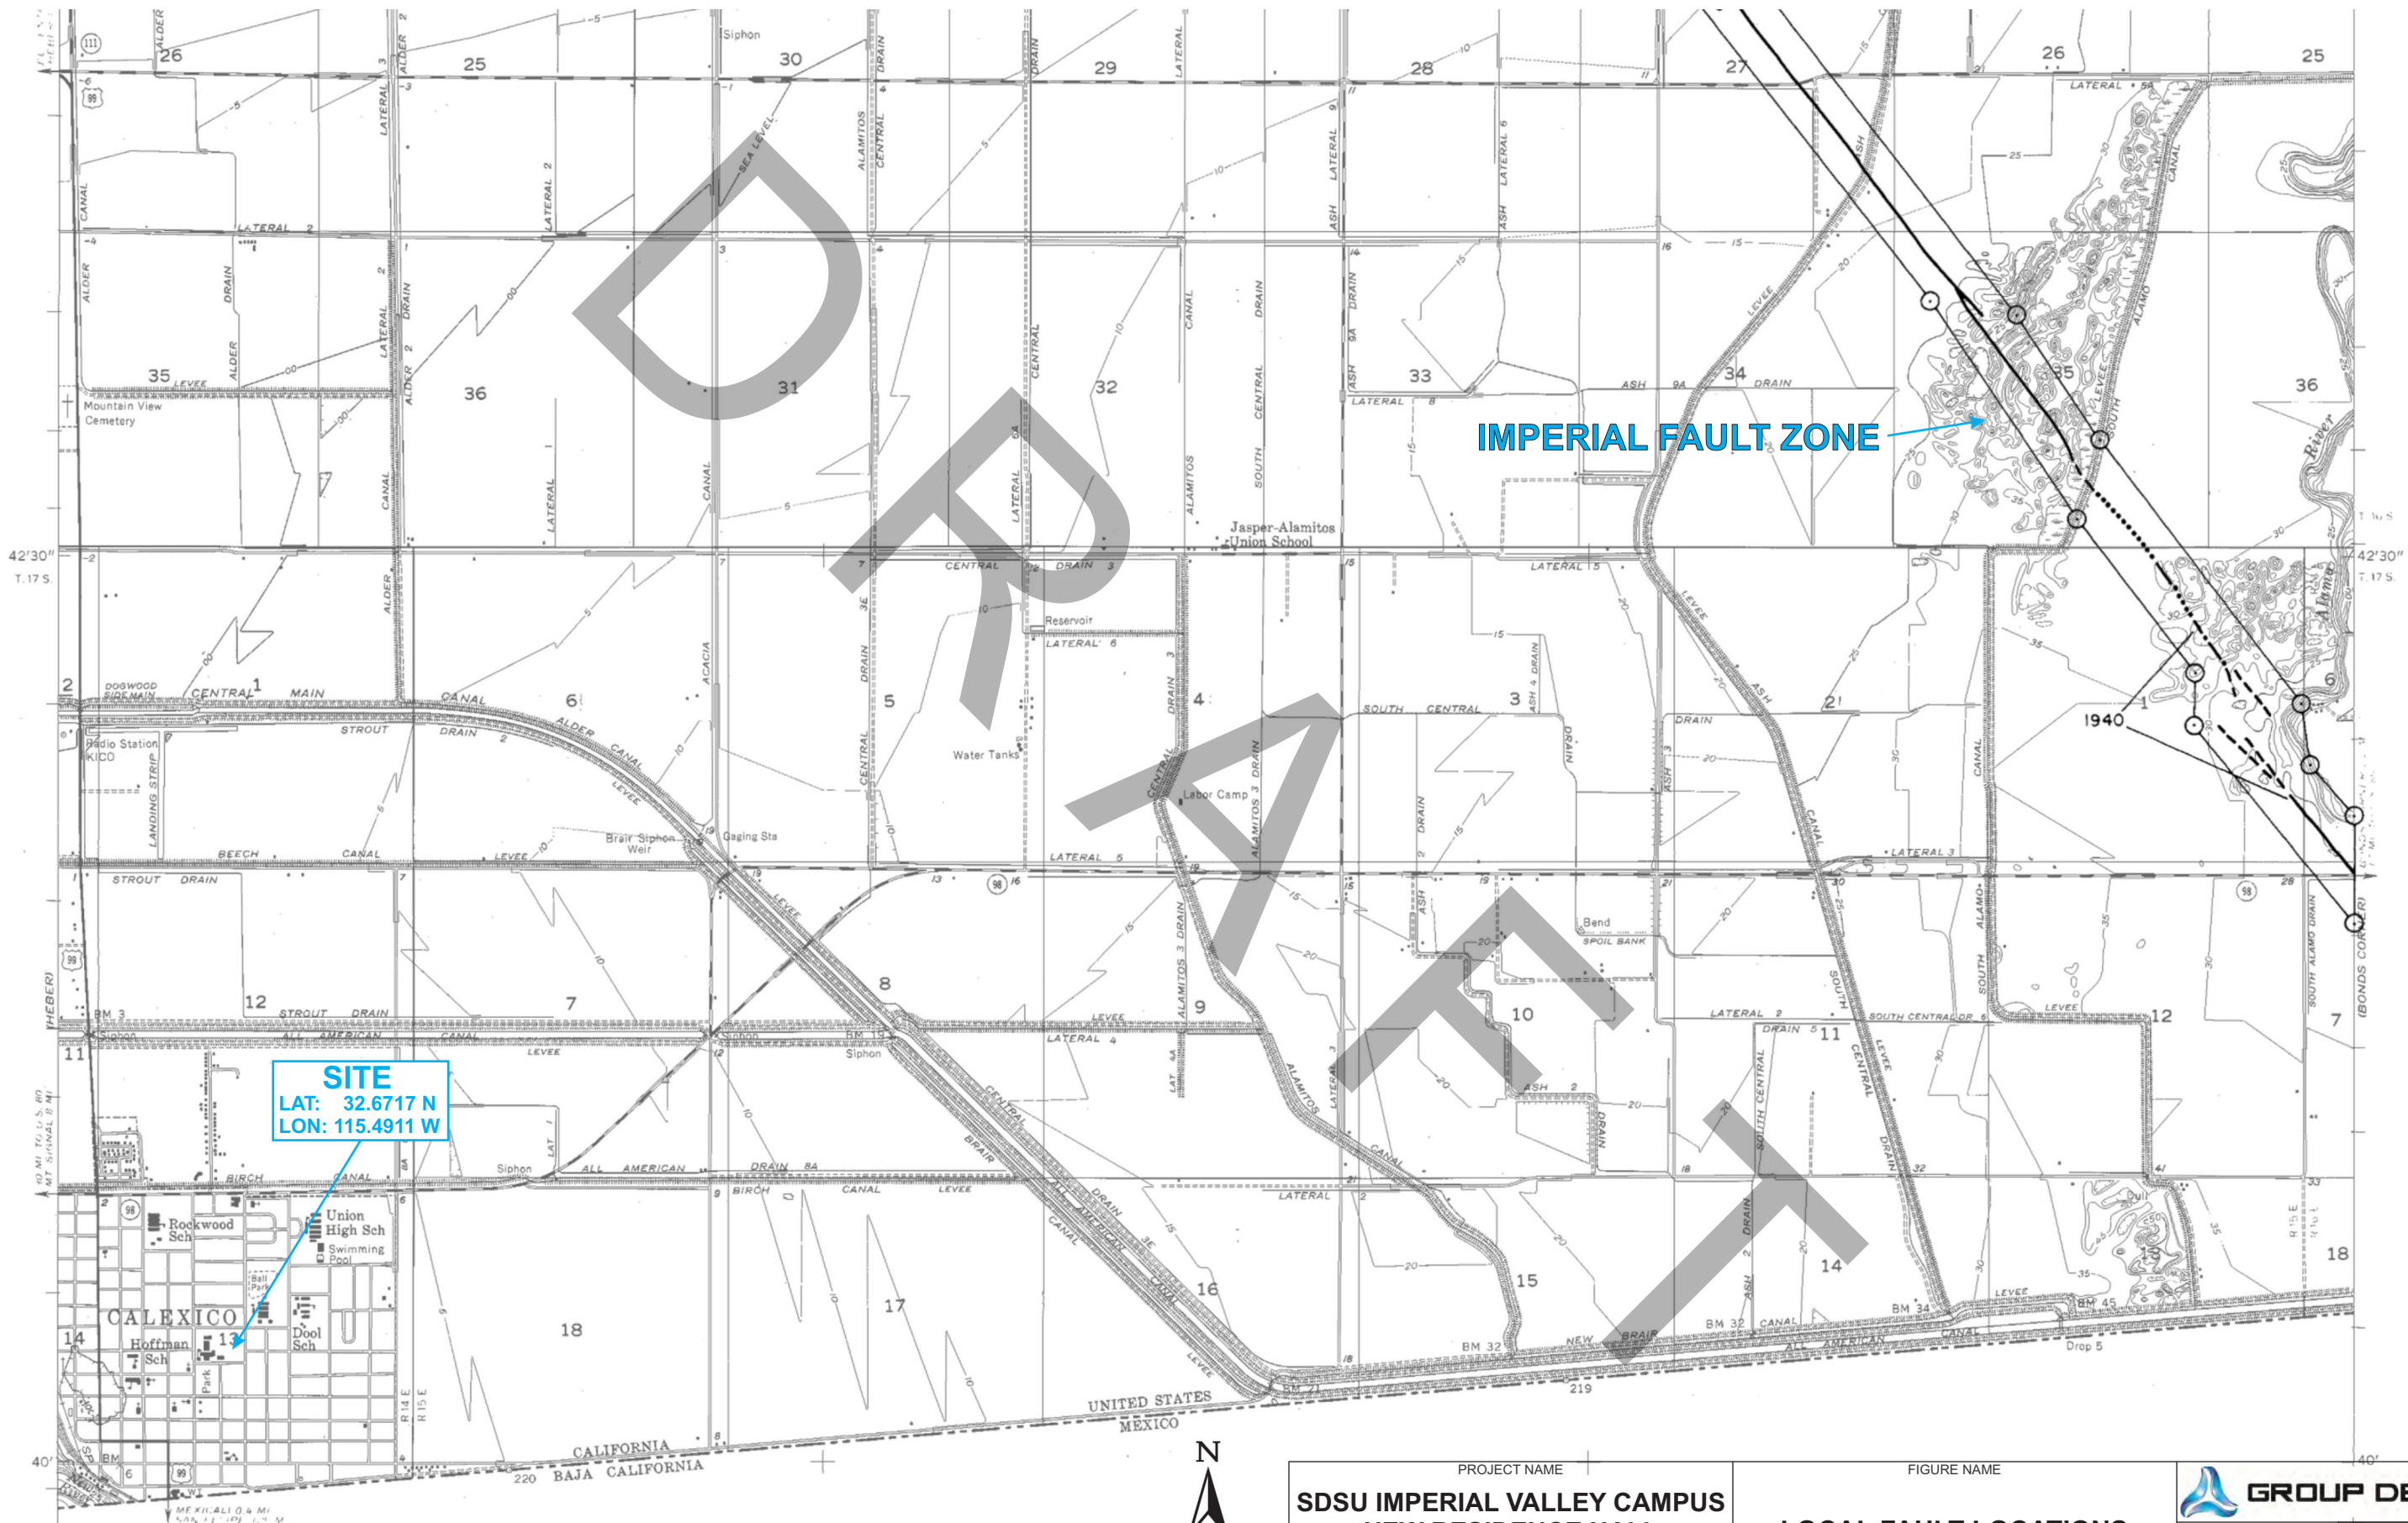
**GROUP DELTA**  
PROJECT NUMBER  
**SD732**  
FIGURE NUMBER  
**5B**

FIGURE NAME  
**LOCAL FAULT LOCATIONS**

Reference: State of California (1990). Alquist-Priolo Special Studies Zones, Calexico Quadrangle, Revised Official Map, January 1.

miles east of the site (see Figure 4 and Figure 5B for the approximate 1940 ground rupture location). Additionally, there are several other known active faults close to the site, including the Superstition Hills and Superstition Mountain fault zones to the northwest, and the Laguna Salada and Cerro Prieto fault zones to the south (see Figures 4 and 5A). The Superstition Hills fault experienced a magnitude 6.7 earthquake in 1987 (Magistrale, 1989). In 2010, a magnitude 7.2 earthquake occurred on the Laguna Salada fault zone south of the international border (Gonzalez-Ortega, 2014). These earthquakes caused damage to structures throughout Imperial Valley, including soil liquefaction, settlement, and surficial slumps along the Imperial Irrigation District canal and drains (USGS, 1982, Gonzalez-Ortega 2014, Holzer, 1989).

Ground rupture results from movement on an active fault reaching the ground surface. The site is not located within an Alquist-Priolo Active Fault Zone and no known active faults are present in the immediate site vicinity, as shown on Figure 5B, Local Faults. Potential for ground rupture should therefore be considered low.
