APPENDIX F  
GEOTECHNICAL INVESTIGATION

May 1, 2018  
Revised April 18, 2019  
File No. 19564

Subject: Environmental Impact Report, Soils and Geology Issues  
Ocean Avenue Project Proposed Mixed-Use Development  
1327-1337 Ocean Avenue and 101-129 Santa Monica Boulevard  
Santa Monica, California

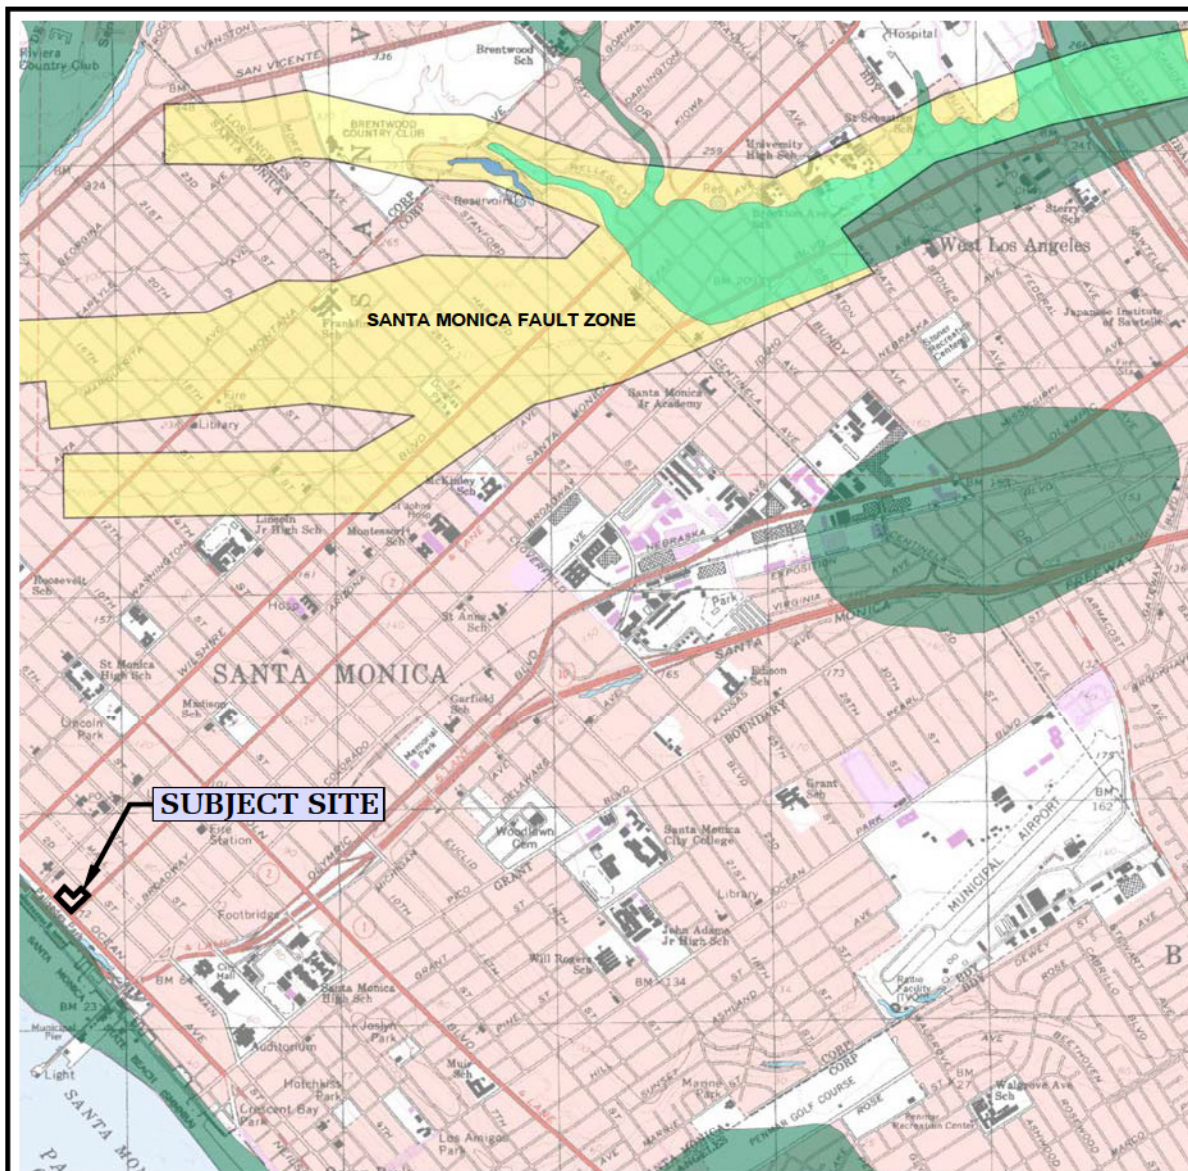
## LEGEND

### Earthquake Fault Zones

REFERENCE: EARTHQUAKE ZONES OF REQUIRED INVESTIGATION - BEVERLY HILLS QUADRANGLE (CGS, 1/11/19)
