APPENDIX F

SUPPLEMENTAL GEOTECHNICAL LETTER

Subject: EIR Update, Dana Point Harbor Hotels, City of Dana Point, California

PRELIMINARY GEOTECHNICAL INVESTIGATION (2019)

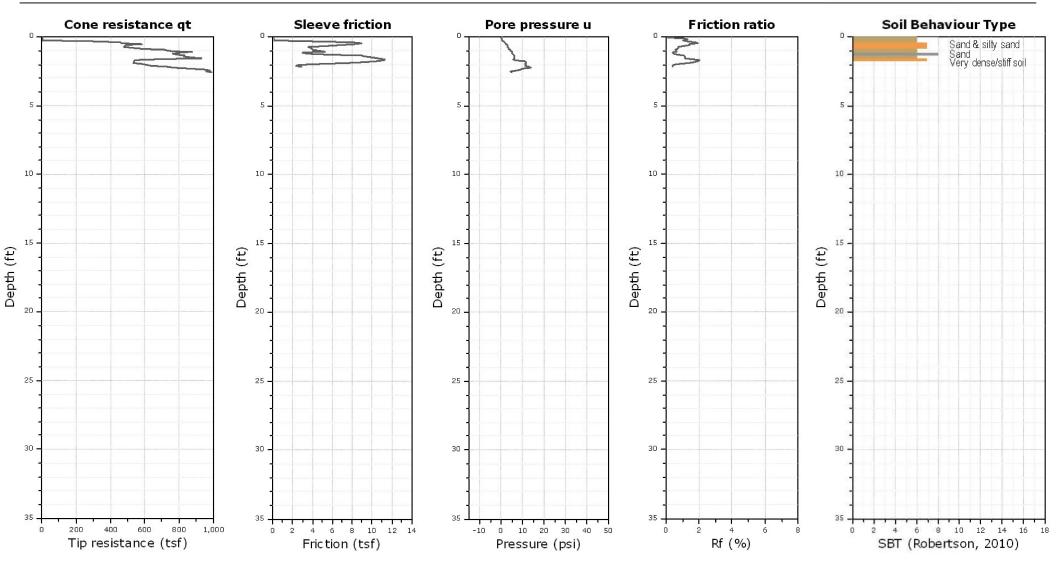
CPT-1 Total depth: 2.56 ft, Date: 9/12/2018 Cone Type: Vertek

Project: GMU Geotechnical, Inc./Hotel Component Location: Casitas Pl & Dana Point Harbor Dr Dana Point, CA

GMU conducted a subsurface exploration program to evaluate the soil conditions within the project limits. A total of thirteen (13) exploratory drill holes and ten (10) cone penetration test (CPT) soundings were performed which consisted of the following:

- Ten (10) hollow-stem-auger exploratory drill holes to a maximum depth of 51 feet below the existing ground surface in order to determine site-specific subsurface geologic and groundwater conditions and to obtain bulk and drive samples for geotechnical testing.
- Three (3) hollow-stem-auger exploratory drill holes to a depth of approximately 6.5 feet below the existing ground surface in order to perform preliminary infiltration testing.
- Ten (10) CPT soundings to a maximum depth of 34 feet below the existing ground surface.

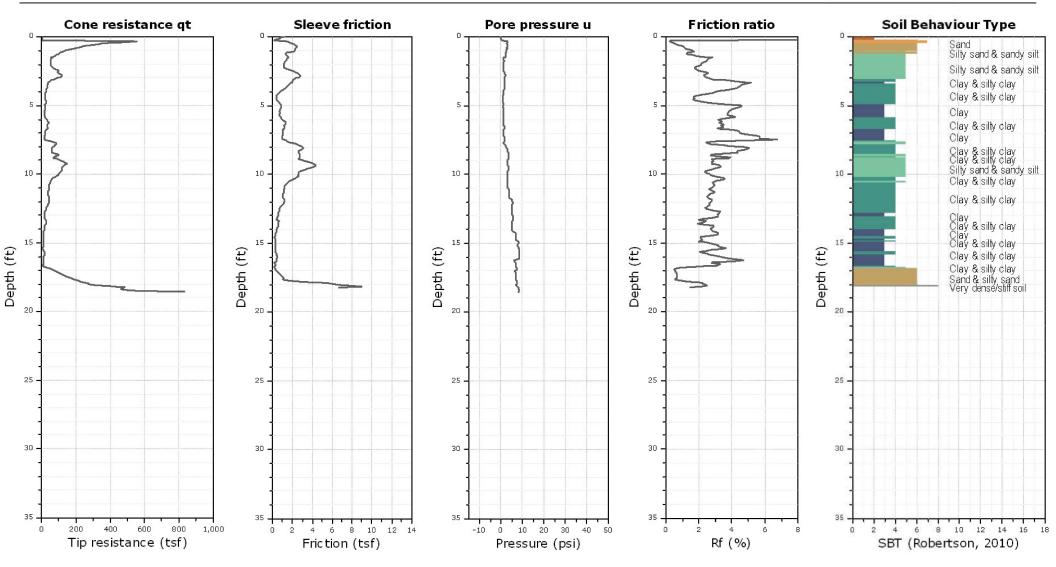
CPT-4 Total depth: 18.57 ft, Date: 9/12/2018 Cone Type: Vertek

Project: GMU Geotechnical, Inc./Hotel Component Location: Casitas Pl & Dana Point Harbor Dr Dana Point, CA

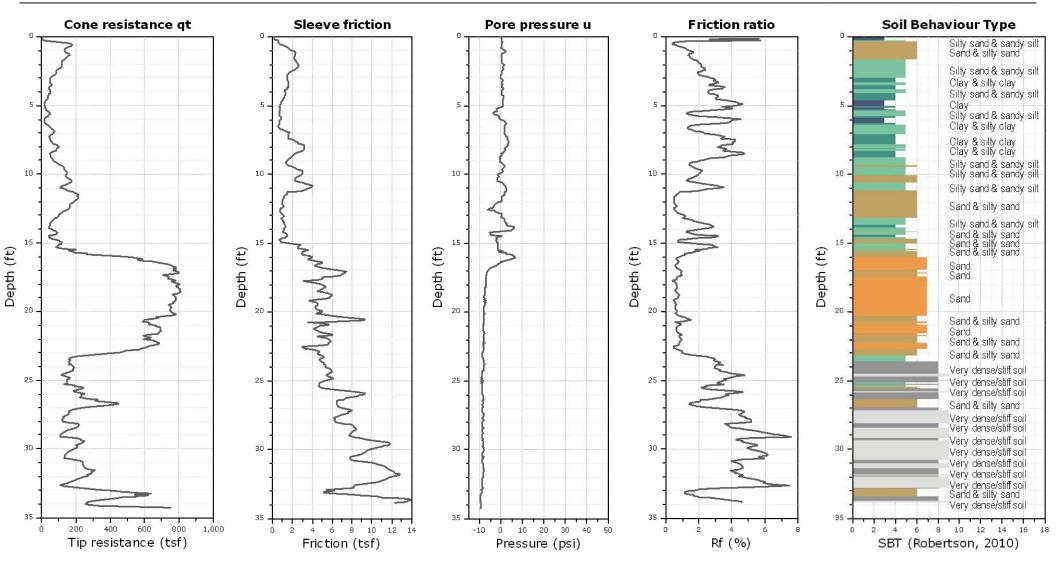
CPT-8 Total depth: 34.26 ft, Date: 9/12/2018 Cone Type: Vertek

Project: GMU Geotechnical, Inc./Hotel Component Location: Casitas Pl & Dana Point Harbor Dr Dana Point, CA

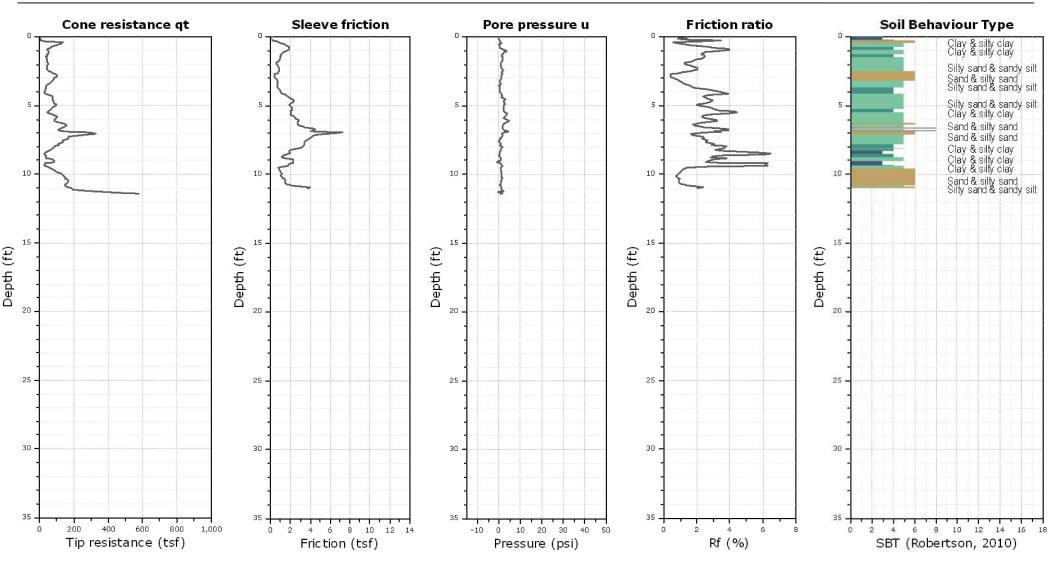
CPT-9 Total depth: 11.42 ft, Date: 9/12/2018 Cone Type: Vertek

Project: GMU Geotechnical, Inc./Hotel Component Location: Casitas Pl & Dana Point Harbor Dr Dana Point, CA

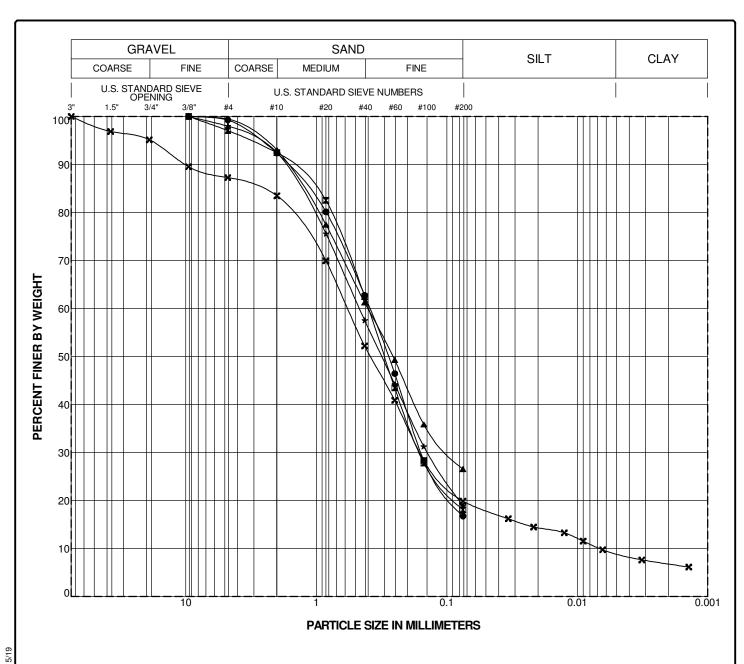
PARTICLE SIZE DISTRIBUTION

Boring Number	Depth (feet)	Geologic Unit	Symbol	LL	PI	Classification
DH- 1	2.5	Qaf	•			SILTY CLAYEY SAND (SC)
DH- 1	15.0	Qaf	X			SILTY SAND (SM)
DH- 6	10.0	Qaf				SILTY SAND TO CLAYEY SAND (SC)
DH-42	7.5	Qaf	*			CLAYEY SAND (SC)
DH-44	0.0	Qaf	×	26	5	SILTY CLAYEY SAND (SC)

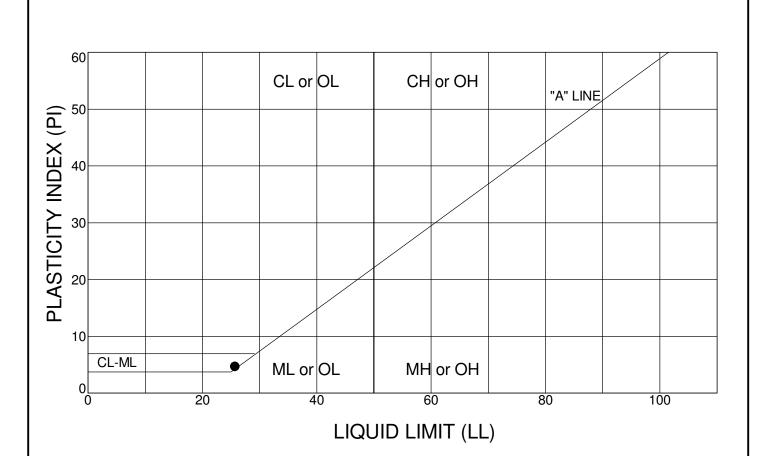
ATTERBERG LIMITS

Boring Number	Depth (feet)	Geologic Unit	Test Symbol	Insitu Water Content (%)	LL	PL	PI	Classification
DH-44	0.0	Qaf	•	9	26	21	5	SILTY CLAYEY SAND (SC)

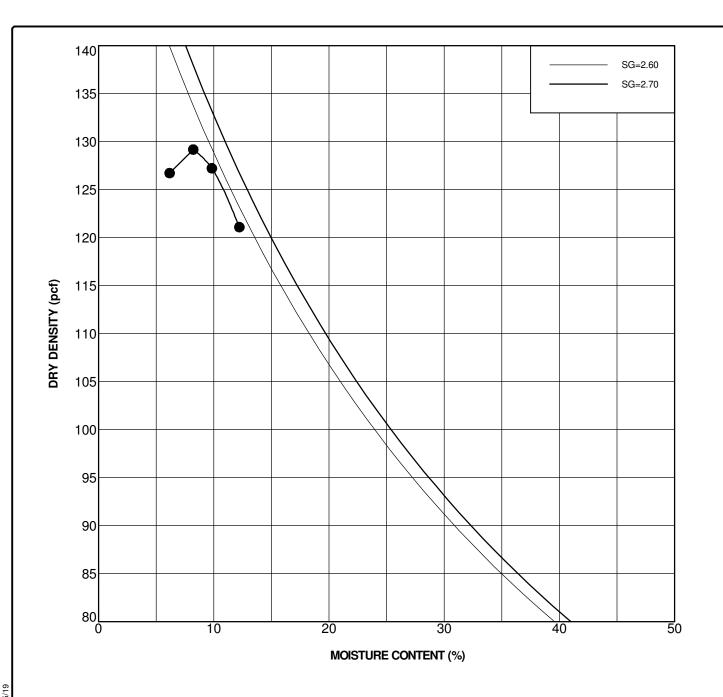
COMPACTION TEST DATA

Boring Number	Depth (feet)	Geologic Unit	Symbol	Maximum Dry Density, pcf	Optimum Moisture Content, %	Classification
DH-43	0.0	Qaf	•	132.5	8	CLAYEY SAND (SC)

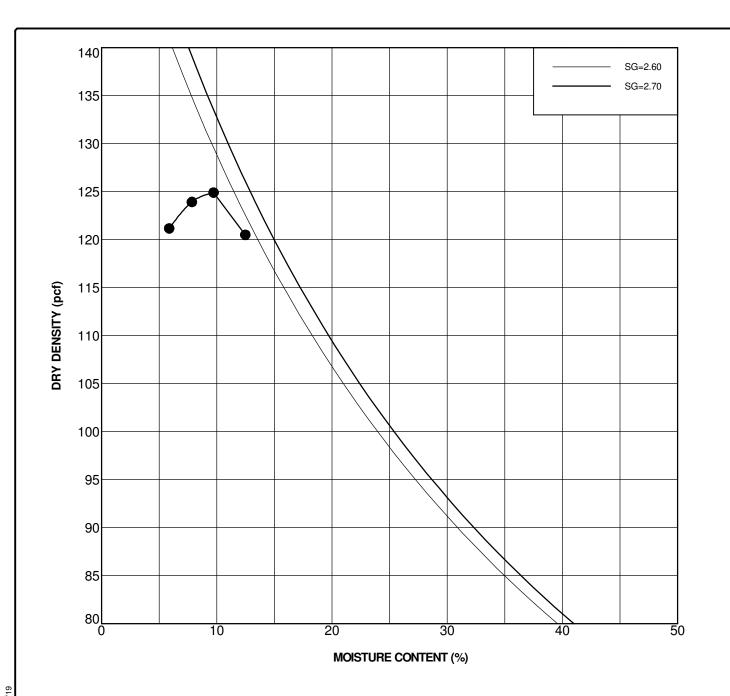
COMPACTION TEST DATA

oring Imber	Depth (feet)	Geologic Unit	Symbol	Maximum Dry Density, pcf	Optimum Moisture Content, %	Classification
D	H-44	0.0	Qaf	•	127	8.5	SILTY CLAYEY SAND (SC)

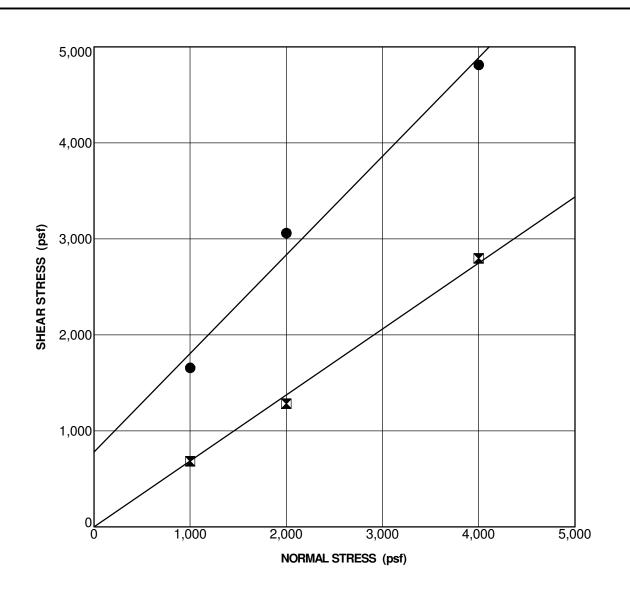
SHEAR TEST DATA

Sample Location:
 DH-1
 @ 5.0 ft
 Geologic Unit:
 Qaf
 Classification:
 CLAYEY SAND (SC)

Strain Rate (in/min):
 0.005
 Sample Preparation:
 Undisturbed

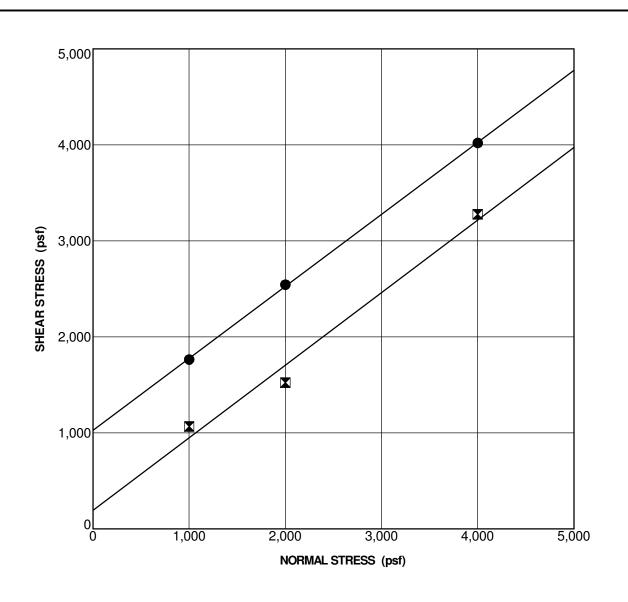
SHEAR TEST DATA

Sample Location:
 DH-1
 @ 30.0 ft
 Geologic Unit:
 Tc
 Classification:
 SANDSTONE (SP)

Strain Rate (in/min):
 0.005
 Sample Preparation:
 Undisturbed

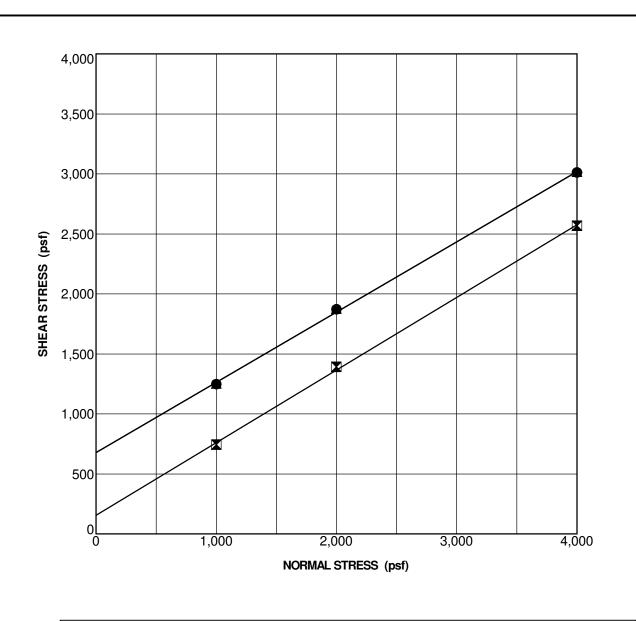
SHEAR TEST DATA

Sample Location:
 DH-15 @ 5.0 ft
 Geologic Unit:
 Tc
 Classification:
 SANDSTONE (SP)

Strain Rate (in/min):
 0.005
 Sample Preparation:
 Undisturbed

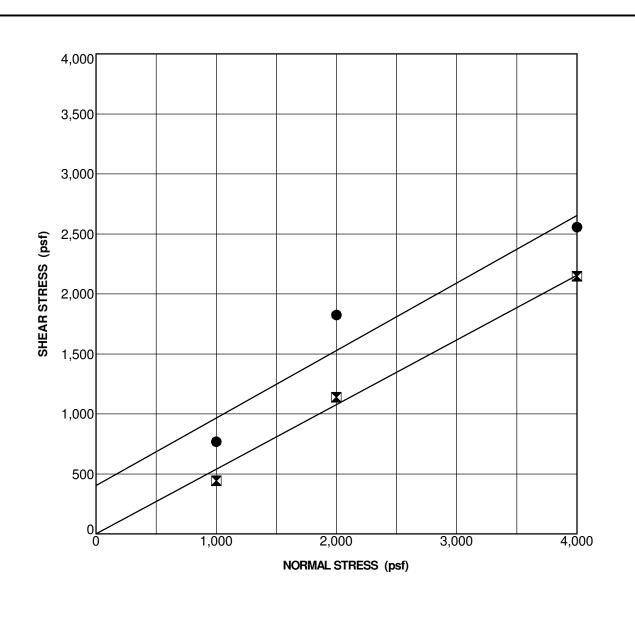
SHEAR TEST DATA

Sample Location:
 DH-43 @ 0.0 ft
 Geologic Unit:
 Qaf
 Classification:
 CLAYEY SAND (SC)

Strain Rate (in/min):
 0.005
 Sample Preparation:
 Remolded

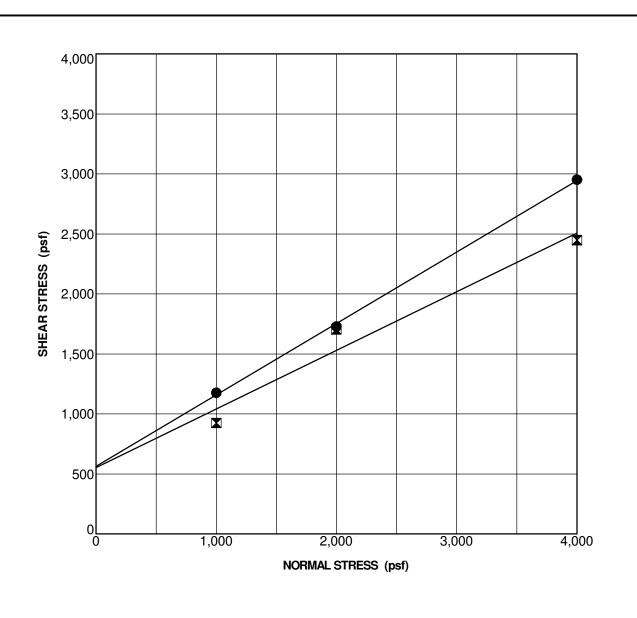
SHEAR TEST DATA

Sample Location:
 DH-43 @ 5.0 ft
 Geologic Unit:
 Qaf
 Classification:
 CLAYEY SAND (SC)

Strain Rate (in/min):
 0.005
 Sample Preparation:
 Undisturbed

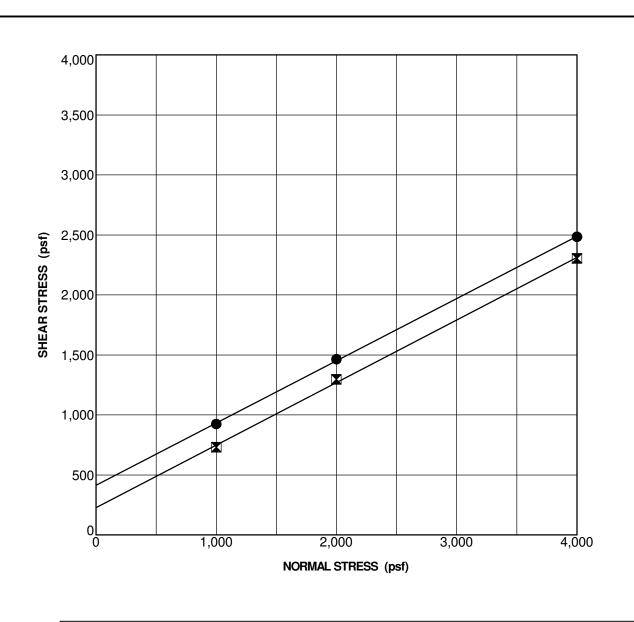
SHEAR TEST DATA

Sample Location:
 DH-44 @ 0.0 ft
 Geologic Unit:
 Qaf
 Classification:
 SILTY CLAYEY SAND (SC)

Strain Rate (in/min):
 0.005
 Sample Preparation:
 Remolded

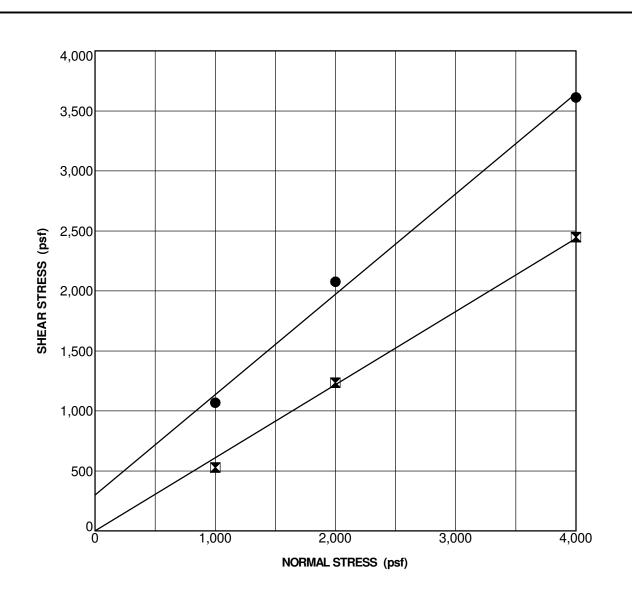
SHEAR TEST DATA

Sample Location:
 DH-44 @ 5.0 ft
 Geologic Unit:
 Qaf
 Classification:
 SILTY CLAYEY SAND (SC)

Strain Rate (in/min):
 0.005
 Sample Preparation:
 Undisturbed

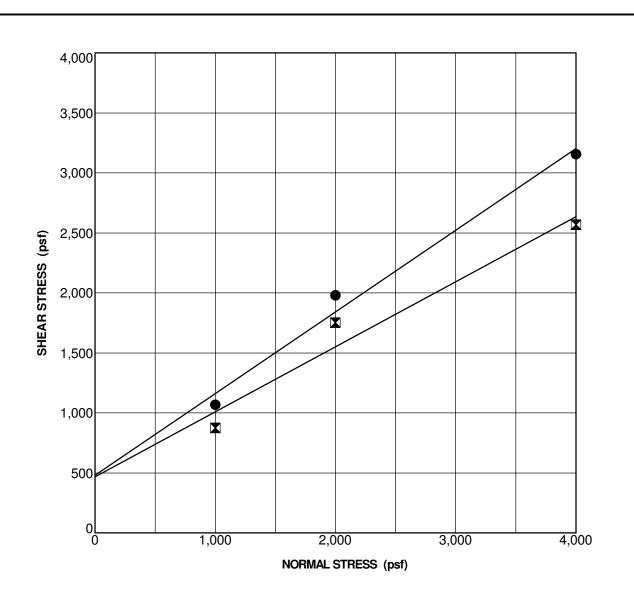
Sample Location:
 DH-45 @ 5.0 ft
 Geologic Unit:
 Qaf
 Classification:
 CLAYEY SAND (SC)

Strain Rate (in/min):
 0.005
 Sample Preparation:
 Undisturbed

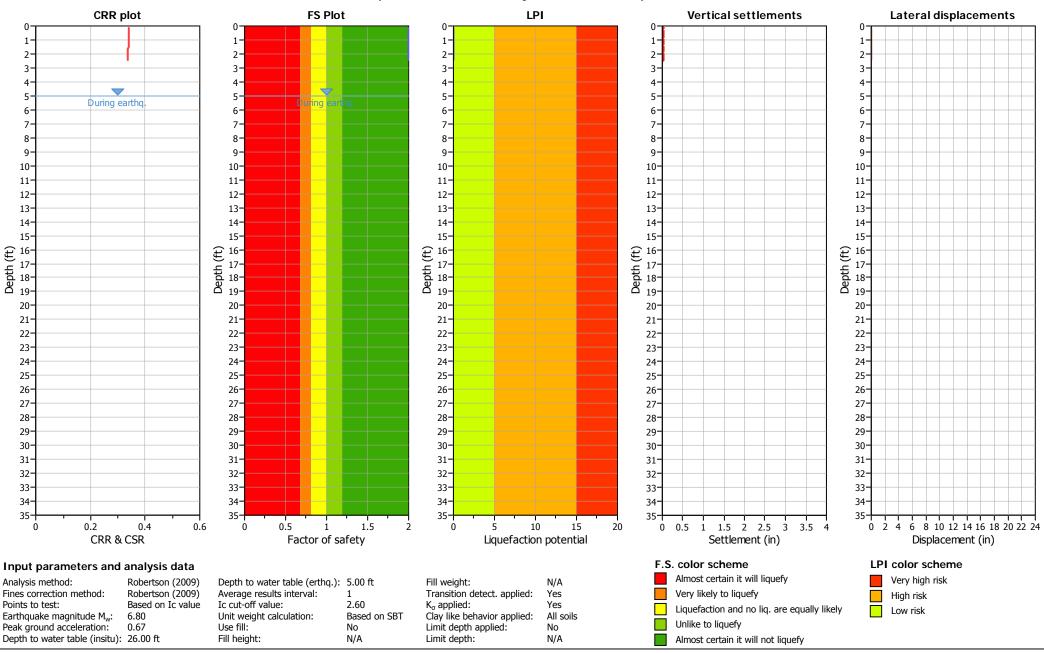
Liquefaction analysis overall plots

CPT name: CPT-1

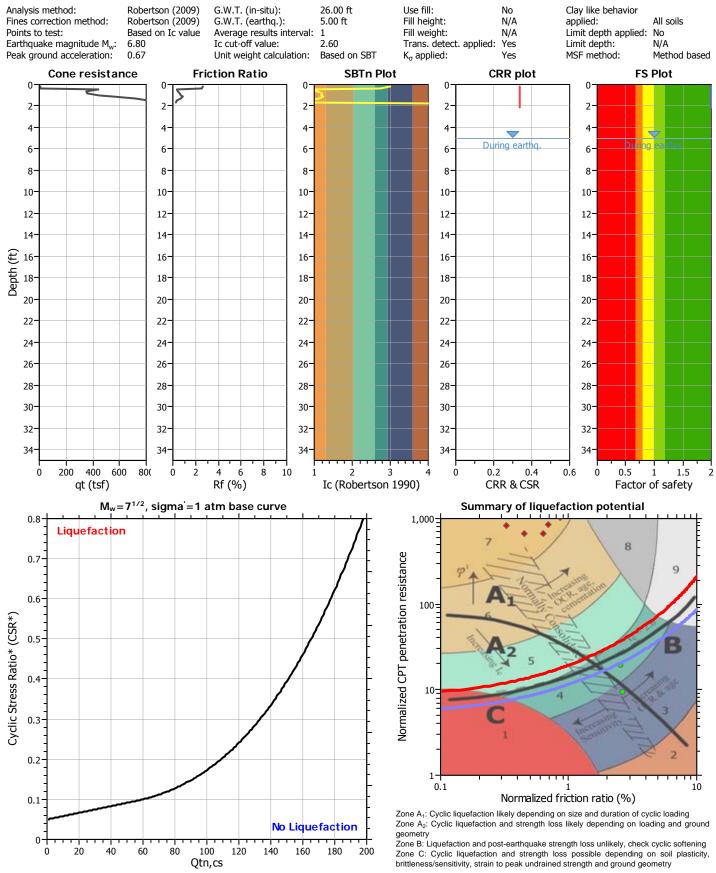
Input parameters and analysis data

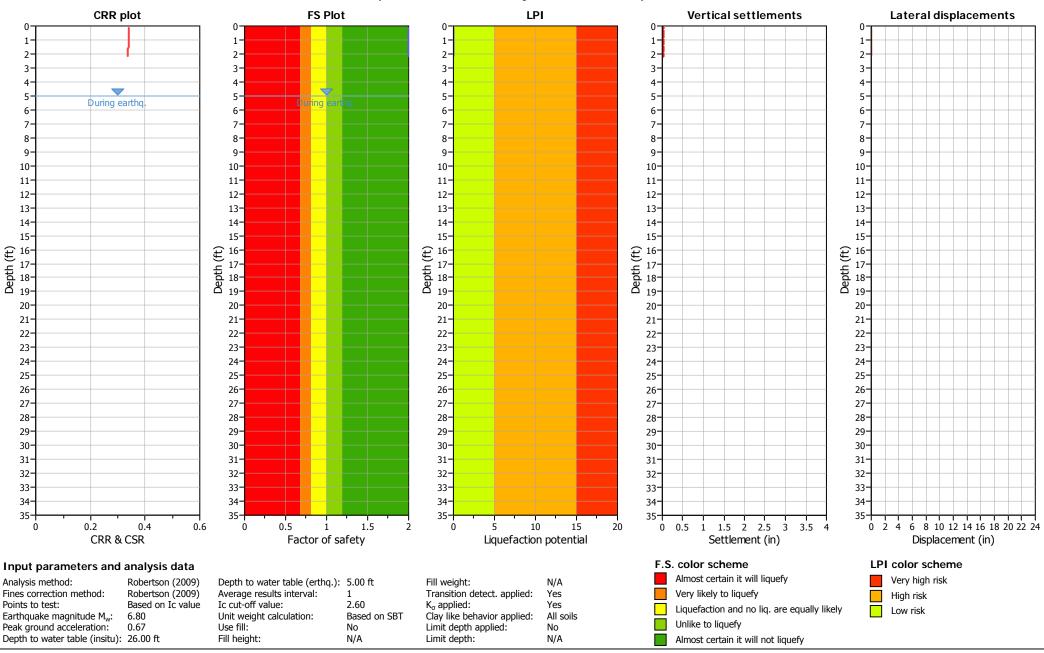
Liquefaction analysis overall plots

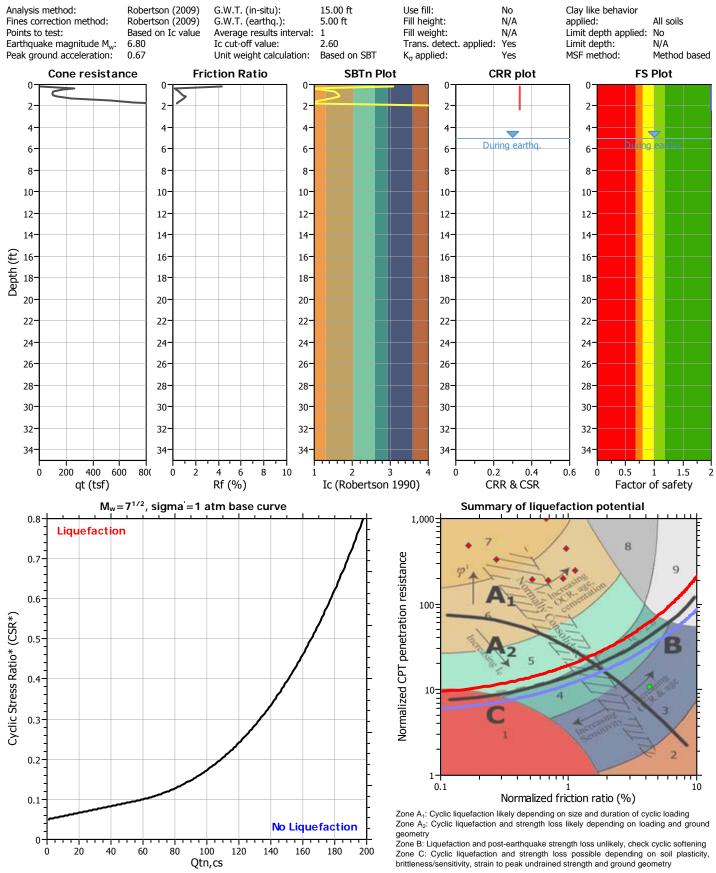
Input parameters and analysis data

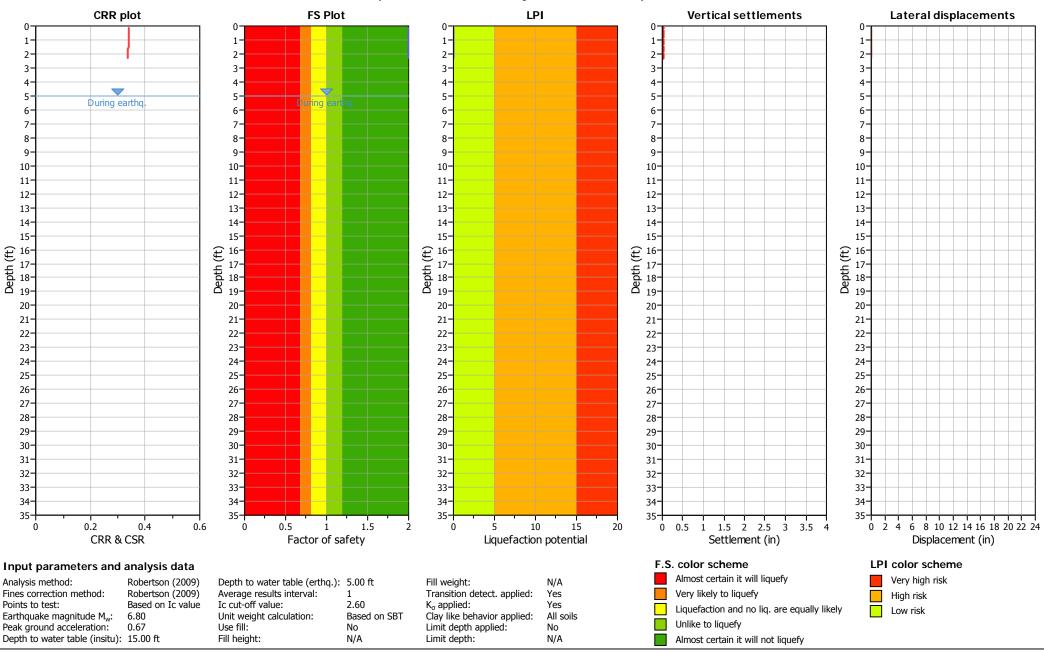
Liquefaction analysis overall plots

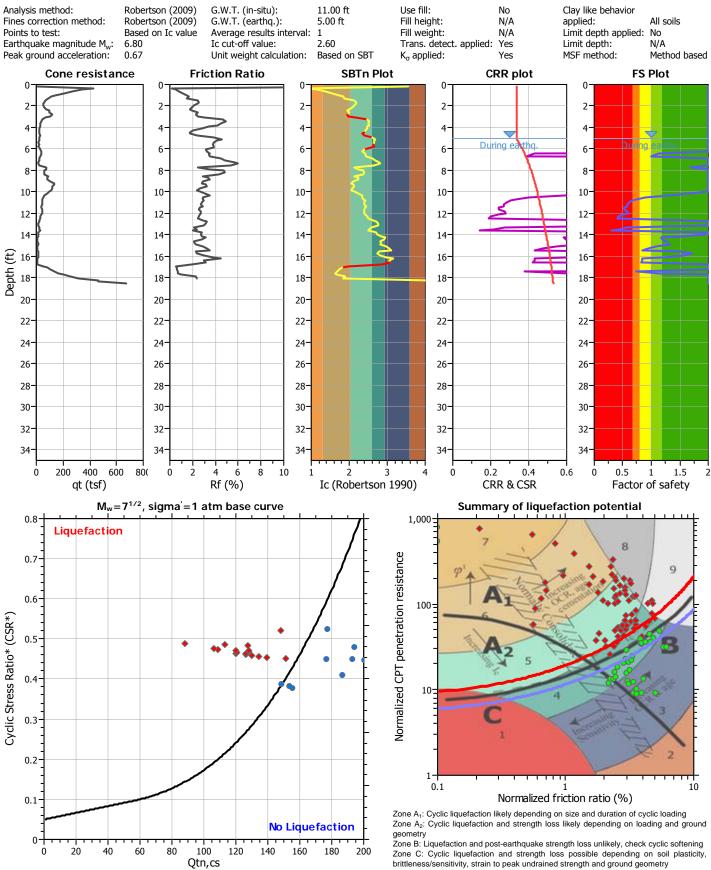
CPT file : CPT-4

Input parameters and analysis data

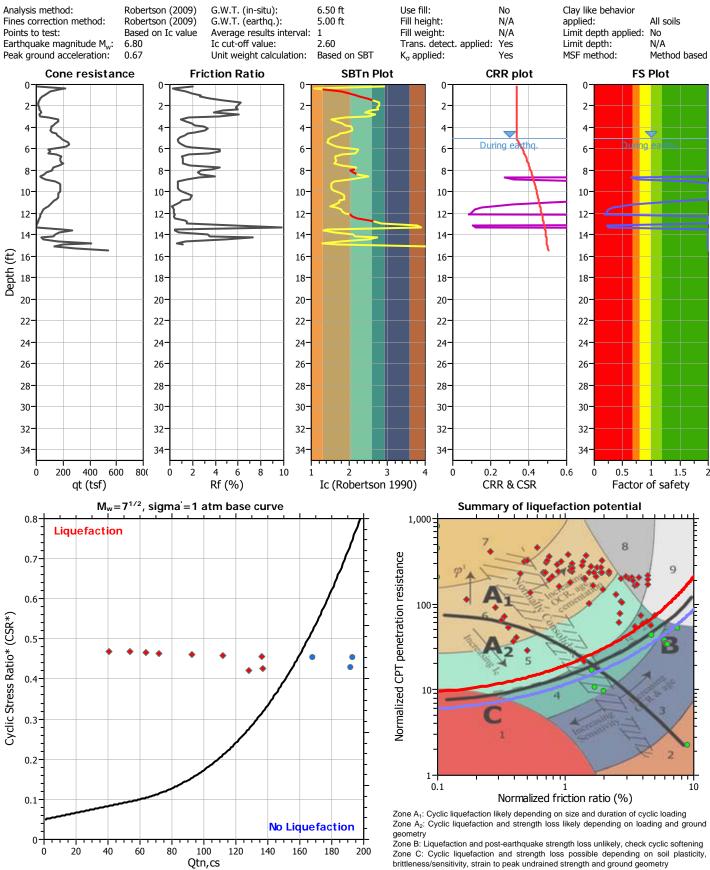
CPT file : CPT-5

Input parameters and analysis data

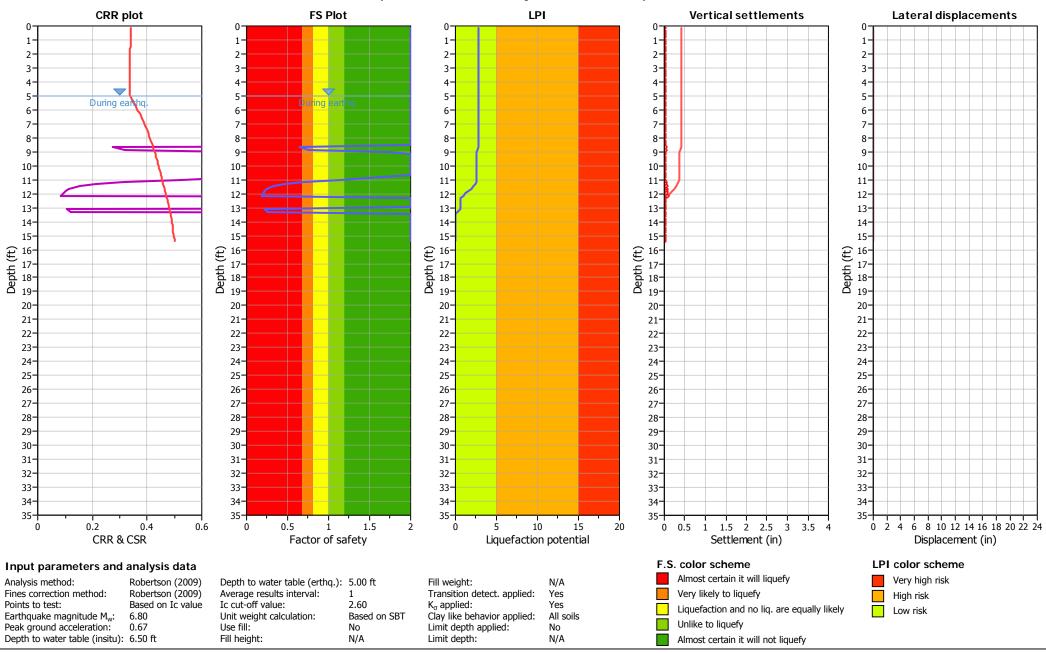
Liquefaction analysis overall plots

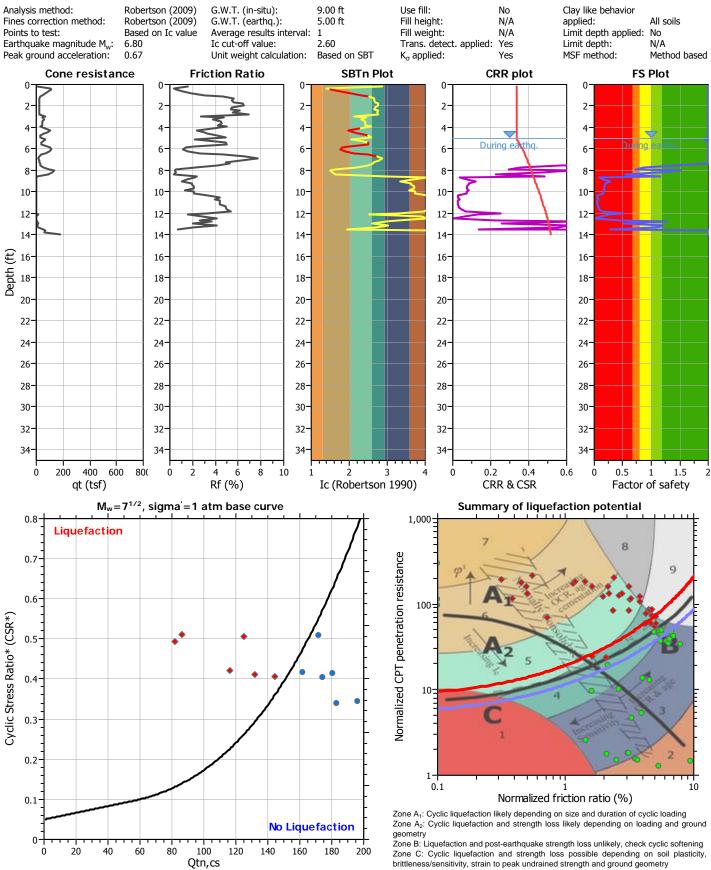
CPT file : CPT-6

Input parameters and analysis data

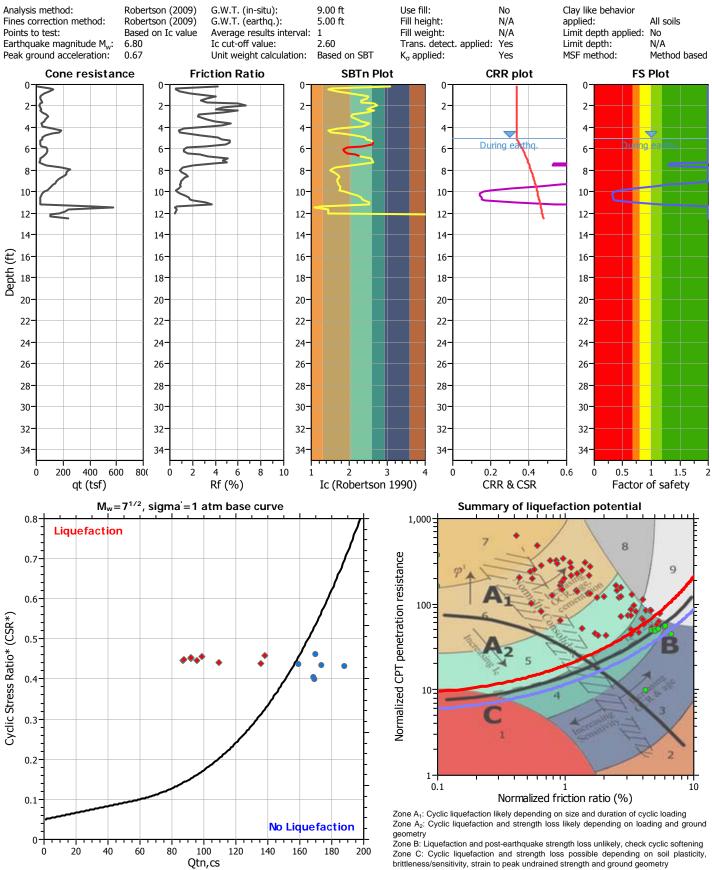
CPT file : CPT-6A

Input parameters and analysis data

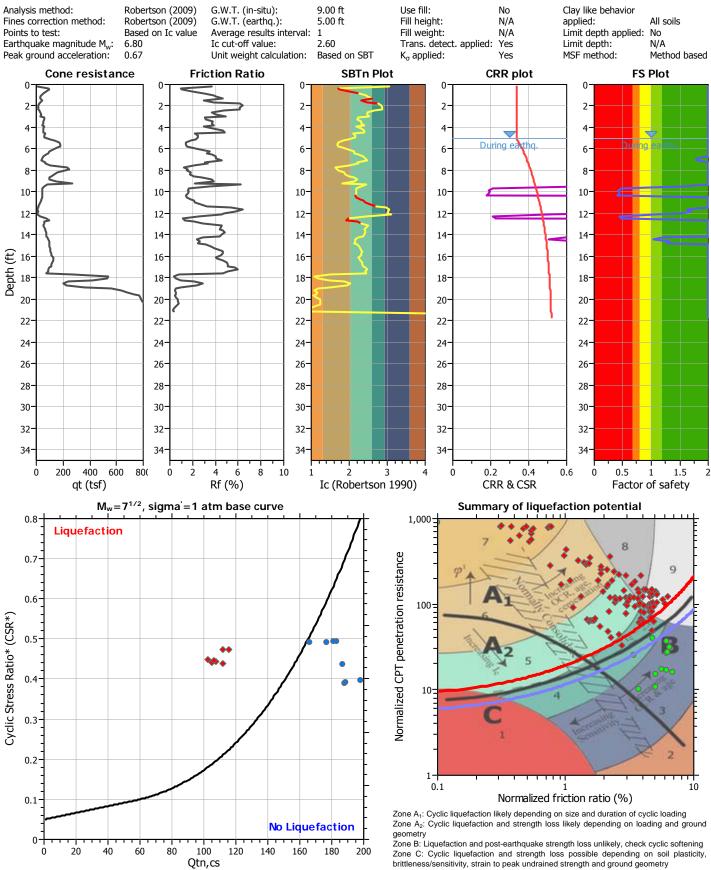
CPT file : CPT-6B

Input parameters and analysis data

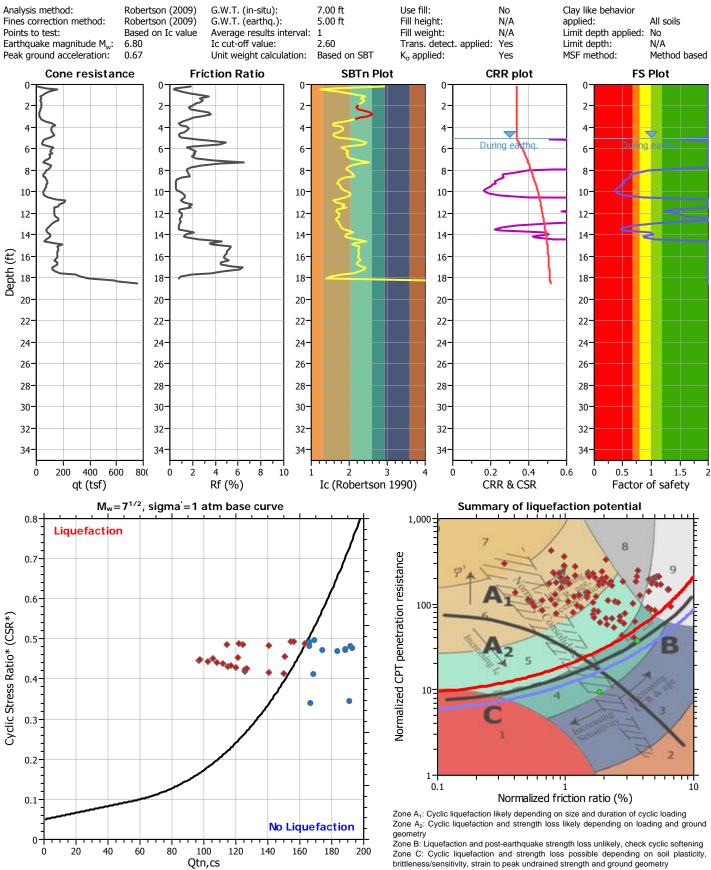
CPT file : CPT-7

Input parameters and analysis data

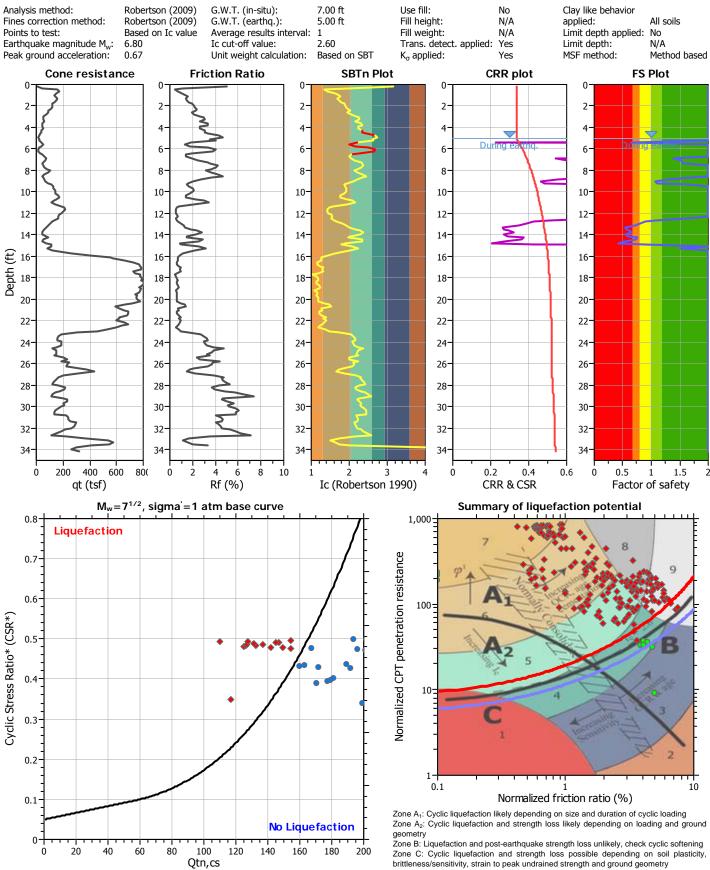
CPT file : CPT-8

Input parameters and analysis data

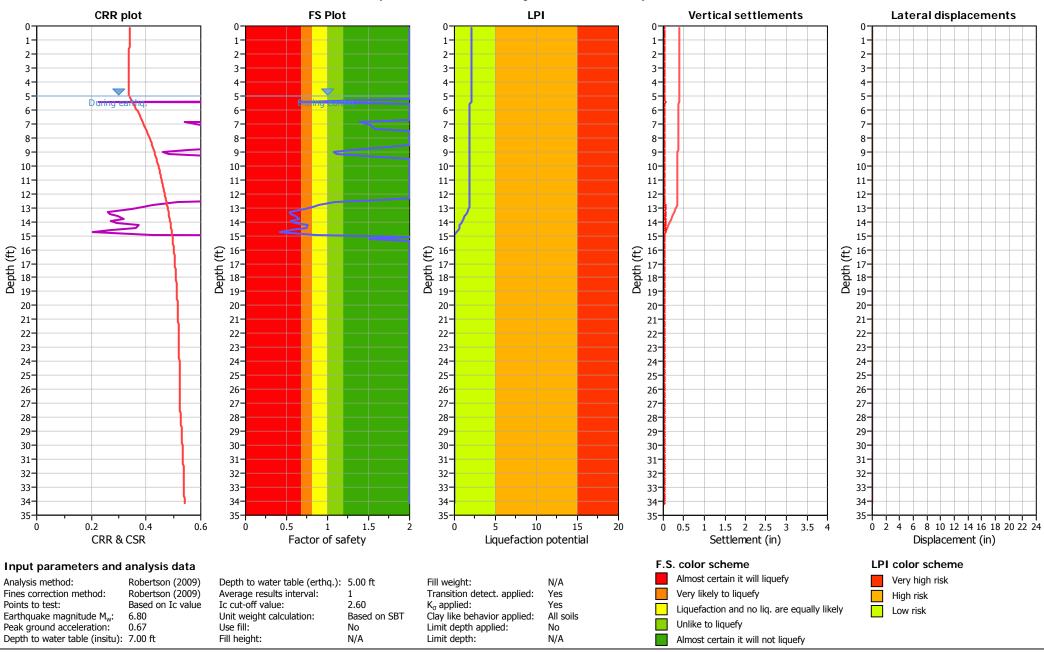
Liquefaction analysis overall plots

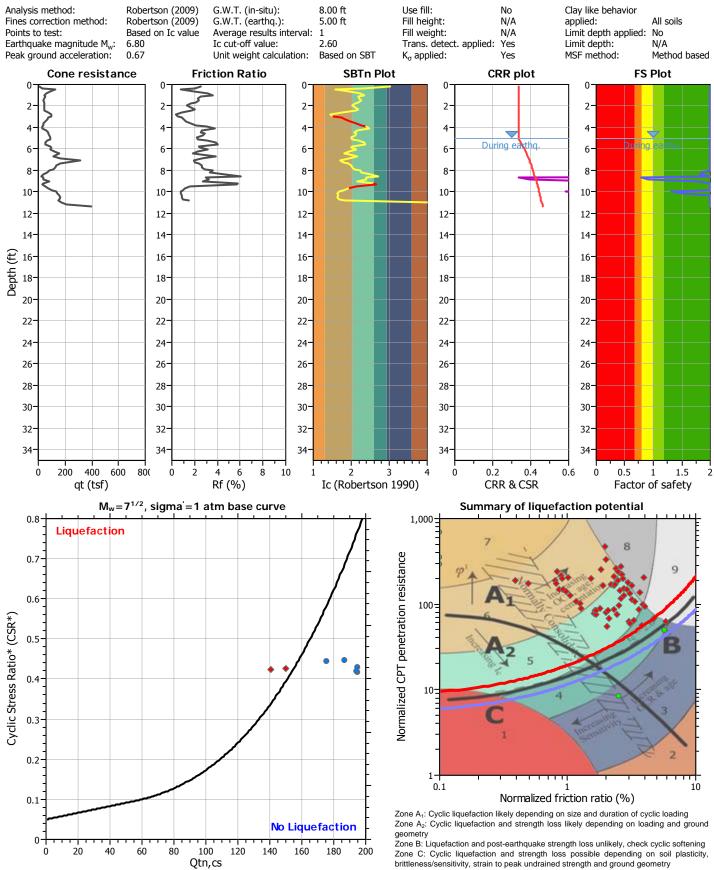
Input parameters and analysis data

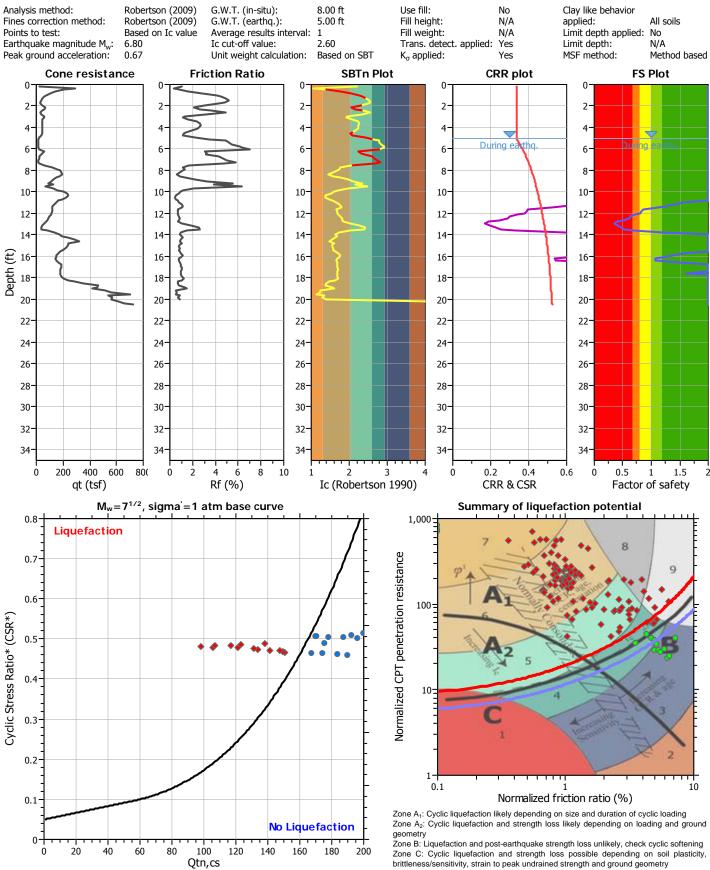
CPT file : CPT-10

Input parameters and analysis data

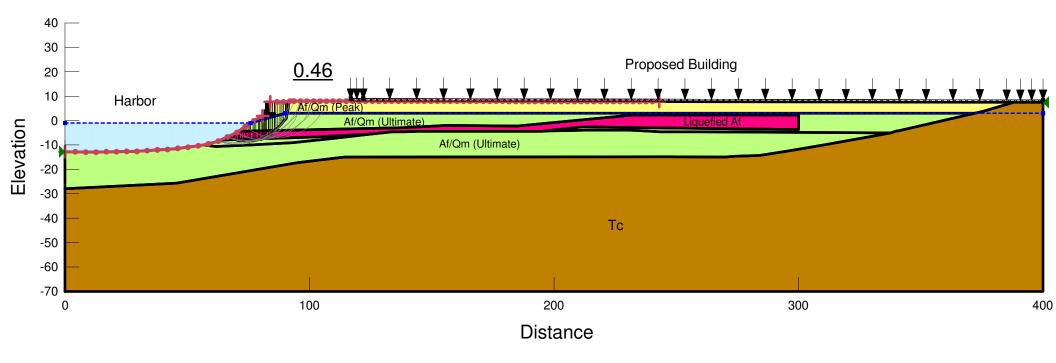
Static Analysis, Run 1.1 Post Earthquake Condition Horz Seismic Coef.: 0 Entry and Exit Name: Af/Qm (Ultimate) Model: Mohr-Coulomb Unit Weight: 125 pcf Cohesion': 80 psf Phi': 30 °

Name: Af/Qm (Peak) Model: Mohr-Coulomb Unit Weight: 125 pcf Cohesion': 395 psf Phi': 31 ° Name: Tc Model: Mohr-Coulomb Unit Weight: 125 pcf Cohesion': 695 psf Phi': 34 °

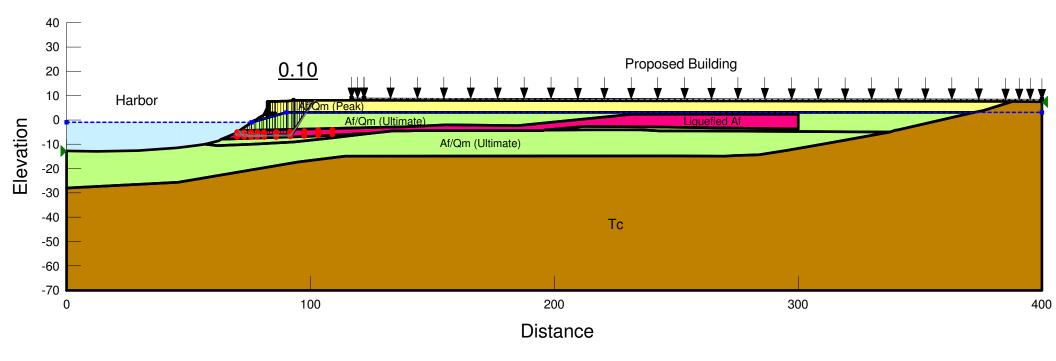
Static Analysis, Run 1.2 Post Earthquake Condition Horz Seismic Coef.: 0 Block Search Name: Af/Qm (Ultimate) Model: Mohr-Coulomb Unit Weight: 125 pcf Cohesion': 80 psf Phi': 30 °

Name: Af/Qm (Peak) Model: Mohr-Coulomb Unit Weight: 125 pcf Cohesion': 395 psf Phi': 31 ° Name: Tc Model: Mohr-Coulomb Unit Weight: 125 pcf Cohesion': 695 psf Phi': 34 °

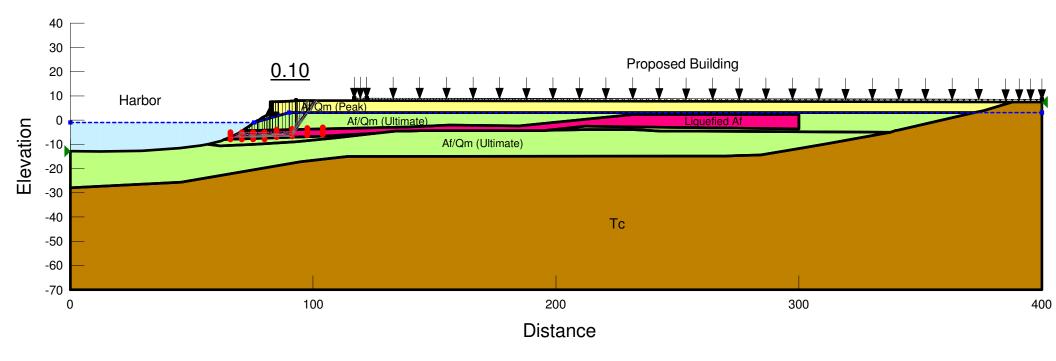
Pseudo-Static Analysis, Run 1.2 Horz Seismic Coef.: 0.15 Block Search Name: Af/Qm (Ultimate) Model: Mohr-Coulomb Unit Weight: 125 pcf Cohesion': 80 psf Phi': 30 °

Name: Af/Qm (Peak) Model: Mohr-Coulomb Unit Weight: 125 pcf Cohesion': 395 psf Phi': 31 ° Name: Tc Model: Mohr-Coulomb Unit Weight: 125 pcf Cohesion': 695 psf Phi': 34 °

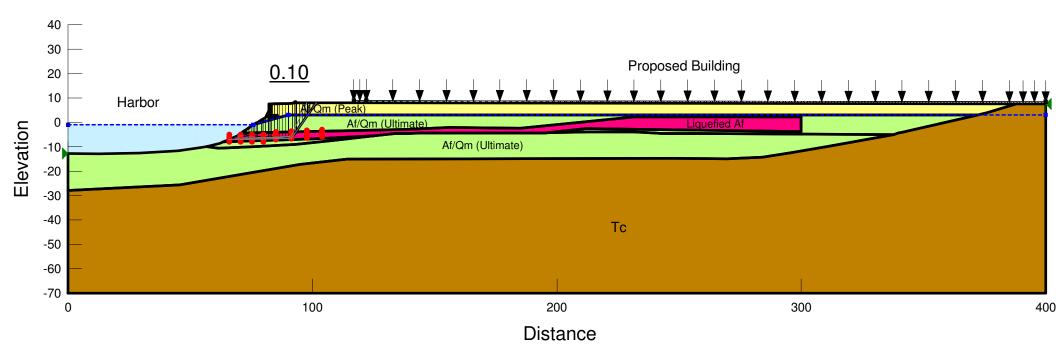
Deformation Analysis, Run 1.2 Horz Seismic Coef.: 0 Deformation > 92 inches Block Search Name: Af/Qm (Ultimate) Model: Mohr-Coulomb Unit Weight: 125 pcf Cohesion': 80 psf Phi': 30 °

Name: Af/Qm (Peak) Model: Mohr-Coulomb Unit Weight: 125 pcf Cohesion': 395 psf Phi': 31 ° Name: Tc Model: Mohr-Coulomb Unit Weight: 125 pcf Cohesion': 695 psf Phi': 34 °

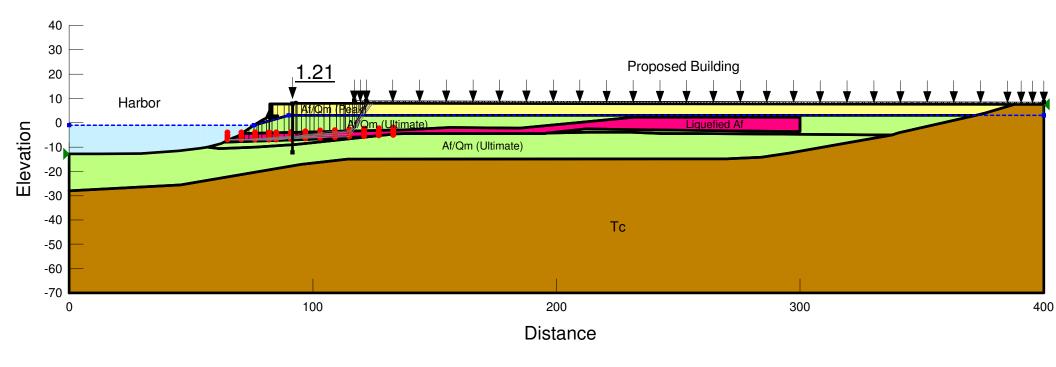
Name: Af/Qm (Peak) Model: Mohr-Coulomb Unit Weight: 125 pcf Cohesion': 395 psf Phi': 31 ° Name: Tc Model: Mohr-Coulomb Unit Weight: 125 pcf Cohesion': 695 psf Phi': 34 °

Name: Liquefied Af Model: S=f(overburden) Unit Weight: 125 pcf Tau/Sigma Ratio: 0.05 Type: Pile Total Length: 20 ft Shear Force: 18,000 lbs Pile Spacing: 1 ft

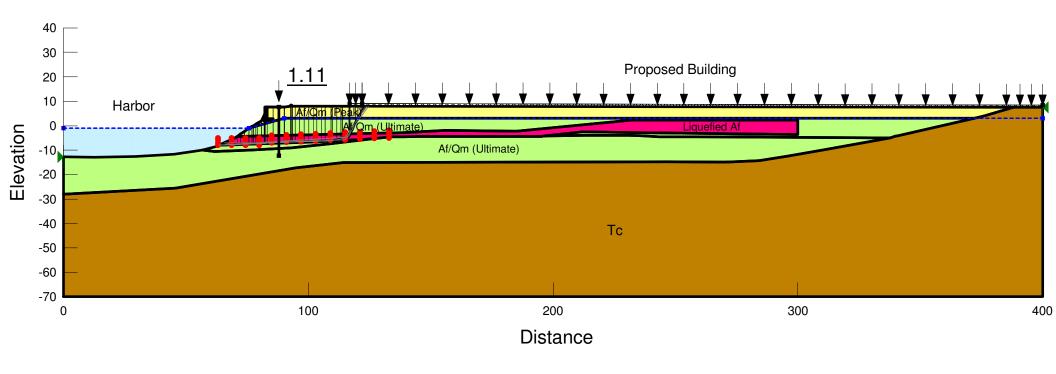
Pseudo-Static Analysis, Run 1.3 with Mitigation Horz Seismic Coef.: 0.15 Block Search Name: Af/Qm (Ultimate) Model: Mohr-Coulomb Unit Weight: 125 pcf Cohesion': 80 psf Phi': 30 °

Name: Af/Qm (Peak) Model: Mohr-Coulomb Unit Weight: 125 pcf Cohesion': 395 psf Phi': 31 ° Name: Tc Model: Mohr-Coulomb Unit Weight: 125 pcf Cohesion': 695 psf Phi': 34 °

Name: Liquefied Af Model: S=f(overburden) Unit Weight: 125 pcf Tau/Sigma Ratio: 0.05 Type: Pile Total Length: 20 ft Shear Force: 28,600 lbs Pile Spacing: 1 ft

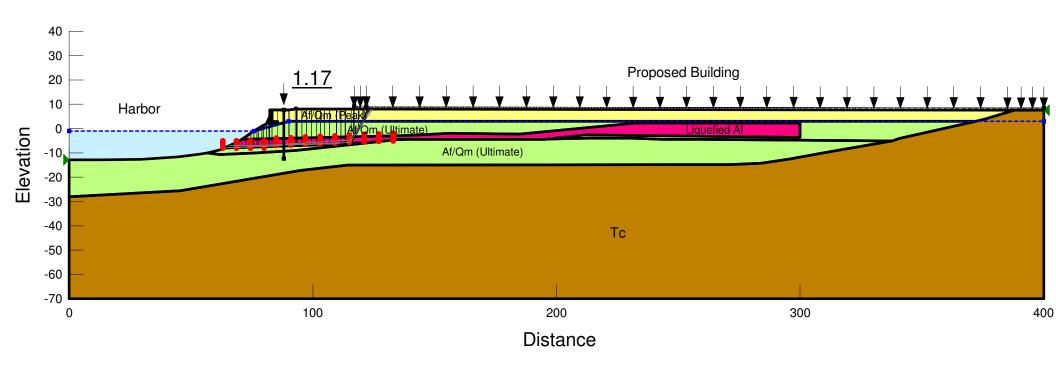
Deformation Analysis, Run 1.3 with Mitigation Horz Seismic Coef.: 0.206 Deformation = 12-inches Block Search Name: Af/Qm (Ultimate) Model: Mohr-Coulomb Unit Weight: 125 pcf Cohesion': 80 psf Phi': 30 °

Name: Af/Qm (Peak) Model: Mohr-Coulomb Unit Weight: 125 pcf Cohesion': 395 psf Phi': 31 ° Name: Tc Model: Mohr-Coulomb Unit Weight: 125 pcf Cohesion': 695 psf Phi': 34 °

Name: Liquefied Af Model: S=f(overburden) Unit Weight: 125 pcf Tau/Sigma Ratio: 0.05 Type: Pile Total Length: 20 ft Shear Force: 32,500 lbs Pile Spacing: 1 ft

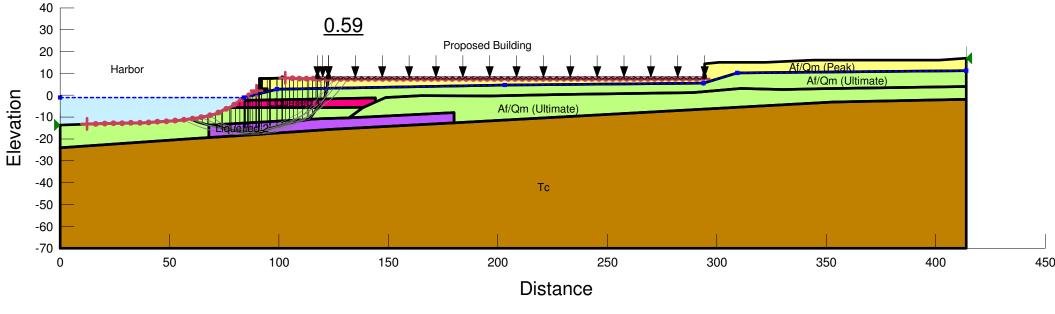
Static Analysis, Run 1.1 Post Earthquake Condition Horz Seismic Coef.: 0 Entry and Exit Name: Af/Qm (Ultimate) Model: Mohr-Coulomb Unit Weight: 125 pcf Cohesion': 80 psf Phi': 30 °

Name: Af/Qm (Peak) Model: Mohr-Coulomb Unit Weight: 125 pcf Cohesion': 395 psf Phi': 31 °

Name: Tc Model: Mohr-Coulomb Unit Weight: 125 pcf Cohesion': 695 psf Phi': 34 ° Name: Liquefied 1 Model: S=f(overburden) Unit Weight: 125 pcf Tau/Sigma Ratio: 0.14
