APPENDIX F

SUPPLEMENTAL GEOTECHNICAL LETTER

Subject: EIR Update, Dana Point Harbor Hotels, City of Dana Point, California

PRELIMINARY GEOTECHNICAL INVESTIGATION (2019)

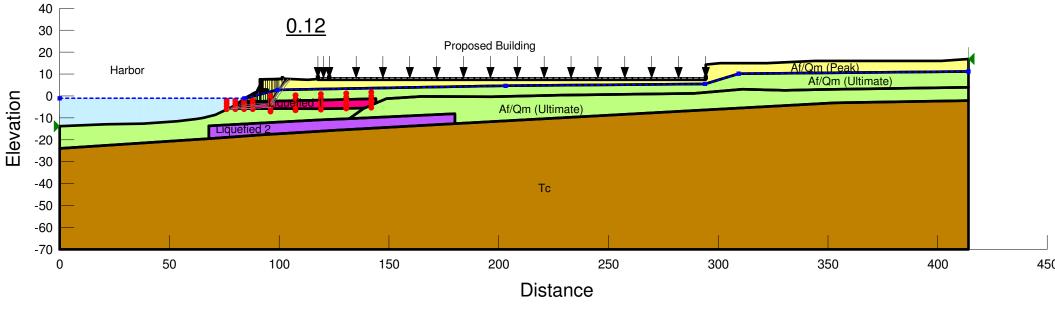
Static Analysis, Run 1.2 Post Earthquake Condition Liquefied Layer 1 Horz Seismic Coef.: 0 Block Search Name: Af/Qm (Ultimate) Model: Mohr-Coulomb Unit Weight: 125 pcf Cohesion': 80 psf Phi': 30 °

Name: Af/Qm (Peak) Model: Mohr-Coulomb Unit Weight: 125 pcf Cohesion': 395 psf Phi': 31 °

Name: Tc Model: Mohr-Coulomb Unit Weight: 125 pcf Cohesion': 695 psf Phi': 34 ° Name: Liquefied 1 Model: S=f(overburden) Unit Weight: 125 pcf Tau/Sigma Ratio: 0.14

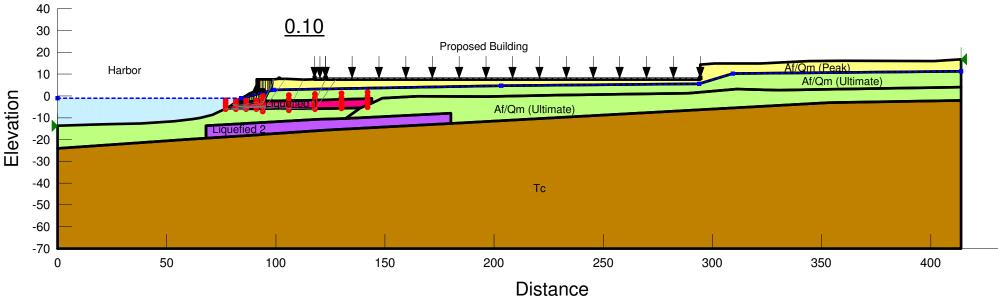
Pseudo-Static Analysis, Run 1.2 Liquefied Layer 1 Horz Seismic Coef.: 0.15 Block Search Name: Af/Qm (Ultimate) Model: Mohr-Coulomb Unit Weight: 125 pcf Cohesion': 80 psf Phi': 30 °

Name: Af/Qm (Peak) Model: Mohr-Coulomb Unit Weight: 125 pcf Cohesion': 395 psf Phi': 31 °

Name: Liquefied 2 Model: S=f(overburden) Unit Weight: 125 pcf Tau/Sigma Ratio: 0.17

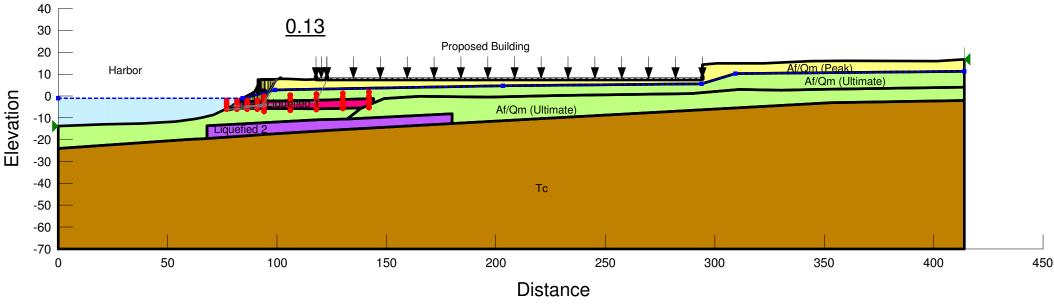
Deformation Analysis, Run 1.2 Liquefied Layer 1 Horz Seismic Coef.: 0 Deformation > 124 inches Block Search Name: Af/Qm (Ultimate) Model: Mohr-Coulomb Unit Weight: 125 pcf Cohesion': 80 psf Phi': 30 °

Name: Af/Qm (Peak) Model: Mohr-Coulomb Unit Weight: 125 pcf Cohesion': 395 psf Phi': 31 °

Name: Tc Model: Mohr-Coulomb Unit Weight: 125 pcf Cohesion': 695 psf Phi': 34 ° Name: Liquefied 1 Model: S=f(overburden) Unit Weight: 125 pcf Tau/Sigma Ratio: 0.14

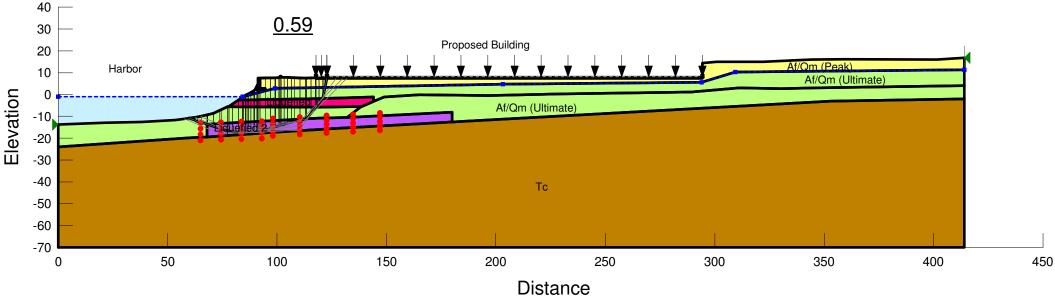
Static Analysis, Run 1.3 Post Earthquake Condition Liquefied Layer 2 Horz Seismic Coef.: 0 Block Search Name: Af/Qm (Ultimate) Model: Mohr-Coulomb Unit Weight: 125 pcf Cohesion': 80 psf Phi': 30 °

Name: Af/Qm (Peak) Model: Mohr-Coulomb Unit Weight: 125 pcf Cohesion': 395 psf Phi': 31 °

Name: Tc Model: Mohr-Coulomb Unit Weight: 125 pcf Cohesion': 695 psf Phi': 34 ° Name: Liquefied 1 Model: S=f(overburden) Unit Weight: 125 pcf Tau/Sigma Ratio: 0.14

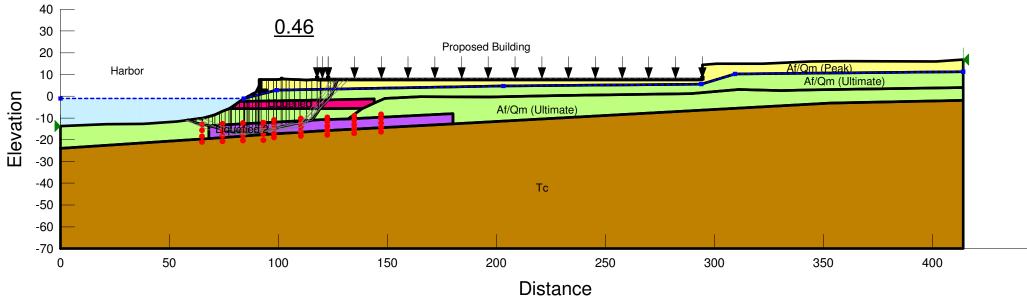
Pseudo-Static Analysis, Run 1.3 Liquefied Layer 2 Horz Seismic Coef.: 0.15 Block Search Name: Af/Qm (Ultimate) Model: Mohr-Coulomb Unit Weight: 125 pcf Cohesion': 80 psf Phi': 30 °

Name: Af/Qm (Peak) Model: Mohr-Coulomb Unit Weight: 125 pcf Cohesion': 395 psf Phi': 31 °

Name: Liquefied 2 Model: S=f(overburden) Unit Weight: 125 pcf Tau/Sigma Ratio: 0.17

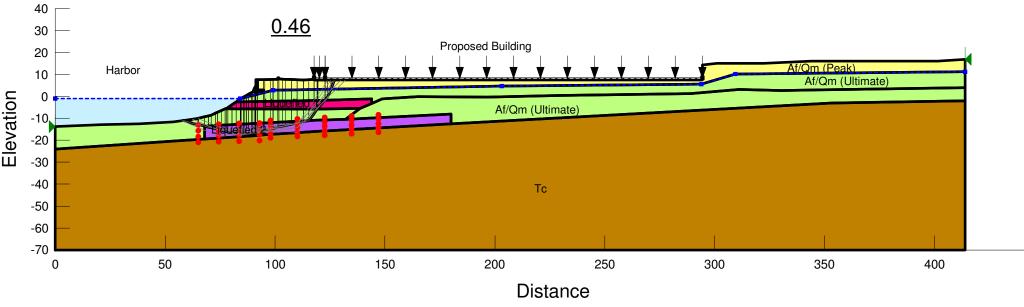
Deformation Analysis, Run 1.3 Liquefied Layer 2 Horz Seismic Coef.: 0.15 Deformation > 99.17 Block Search Name: Af/Qm (Ultimate) Model: Mohr-Coulomb Unit Weight: 125 pcf Cohesion': 80 psf Phi': 30 °

Name: Af/Qm (Peak) Model: Mohr-Coulomb Unit Weight: 125 pcf Cohesion': 395 psf Phi': 31 °

Name: Liquefied 2 Model: S=f(overburden) Unit Weight: 125 pcf Tau/Sigma Ratio: 0.17

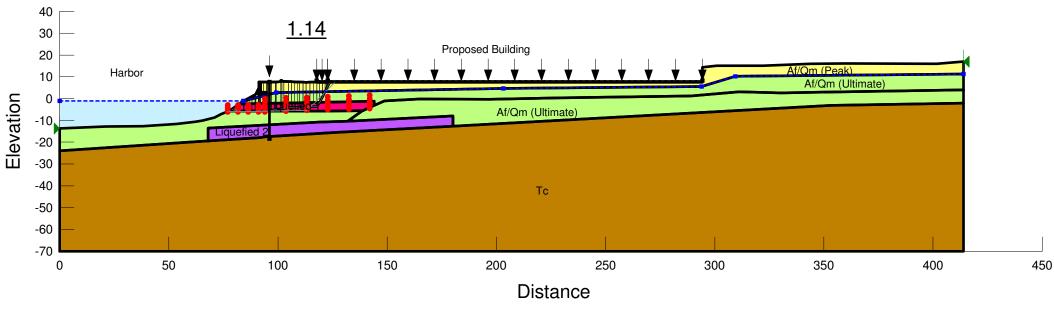
Pseudo-Static Analysis, Run 1.4 Liquefied Layer 1 with Mitigation Horz Seismic Coef.: 0.15 Block Search Name: Af/Qm (Ultimate) Model: Mohr-Coulomb Unit Weight: 125 pcf Cohesion': 80 psf Phi': 30 °

Name: Af/Qm (Peak) Model: Mohr-Coulomb Unit Weight: 125 pcf Cohesion': 395 psf Phi': 31 °

Name: Tc Model: Mohr-Coulomb Unit Weight: 125 pcf Cohesion': 695 psf Phi': 34 ° Name: Liquefied 1 Model: S=f(overburden) Unit Weight: 125 pcf Tau/Sigma Ratio: 0.14

Name: Liquefied 2 Model: S=f(overburden) Unit Weight: 125 pcf Tau/Sigma Ratio: 0.17 Type: Pile Total Length: 26 ft Shear Force: 23,000 lbs Pile Spacing: 1 ft

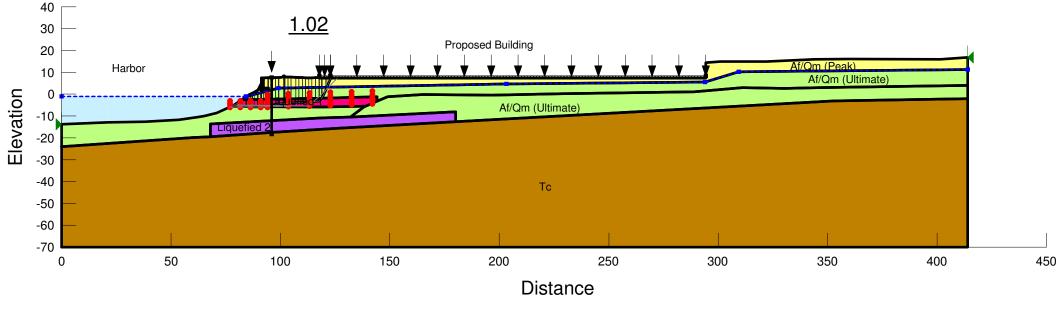
Deformation Analysis, Run 1.4 Liquefied Layer 1 with Mitigation Horz Seismic Coef.: 0.215 Deformation = 12 inches Block Search Name: Af/Qm (Ultimate) Model: Mohr-Coulomb Unit Weight: 125 pcf Cohesion': 80 psf Phi': 30 °

Name: Af/Qm (Peak) Model: Mohr-Coulomb Unit Weight: 125 pcf Cohesion': 395 psf Phi': 31 °

Name: Tc Model: Mohr-Coulomb Unit Weight: 125 pcf Cohesion': 695 psf Phi': 34 ° Name: Liquefied 1 Model: S=f(overburden) Unit Weight: 125 pcf Tau/Sigma Ratio: 0.14

Name: Liquefied 2 Model: S=f(overburden) Unit Weight: 125 pcf Tau/Sigma Ratio: 0.17 Type: Pile Total Length: 26 ft Shear Force: 24,700 lbs Pile Spacing: 1 ft

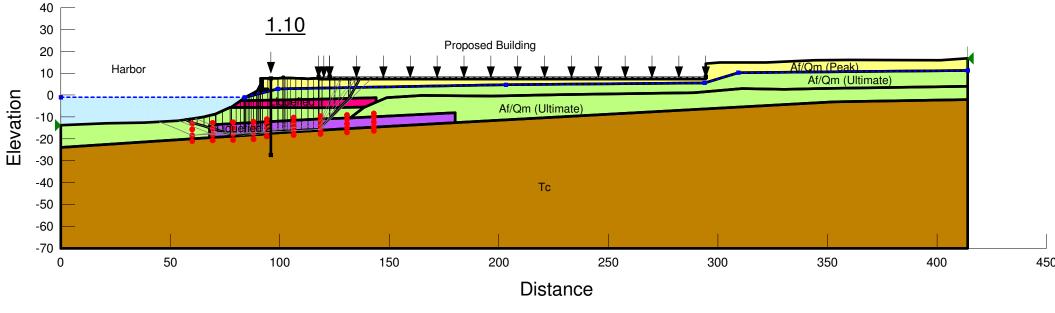
Pseudo-Static Analysis, Run 1.5 Liquefied Layer 2 with Mitigation Horz Seismic Coef.: 0.15 Block Search Name: Af/Qm (Ultimate) Model: Mohr-Coulomb Unit Weight: 125 pcf Cohesion': 80 psf Phi': 30 °

Name: Af/Qm (Peak) Model: Mohr-Coulomb Unit Weight: 125 pcf Cohesion': 395 psf Phi': 31 °

Name: Tc Model: Mohr-Coulomb Unit Weight: 125 pcf Cohesion': 695 psf Phi': 34 ° Name: Liquefied 1 Model: S=f(overburden) Unit Weight: 125 pcf Tau/Sigma Ratio: 0.14

Name: Liquefied 2 Model: S=f(overburden) Unit Weight: 125 pcf Tau/Sigma Ratio: 0.17 Type: Pile Total Length: 35 ft Shear Force: 33,000 lbs Pile Spacing: 1 ft

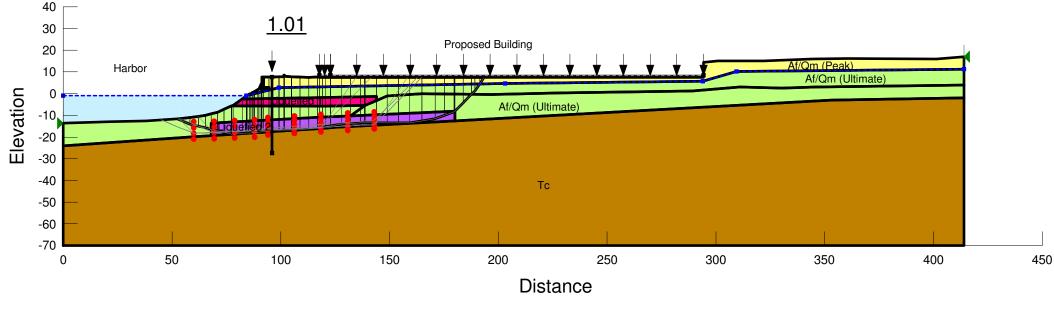
Deformation Analysis, Run 1.5 Liquefied Layer 2 with Mitigation Horz Seismic Coef.: 0.21 Deformation = 12 inches Block Search Name: Af/Qm (Ultimate) Model: Mohr-Coulomb Unit Weight: 125 pcf Cohesion': 80 psf Phi': 30 °

Name: Af/Qm (Peak) Model: Mohr-Coulomb Unit Weight: 125 pcf Cohesion': 395 psf Phi': 31 °

Name: Tc Model: Mohr-Coulomb Unit Weight: 125 pcf Cohesion': 695 psf Phi': 34 ° Name: Liquefied 1 Model: S=f(overburden) Unit Weight: 125 pcf Tau/Sigma Ratio: 0.14

Name: Liquefied 2 Model: S=f(overburden) Unit Weight: 125 pcf Tau/Sigma Ratio: 0.17 Type: Pile Total Length: 35 ft Shear Force: 49,000 lbs Pile Spacing: 1 ft
