**Hollandia Dairy CUP Modification
Technical Appendices**

**Appendix D
Geotechnical Investigation**

REPORT GEOTECHNICAL INVESTIGATION

Hollandia Dairy Fluid Milk Plant Improvements
622 E. Mission Road, San Marcos, California

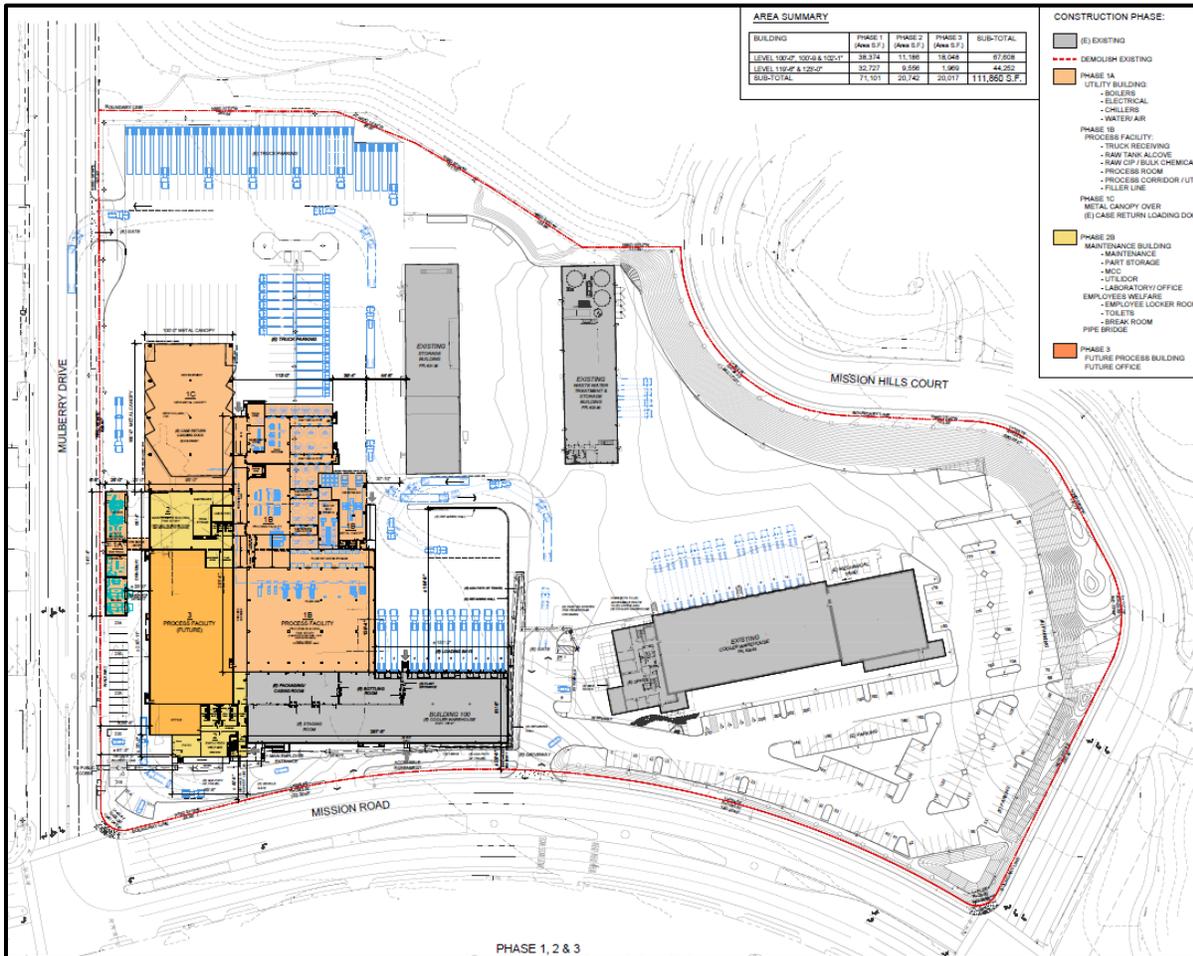
Figure 2-3. Phased Development Plan

- Phase 2B: Demolition of existing process facility building, construction of a maintenance building, employee welfare building, and a pipe bridge.
- Phase 3: Construction of a process facility building and offices (future).

Figure 3 on the following page is a representation of all phased construction.

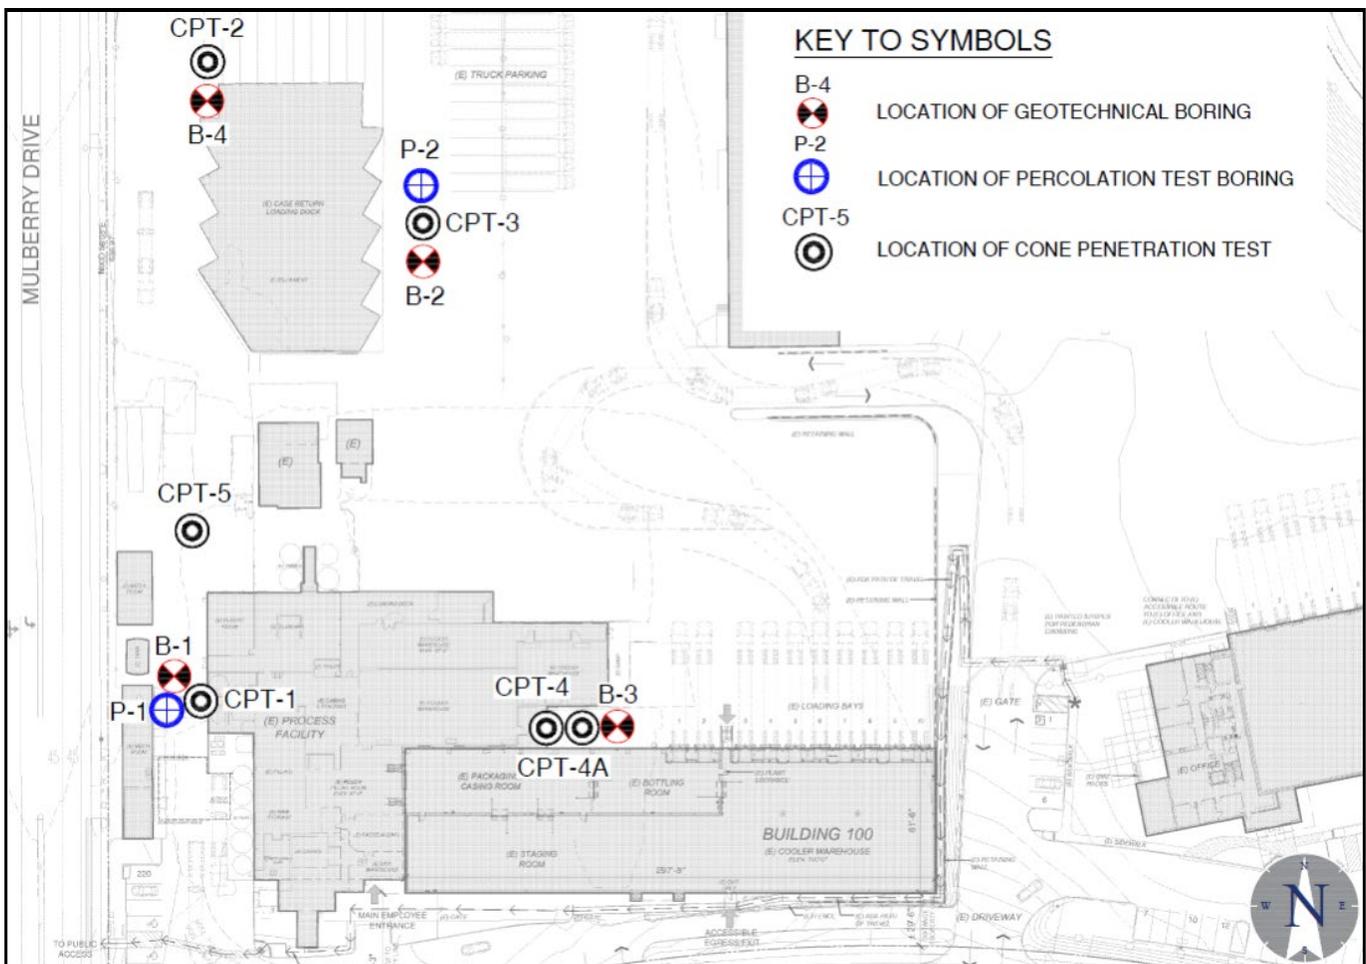
Figure 3-1. Location of the Engineering Borings, CPT Soundings and Percolation Test Borings

Figure 3-1 depicts the locations of the separate elements of the subsurface exploration. Plate 1, provided immediately following the text of this report, depicts the above information in larger scale.

Six (6) Cone Penetrometer Test soundings ('CPT', after ASTM 5778) were completed to depths of between 29.9 feet and 43.3 feet bgs on March 9, 2019 at locations indicated on Figure 3-1.

NOVA directed the excavation and construction of two (2) percolation test borings following the recommendations for percolation testing presented in the latest edition of the City of San Marcos BMP Design Manual. The locations of these borings are shown in Figure 3-1.

Section 3.4 provides a description of the field work undertaken to complete percolation testing. Figure 3-1 depicts the location of the testing. This section provides the results of that testing and related recommendations for management of stormwater in conformance with the BMP Manual.

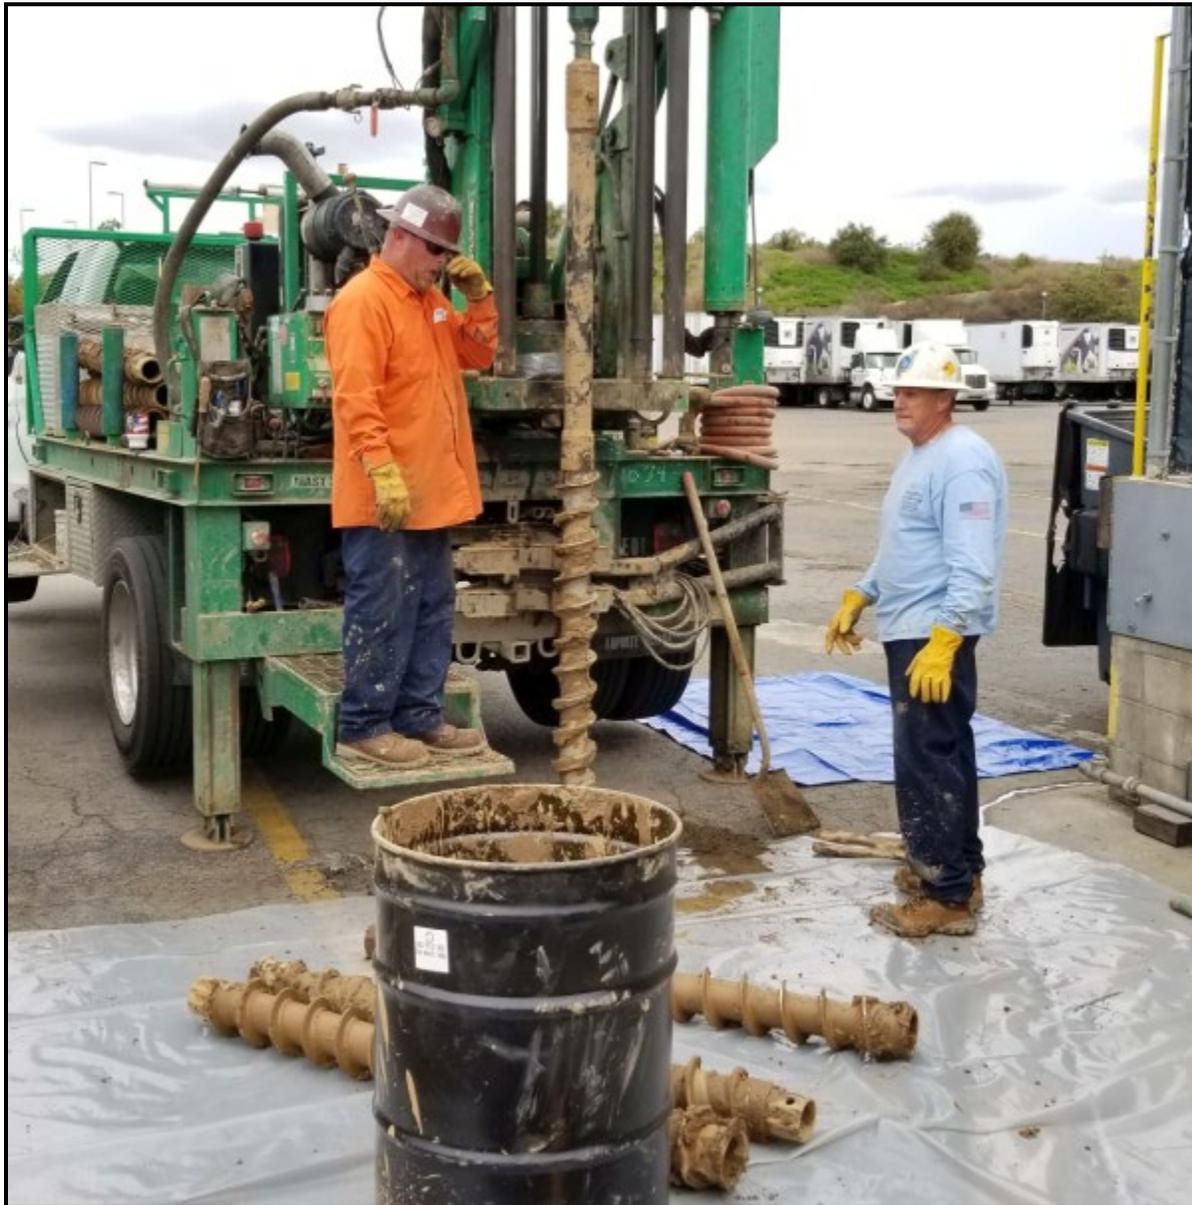
Figure 3-2. Drilling Operations on March 10, 2019

Figure 3-2 (following page) depicts drilling operations in March 2019.

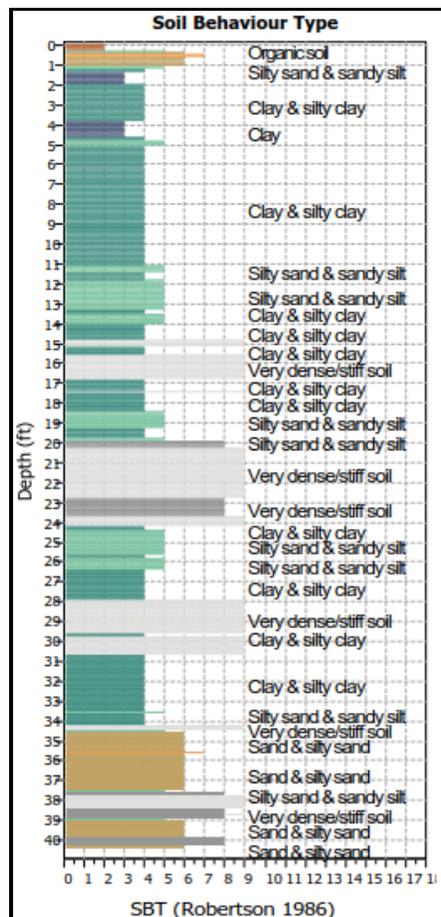
Figure 3-3. Subsurface Profile at CPT-1

Both the CPT soundings and the borings indicate the subsurface is dominated by finer grained soils. Subsurface exploration using the cone penetration test (CPT) allows development of a continuous profile of the subsurface, useful for more detailed characterization of the soils. Figure 3-3 reproduces the profile develop by CPT-1, from which it can be seen that silts and clays dominate the near subsurface.

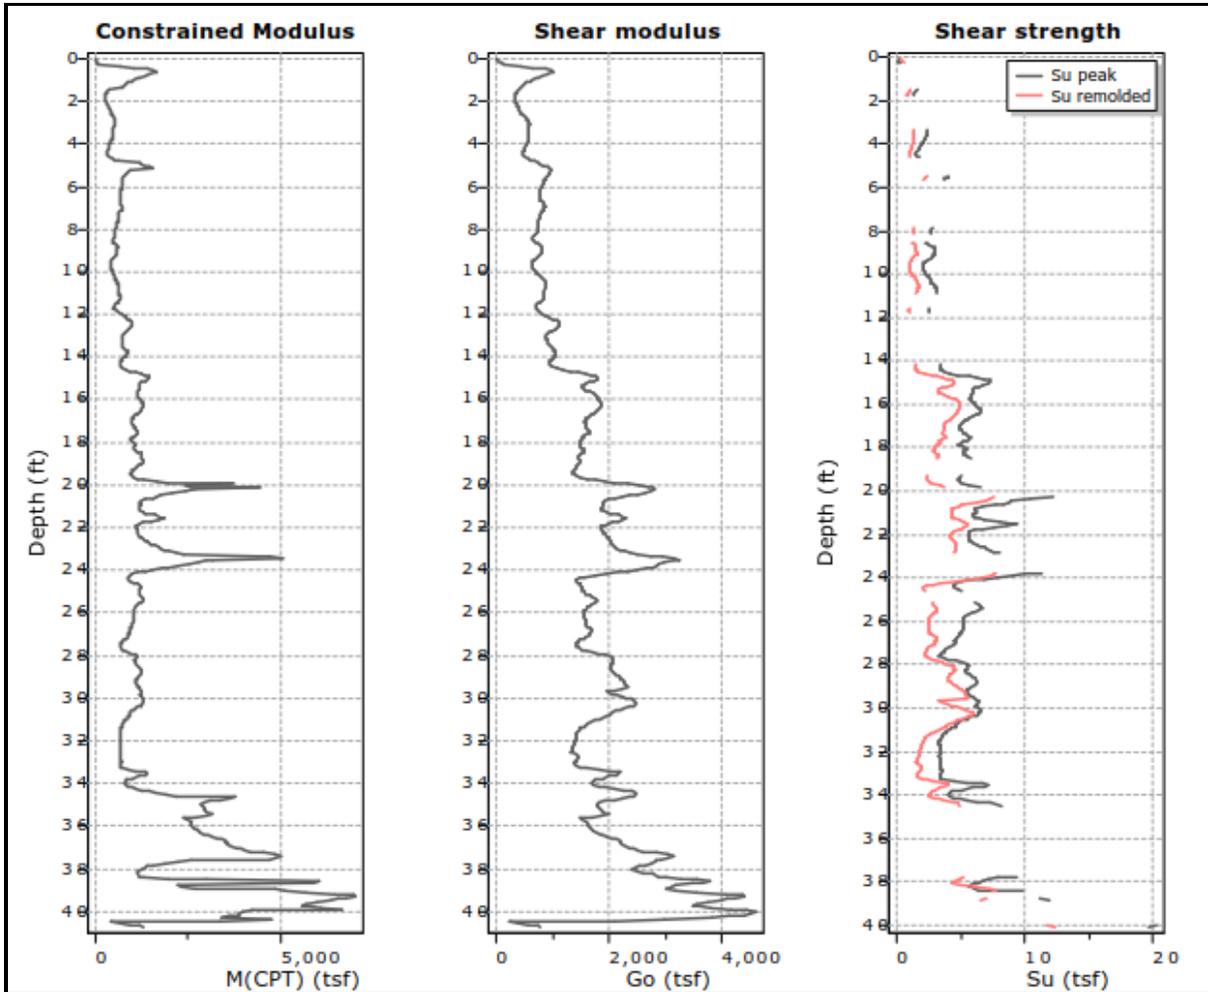
Figure 3-4. Stiffness of the Subsurface

Finer grained soils are often associated with lesser strength and higher compressibility, commonly making these soils unfavorable for development of foundations. However, the data obtained from the subsurface exploration indicates the soils at this site are relatively stiffer.

Figure 3-4 is a graphic that provides the variation of constrained soil modulus (M), shear modulus (G) and shear strength with depth, all indicators of soil stiffness.

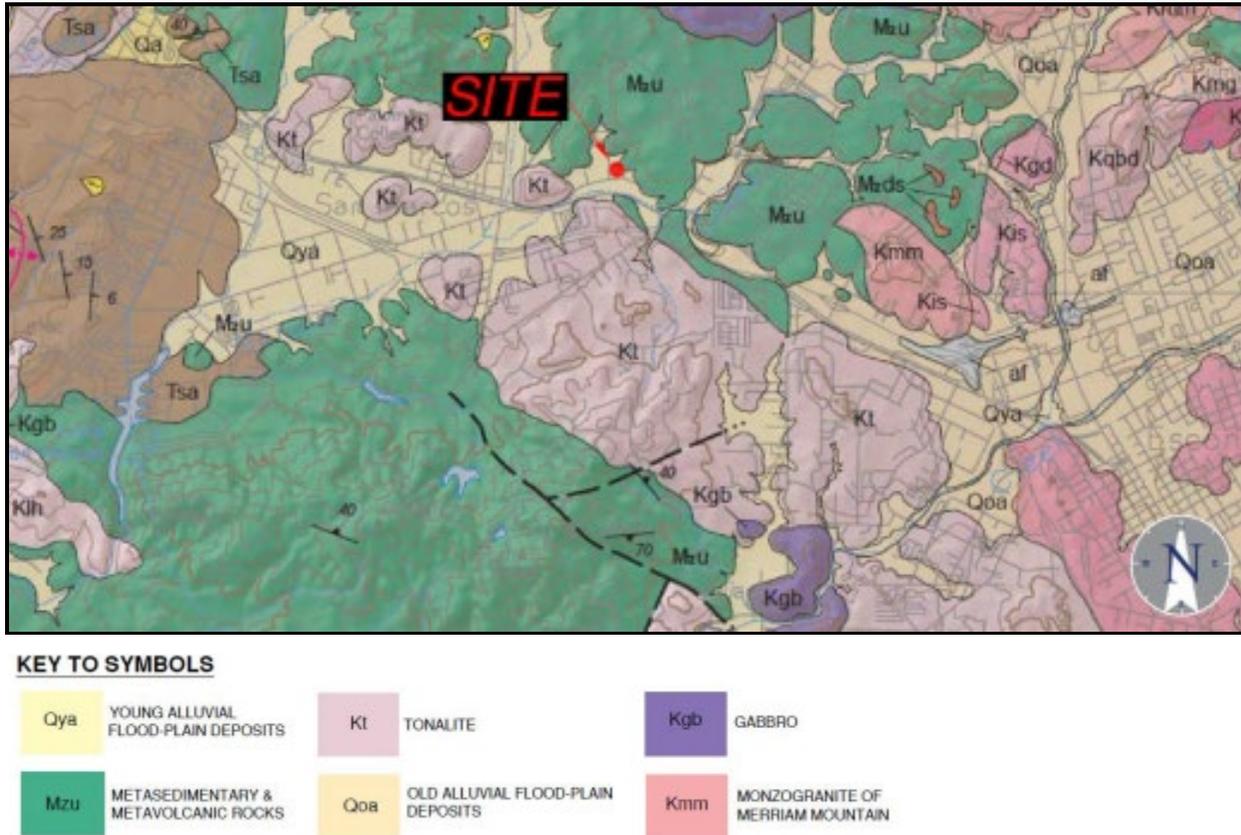
Figure 4-1. Geologic Mapping of the Site Vicinity

Figure 4-1(following page) reproduces geologic mapping of the near surface geology in the vicinity of the site. As may be seen by review of this mapping, younger alluvium (Qya) is mapped as the surface shall geologic unit in the site area. The metavolcanic bedrock rises to the surface just north and east of the site. This bedrock is buried beneath the above- described alluvial sequence within the site limits.

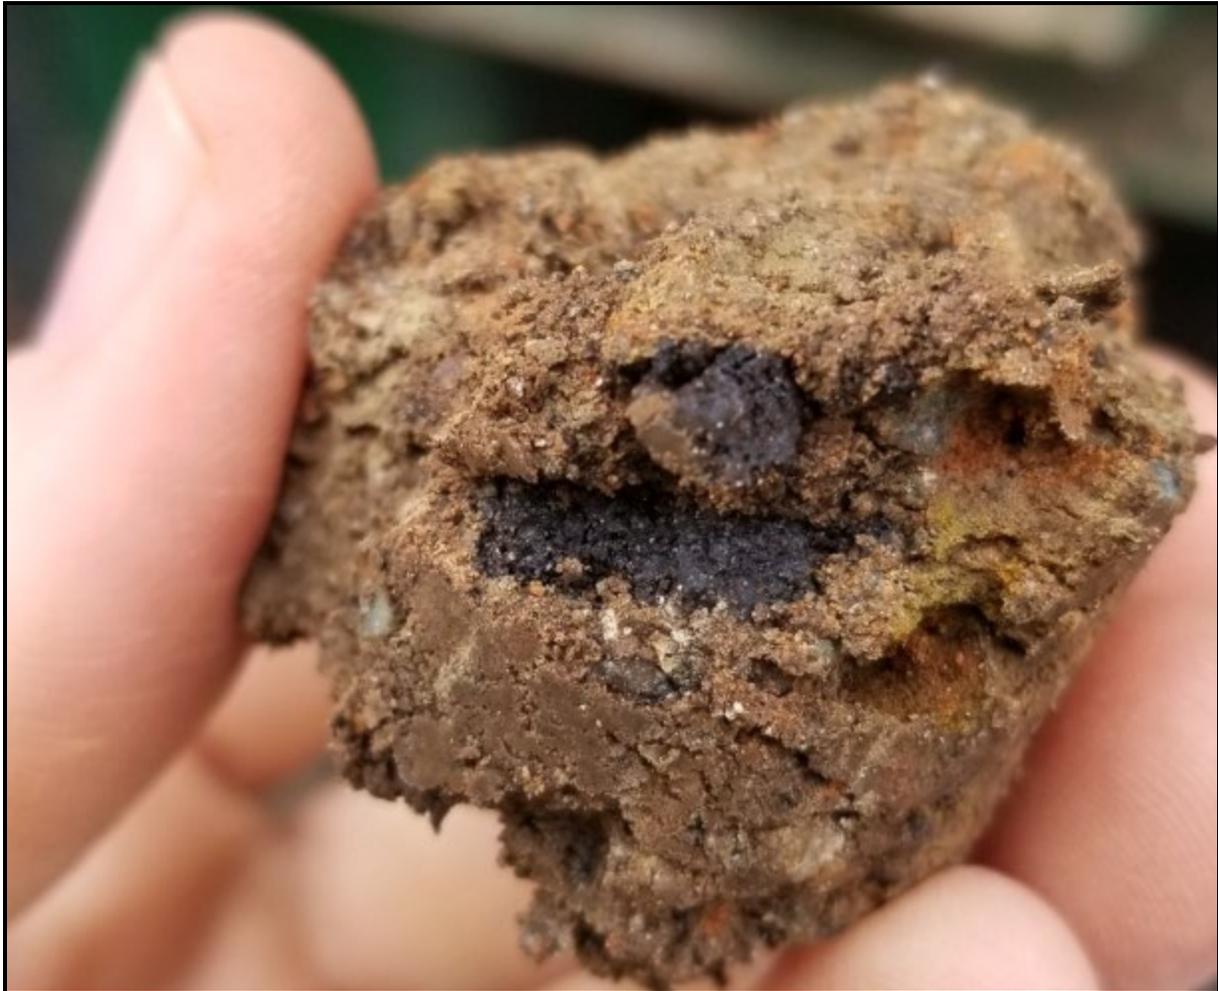
Figure 4-2. Unit 1 Undocumented Clayey Fill

1. Unit 1, Fill. Fill was encountered in B-3 to a depth of 5.5 feet bgs. The fill is comprised of sandy silt of firm to stiff consistency. Because no records exist regarding the placement of this fill, the fill is considered ‘undocumented,’ and at risk for wide variations in quality. Figure 4-2 (following page) depicts a sample of this soil unit.

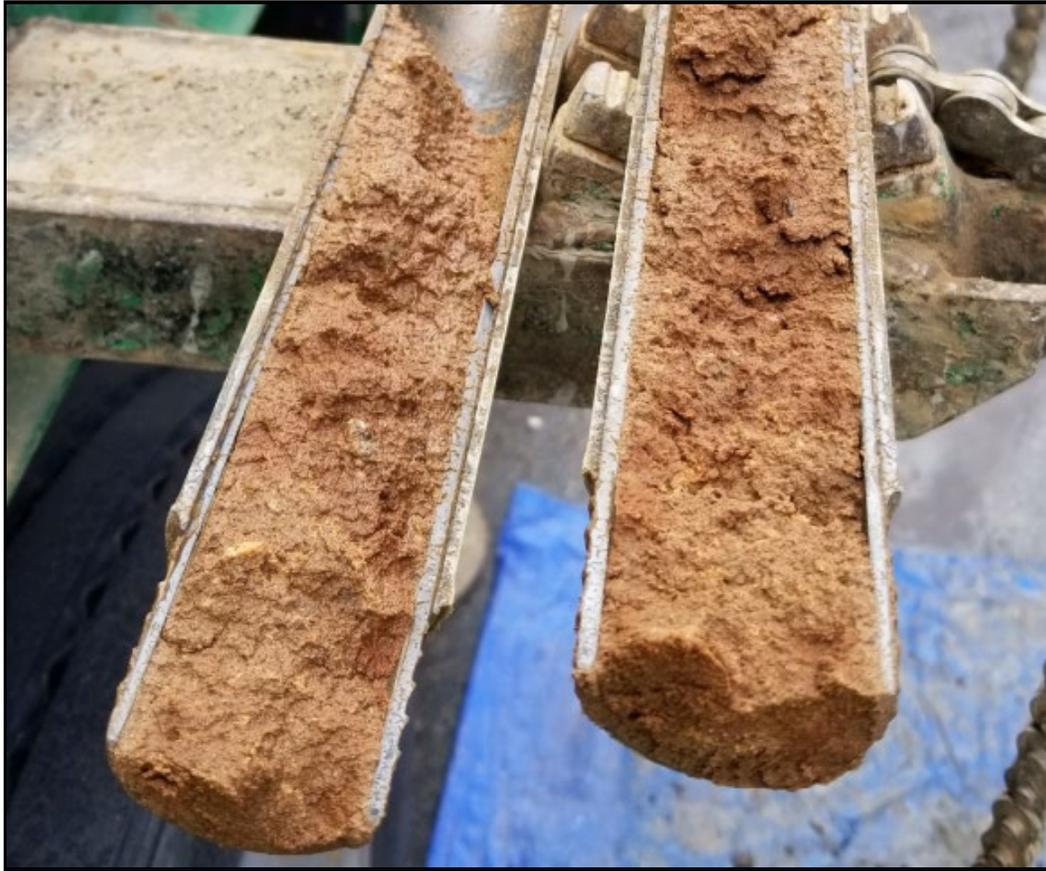
Figure 4-3. Unit 2 Older Alluvium (Qoa)

2. Unit 2, Alluvium. This unit is comprised of a thin strata of Younger Alluvium (Qya) that extends to about 7.5 feet bgs, below which occur deposits of Older Alluvium (Qoa) to depths of up to 41 feet bgs. The younger alluvium is brown to dark brown, characteristically silty and clayey, of stiff consistency. The older alluvium is comprised of reddish silts, silty sands and silty clays.

Figure 4-3 (following page) depicts the alluvium.

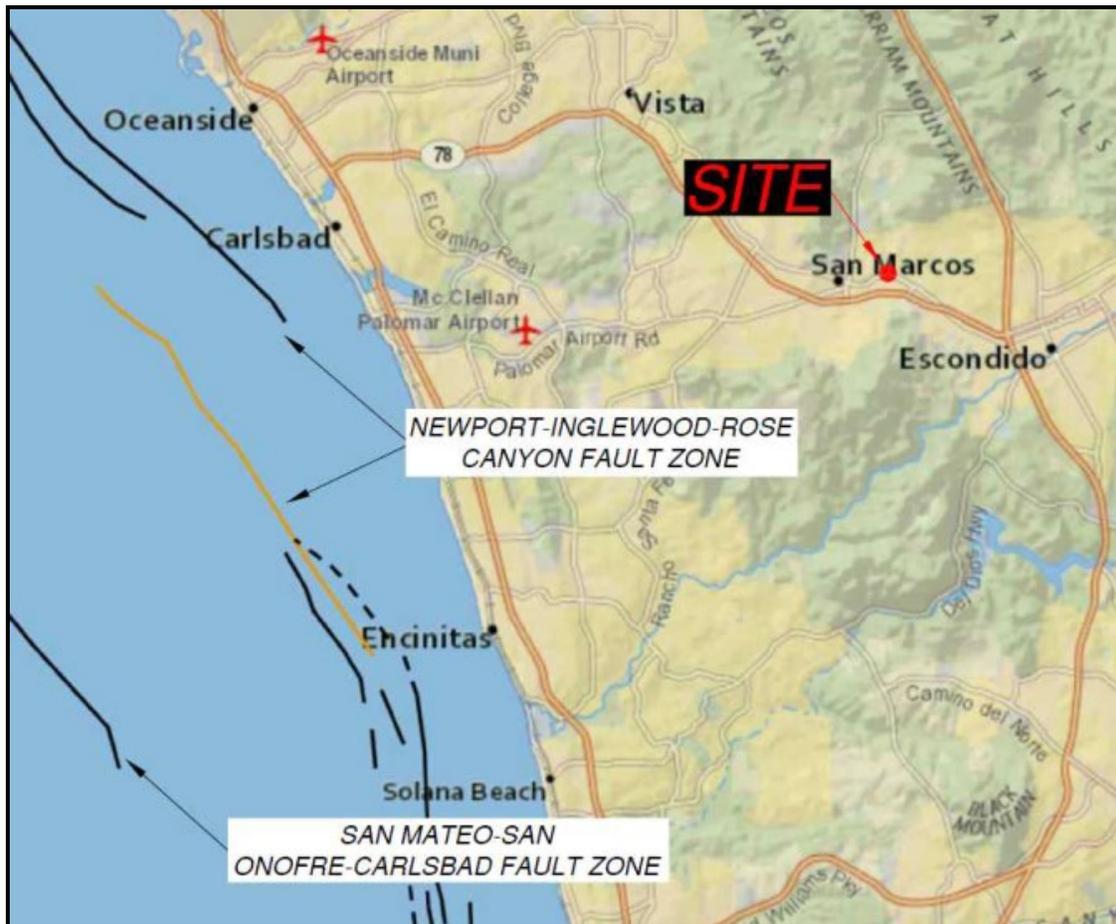
Figure 5-1. Active Faulting in the Site Vicinity

As is discussed above, the nearest known active fault is the Newport-Inglewood-Rose Canyon fault system, more than 13 miles west of the site. Figure 5-1 (following page) reproduces published mapping of active faulting in the site vicinity

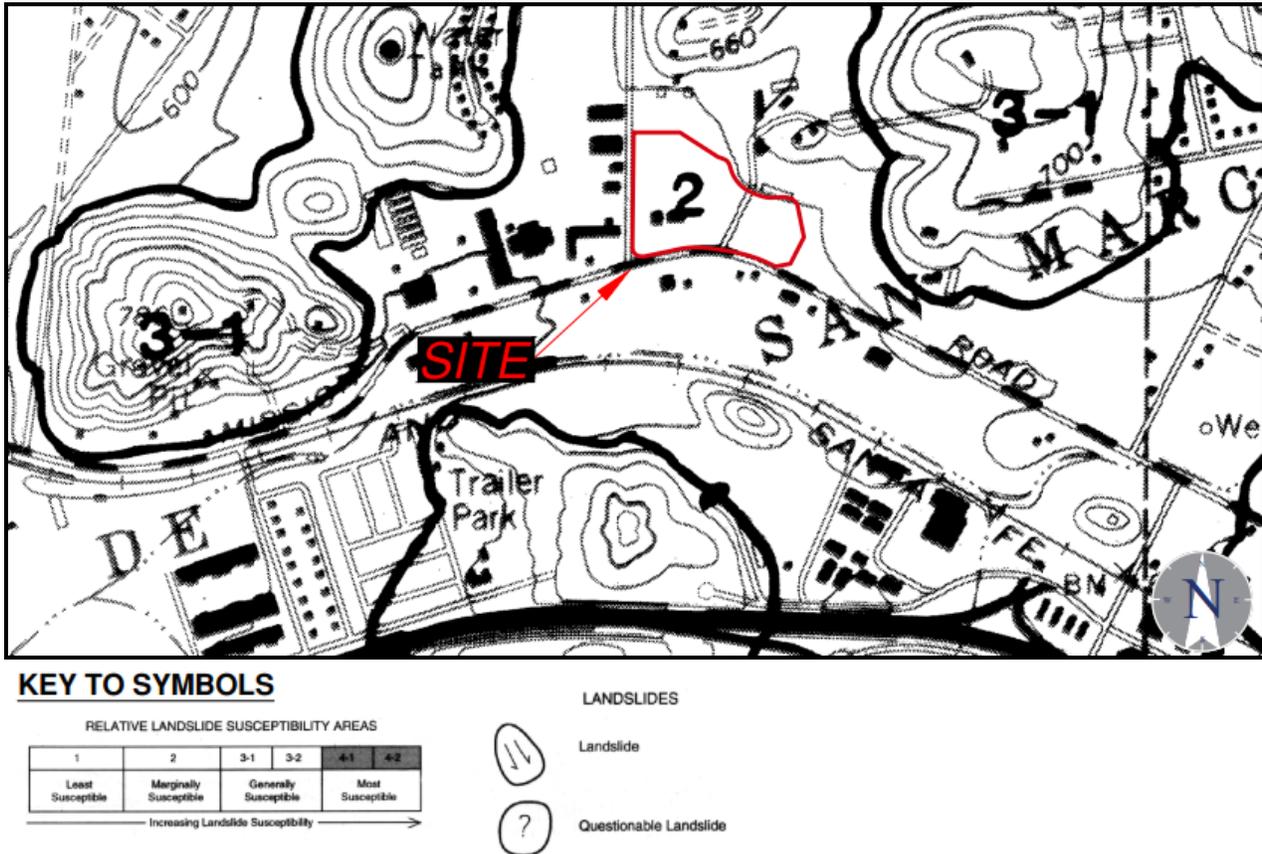
Figure 5-2. Landslide Risk in the Site Area
 (source: adapted from Tan 1995)

Associated with this assessment, NOVA completed review of published information regarding historical landslides and the risk of landsliding in the site vicinity. Figure 5-2 (following page) reproduces the findings of that work, from which it can be seen that (i) the site itself is marginally susceptible to landsliding; and, (ii) there are no mapped historic landslides in the site area.

In consideration of the level ground at and around the site, review of published information regarding NOVA considers the landslide hazard at the site to be ‘negligible’ for the site and the surrounding area.

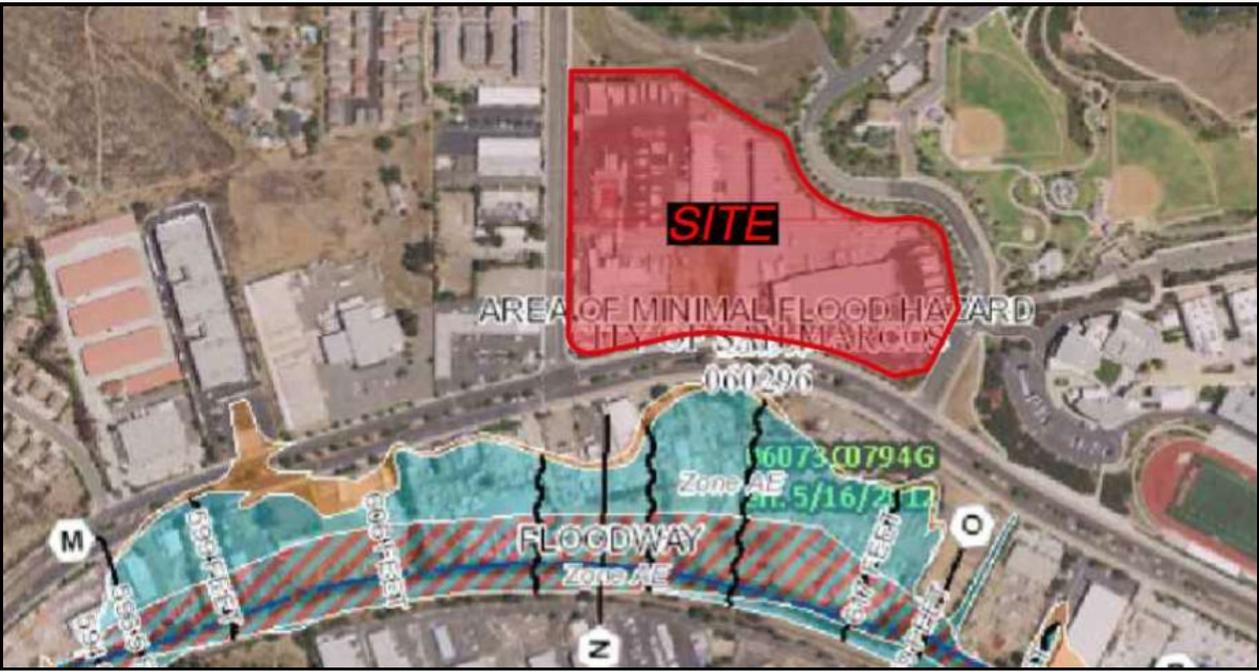
Figure 5-3. Flood Mapping of the Site Area
(source: adapted from FEMA Flood Map 06073C0794G, Revised May 16, 2012)

Figure 5-3 reproduces flood mapping by FEMA of the site area.

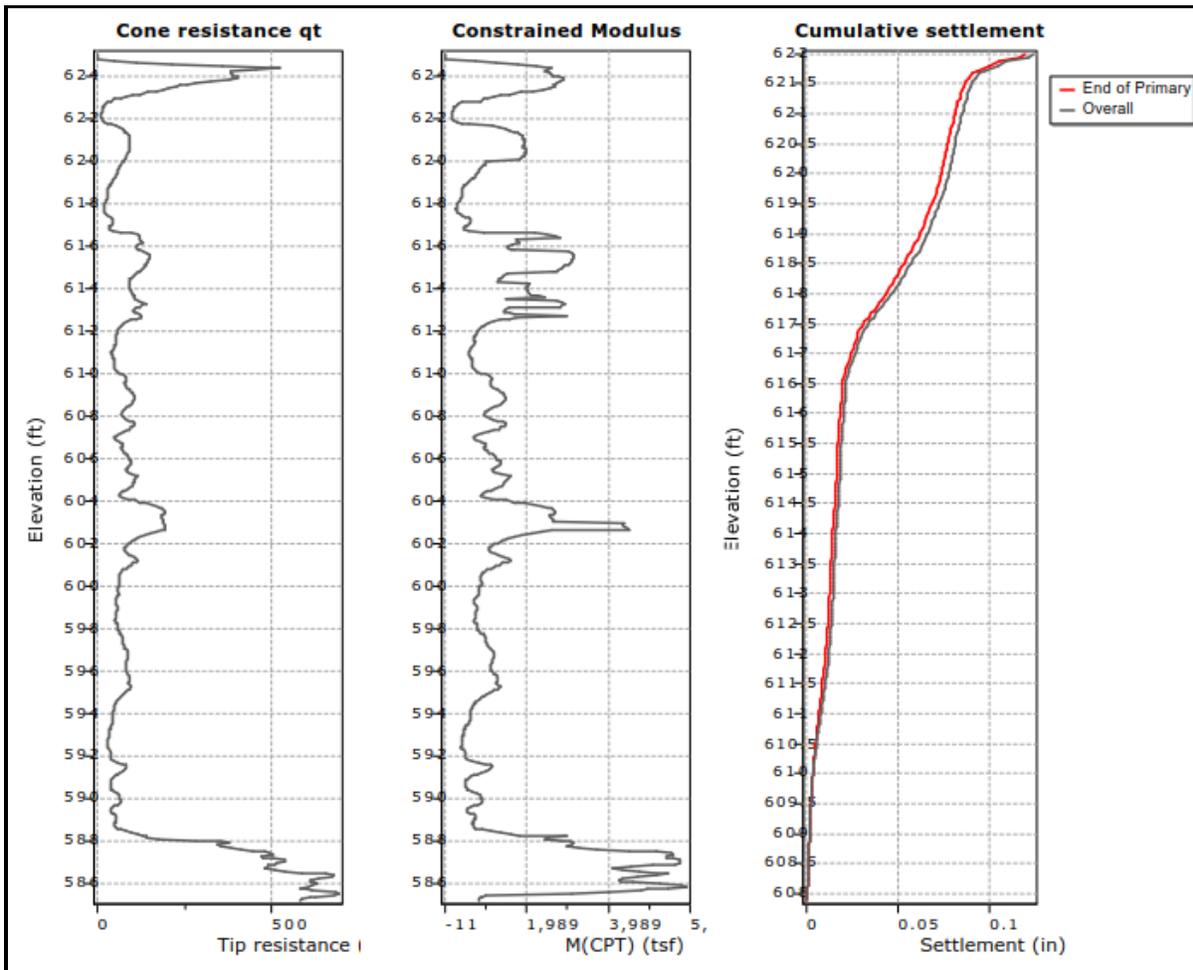
Figure 6-1. Settlement of a 6-Foot Square footing Bearing at 3 ksf

The stiffer subsurface is favorable for development of shallow foundations for support of light to moderate loads. Figure 6-1 (following page) depicts the estimated performance of a 6 foot x 6 foot footing bearing at 3 kips per square foot on the near surface alluvial soils. As may be seen by review of this graphic, settlement of this footing will be low.

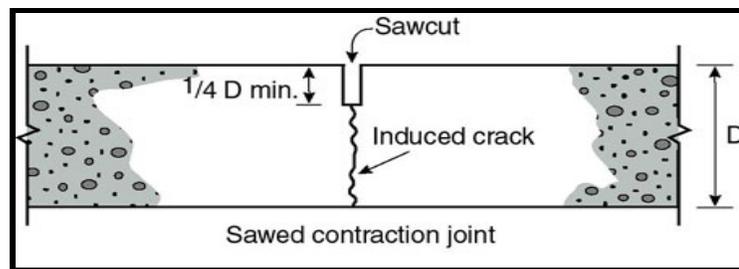
Figure 6-2. Sawed Contraction Joint

To reduce the potential for excessive cracking, concrete slabs-on-grade should be provided with construction or ‘weakened plane’ joints at frequent intervals. Joints should be laid out to form approximately square panels and never exceeding a length to width ratio of 1.5 to 1. Proper joint spacing and depth are essential to effective control of random cracking. Joints are commonly spaced at distances equal to 24 to 30 times the slab thickness. Joint spacing that is greater than 15 feet should include the use of load transfer devices (dowels or diamond plates). Contraction/control joints should be established to a depth of $\frac{1}{4}$ the slab thickness as depicted in Figure 6-2.

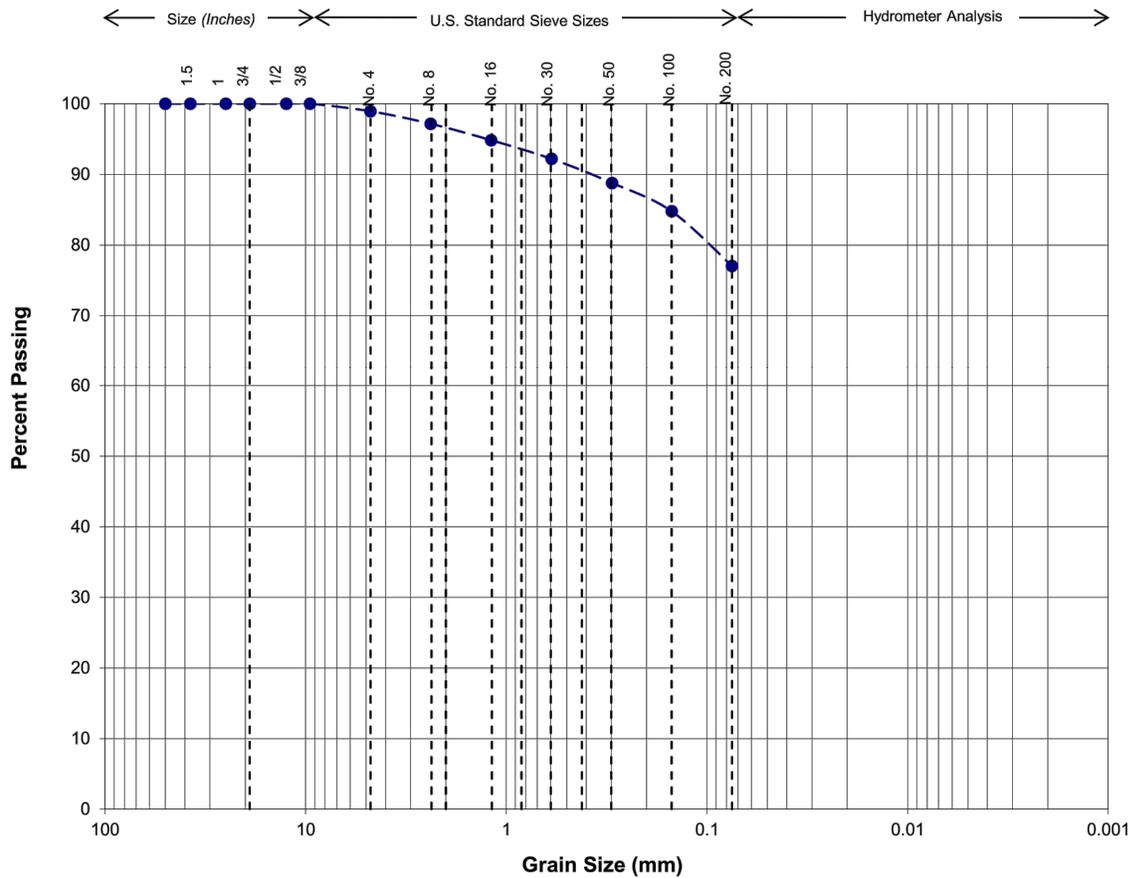
Sample Location: B-1
 Depth (ft): 2.5'
 USCS Soil Type: CL
 Passing No. 200 (%): 77

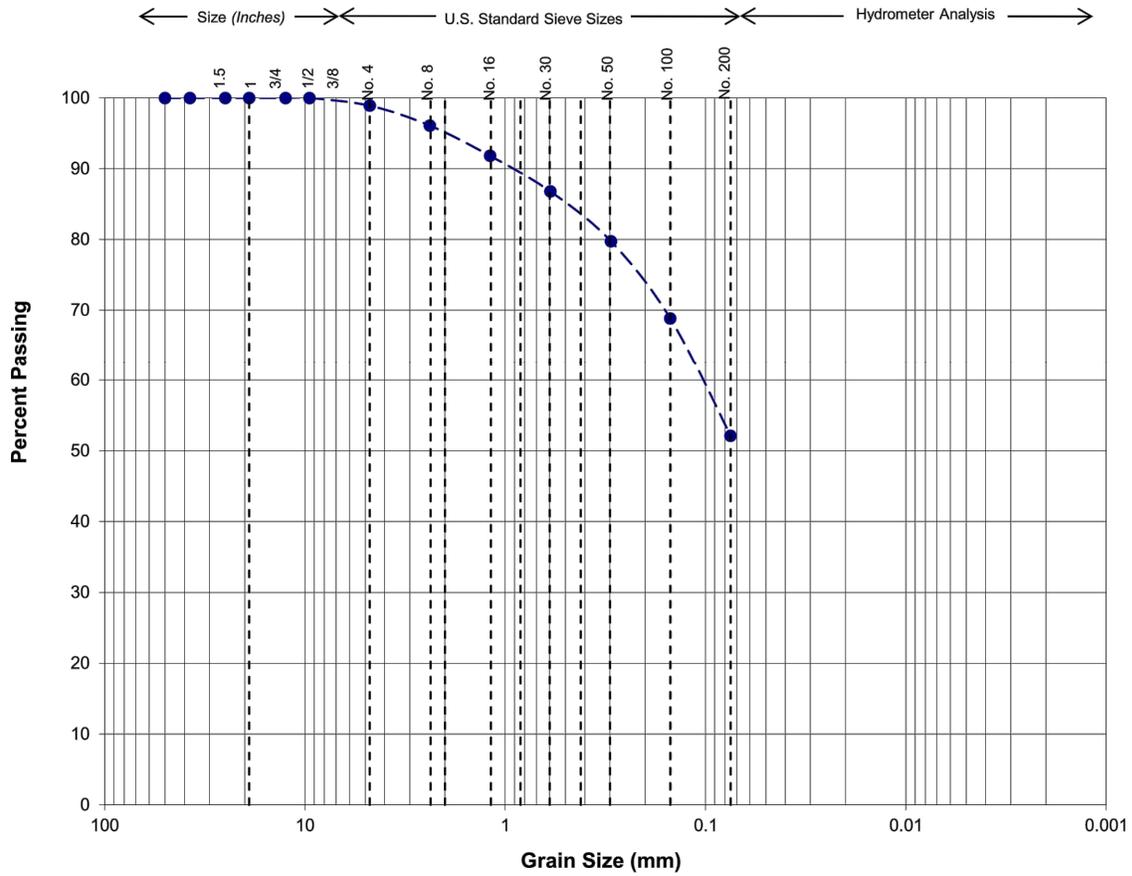
Sample Location: B-1
 Depth (ft): 25.0'
 USCS Soil Type: ML
 Passing No. 200 (%): 52

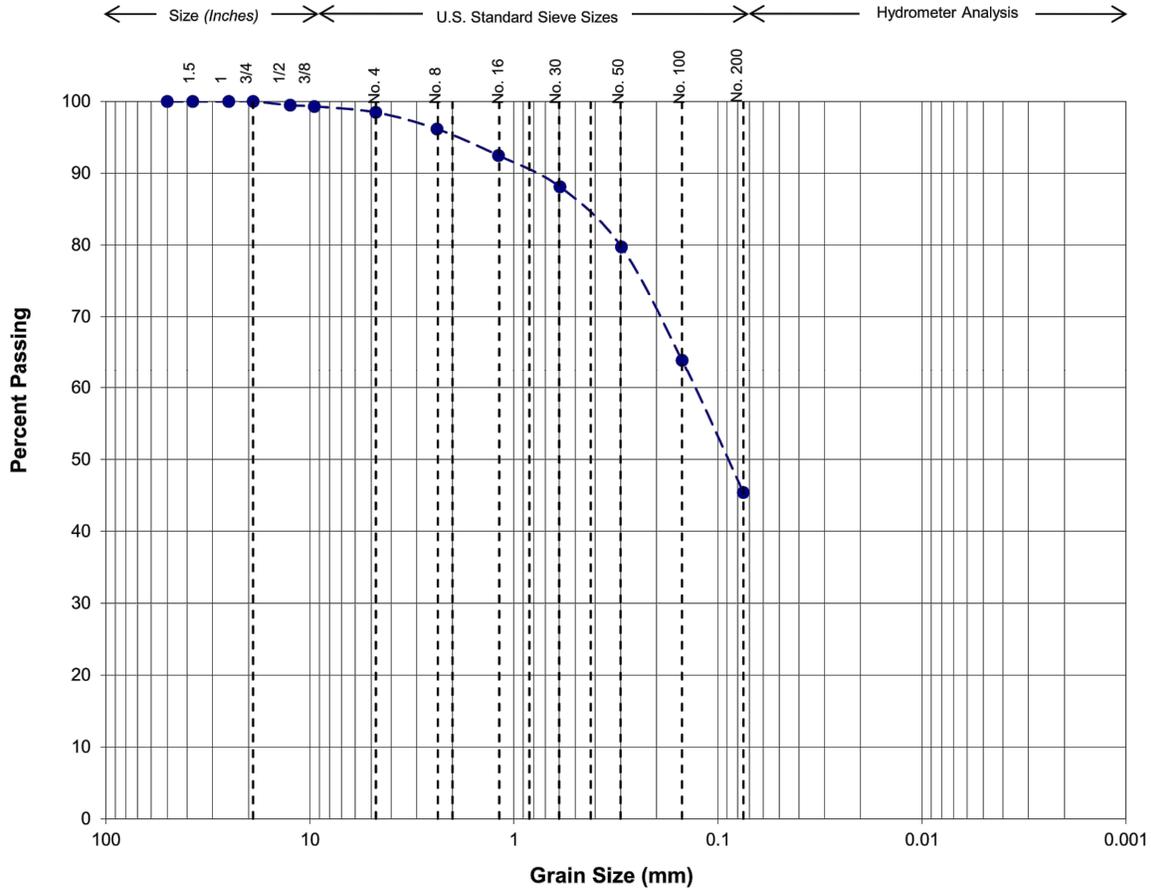
Sample Location: B-1
 Depth (ft): 30.0'
 USCS Soil Type: SM-ML
 Passing No. 200 (%): 45

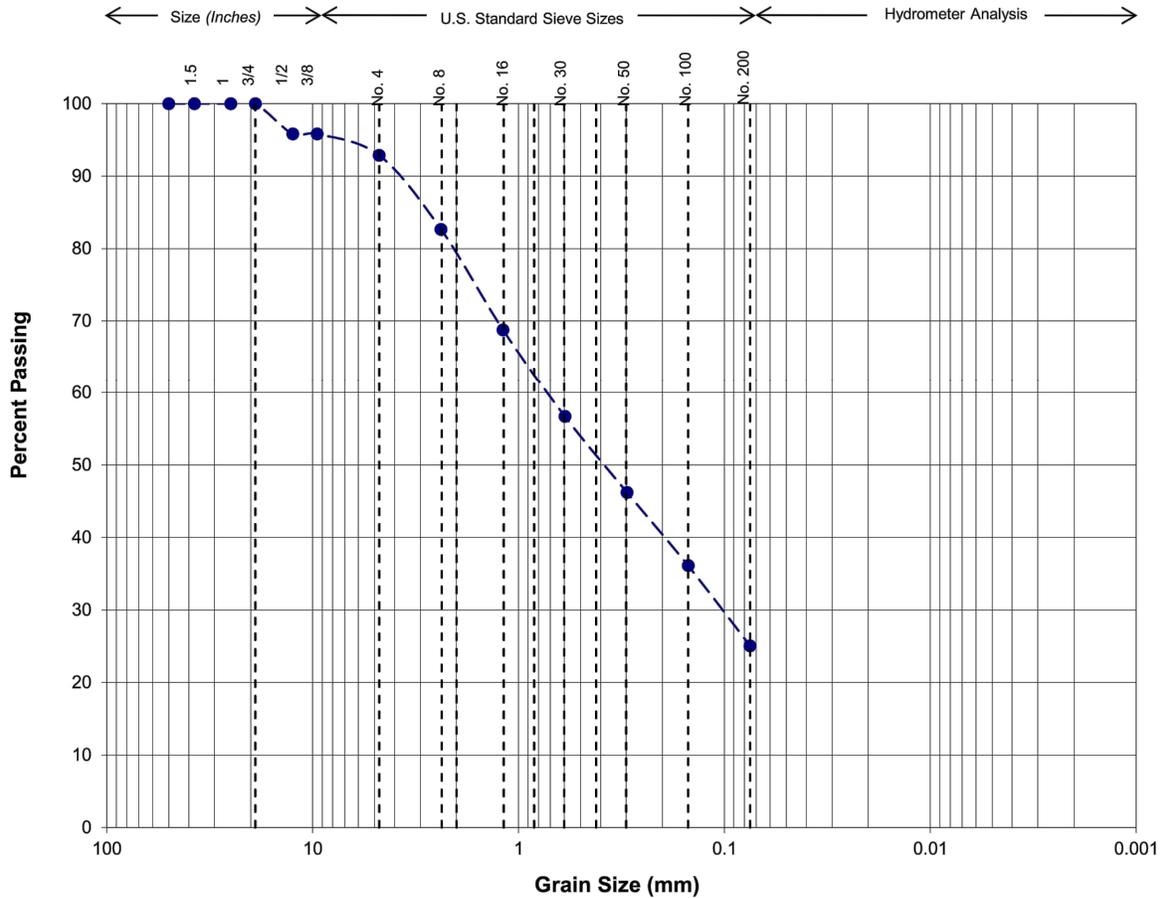
Sample Location: B-1
 Depth (ft): 35.0'
 USCS Soil Type: SM
 Passing No. 200 (%): 25

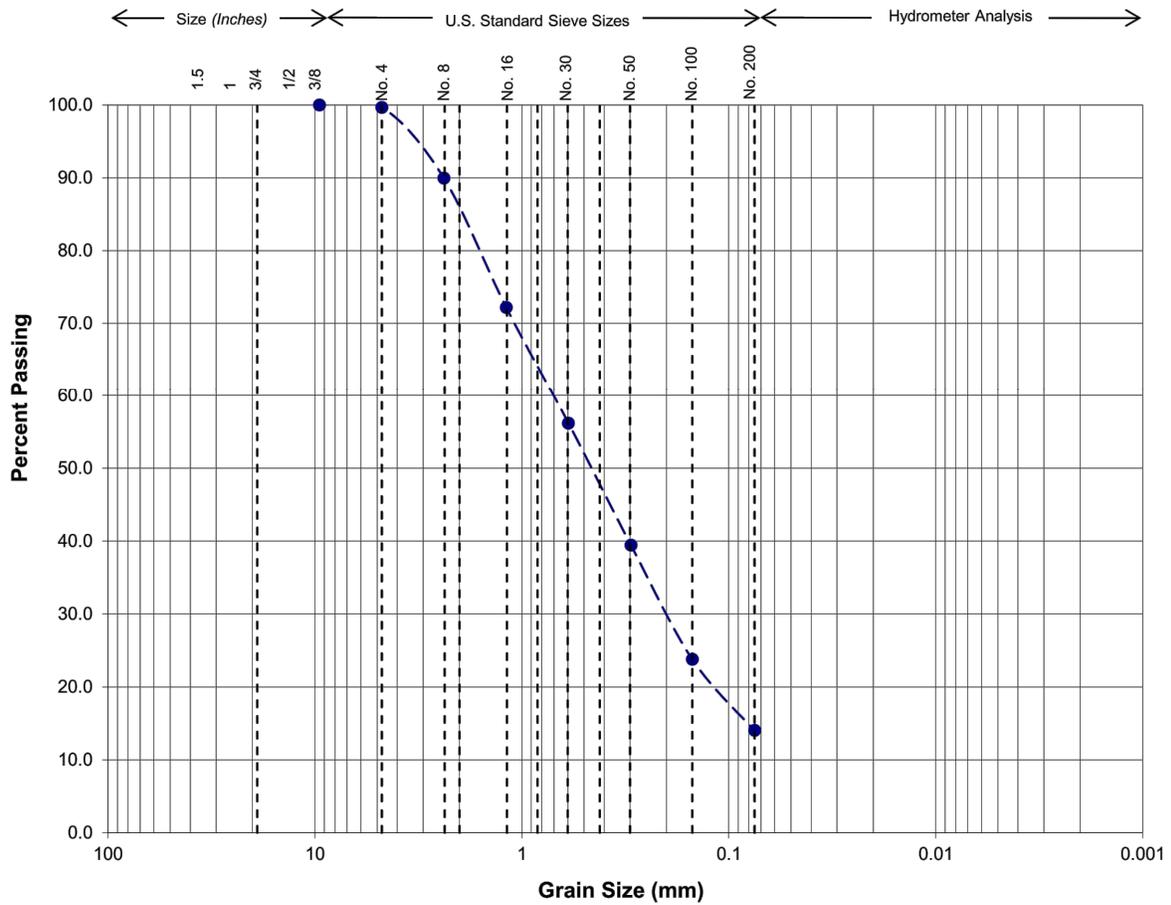
Sample Location: B-1
 Depth (ft): 40.0'
 USCS Soil Type: SM
 Passing No. 200 (%): 14

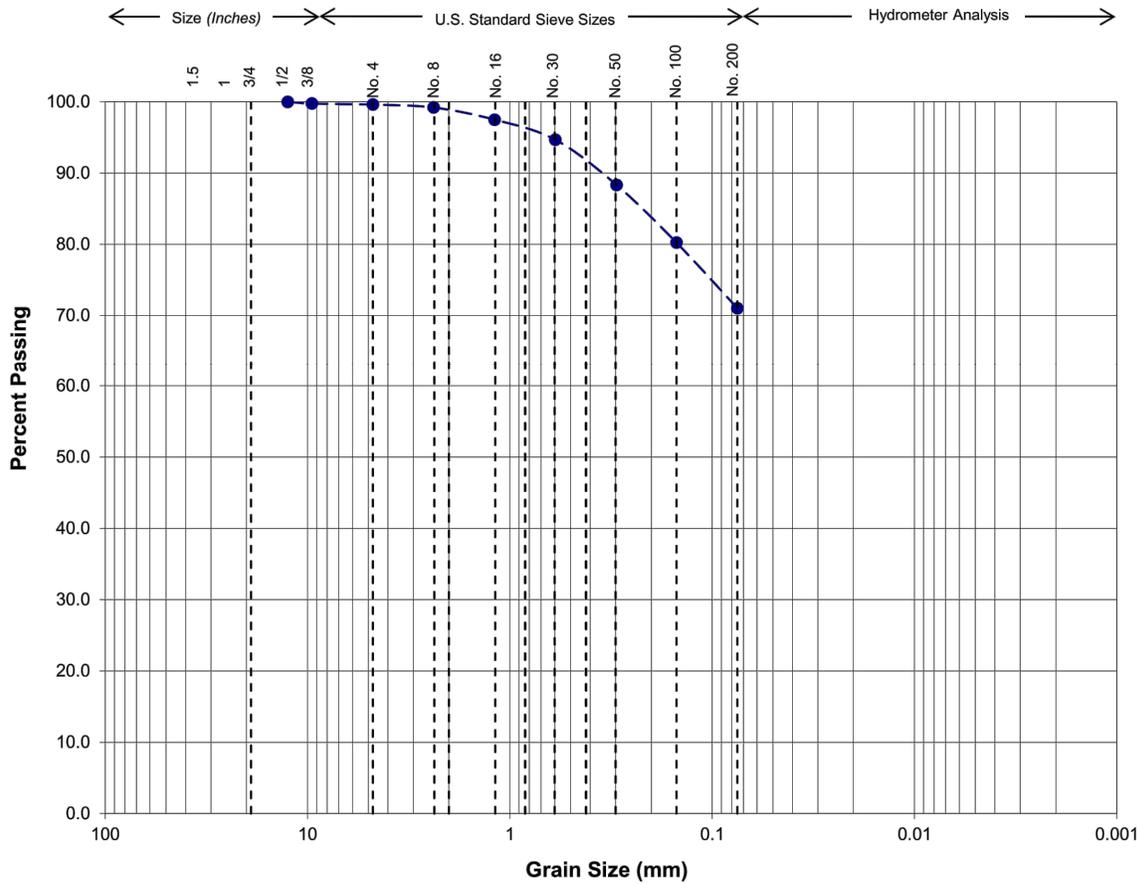
Sample Location: B-2
 Depth (ft): 10.0'
 USCS Soil Type: CL-ML
 Passing No. 200 (%): 71

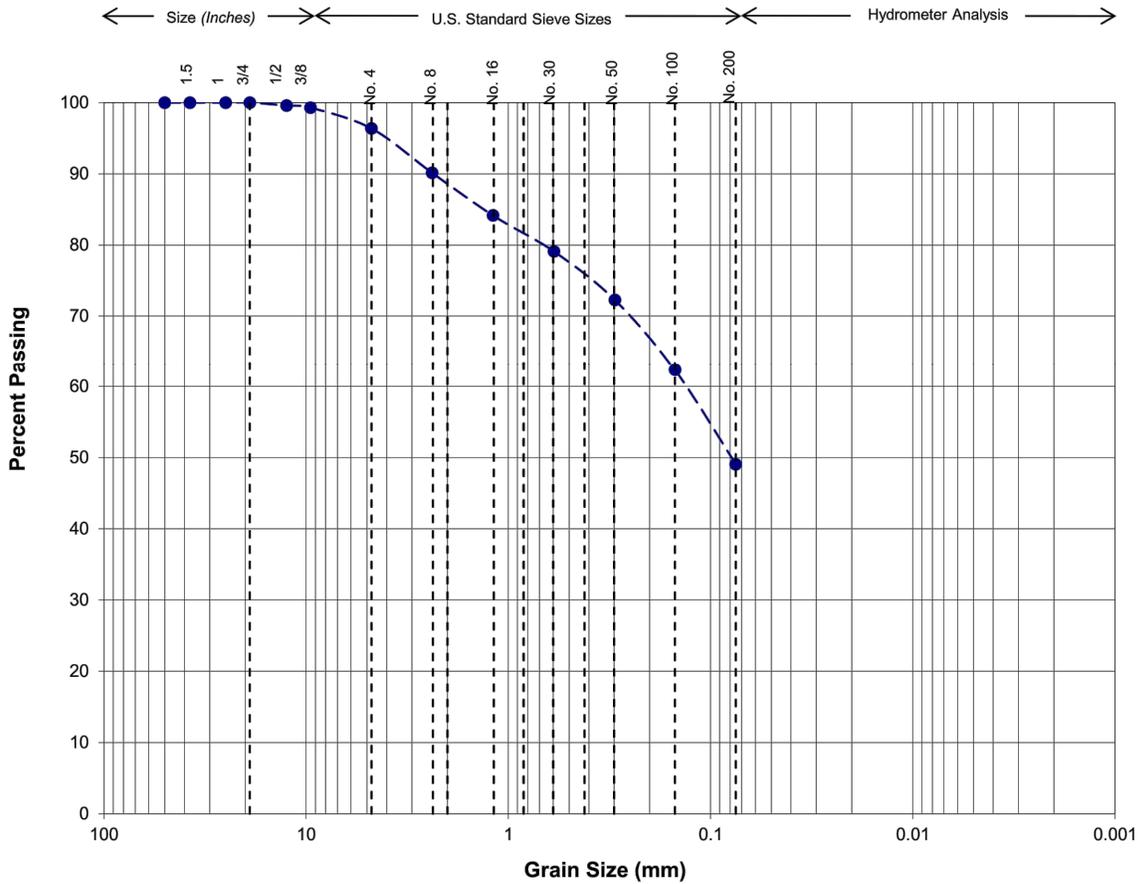
Sample Location: B-2
 Depth (ft): 15.0'
 USCS Soil Type: SM-ML
 Passing No. 200 (%): 49

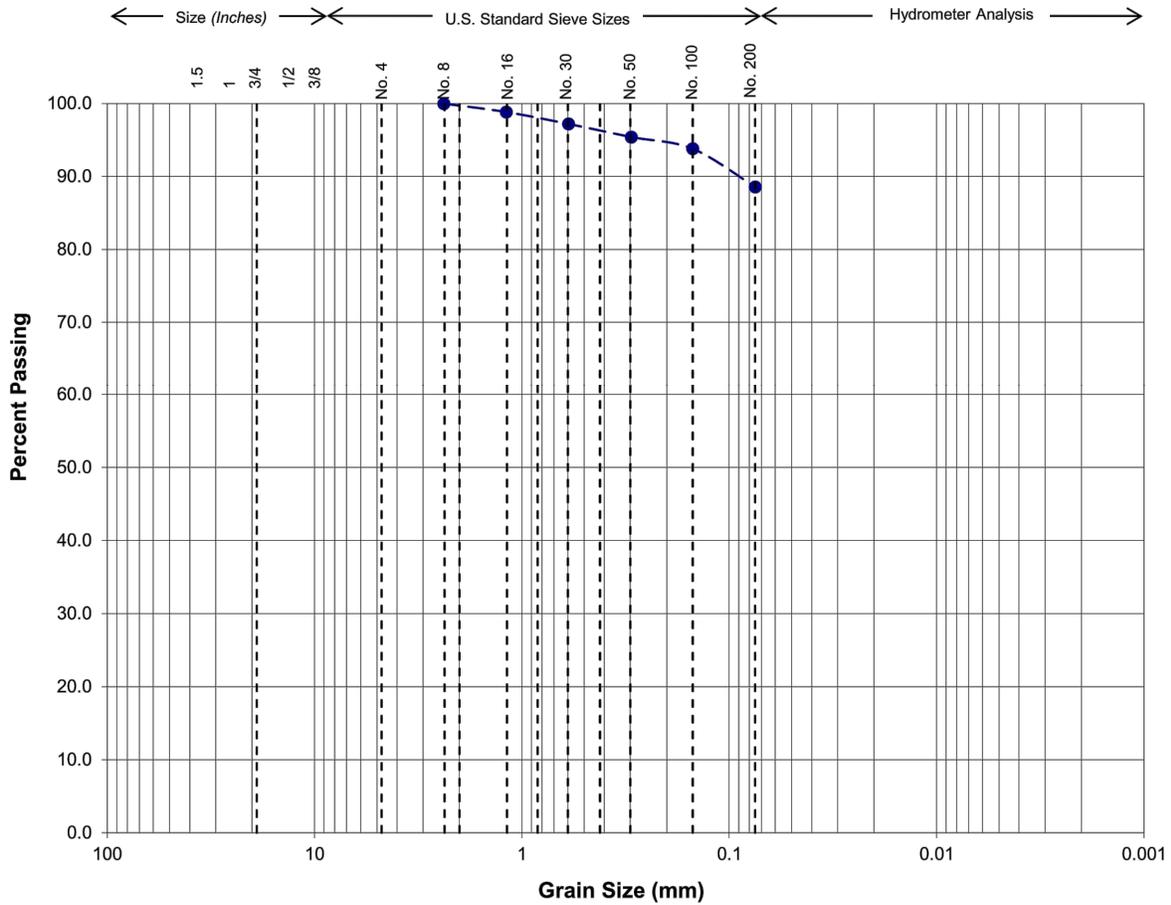
Sample Location: B-2
 Depth (ft): 20.0'
 USCS Soil Type: ML
 Passing No. 200 (%): 89
