**Hollandia Dairy CUP Modification
Technical Appendices**

**Appendix D
Geotechnical Investigation**

REPORT GEOTECHNICAL INVESTIGATION

Hollandia Dairy Fluid Milk Plant Improvements
622 E. Mission Road, San Marcos, California

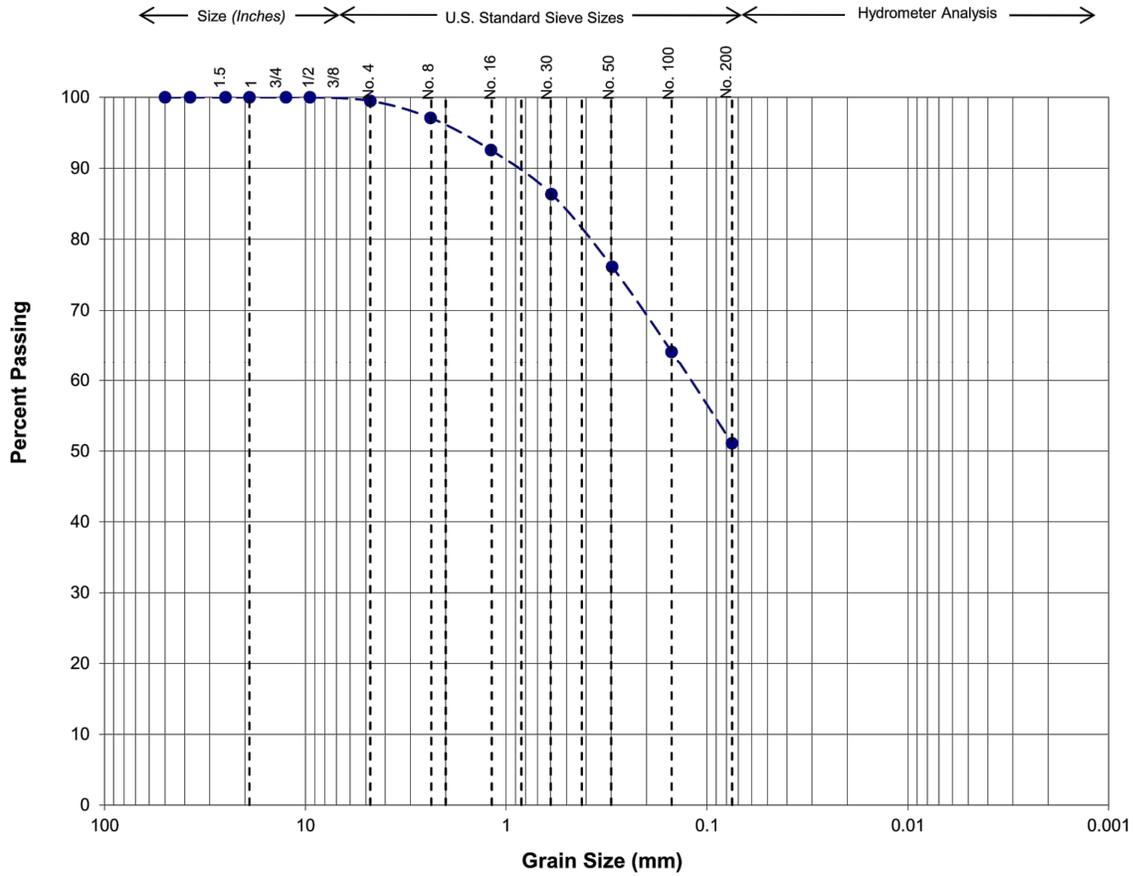
Sample Location: B-2
 Depth (ft): 30.0'
 USCS Soil Type: ML
 Passing No. 200 (%): 51

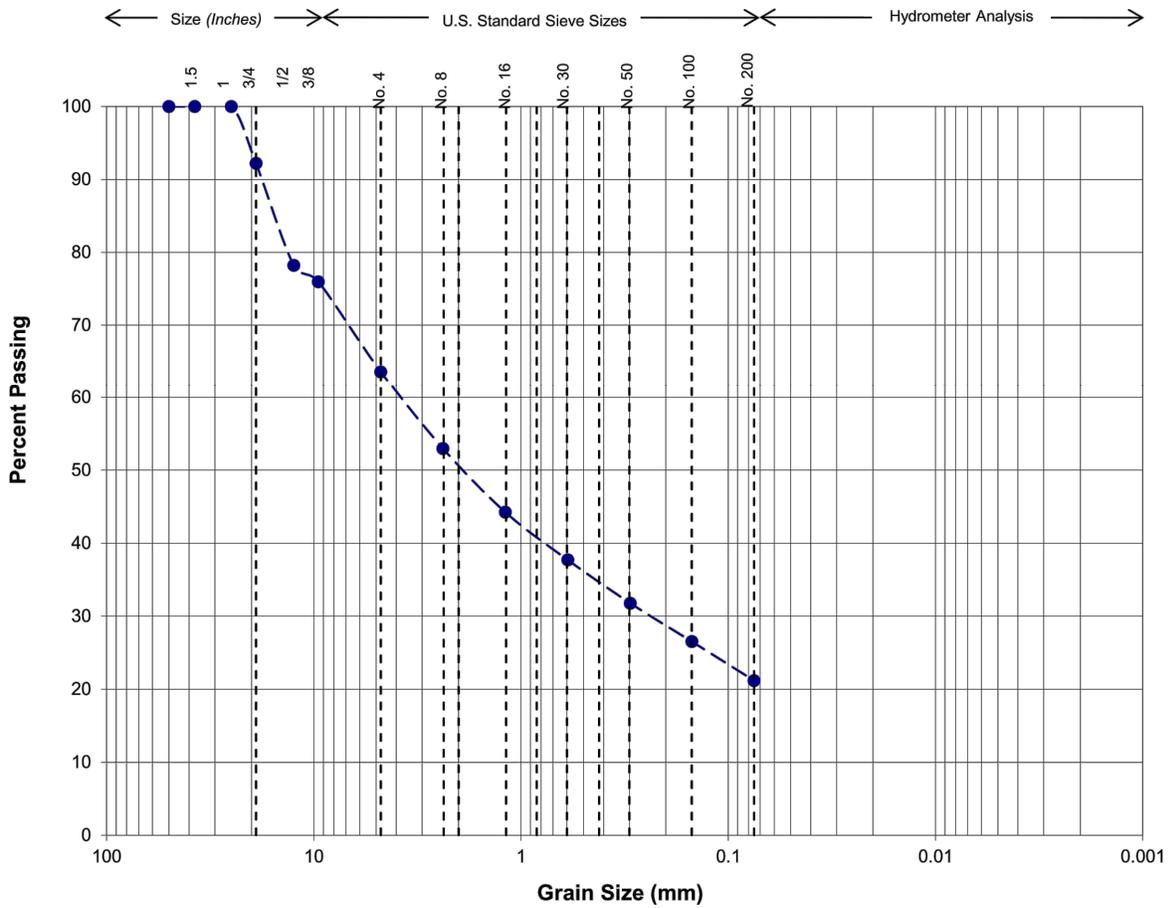
Sample Location: B-2
 Depth (ft): 38.0'
 USCS Soil Type: SM
 Passing No. 200 (%): 21

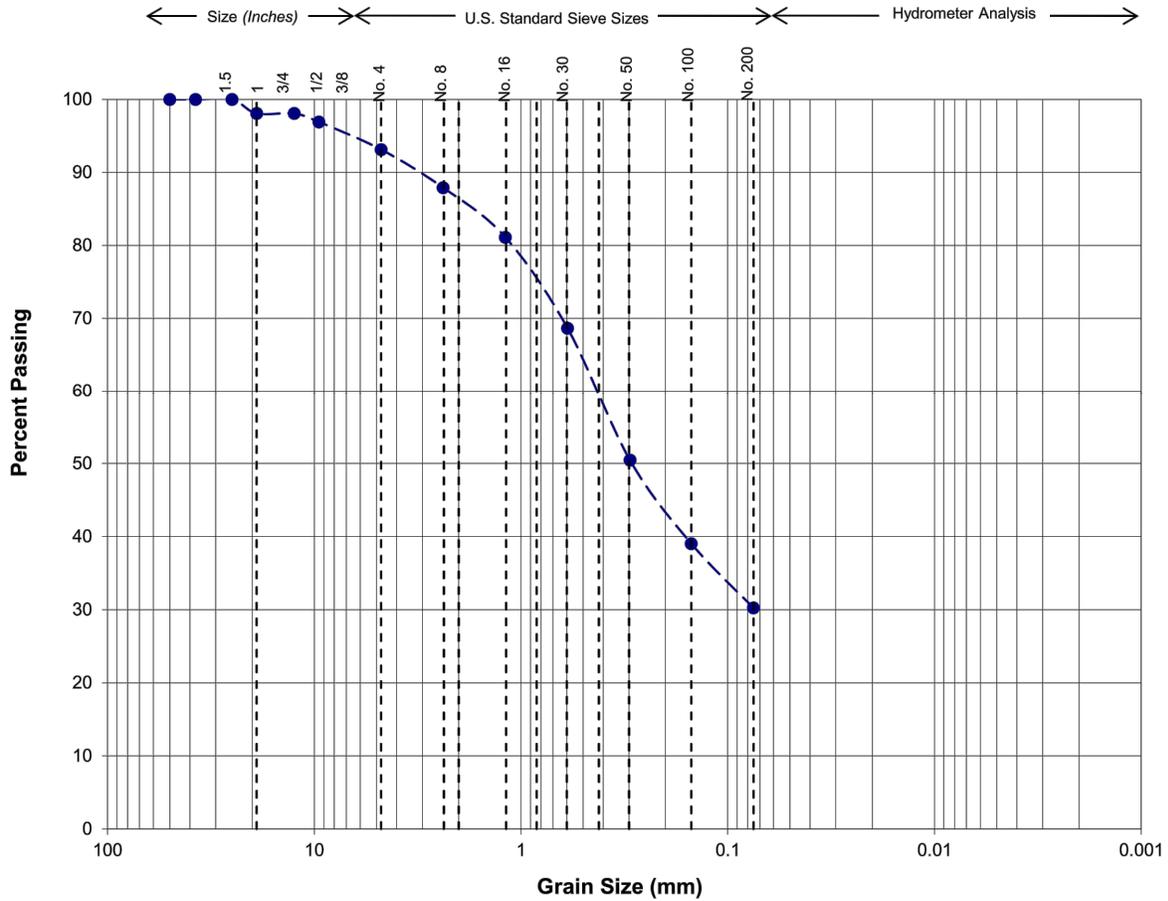
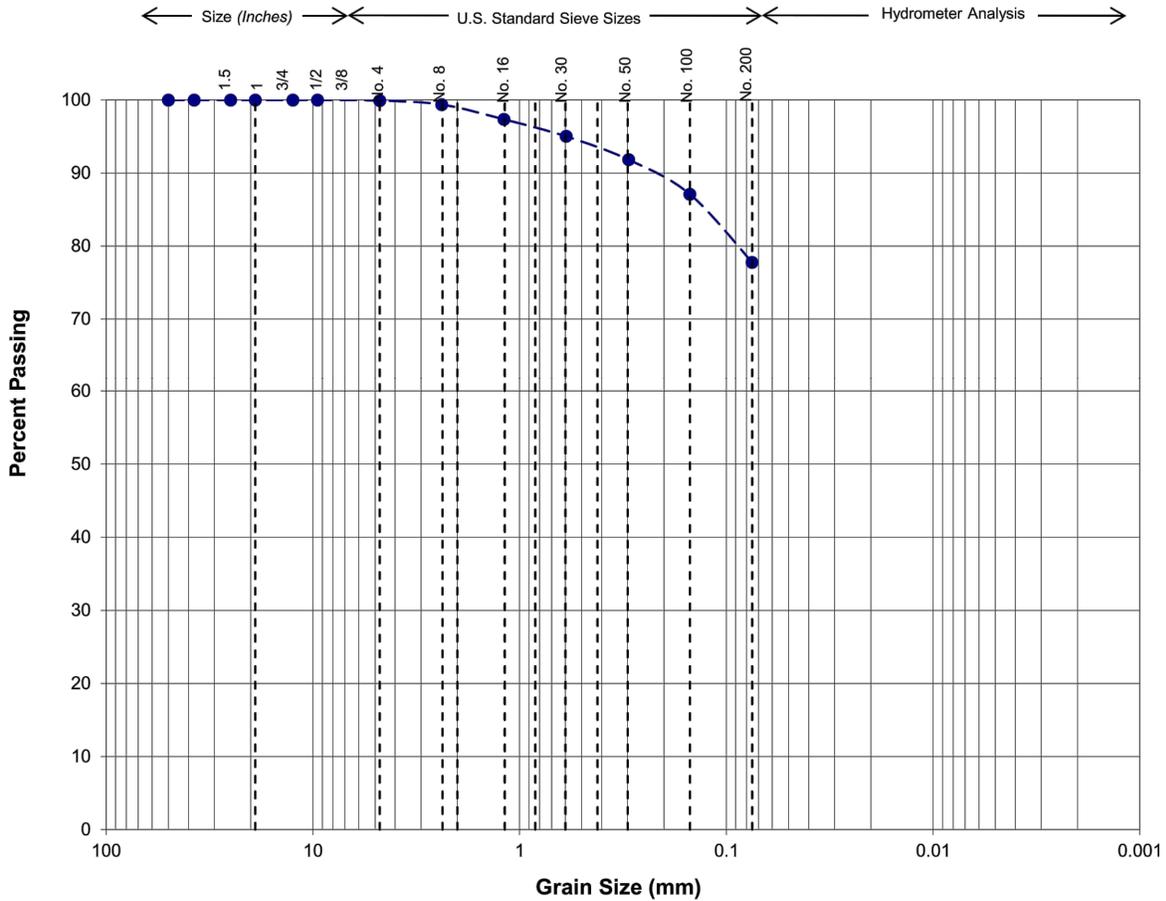
APPENDIX: D.14

Gravel		Sand			Silt or Clay
Coarse	Fine	Coarse	Medium	Fine

Sample Location: B-3
 Depth (ft): 7.5'
 USCS Soil Type: CL
 Passing No. 200 (%): 78

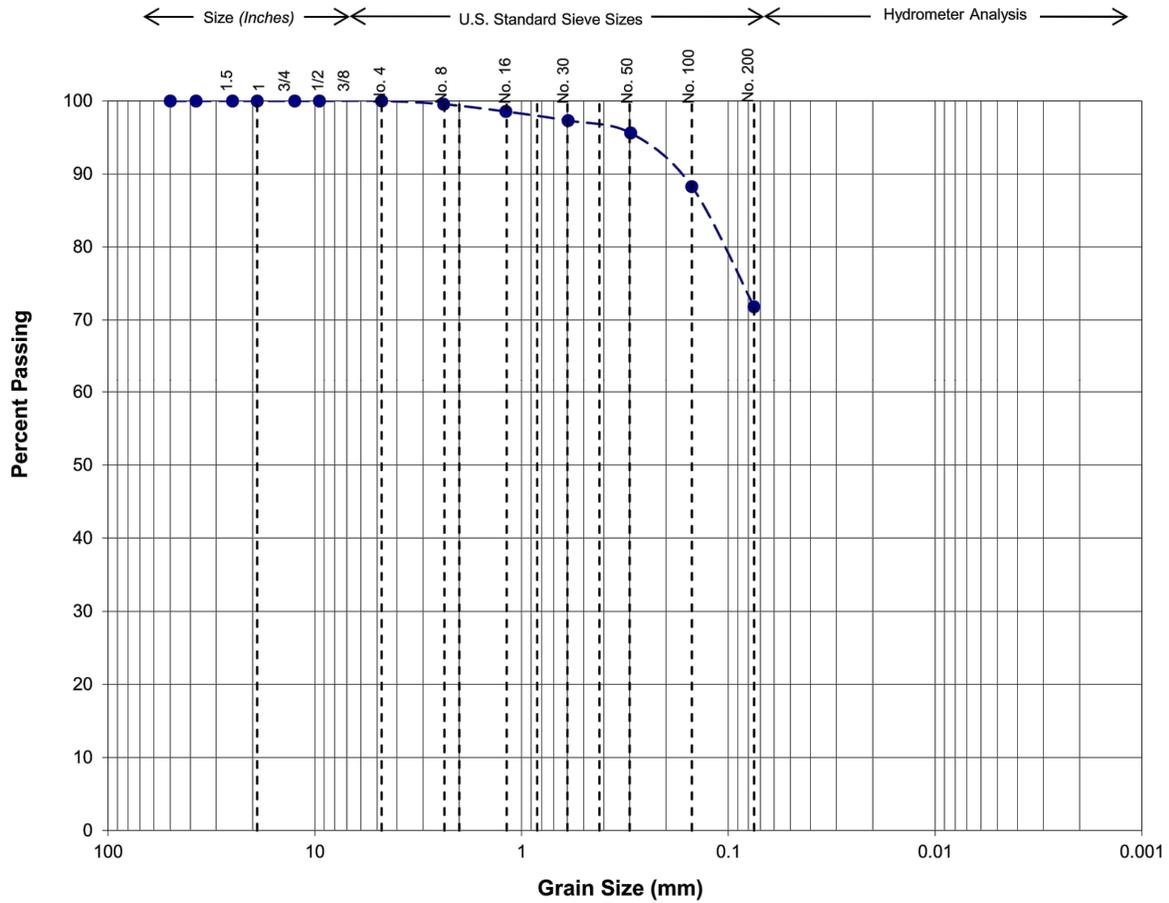
APPENDIX: D.16

Gravel		Sand			Silt or Clay
Coarse	Fine	Coarse	Medium	Fine

Sample Location: B-3
 Depth (ft): 15.0'
 USCS Soil Type: CL
 Passing No. 200 (%): 72

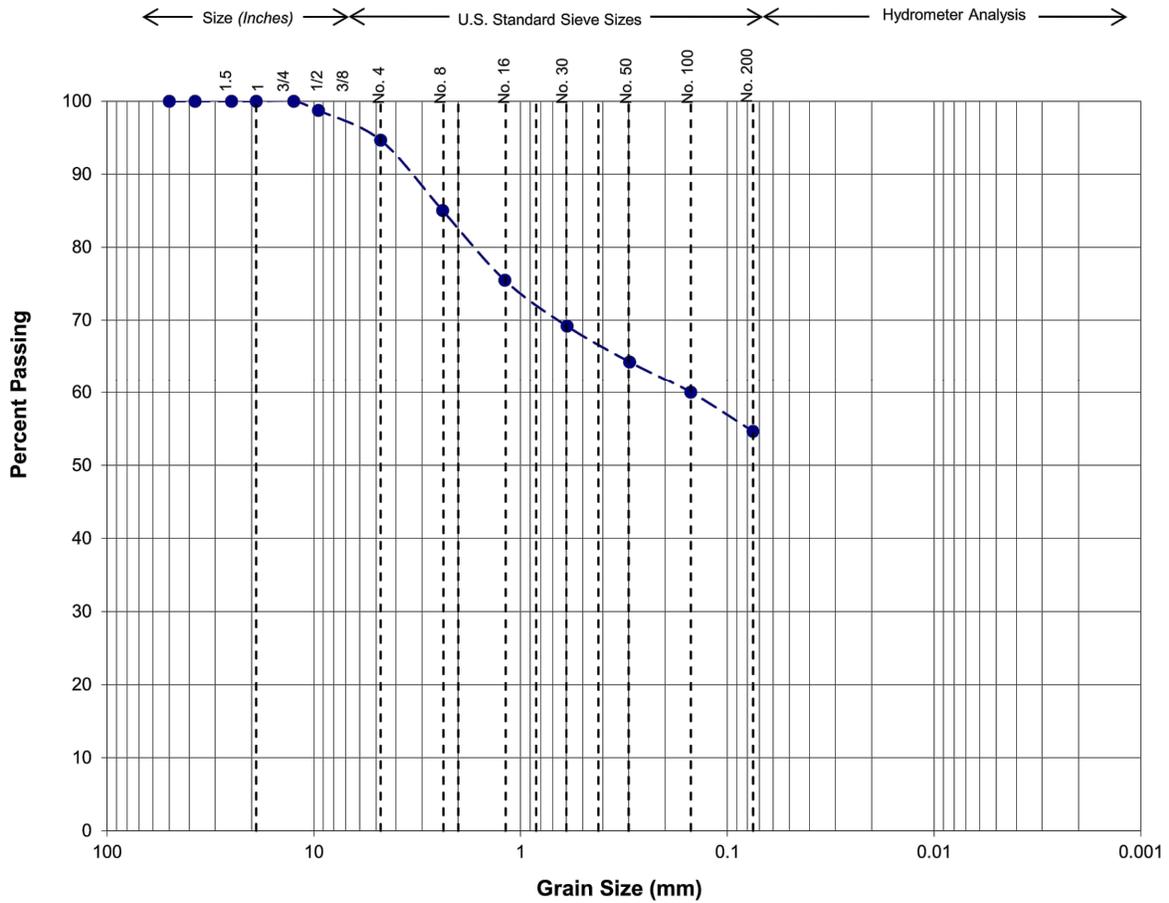
BY: DTW	DATE: APRIL 2019	PROJECT: 2019039	APPENDIX: D.17
---------	------------------	------------------	----------------

Gravel		Sand			Silt or Clay
Coarse	Fine	Coarse	Medium	Fine

Sample Location: B-4
 Depth (ft): 1.0'
 USCS Soil Type: CL
 Passing No. 200 (%): 55

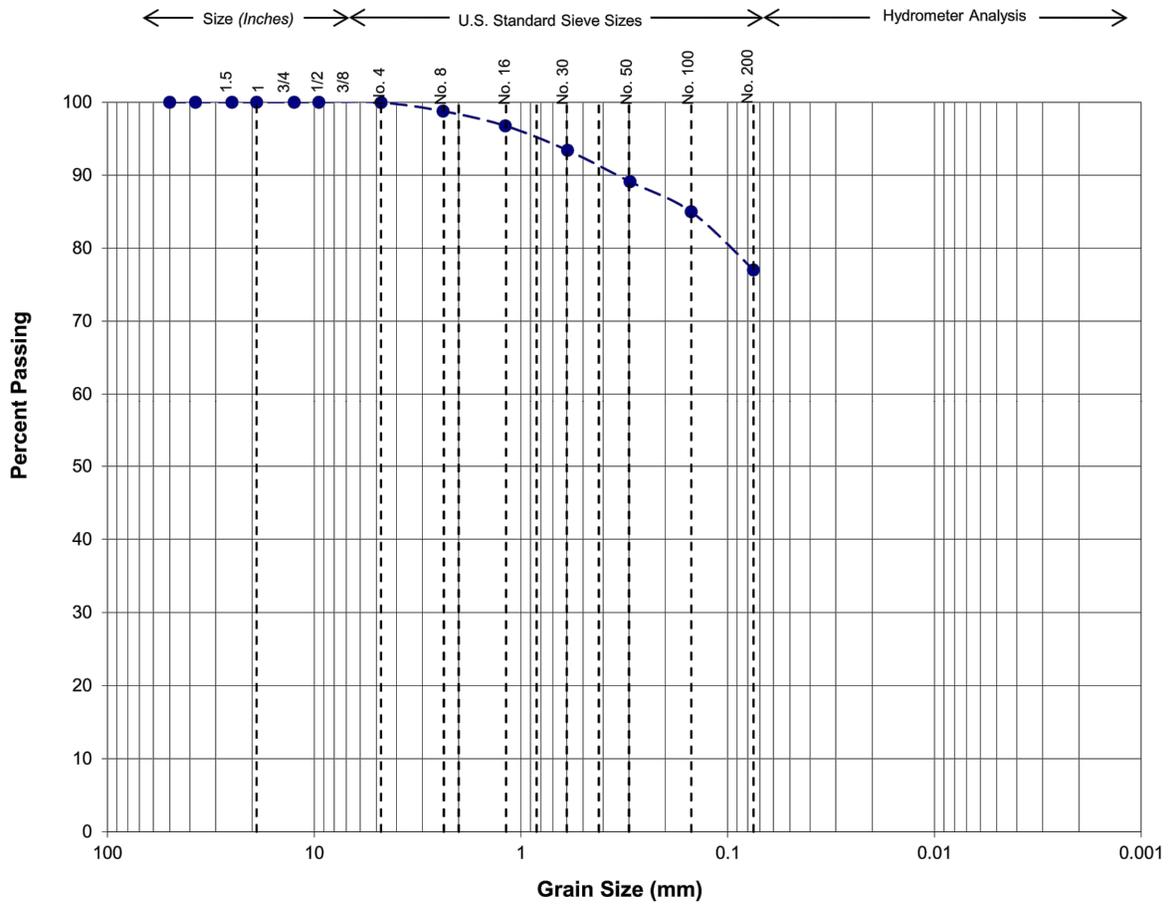
BY: DTW	DATE: APRIL 2019	PROJECT: 2019039	APPENDIX: D.18
---------	------------------	------------------	----------------

Gravel		Sand			Silt or Clay
Coarse	Fine	Coarse	Medium	Fine

Sample Location: B-4
 Depth (ft): 5.0'
 USCS Soil Type: ML-CL
 Passing No. 200 (%): 77
