TECHNICAL MEMORANDUM

Geotechnical Exploration
Planned New Wine Cave
13330 Old Oak Way, Saratoga, California
APN: 503-15-077

**DRAFT REPORT
GEOTECHNICAL ENGINEERING INVESTIGATION
PROPOSED ALTERNATE EVA
HOUSE FAMILY VINEYARDS
OLD OAK WAY
SARATOGA, CALIFORNIA**

ADDENDUM TO GEOTECHNICAL ENGINEERING
INVESTIGATION
PROPOSED ROADWAY IMPROVEMENTS
HOUSE FAMILY VINEYARDS
OLD OAK ROAD
SARATOGA, CALIFORNIA

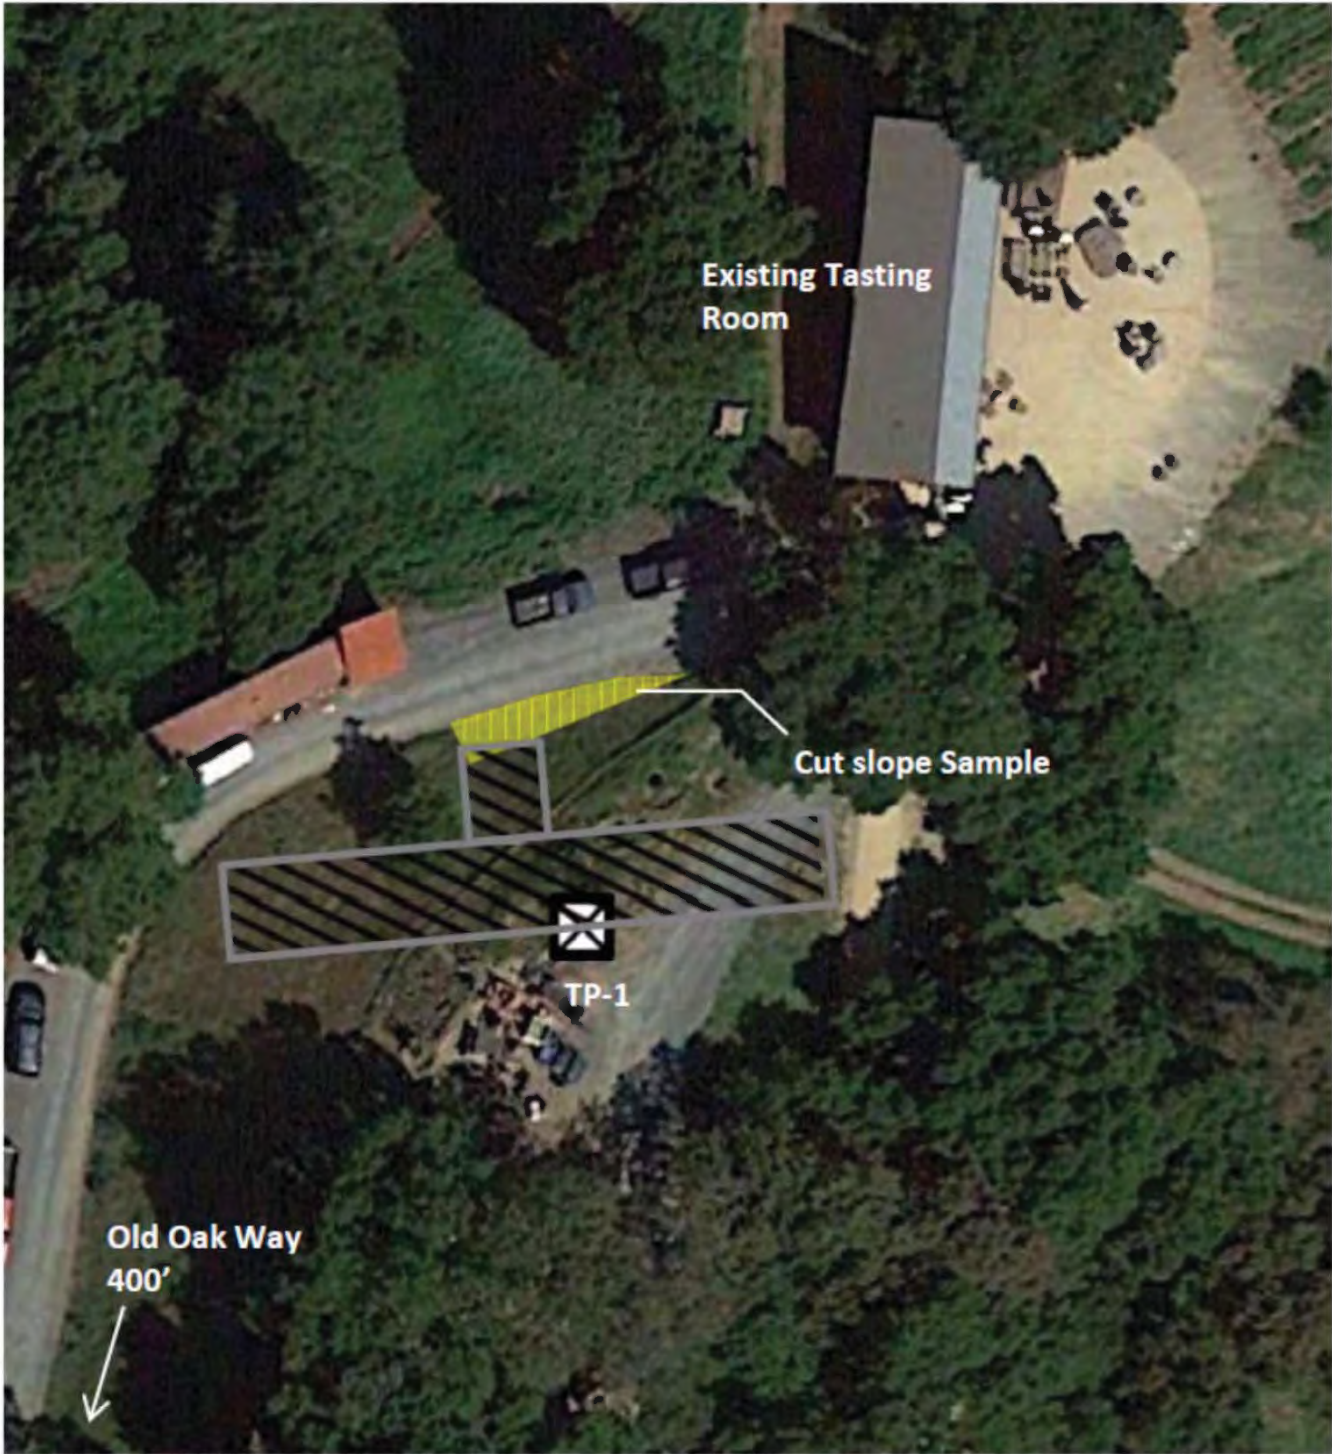
PROJECT	Planned New Wine Cave	BY	BAV	FIGURE	2
CLIENT	House Family Vineyards	DATE	10/13/16		
LOCATION	13330 Old Oak Way, Saratoga, California	CHECK	JER	JOB NO.	8099.00
	Site Map	SCALE	AS SHOWN

Approximate Test Pit Location

Existing Cut
