### Supplemental Geotechnical Investigation Services - Lassen Facility

November 16, 2023

**GOLDEN STATE NATURAL RESOURCES LASSEN COUNTY PERCOLATION TEST**

551000 Roosevelt Avenue  
Nubieber, Lassen County, California  
UES No. 4630.2200118.0000

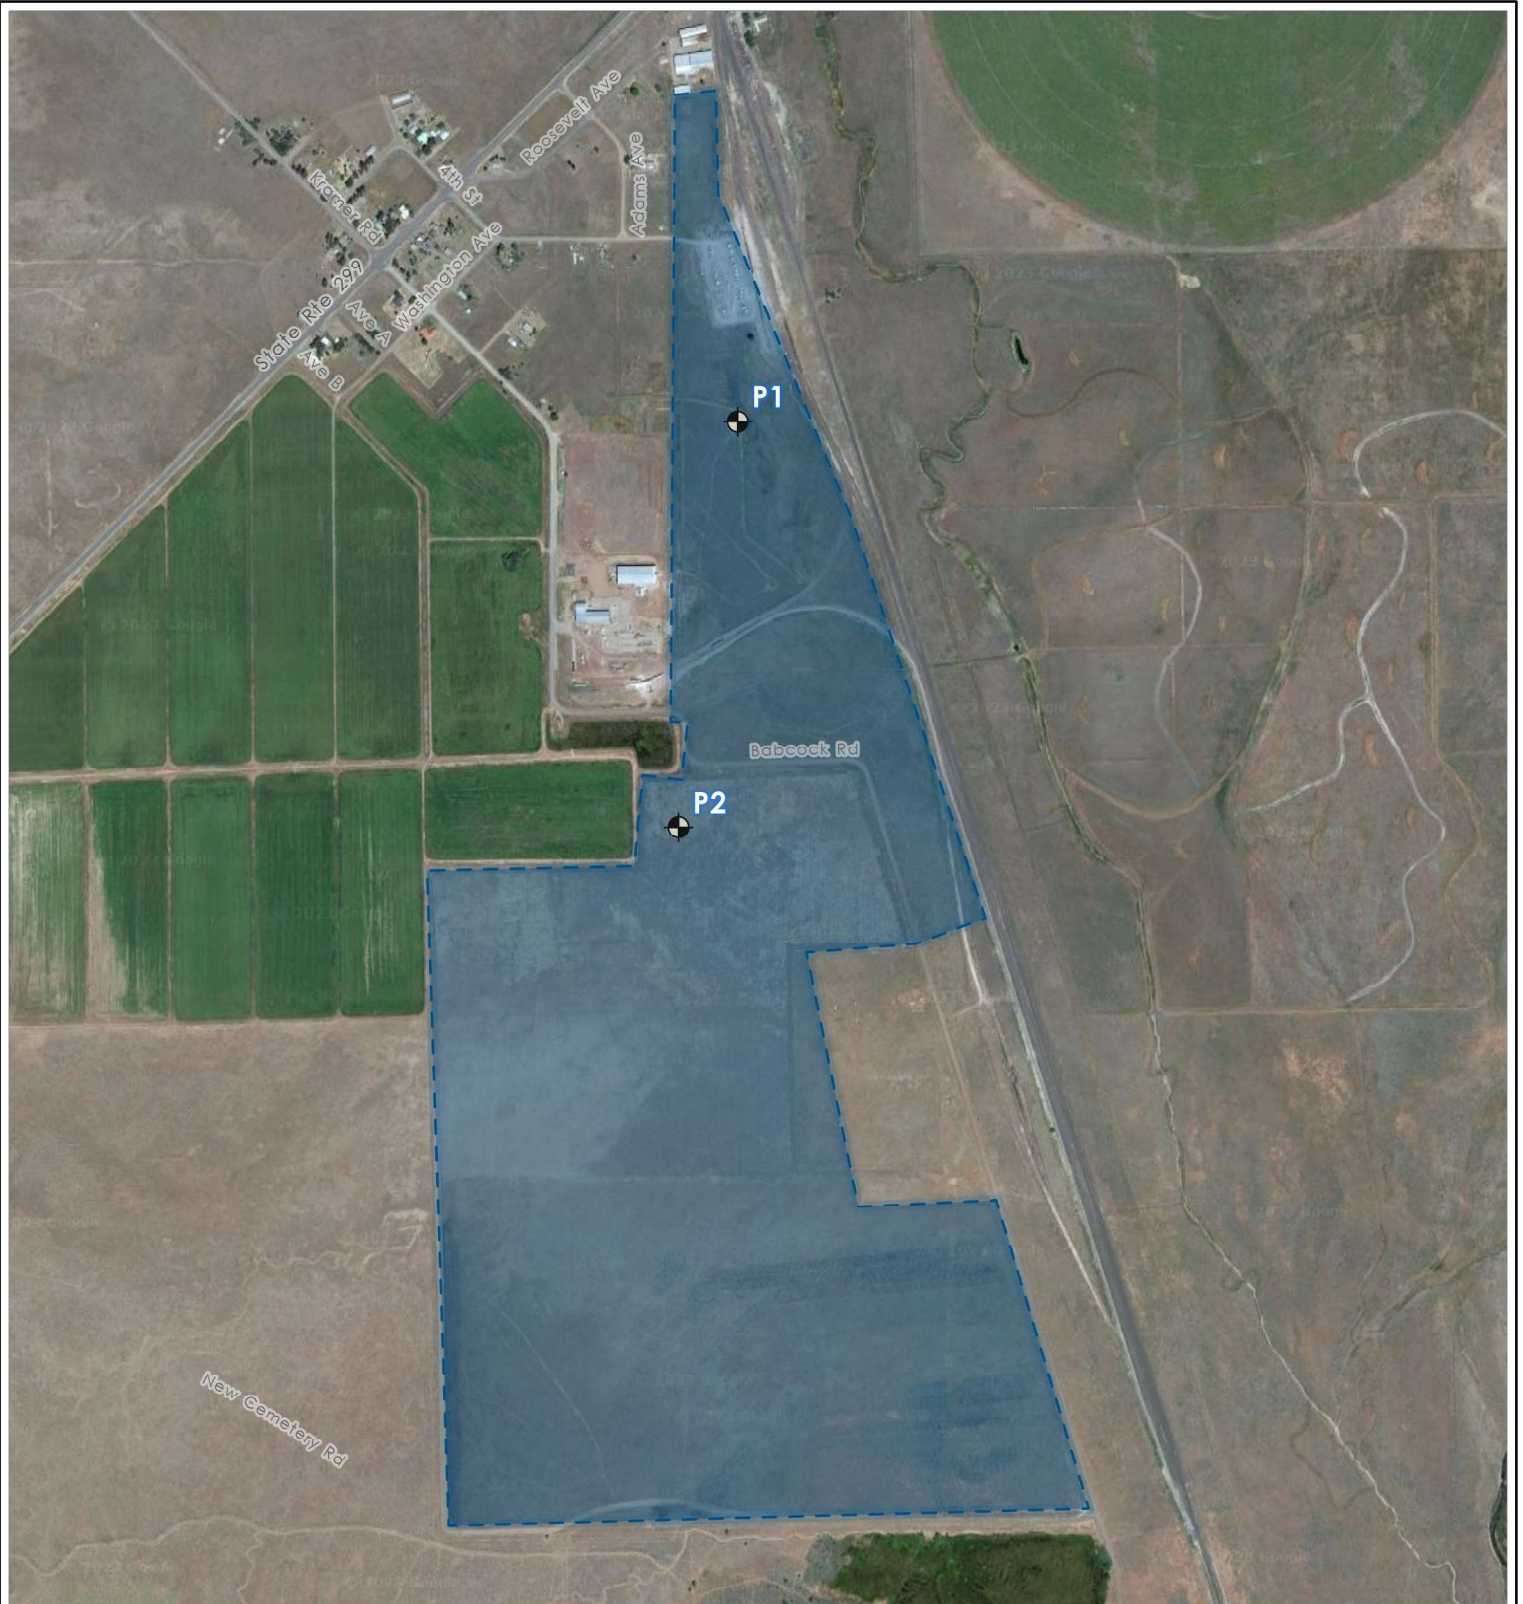
This report contains a Vicinity Map as Figure 1, a Site Plan showing percolation test locations, as Figure 2.

On November 13, 2023 two percolation tests (P1 and P2) were drilling at the approximate locations shown in Figure 2. The percolation tests were hand-augered to depths of about 3 feet below existing site grades. The percolation test locations were selected by Rural County Representatives of California. At the completion of drilling, the boreholes were set up for percolation testing using two-inch-diameter, machine-slotted perforated plastic pipes, with the top of pipe located near the existing ground surface. The surrounding annular space around the casings was filled with pea gravel. The percolation test holes were pre-soaked by filling the holes with clean potable water and allowing the test holes to soak overnight. At the completion of the percolation testing the borings were backfilled with soil cuttings.

On November 1, 2023, two percolation tests (P1 and P2) were performed at the approximate locations indicated in Figure 2. The percolation test pipe extended to a depth of about 3 feet below the existing ground surface.

As requested, we have prepared this proposal to provide percolation testing of the near-surface soils at the site. We understand that supplemental soil investigation is desired at two locations across the site to assess septic/leach field potential. The project team had requested an evaluation of the percolation characteristics of the soils at the proposed infiltration system locations (see Figure 2).
