Appendix I

Geotechnical Investigation and Preliminary Lab Soils

REPORT OF
PRELIMINARY GEOTECHNICAL INVESTIGATION
PROPOSED INTEX CORPORATION BUILDING DEVELOPMENT
SITE BOUNDED BY CARSON STREET, VIA ORO
VIA PLATA, AND VIA ALCADE AVENUES
LONG BEACH, CALIFORNIA
FOR THE
UNITEX MANAGEMENT CORPORATION
(OUR JOB NO. AEF-88292)

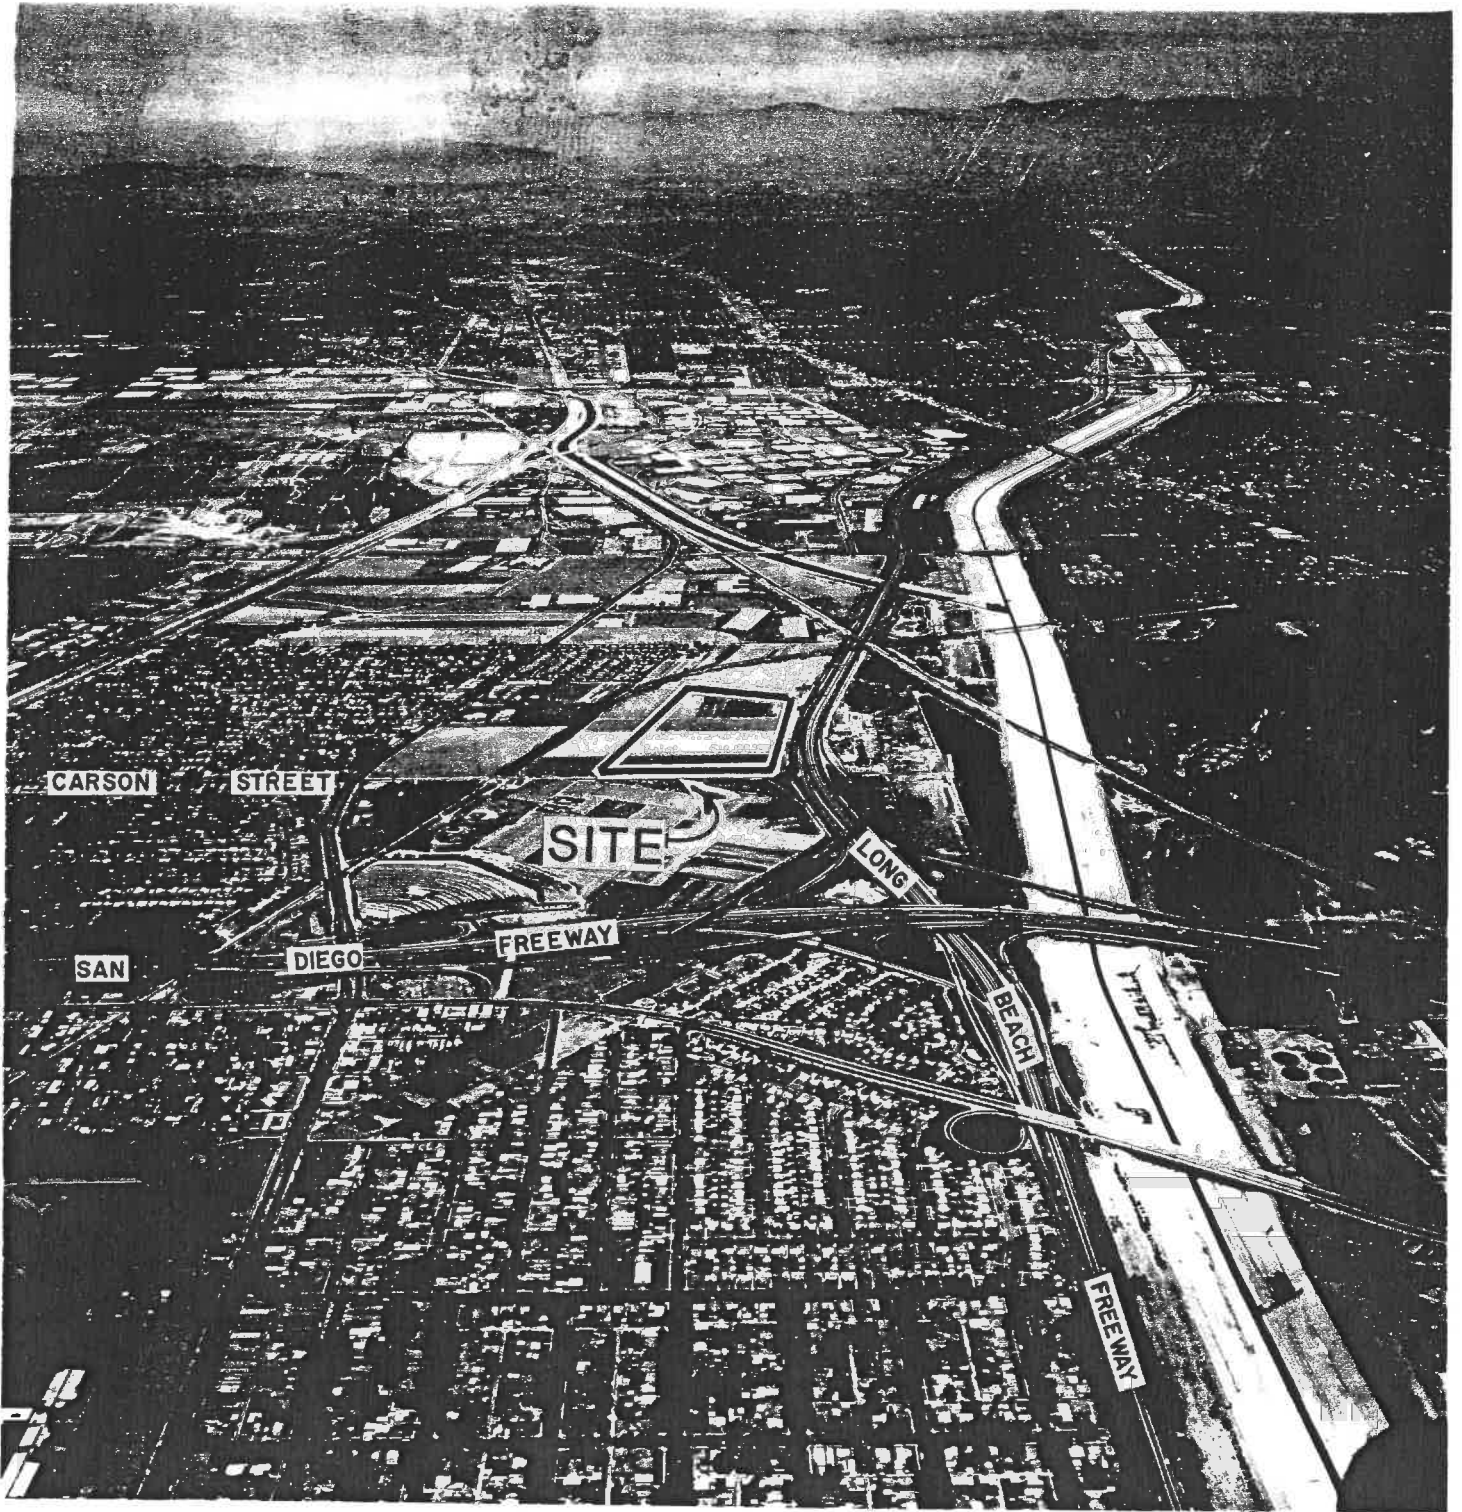
SPENCE COLLECTION AERIAL PHOTOGRAPH
8/4/71 LONG BEACH, CALIFORNIA
