Geotechnical Report

REPORT GEOTECHNICAL REVIEW

County of Santa Barbara Calle Real Campus Master Plan Program Environmental Impact Report (PEIR)

NOVA Project 3023006
August 18, 2023

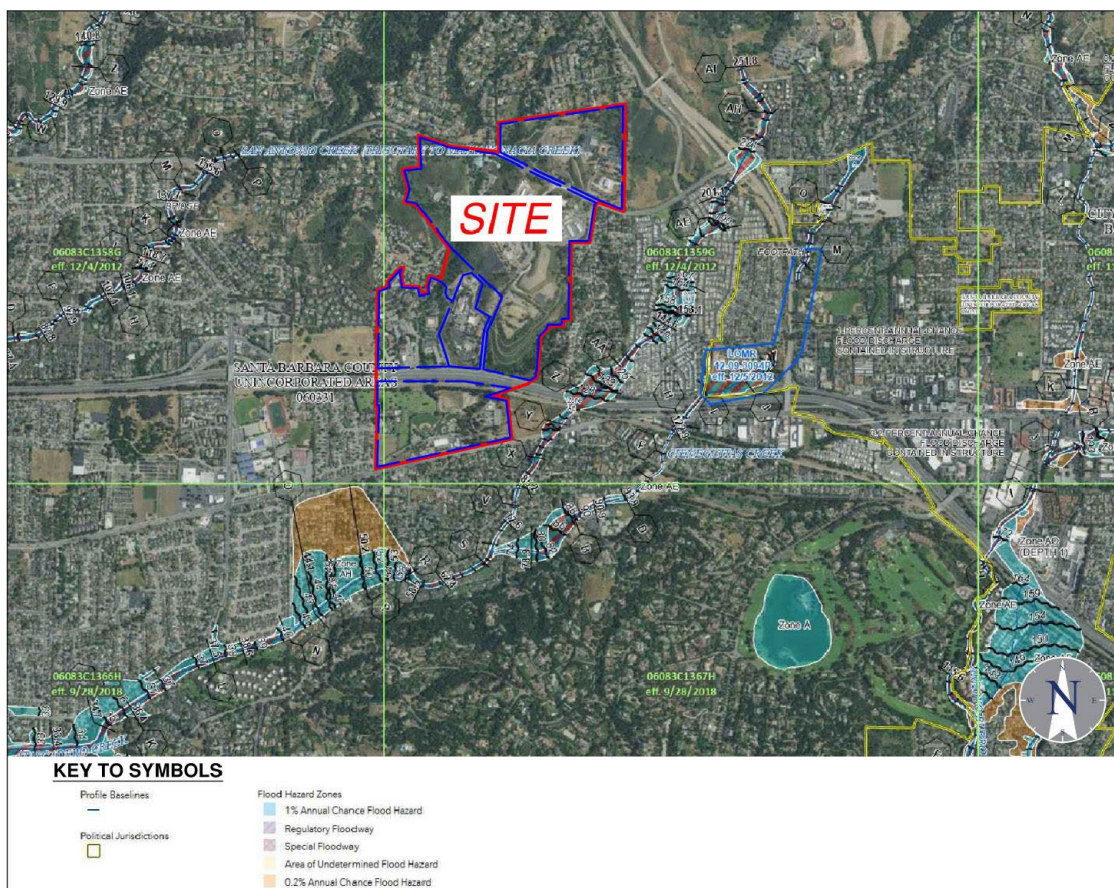
Figure 6-1. Flood Mapping of the Campus Vicinity

The Campus is located within a FEMA-designated flood zone designated as Flood "Zone X". Zone X is an "area of minimal flood hazard." Figure 6-1 reproduces flood mapping of the area.
