UPDATE GEOTECHNICAL INVESTIGATION

OLIVE PARK APARTMENTS
OLIVE DRIVE
OCEANSIDE, CALIFORNIA

MARCH 12, 2024
REVISED DECEMBER 17, 2024
PROJECT NO. G3035-52-01

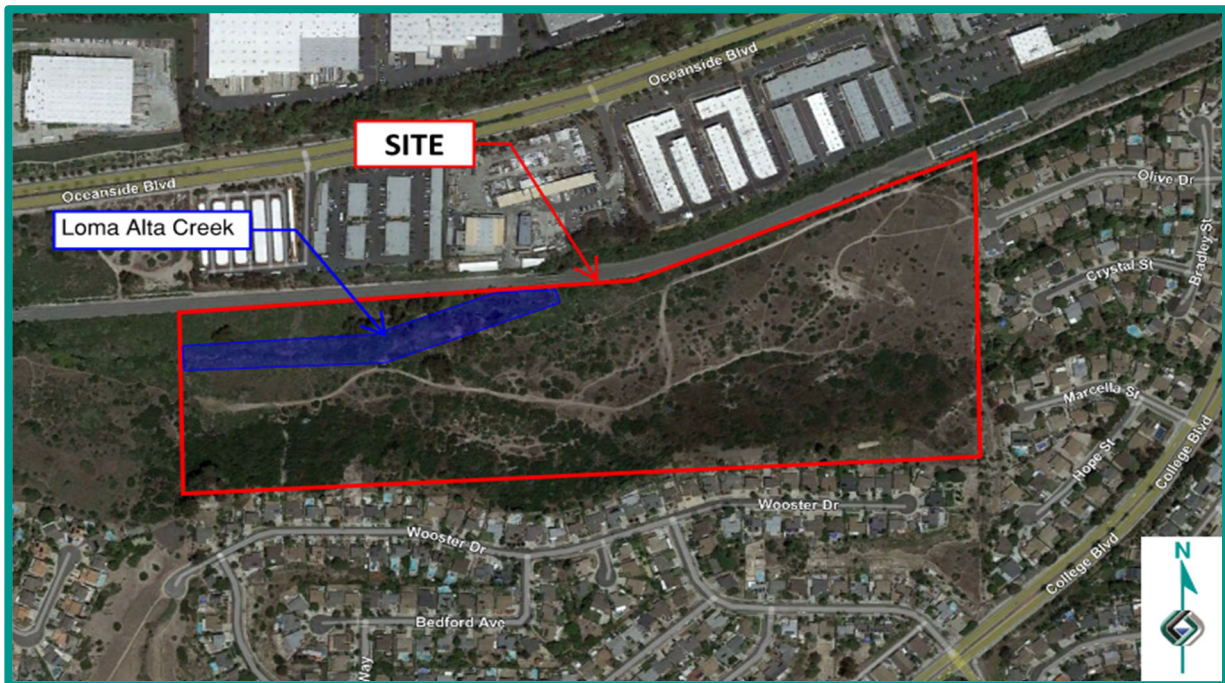
The site is an approximately 43-acre, east-west oriented, semi-rectangular-shaped property. The site is south of Oceanside Boulevard and the North County Transit District (NCTD) Sprinter line, east of an undeveloped property, and north and west of existing residential subdivisions. The Existing Site Plan shows the current site conditions.

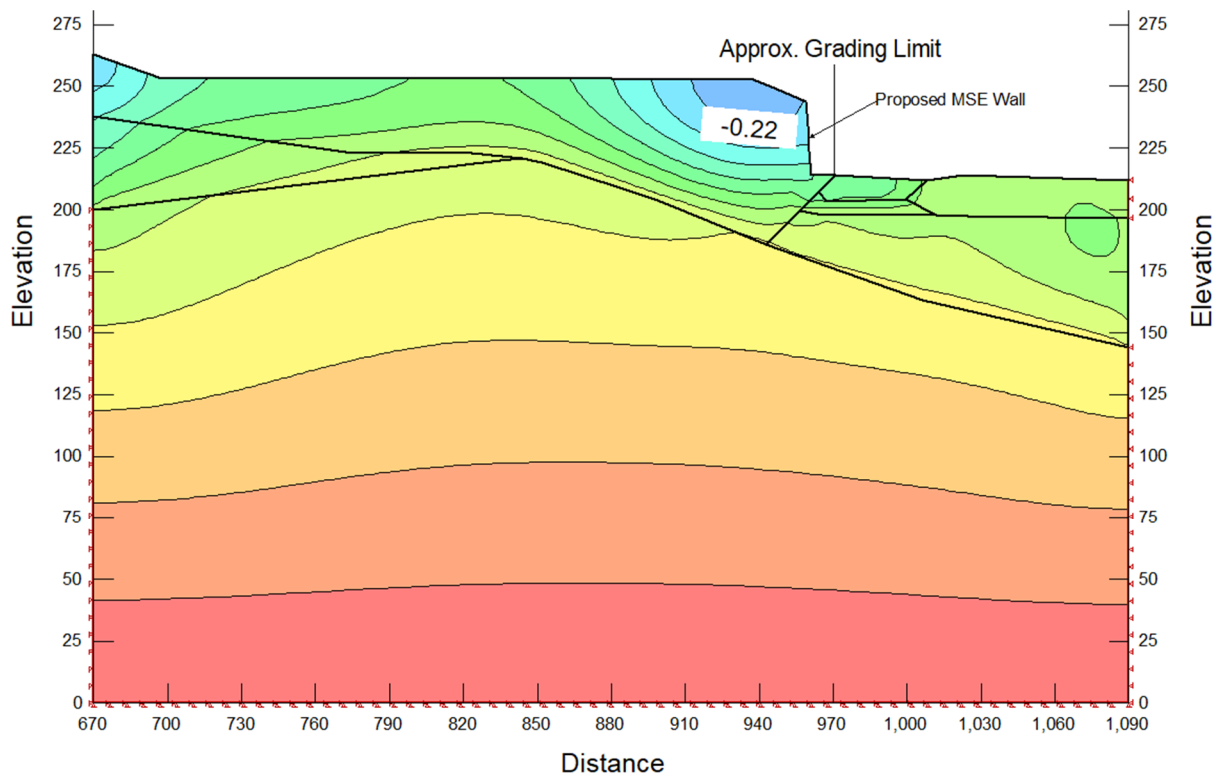
Vertical Settlement Analysis – Western Portion of Retaining Wall

The amount of settlement that could occur is a function of how thick the fill layer is, how compressible the existing layer is, and the magnitude of the new vertical load (weight of new fill or future building loads). We performed a settlement evaluation using Geostudio2018 (SigmaW). Based on laboratory test results and engineering analyses, we estimate theoretical maximum settlements of up to 3 inches (0.22 feet) and 3.6 (0.3 feet) inches for the retaining wall and western parking lot, respectively. The following figures present the computer output of our static condition settlement analyses for the retaining wall and parking lot (with settlements indicated in feet).
