GEOTECHNICAL ENGINEERING REPORT AND LIMITED GEOLOGIC EVALUATION PROPOSED FOUR-LOT SUBDIVISION 3464 AMBUM AVENUE SAN JOSE, CALIFORNIA

PROJECT: PROPOSED FOUR-LOT SUBDIVISION

3464 AMBUM AVENUE SAN JOSE, CALIFORNIA

SUBJECT: Geotechnical Engineering Report and Limited Geologic Evaluation

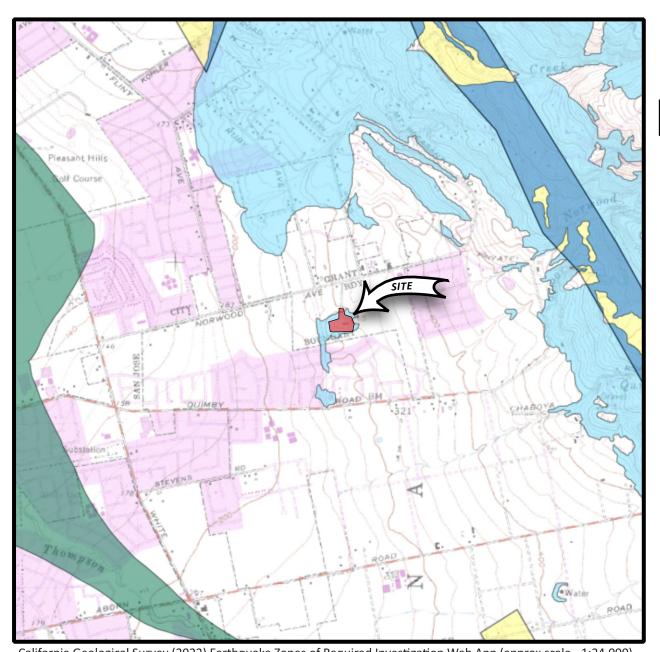
California Geological Survey (2022) Earthquake Zones of Required Investigation Web App (approx scale - 1:24,000)

Liquefaction - Areas where historic occurrence of liquefaction, or local geological, geotechnical and groundwater conditions indicate a potential for permanent ground displacements such that mitigation would be required.

Earthquake-induced landslides - Areas where previous occurrence of landslide movement, or local geological, geotechnical and subsurface water conditions indicate a potential for permanent ground displacements such that mitigation would be required.

Earthquake fault zones - Zone boundaries are delineated by straight-line segments; the boundaries define the zone encompassing active faults that constitute a potential hazard to structures from surface faulting or creep such that avoidance would be required.
