Report of Preliminary Geotechnical Investigation – Evolve  
Student Housing

**REPORT OF PRELIMINARY GEOTECHNICAL EVALUATION  
EVOLVE STUDENT HOUSING  
SAN DIEGO STATE UNIVERSITY  
SAN DIEGO, CALIFORNIA**

Project No. SD814  
June 7, 2024

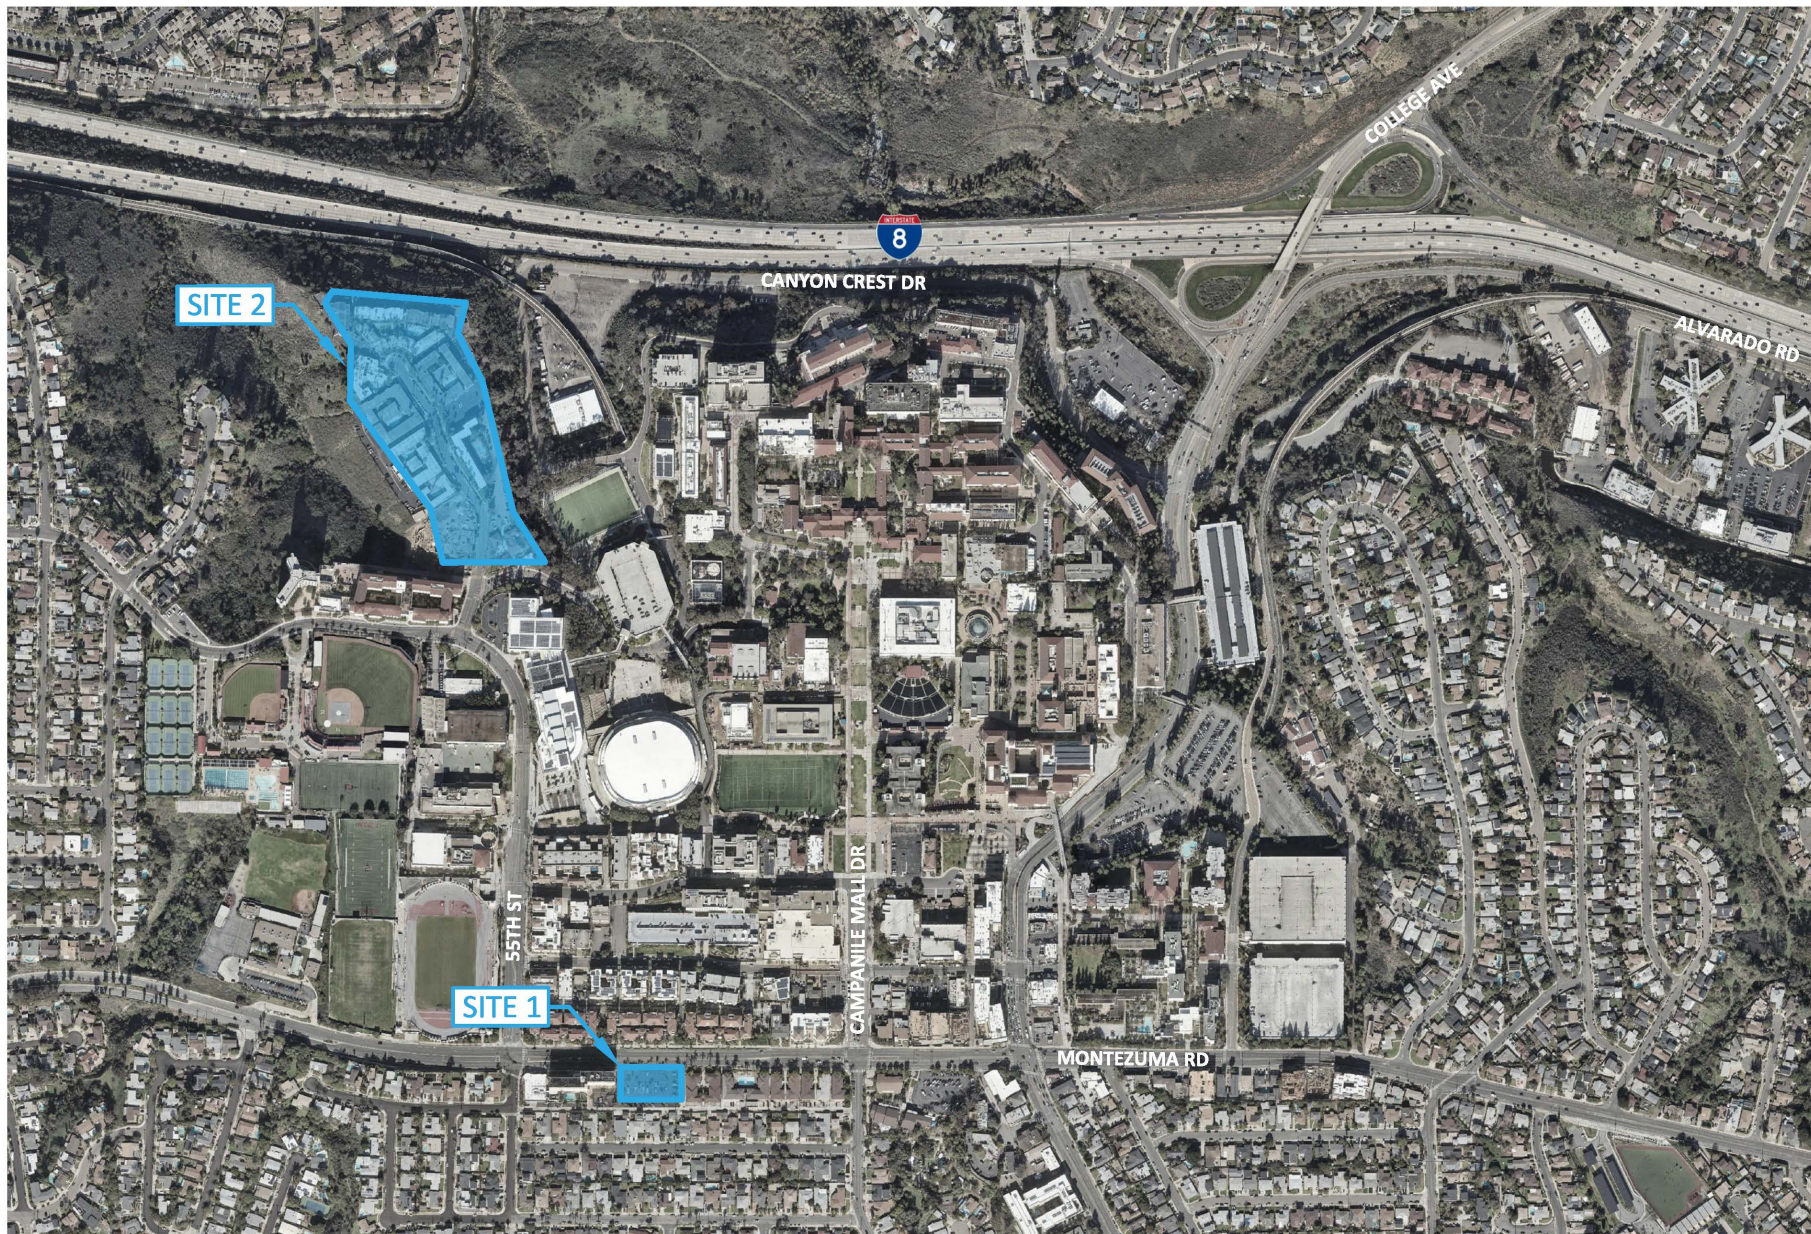
REFERENCE: GOOGLE, INC (2023) GOOGLE EARTH PRO, AERIAL IMAGERY DATED: DECEMBER 1, 2022

SDSU plans to redevelop the surface parking for the University Towers building at the intersection of 55<sup>th</sup> Street and Montezuma Road (Site 1) and the residential area surrounding the northerly terminus of 55<sup>th</sup> Street (Site 2) to provide 3,200 residential beds. Figure 1 shows the location of the Sites. We have based our understanding of the project on information in the Request for Qualifications for Collaborative Design-Build Services (CSU, 2024).

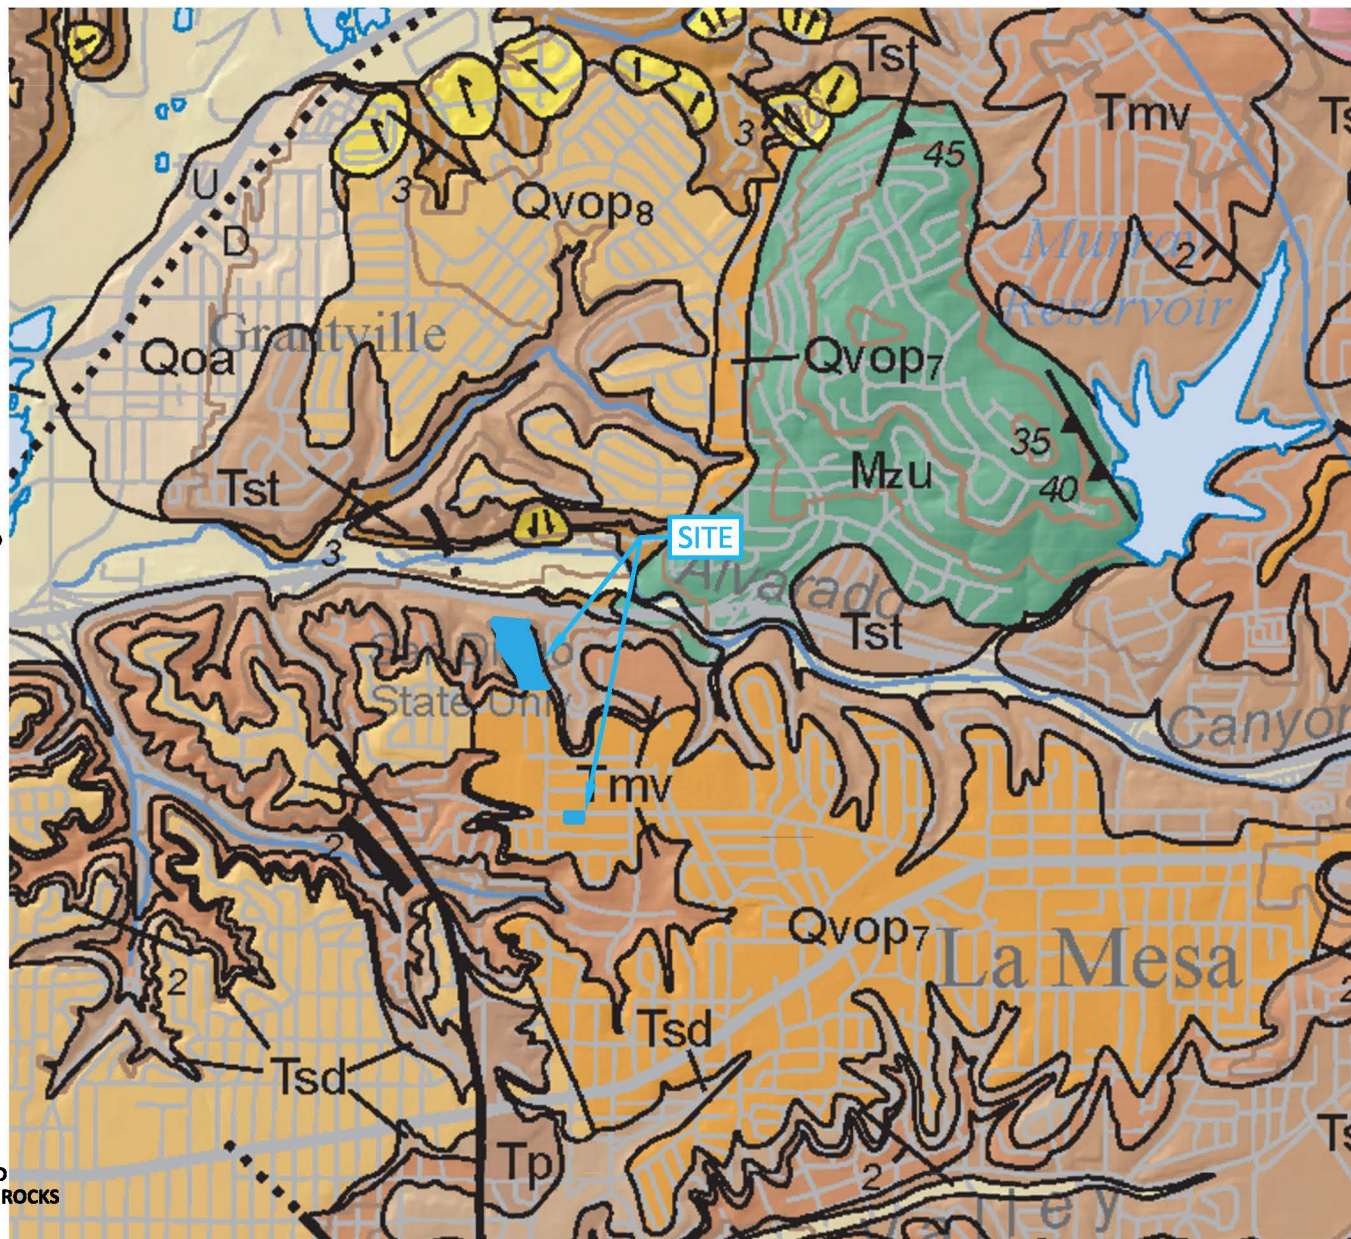
REFERENCE: GEOLOGIC MAP OF THE SAN DIEGO 30'X60' QUADRANGLE, CALIFORNIA BY KENNEDY AND TAN (2008)

Subsurface conditions at the Sites should consist of locally thin undocumented fill placed over the formational materials described in the preceding paragraph. Undocumented fill is soil that has been placed and compacted with no documentation of observation and compaction testing by a geotechnical engineer. There may be a thin layer of remnant topsoil, colluvium, and/or residual soil between the fill and formational materials. The following sections describe the subsurface conditions of these materials.
