GEOTECHNICAL INVESTIGATION AND WATER PERCOLATION TEST REPORT

10TH AND FLOWER STREET PARK
SOUTHEAST CORNER OF 10TH STREET AND FLOWER STREET
CITY OF SANTA ANA, ORANGE COUNTY, CALIFORNIA

CONVERSE PROJECT No. 23-32-103-01

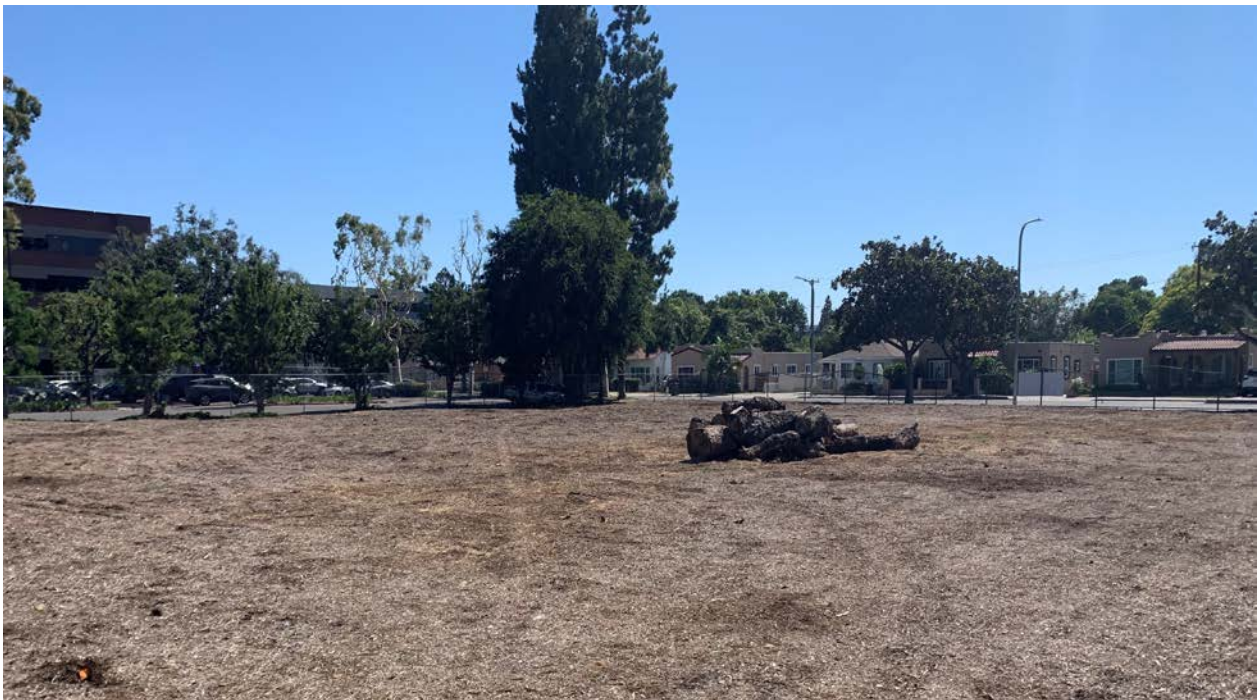
Photograph No. 1: Current site conditions facing southwest.

Surficial material appears to be comprised of a thin layer of engineered wood fiber. There are trees at the outside perimeter of the fence and overhead utilities on the east side of Garnsey Street. *Photographs Nos. 1 through 3* depict the present the site conditions.

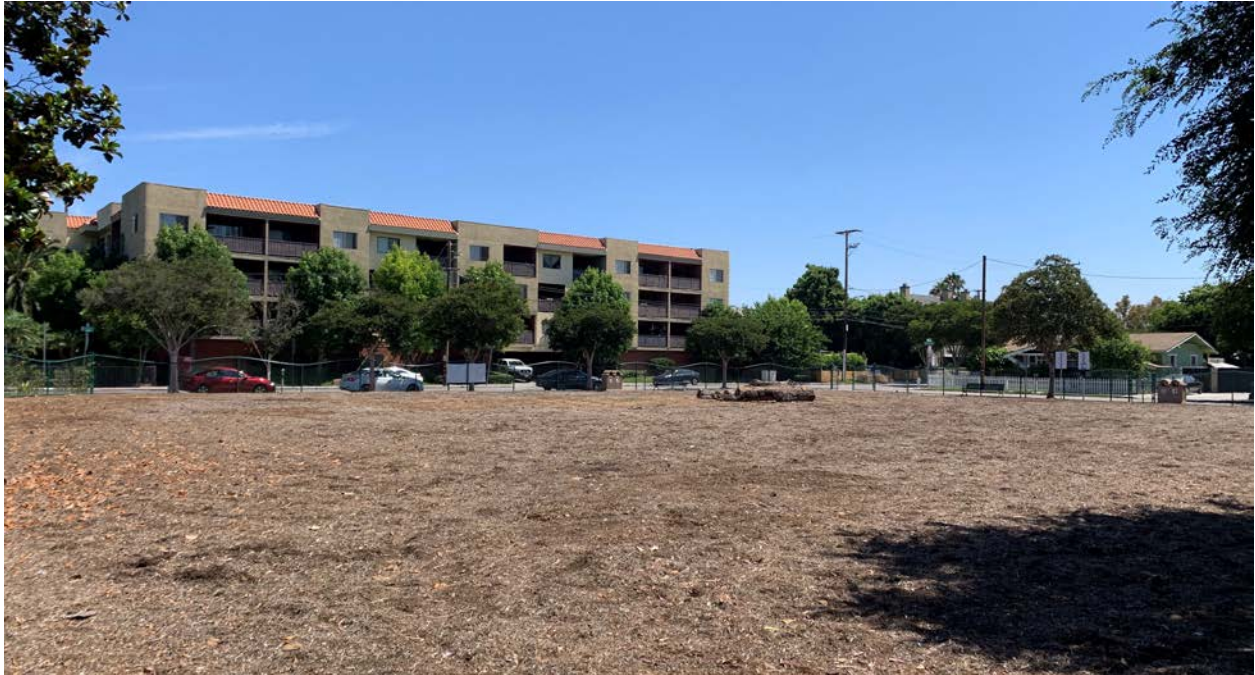
Photograph No. 2: Current site conditions facing northeast.

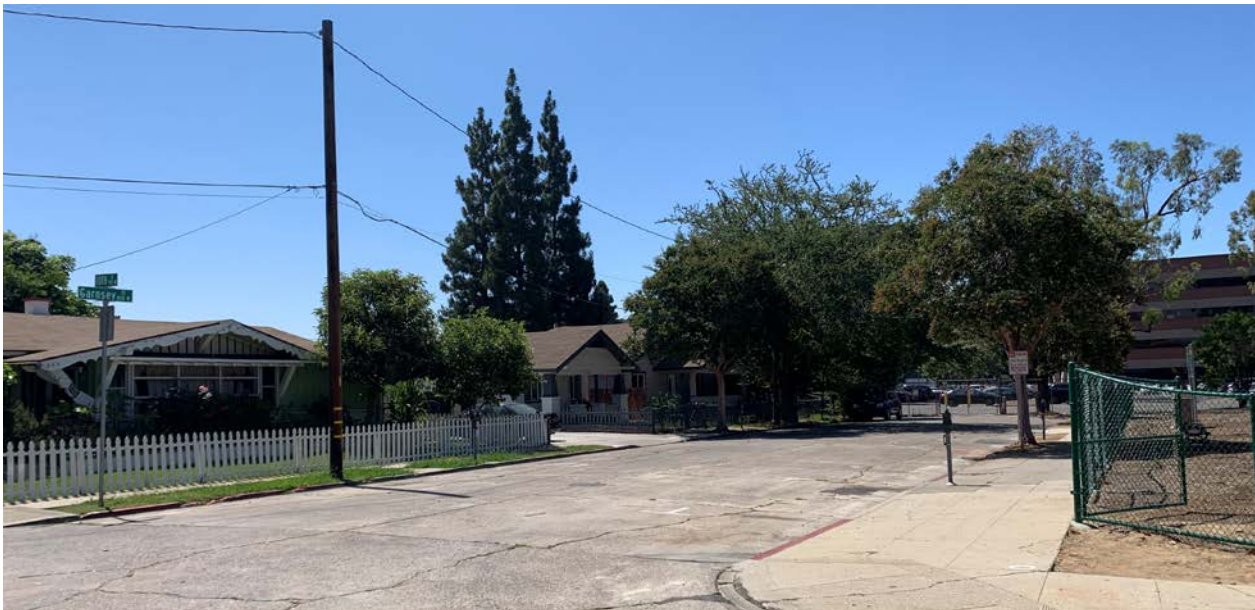
Photograph No. 3: Current conditions at Garnsey Street facing southeast.

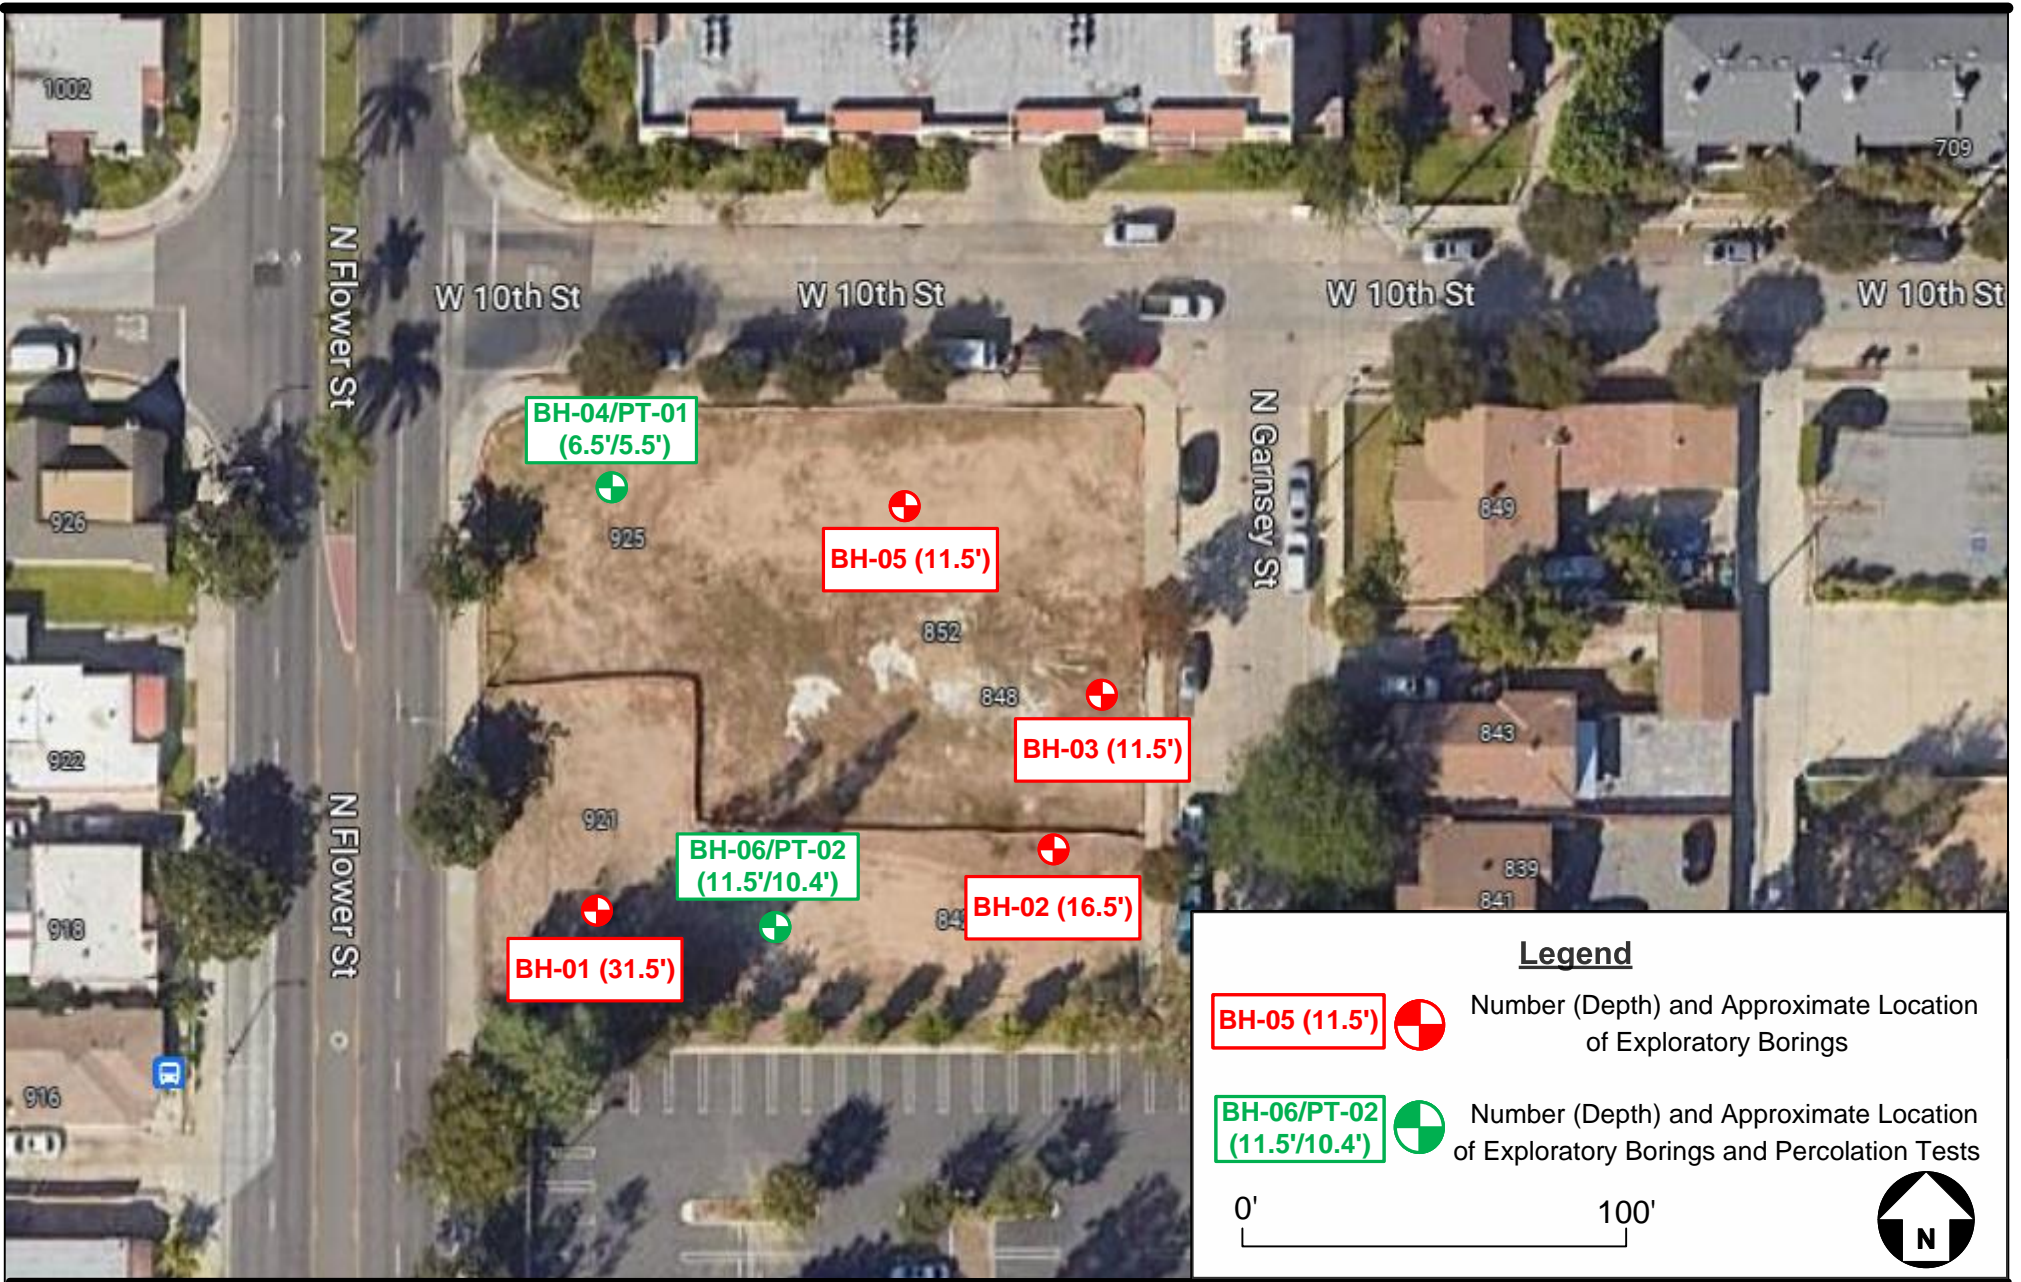
Approximate Borings and Percolation Test Locations Map

Project: 10th and Flower Street Park
 Location: Southeast corner of 10th and Flower Streets
 City of Santa Ana, Orange County, California
 For: David Evans and Associates, Inc.

The approximate locations of the borings are shown on Figure No. 2, *Approximate Boring and Percolation Tests Locations Map*. A detailed discussion of the subsurface exploration program is presented in Appendix A, *Field Exploration*.
