# Technical Memorandum

Subject: Aircraft Hazard and Land Use Risk Assessment & Wildlife Hazard Management Analysis – Snug Harbor Project

## A. Introduction

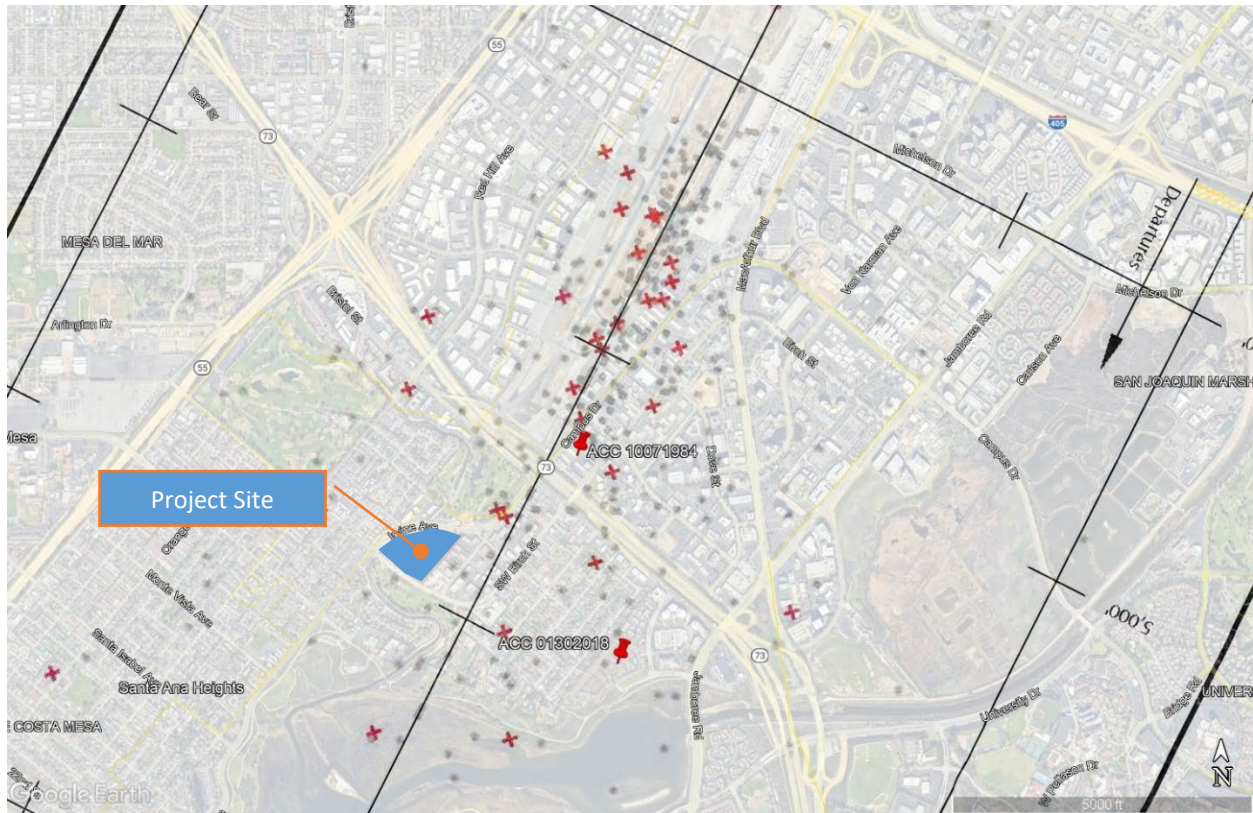
Figure 9 – Handbook Accident Research and Project Site

The Handbook provides a plot of the approximate location of general aviation departure-related accidents for airports nationwide for the period 1983-1992 (shown as circles). That same plot in the Handbook also includes an analysis of 154 accidents in California between 2000 and 2009 (shown as X's). That plot is shown in Figure 9, is lined up with Runway 20L, and shows the Project site and actual accident locations south of the Airport (within 7,500 feet from the departure end of the runway), for perspective. The plot is lined up with Runway 20L because that runway is used by general aviation aircraft approximately 50 percent of the time according to the EIR.

Using the accident data in the Handbook and from the NTSB database for SNA, it is possible to develop a rough order of magnitude estimate of accident risk at the Project site. There were no actual SNA-recorded accidents in the Project area, nor would any accidents have occurred in the Project area based on the 2011 Handbook accident research. Since there was a potential of one accident occurring in the Project area based on the 2002 Handbook research, for the purpose of this rough order of magnitude estimate, only the Handbook's accident research between 1983 and 1992 is included (873 accidents).

Approximately 1, or 0.115%, of the 873 total accidents represented in the 1983 to 1992 Handbook database would have occurred within the Project site.
