## Appendix C: Geotechnical Report

File No: 8560-00  
Report No: R1-8560

Subject: **Geotechnical Investigation**  
Proposed Custom Home Construction  
820 Gainsborough Drive  
Laguna Beach, California

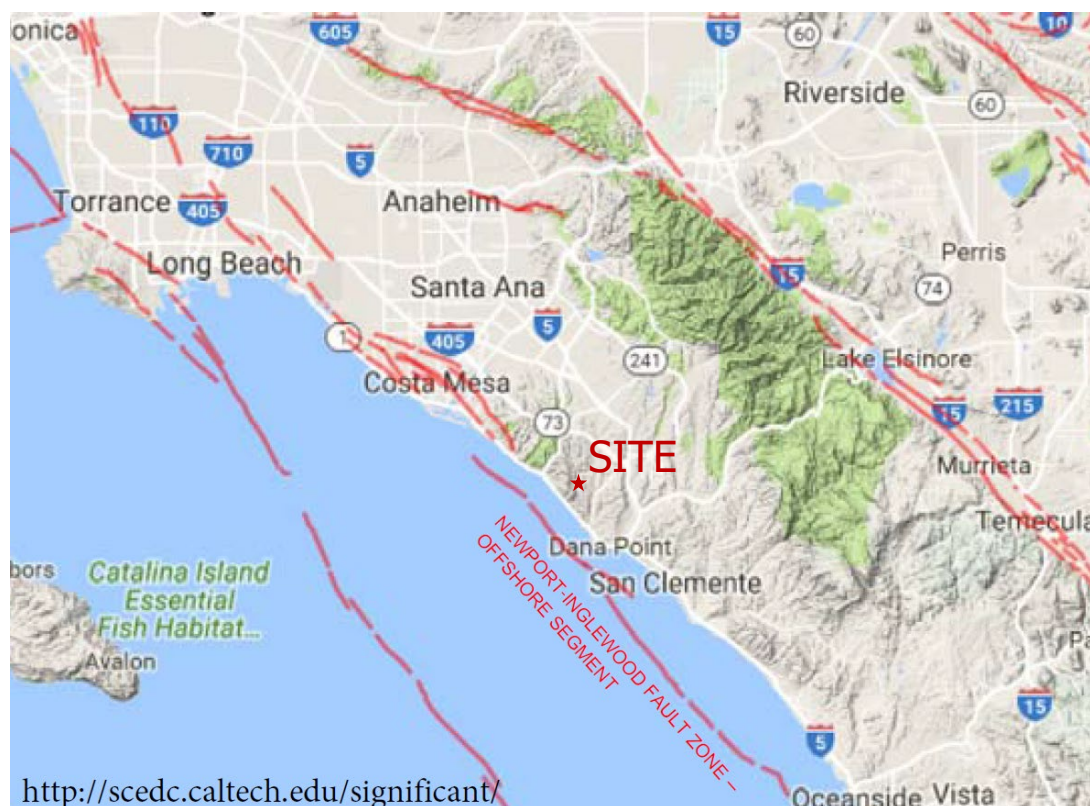
By definition, faults with no evidence of surface displacement within the last 1.6 million years are considered inactive and generally pose no concern for earthquakes due to renewed movement. Potentially active faults are those with the surface displacement within the last 1.6 million years. Further refinement of potentially active faults is sometimes described based on the age of the last known movement such as late Quaternary (last 700,000 years) implying a

The major concern relating to geologic faults is ground shaking that affects many properties over a wide area. Direct hazards from faulting are essentially due to surface rupture along fault lines that could occur during an earthquake. Therefore, geologists have mapped fault locations and established criteria for determining the risks of potential surface rupture based on the likelihood of renewed movement on faults that could be located under a site.

Based on criteria established by the California Division of Mines and Geology (CDMG), now referred to as the California Geological Survey, faults are generally categorized as active, potentially active or inactive (Jennings, 1994). The basic principle of faulting concern is that existing faults could move again, and that faults which have moved more recently are the most likely faults to move again and affect us. As such, faults have been divided into categories based on their age of last movement. Although the likelihood of an earthquake or movement to occur on a given fault significantly decreases with inactivity over geologic time, the potential for such events to occur on any fault cannot be eliminated within the current level of understanding.

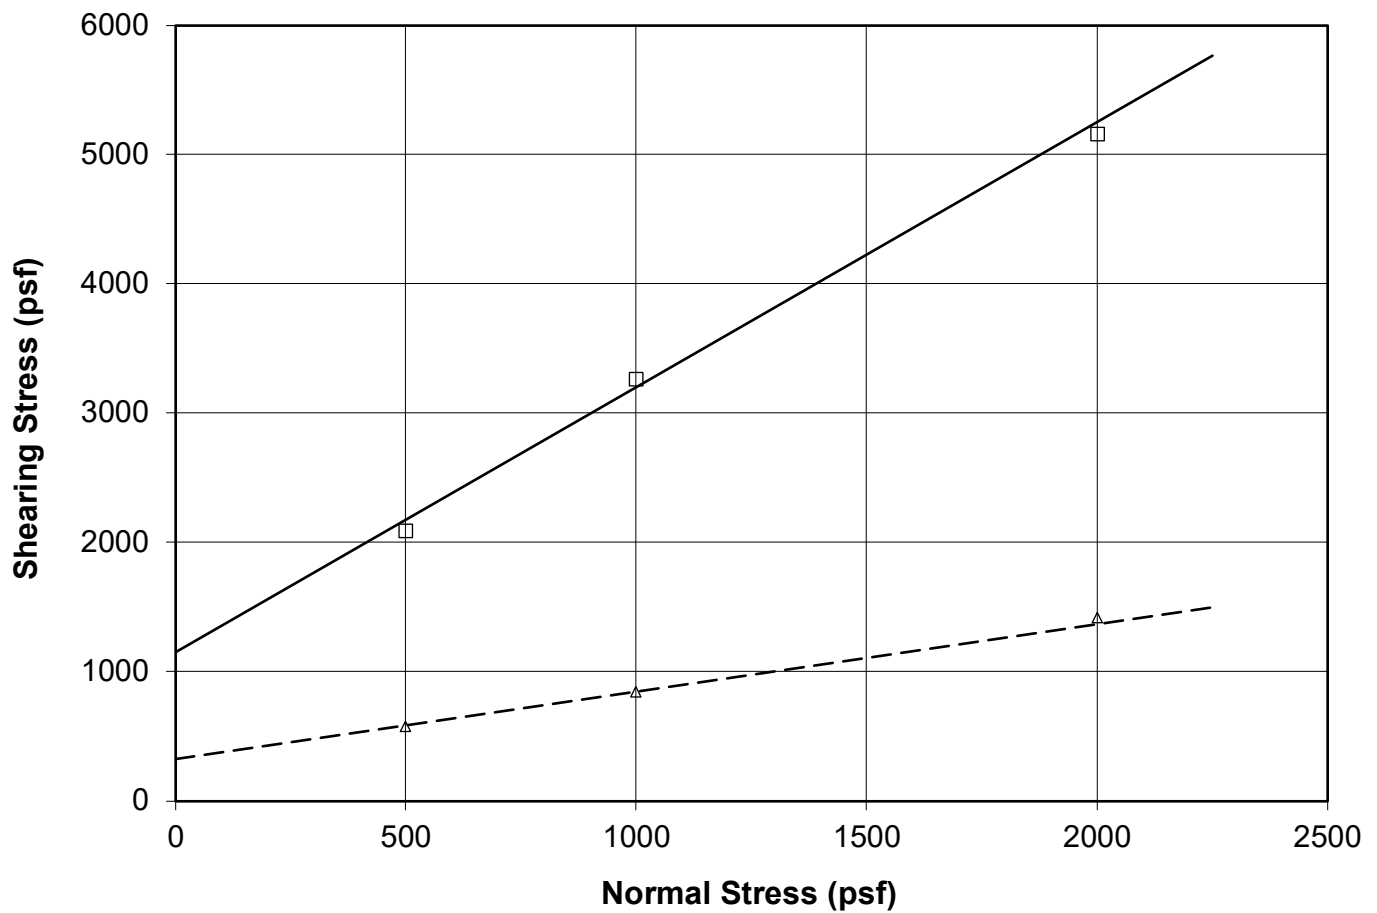
| Sample Identification | TP-1 (Carved Block bedrock sample) |

| Rate of Shear | 0.005 | in/min | Sample Type | In-situ |

Direct shear tests were performed on selected relatively undisturbed samples which were saturated under a surcharge equal to the applied normal force during testing. The apparatus used is in conformance with the requirements outlined in ASTM D3080. The test specimens, approximately 2.5-inches in diameter and 1-inch in height, were subjected to simple shear along a plane at mid-height after allowing time for pore pressure dissipation prior to application of shearing force. The samples were tested under various normal loads, a different specimen being used for each normal load. The samples were sheared at a constant rate of strain of 0.005-inches per minute. Shearing of the specimens was continued until the shear stress became essentially constant or until a deformation of approximately 10 percent of the original diameter was reached. The peak and ultimate shear stress values were plotted versus applied normal stress, and a best-fit straight line through the plotted points was determined to arrive at the cohesion and the angle of internal friction parameters of the soil samples. The direct shear test results are presented in Figure C-3.
