845 SANTA FE DRIVE - DENSITY BONUS PROJECT HISTORICAL EVALUATION REPORT

DRAFT
February 19, 2025

Prepared by
Heritage Architecture & Planning
832 Fifth Avenue
San Diego, California 92101

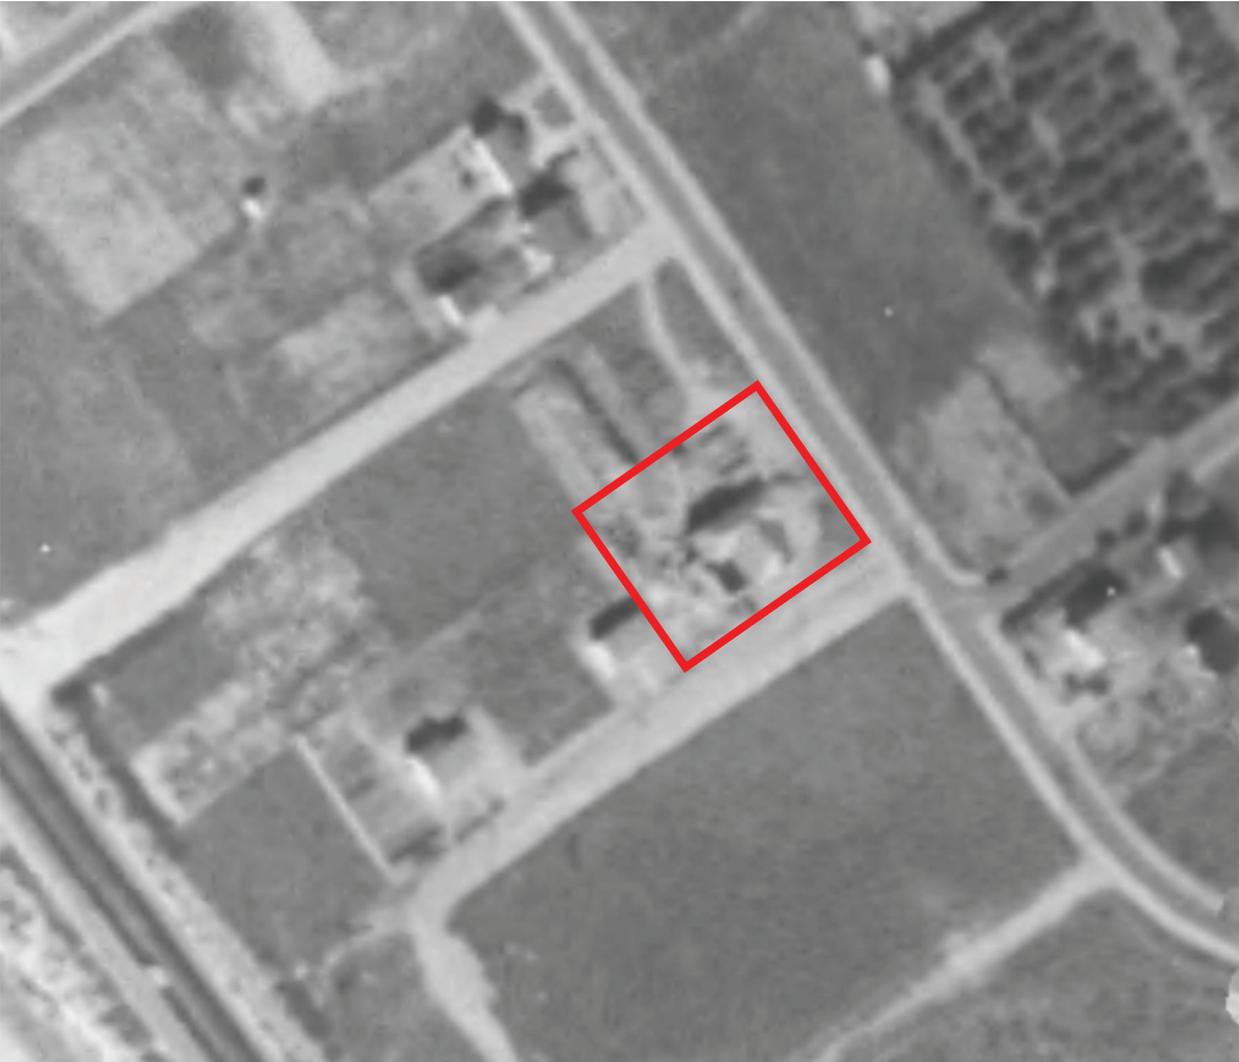
Figure 4: 1947 Aerial photograph showing the property. Source: historicaerials.com

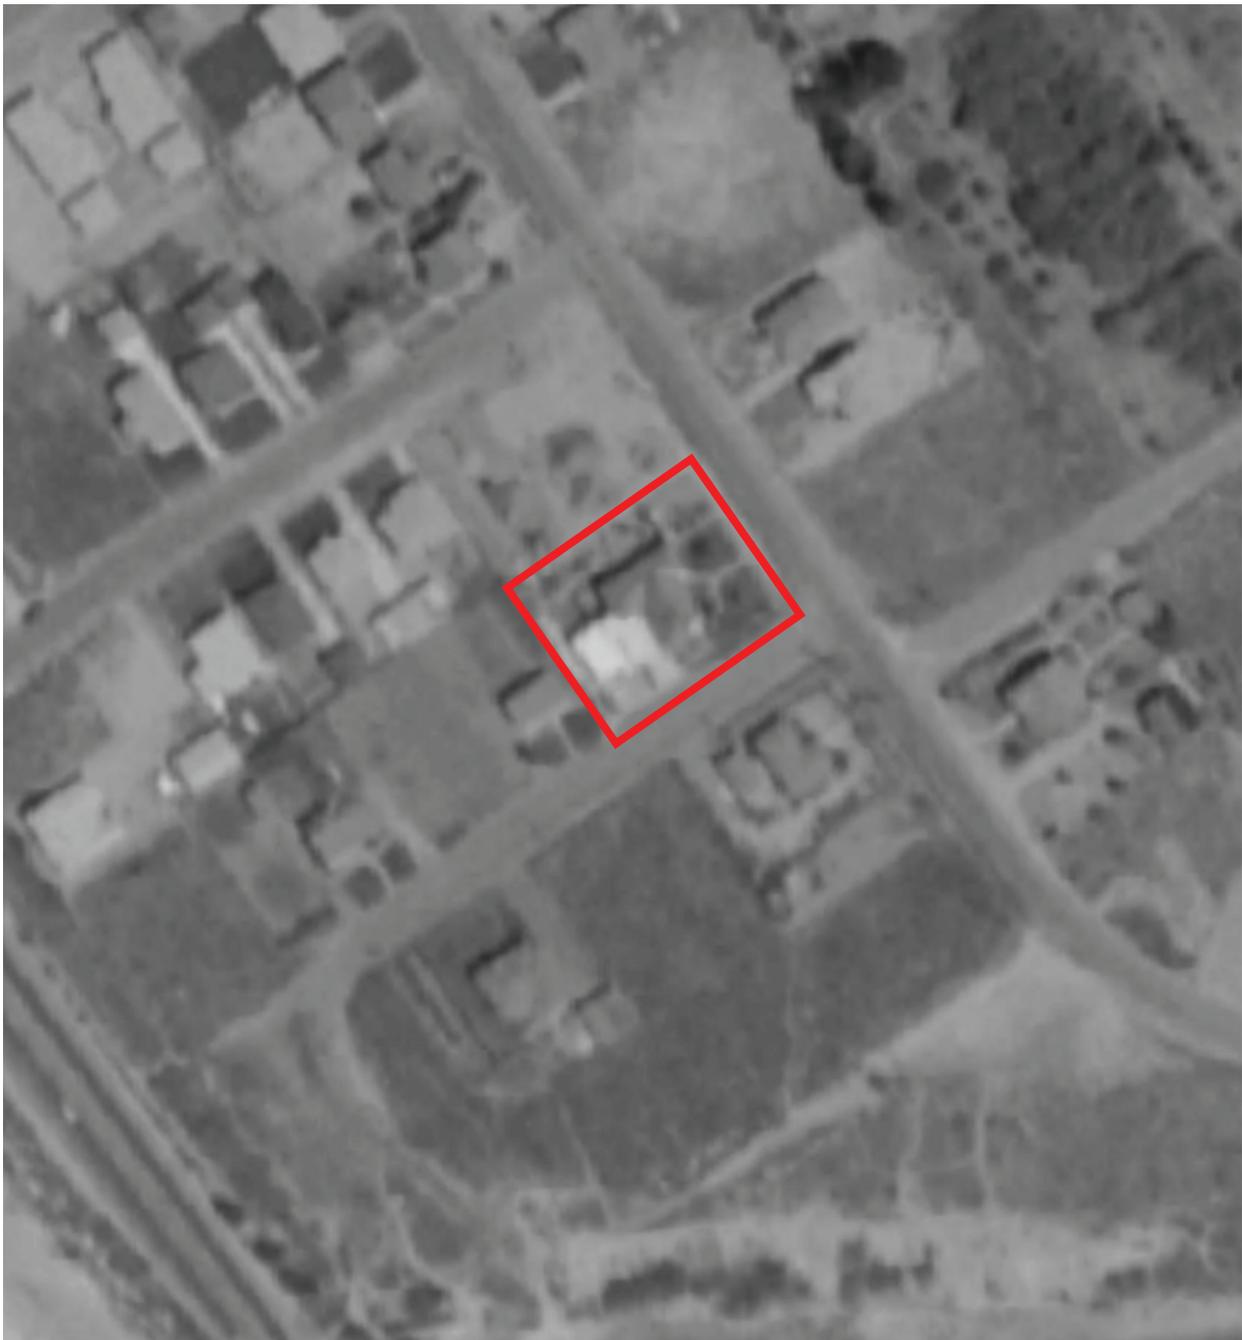
Figure 5: 1953 Aerial photograph showing the property. Source: historicaerials.com

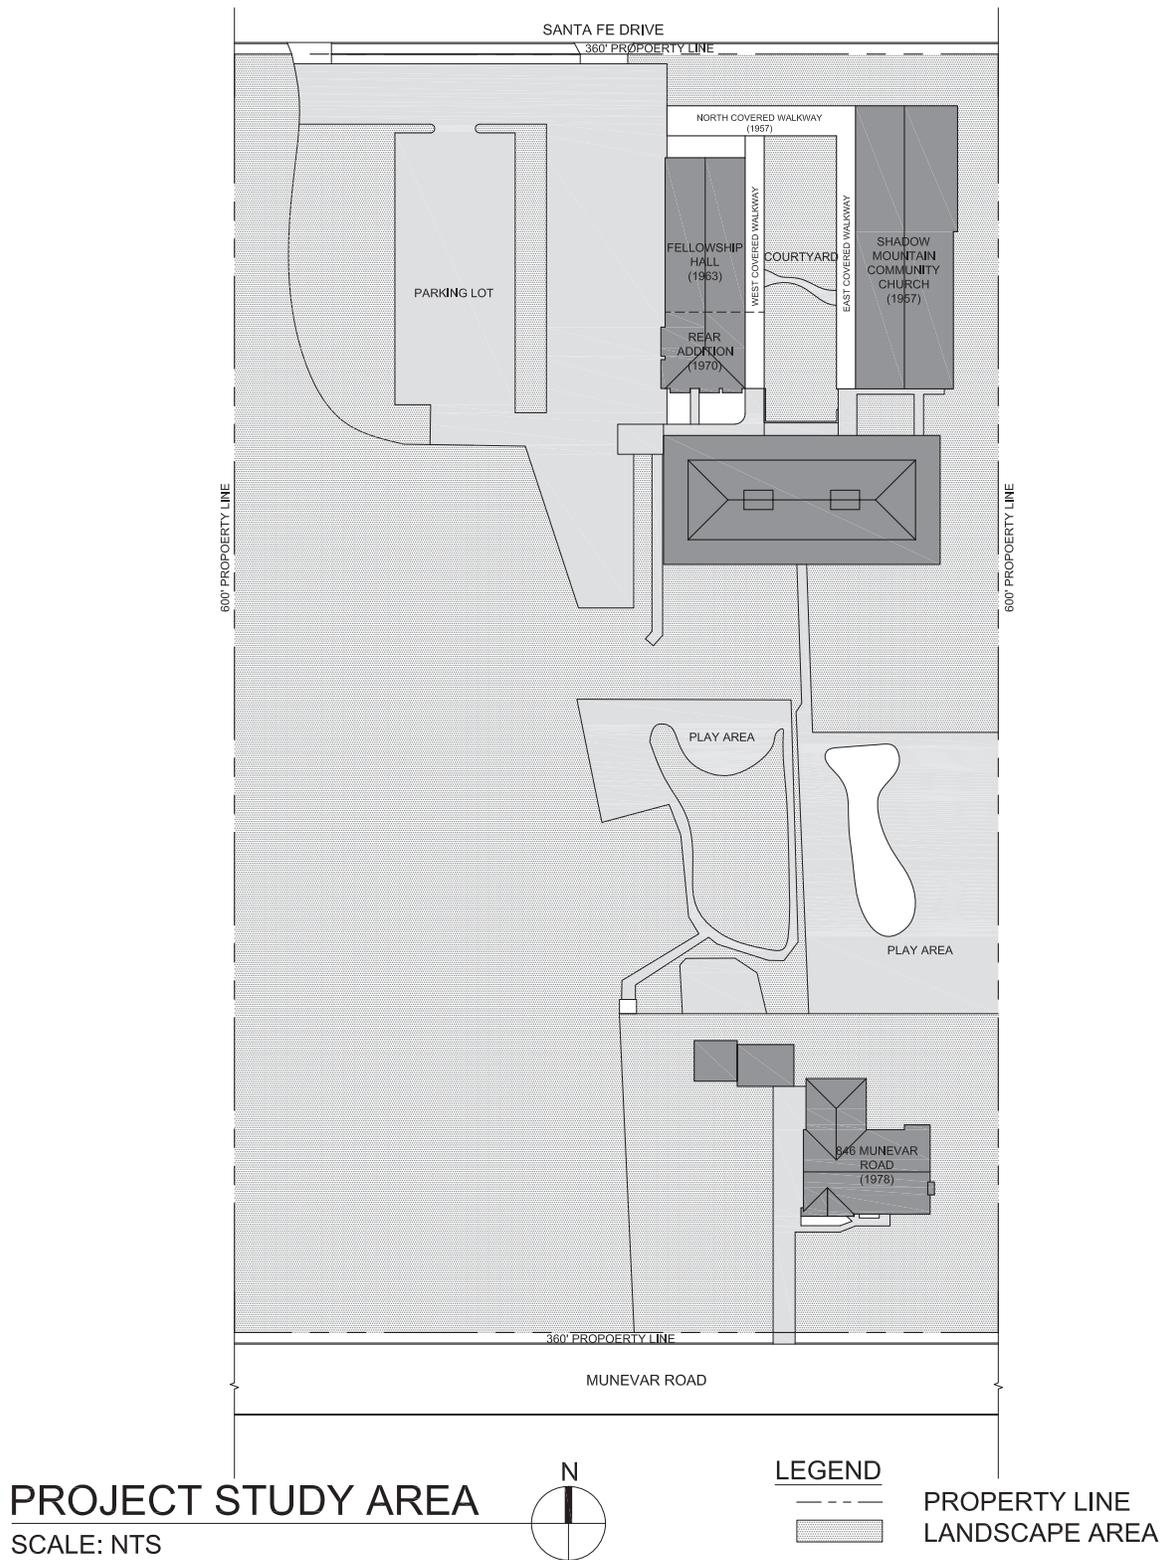
Figure 7: Site plan showing the layout of the church, Fellowship Hall, Pre-school and Single Family Residence.

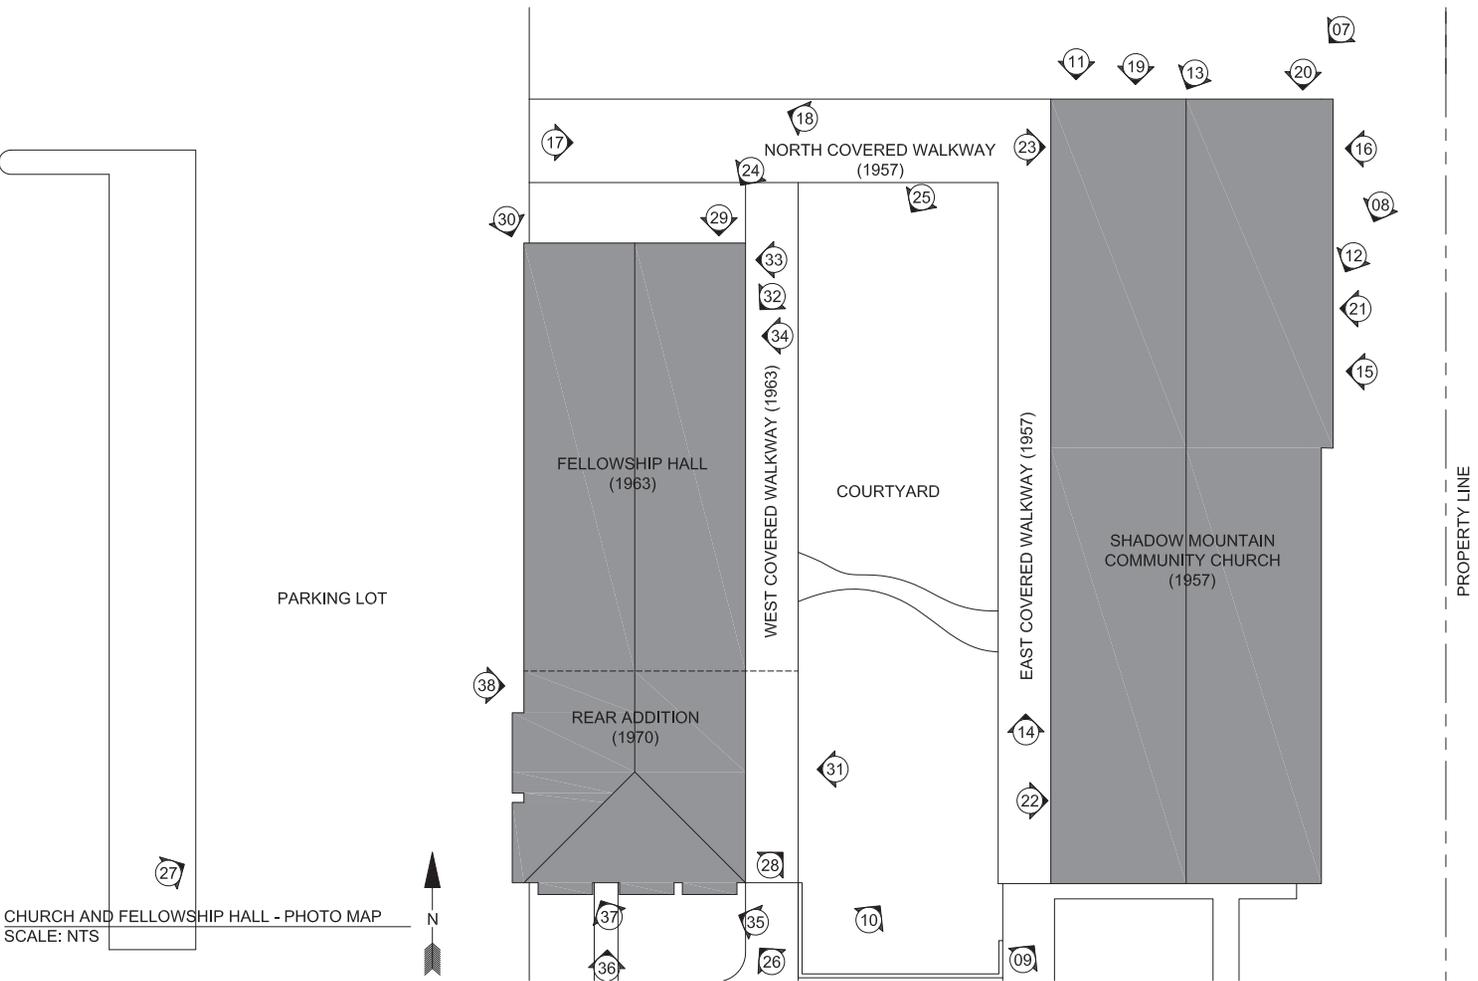
Figure 8: Photo key plan for the main Church building and Fellowship Hall.

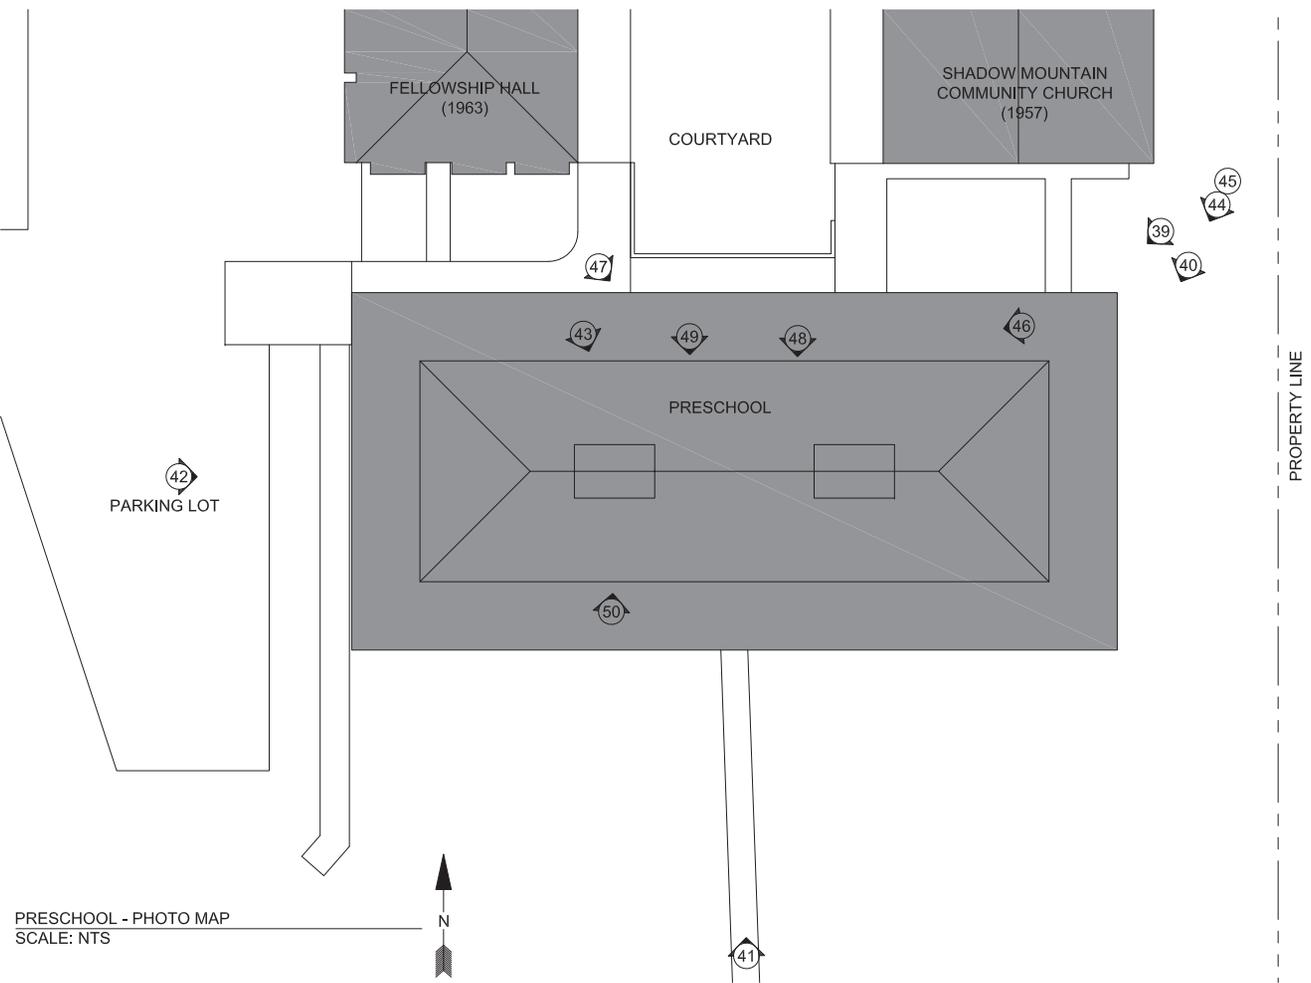
Figure 9: Photo key plan for the Preschool.

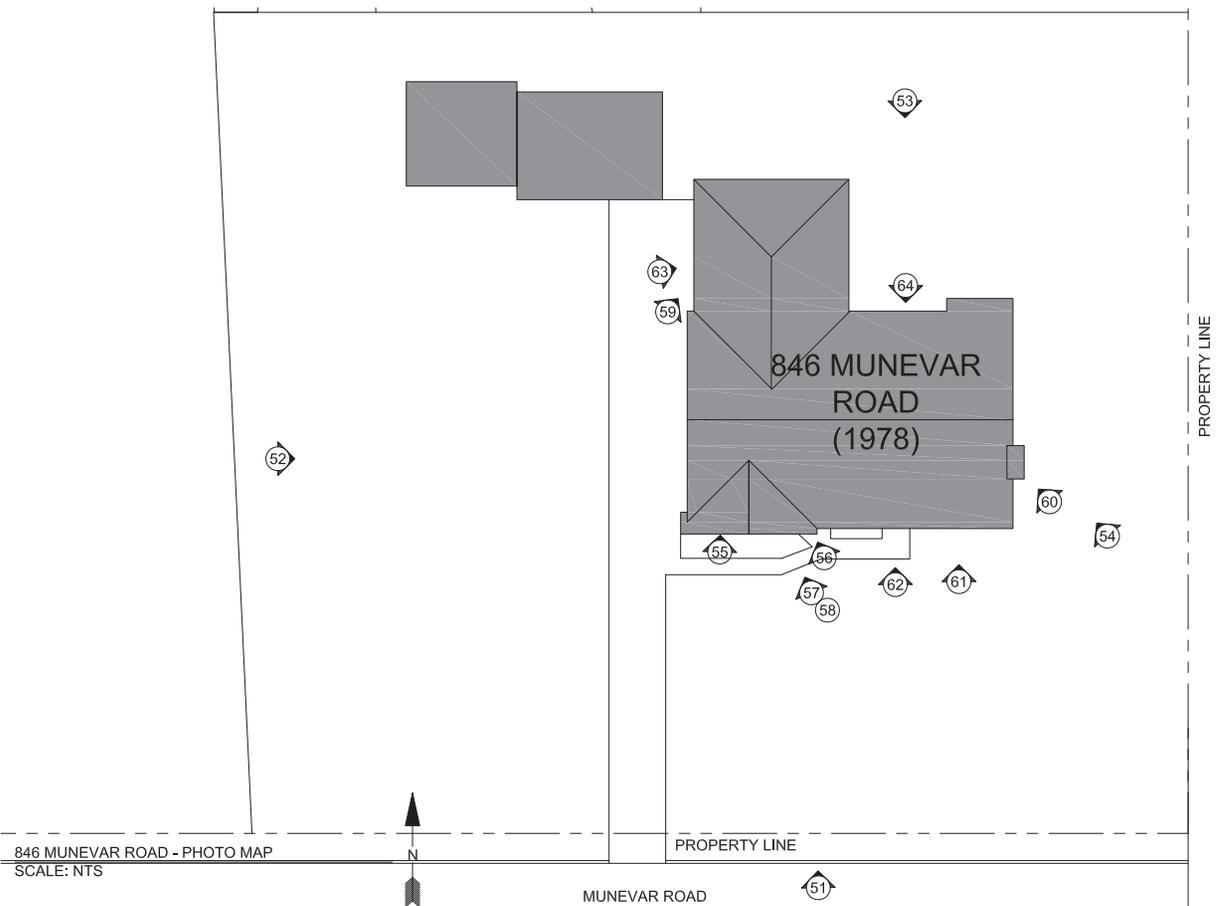
Figure 10: Photo key plan for the single-family residence.

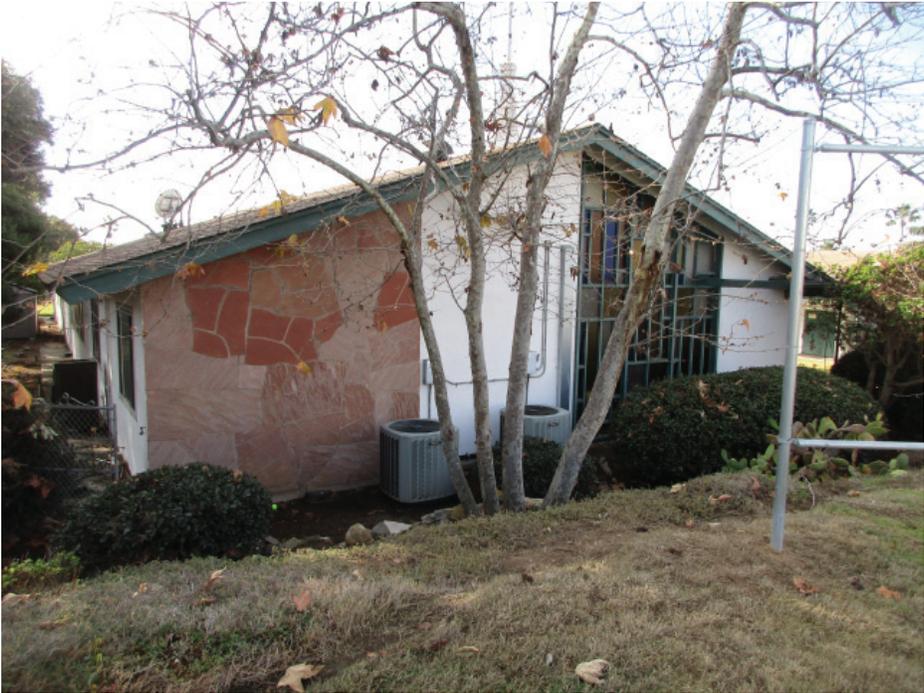
Photo 7: Looking south at the north facade of the the main Church building.

At the north façade fenestration consists of a wood framed trapezoidal window with an irregular wood mullion pattern creating a color-block effect with the stained glass. The glazing is obscured. At the northeast corner there is a full-height flagstone veneer. Opposite this wall is the foyer. Surface mounted utility equipment had been installed between the flagstone veneer and the stained-glass obscure window.

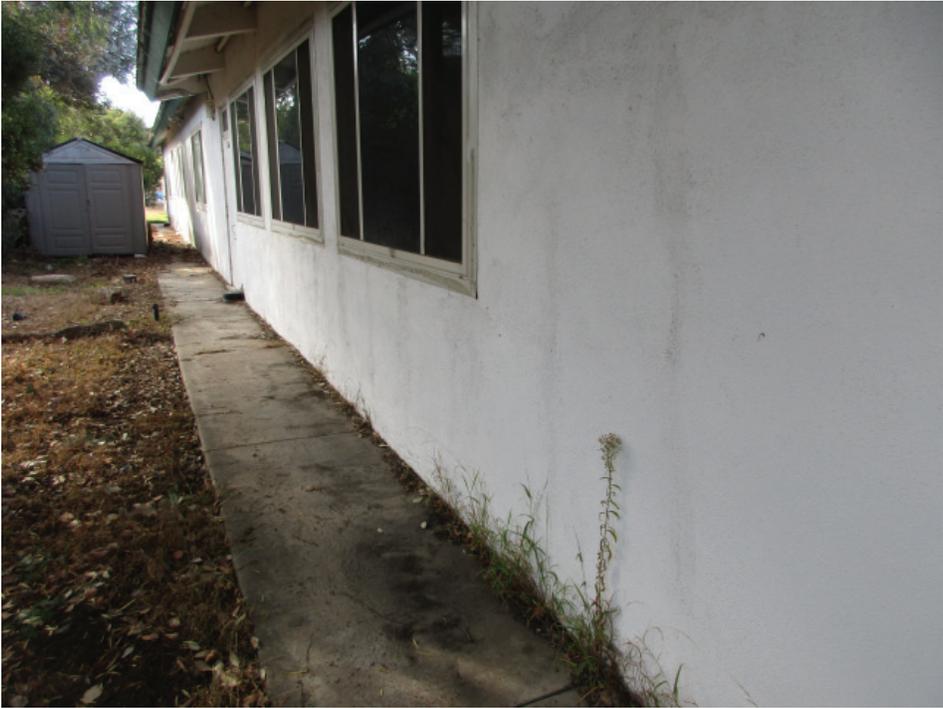
Photo 8: Looking southwest at the east facade of the the main Church building.

At the secondary east façade, all fenestration has been replaced with vinyl sliding windows and frames. There are three secondary wood slab entry doors with cast-in-place concrete thresholds. Above each door is a fixed replacement vinyl transom window. A covered cast-in-place concrete walkway runs the entire length of the façade.

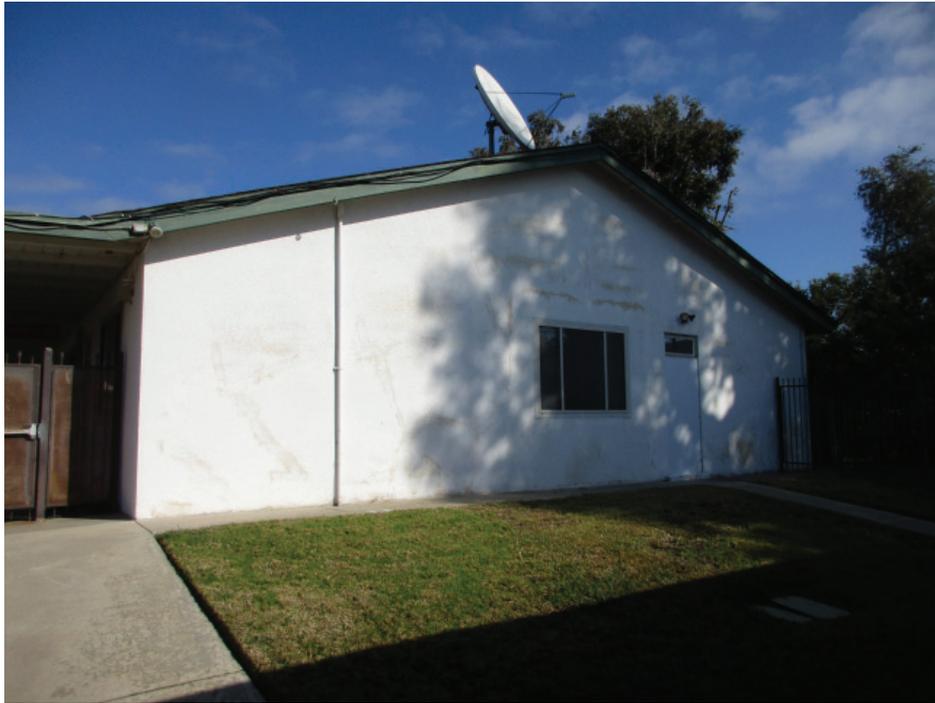
Photo 9: Looking north at the south facade of the the main Church building.

The rear south façade has a single vinyl replacement sliding window and a flush wood door with cast-in-place concrete threshold and replacement vinyl transom window mimicking changes throughout the building. An uncovered cast-in-place concrete walkway that runs the entire length of the south façade. Some surface mounted conduit are evident towards the western side of the façade.

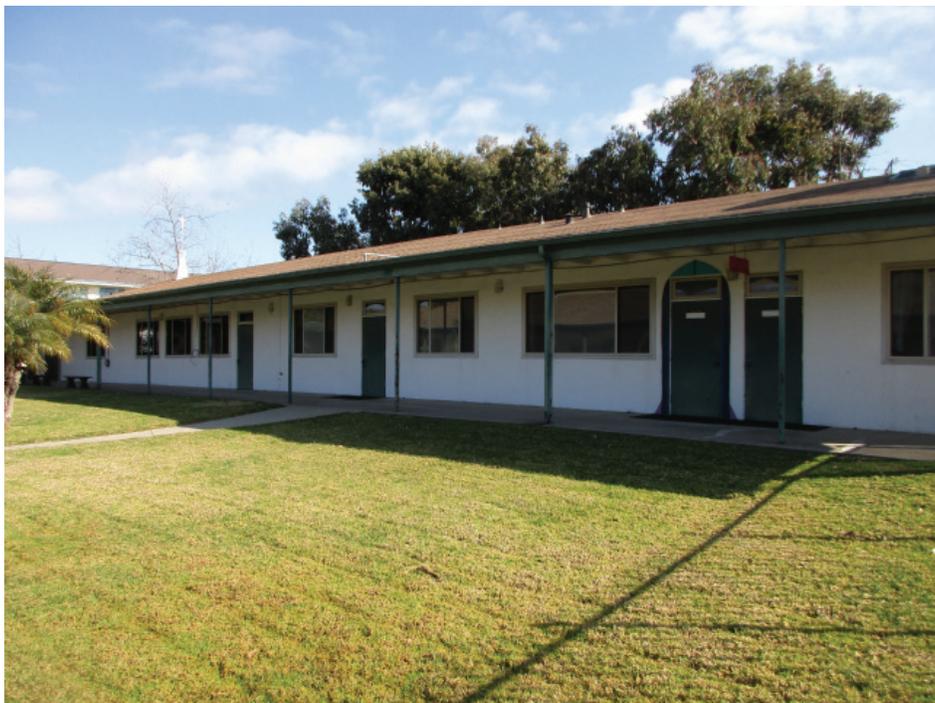
Photo 10: Looking northeast at the west facade of the the main Church building.

Fenestration at the west façade consists of vinyl replacement sliding windows and frames. There are four secondary solid core flush wood doors with fixed vinyl transom windows above. At the northwest corner is the primary entry which consists of a pair of wood style and rail doors with ten square panels in each door leaf. Each panel bears a decorative clover-leaf motif. Above the doors are two separate fixed vinyl replacement transom windows.

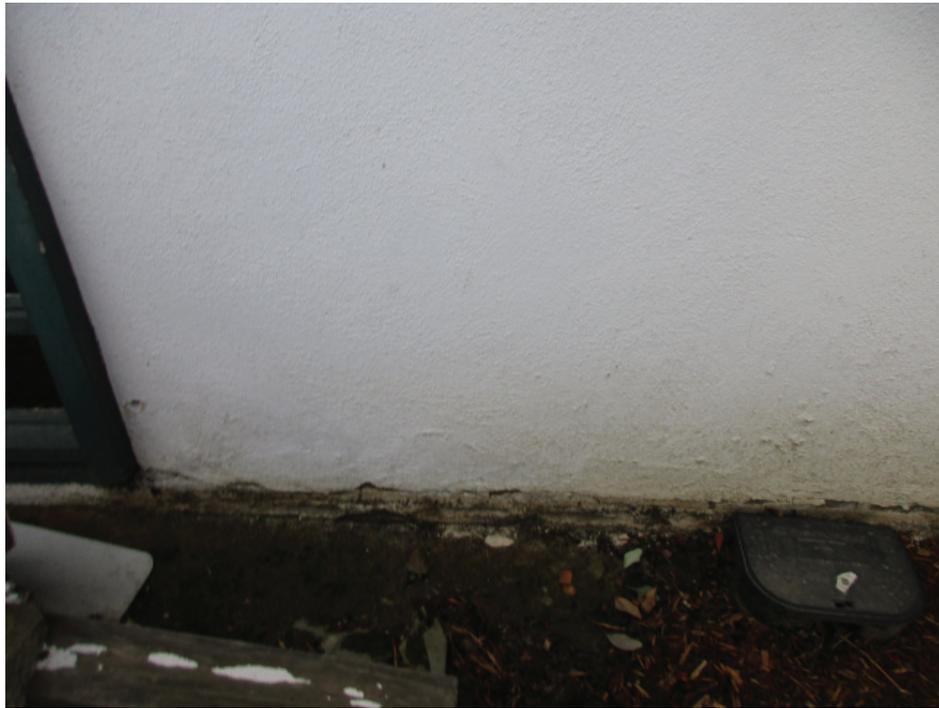
Photo 11: Detail photo showing the smooth sand texture stucco finish at the main Church building.

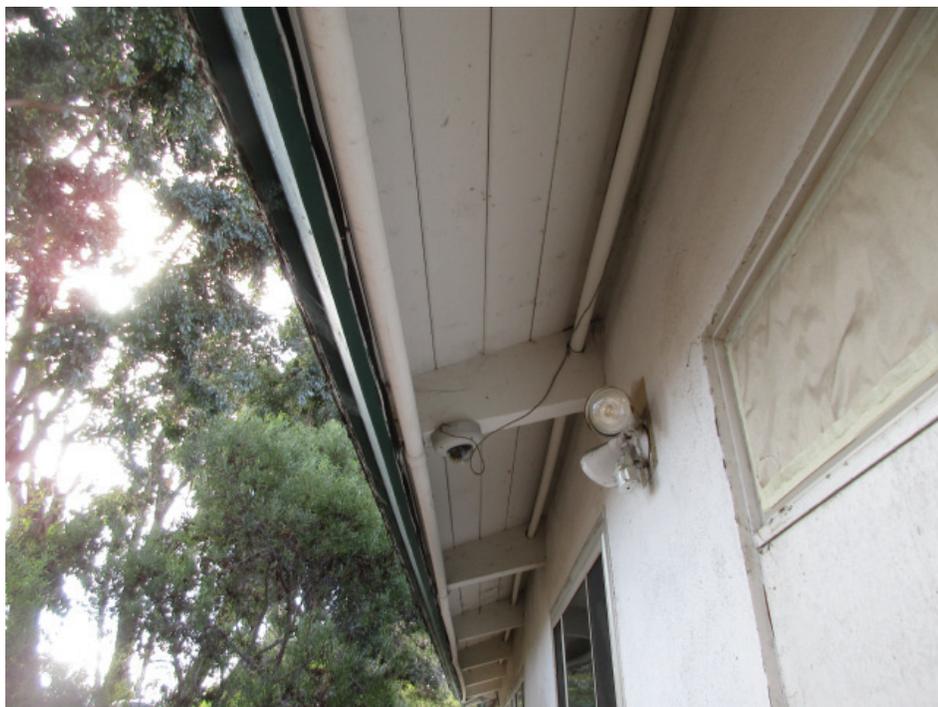
Photo 12: Detail photo of the main Church building showing the open roof eave overhang at the east facade with exposed shaped rafter tails and 1x v-groove T&G decking.

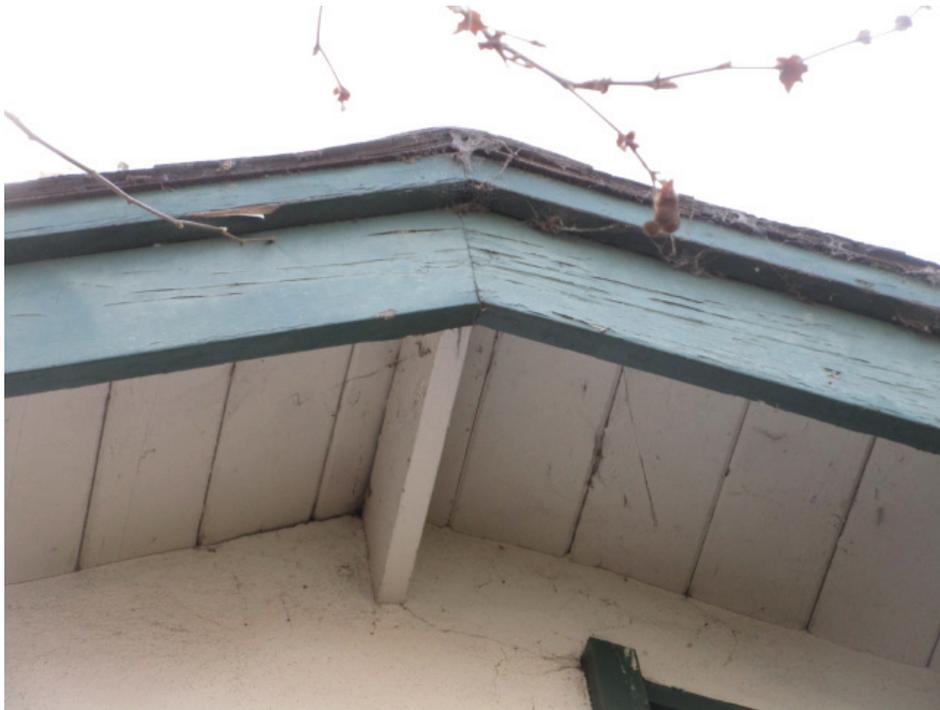
Photo 13: Detail photo showing the open roof rake at the north facade of the main Church building.

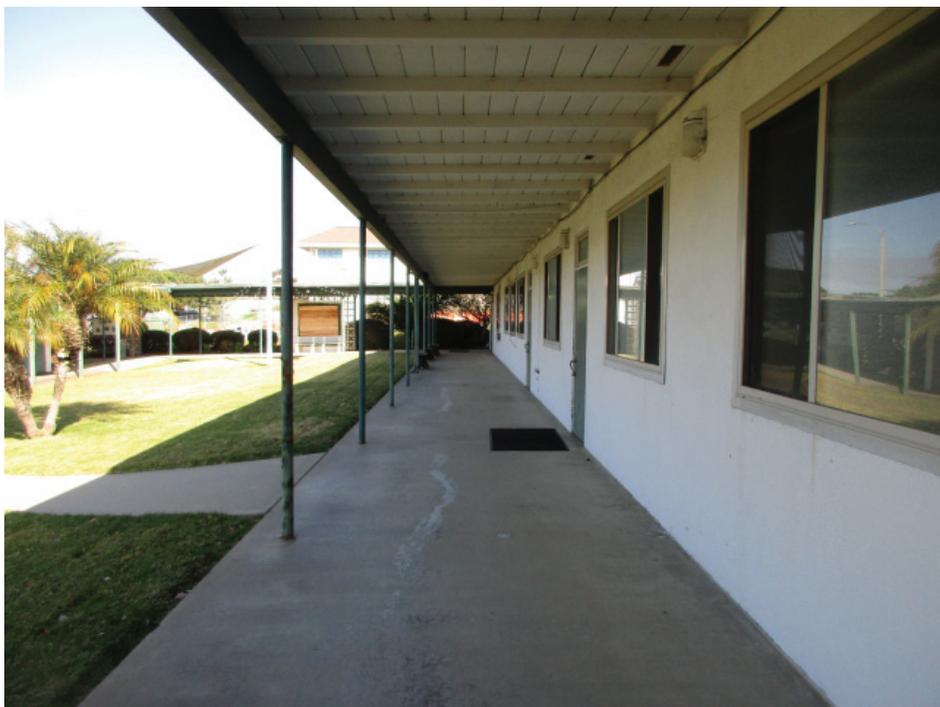
Photo 14: Looking north under the breezeway at the east side of the main Church building.

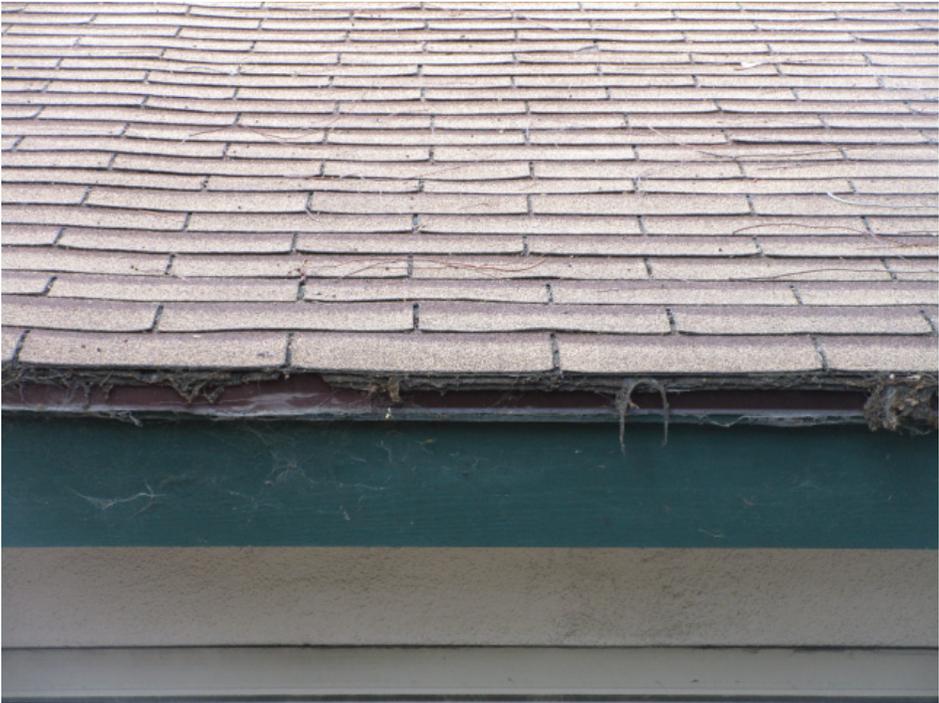
Photo 15: Detail photo showing the non-original asphalt shingle roofing at the main Church building.

posts embedded into the cast-in-place concrete walkway. The roofing finish consists of replacement asphalt shingles.

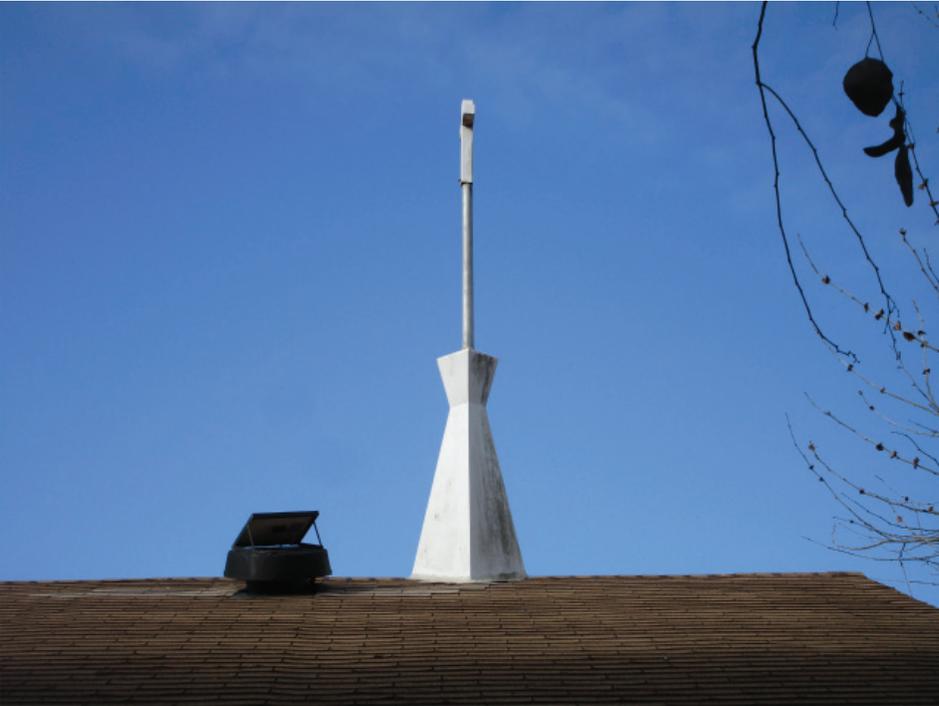
Photo 16: Detail photo of the main Church building showing the roof mounted cross at the northern end of the gable roof.

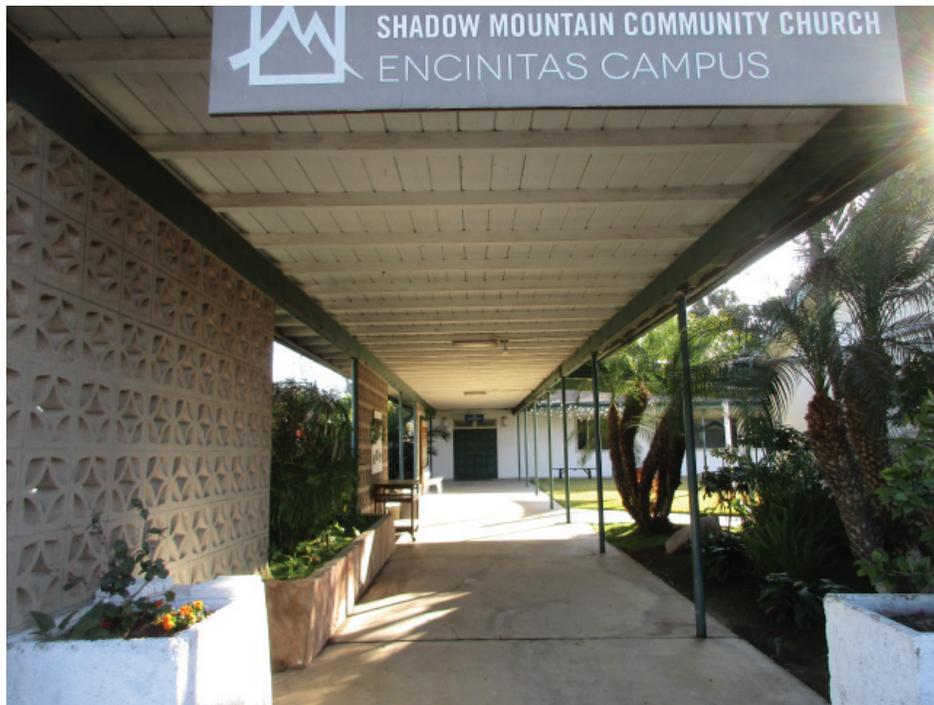
Photo 17: Looking east at towards the main Church through the covered walkway. The decorative concrete block screens are located at the north side.

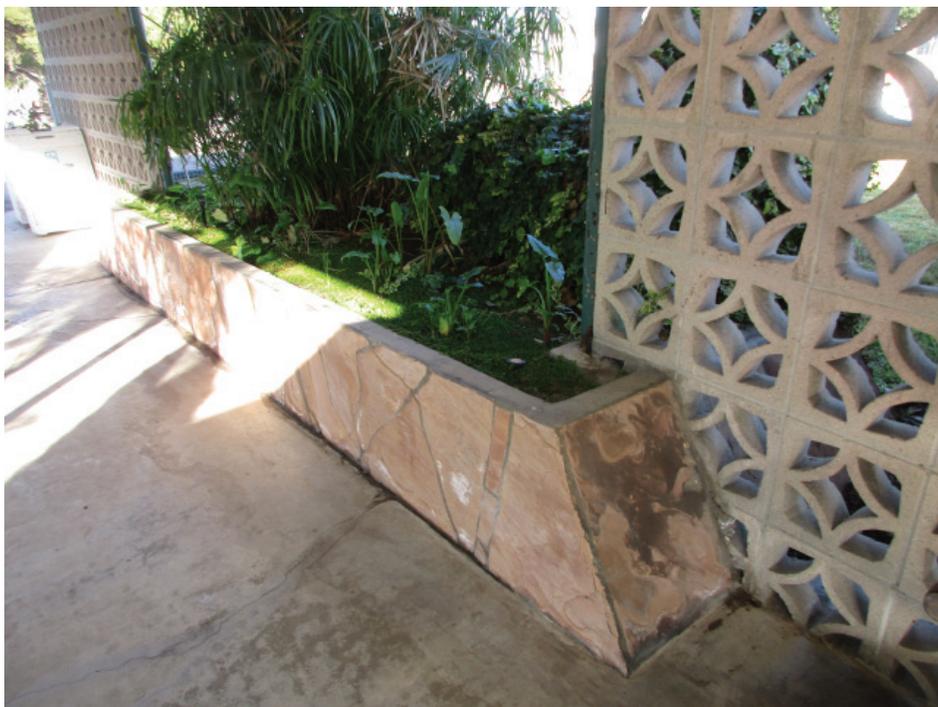
Photo 18: Detail photo showing the cast-in-place concrete planter with flagstone veneer similar to the veneer at the northeast corner of the main Church building.

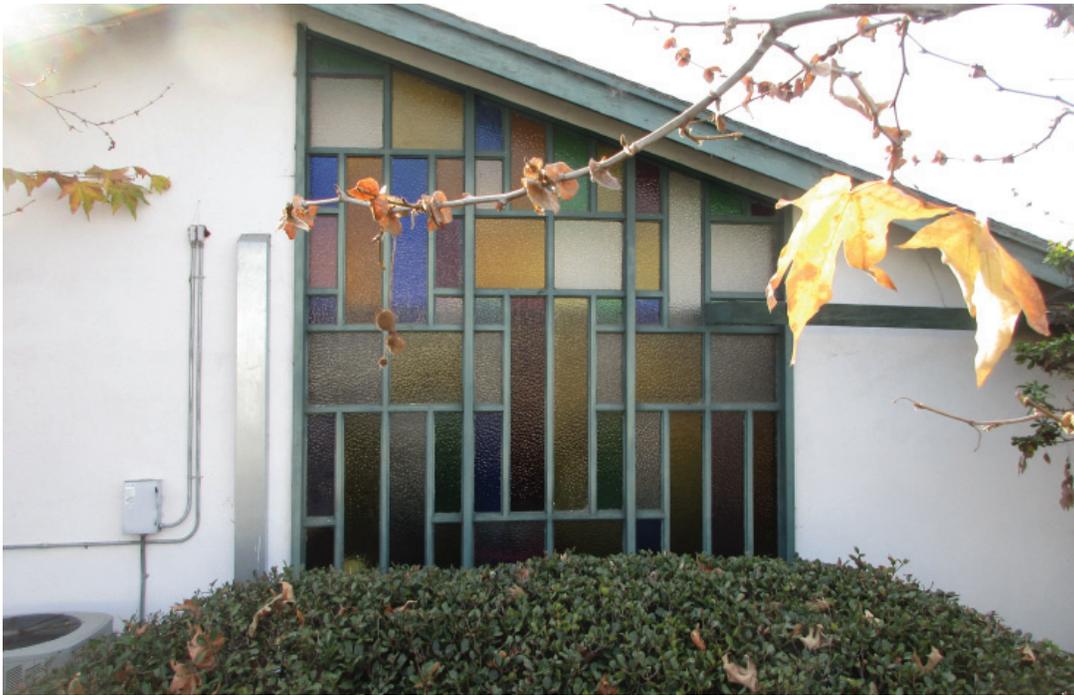
Photo 19: Detail photo showing the wood framed decorative floor-to-ceiling stained glass windows. The feature includes obscure glazing with an irregular wood mullion grid pattern.

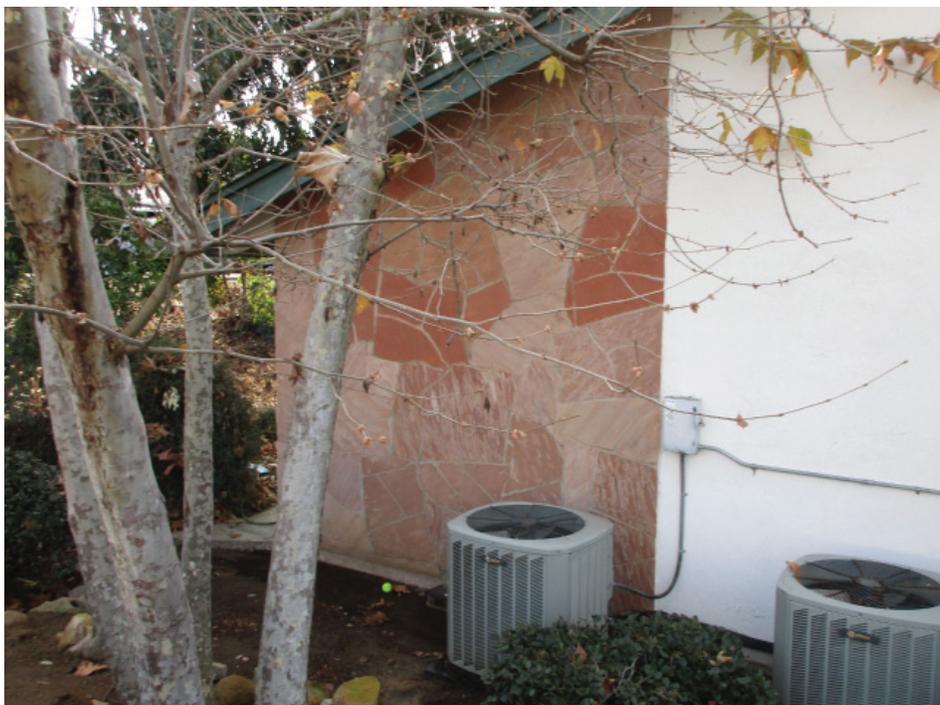
Photo 20: Detail photo showing the flagstone veneer at the northeast corner of the main Church building.

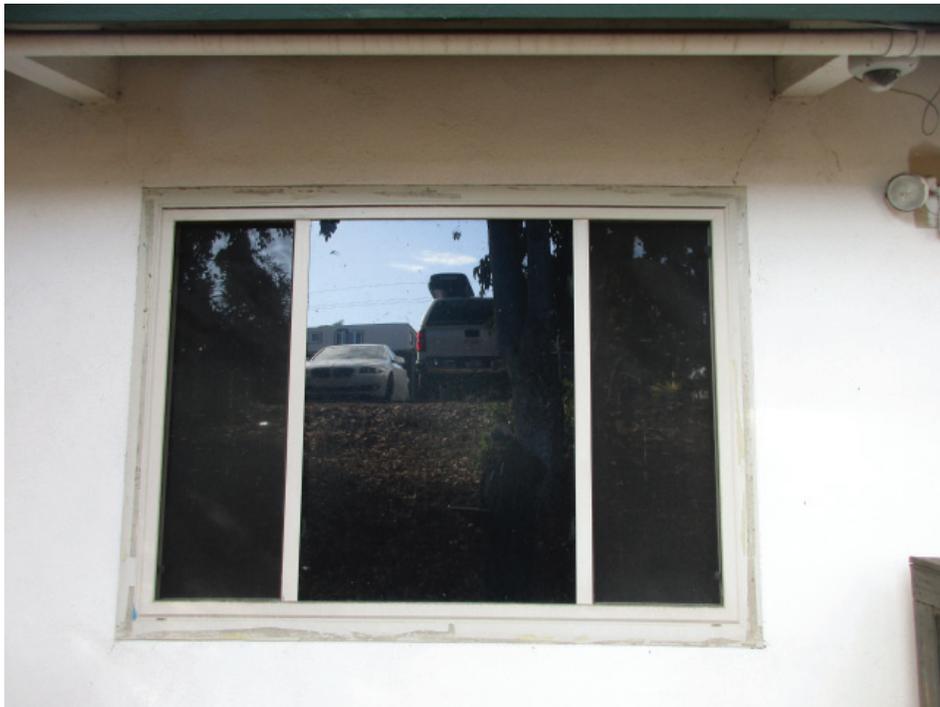
Photo 21: Detail photo showing a typical vinyl replacement window and frame at the main Church building.

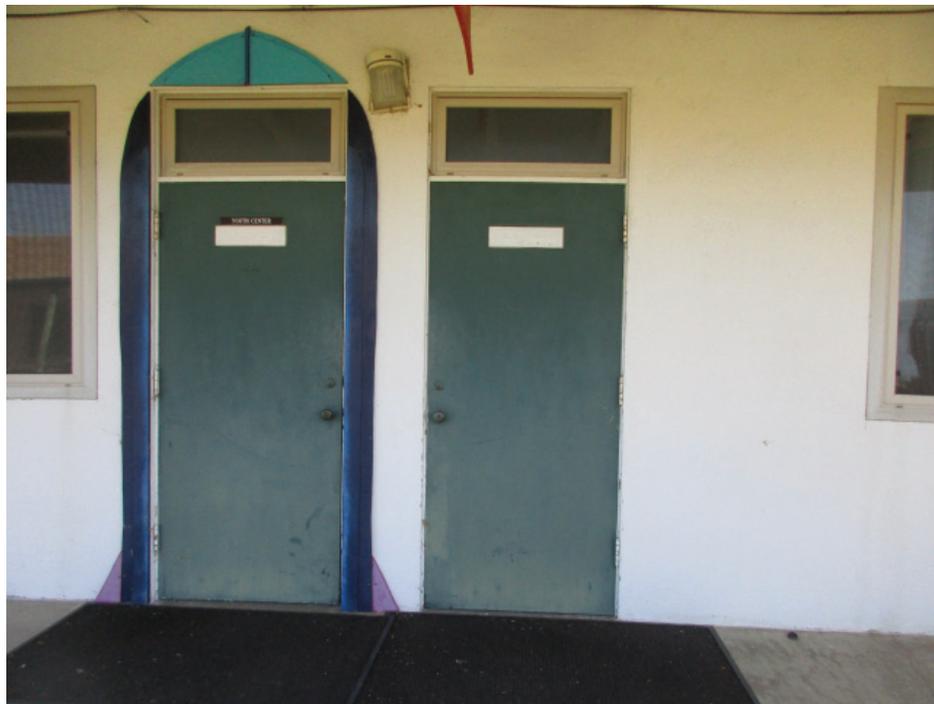
Photo 22: Detail photo showing a typical wood flush door with replacement vinyl transom above at the main Church building.

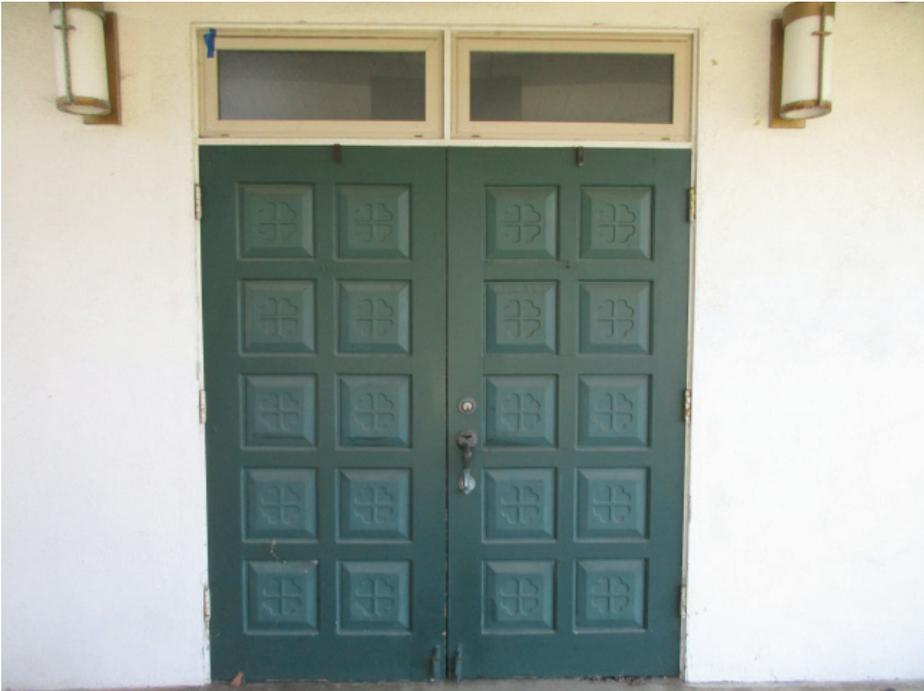
Photo 23: Detail photo showing the primary entry wood panel doors with clover-leaf motif at the main Church building.

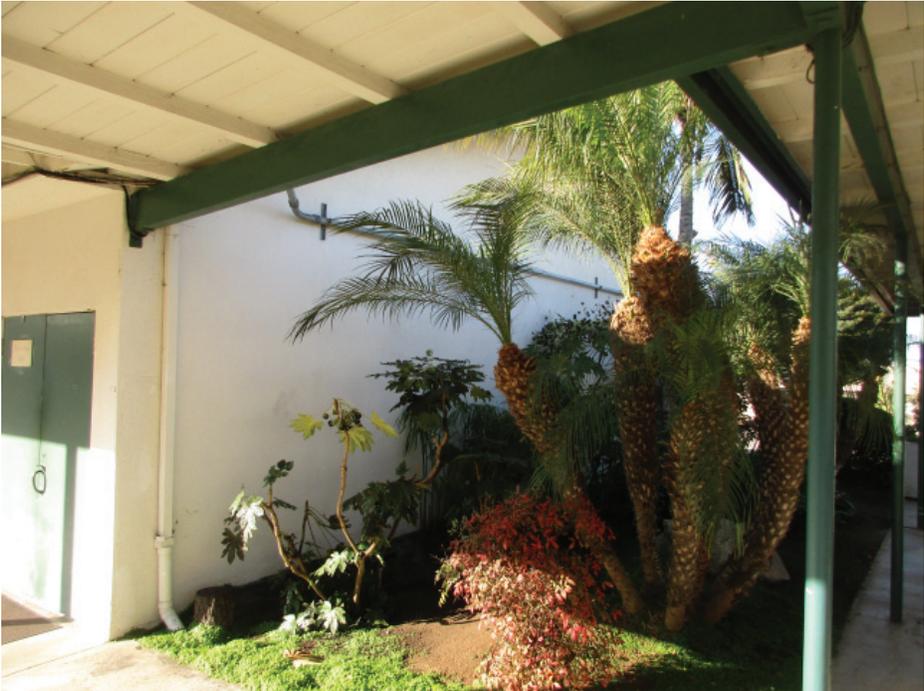
Photo 24: Looking southwest at the north facade of Fellowship Hall.

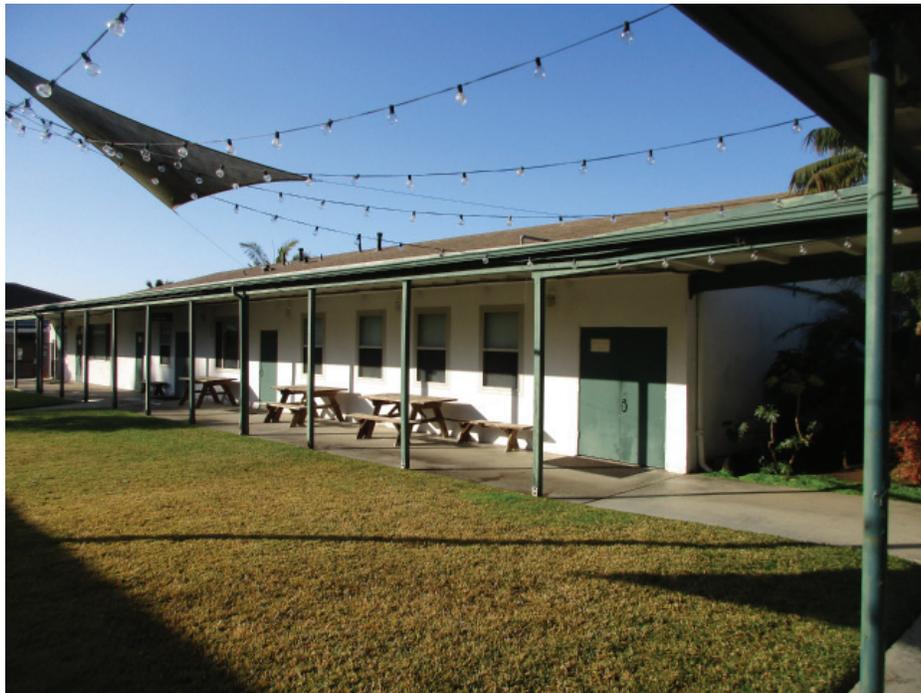
Photo 25: Looking southwest at the east facade of Fellowship Hall.

The east façade door openings comprise primarily of wood slab doors with flush wood frames. Fenestration consists primarily of single-hung and vinyl replacement sliding windows and frames. At the 1989 south addition are flush aluminum sliding windows and a hollow-metal six-panel door with a fixed transom window above.

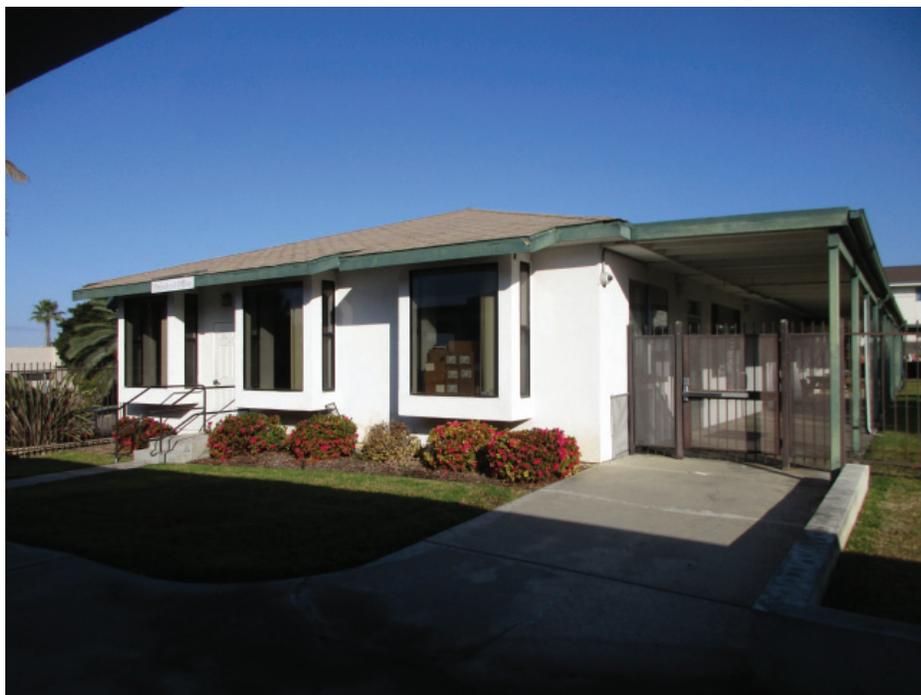
Photo 26: Looking north at the rear south facade of Fellowship Hall.
