845 SANTA FE DRIVE - DENSITY BONUS PROJECT HISTORICAL EVALUATION REPORT

DRAFT
February 19, 2025

Prepared by
Heritage Architecture & Planning
832 Fifth Avenue
San Diego, California 92101

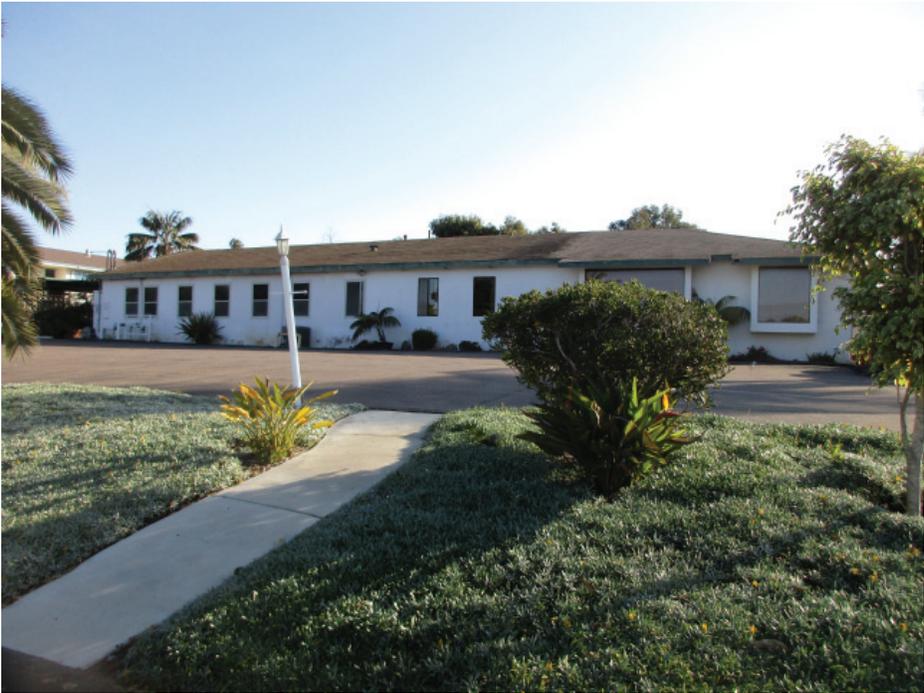
Photo 27: Looking east at the west facade of Fellowship Hall.

The west façade faces the surface parking lot. It contains vinyl replacement single-hung windows and frames and two replacement coated aluminum sliding windows. Two angled bay windows are located at the 1989 south addition and are similar to those found at the south façade.

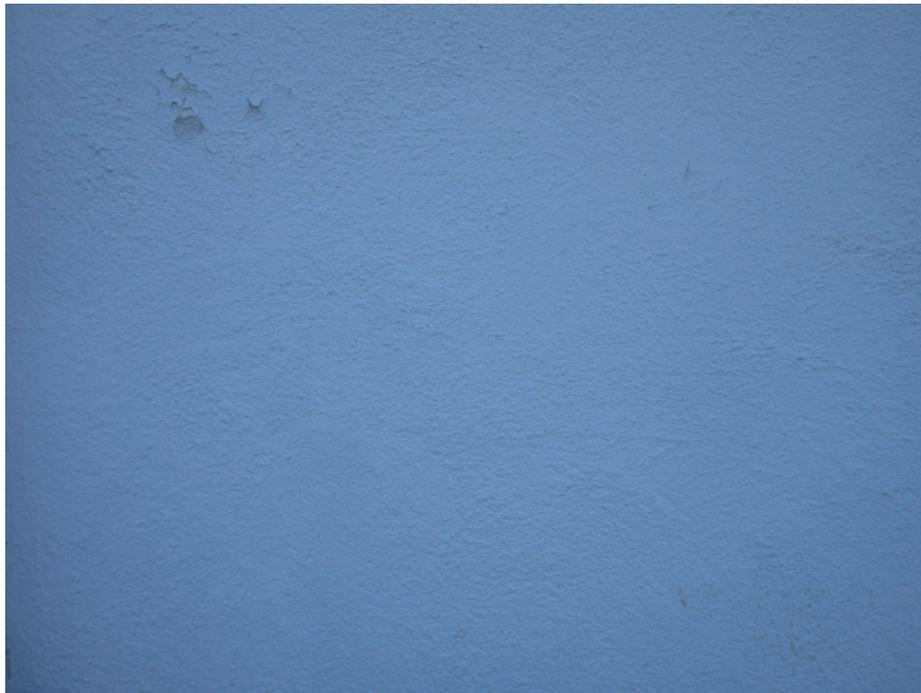
Photo 29: Detail photo showing the smooth sand texture stucco finish.

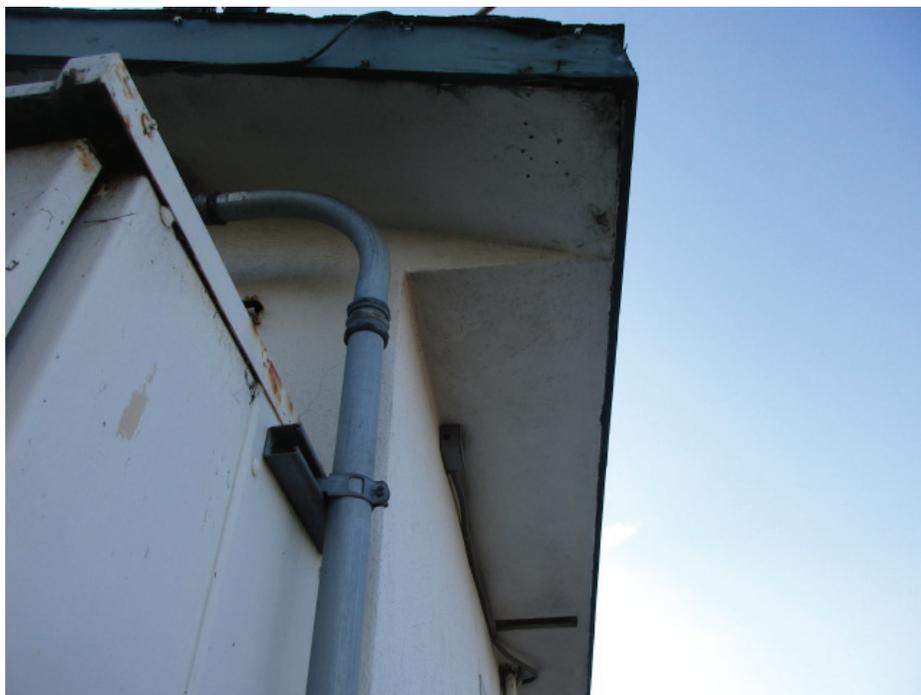
Photo 30: Detail photo showing the enclosed soffit with a smooth sand texture stucco finish.

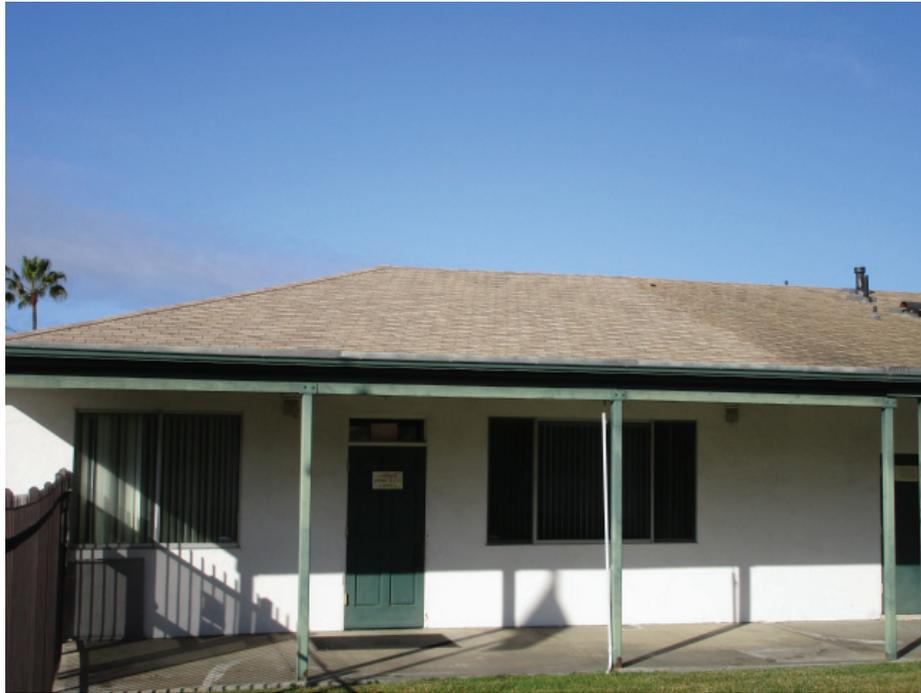
Photo 31: Looking west at the east side of the 1989 addition at the rear of the Fellowship Hall. The asphalt shingles, aluminum windows, hollow metal door, and metal weep screed at the base of the wall all differ from the original construction.

The east façade door openings comprise primarily of wood slab doors with flush wood frames. Fenestration consists primarily of single-hung and vinyl replacement sliding windows and frames. At the 1989 south addition are flush aluminum sliding windows and a hollow-metal six-panel door with a fixed transom window above.

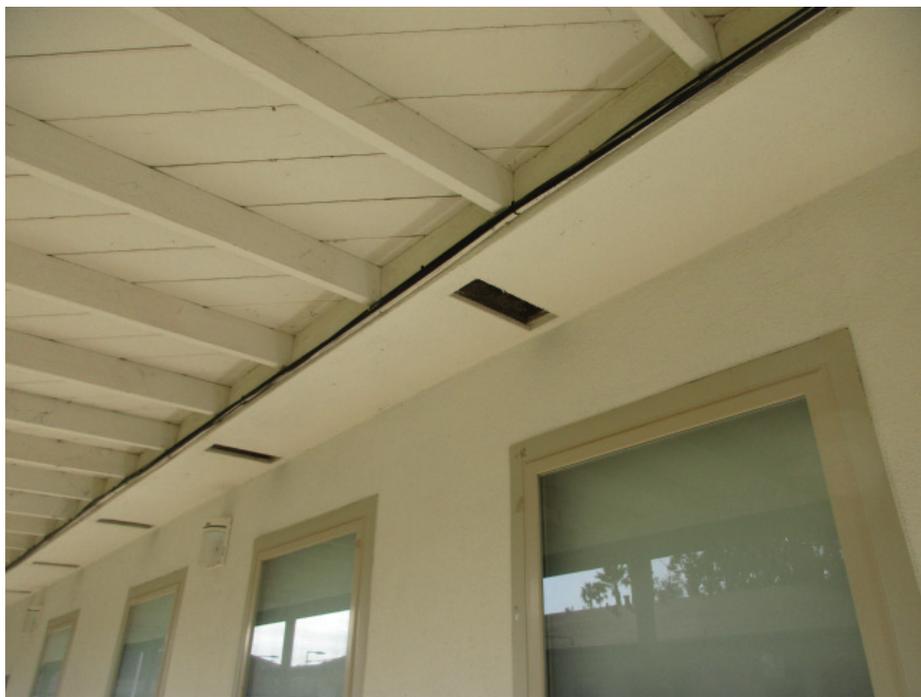
Photo 32: Detail photo showing the interaction between the covered breezeway roof and enclosed soffit at the east facade of the Fellowship Hall building.

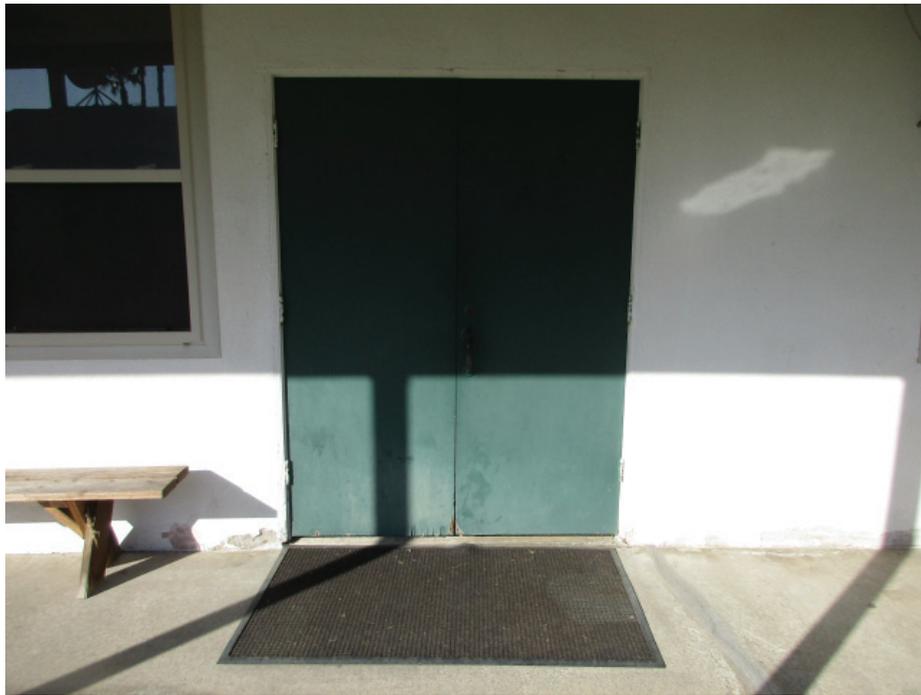
Photo 33: Typical wood flush door at the Fellowship Hall.

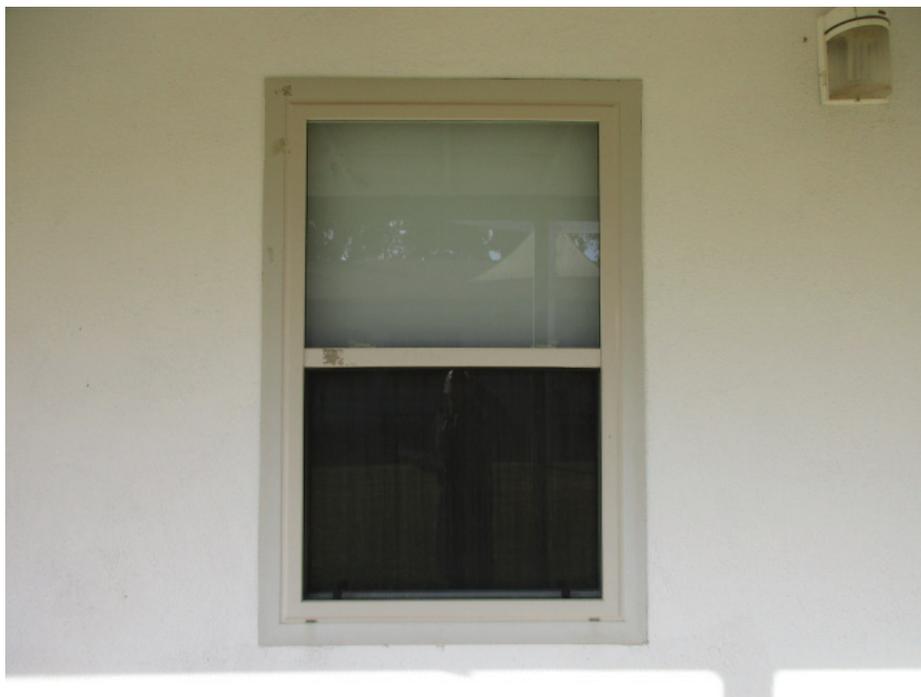
Photo 34: Detail photo showing a typical vinyl replacement single-hung window with vinyl trim surround.

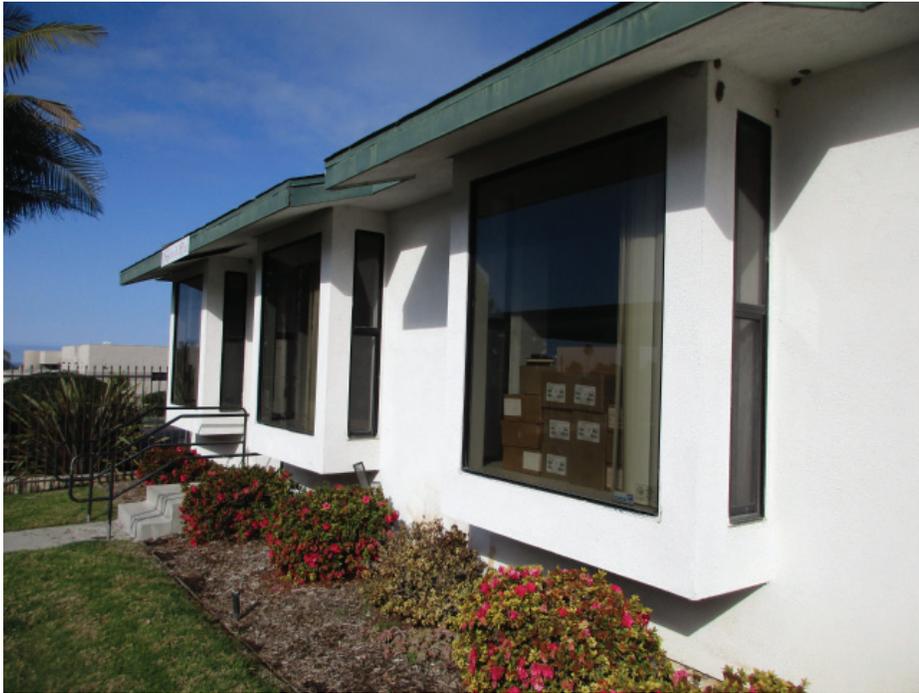
Photo 35: Detail photo showing the stucco finished angled bay windows with fixed and single-hung aluminum windows at the 1989 addition located at the rear of the Fellowship Hall.

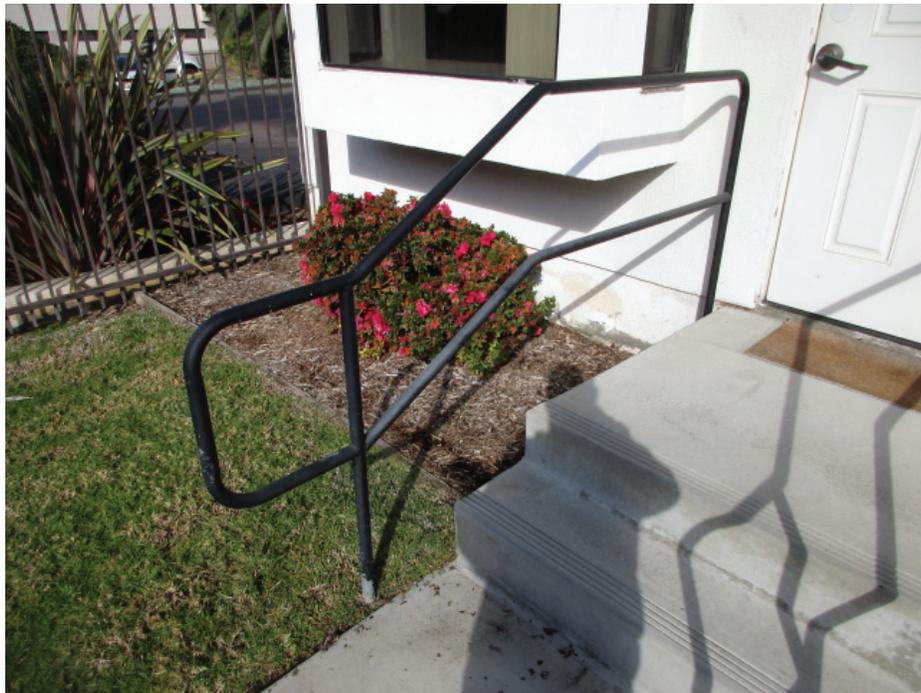
Photo 37: Detail photo showing the non-original cast-in-place concrete stairs and pipe metal railing at the rear facade of Fellowship Hall.

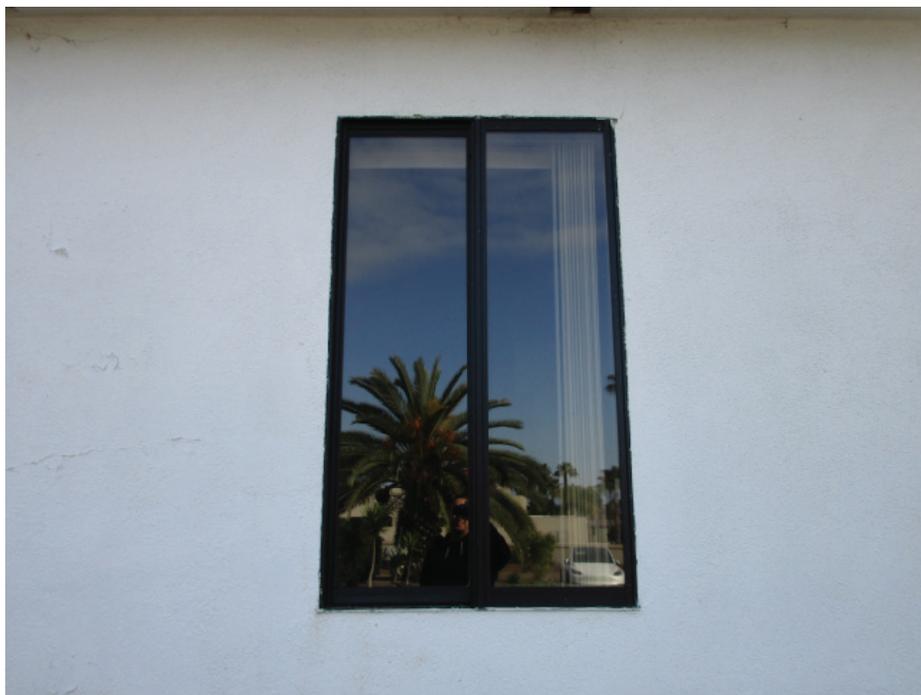
Photo 38: Detail photo showing a non-original aluminum slider window at the west facade of Fellowship Hall.

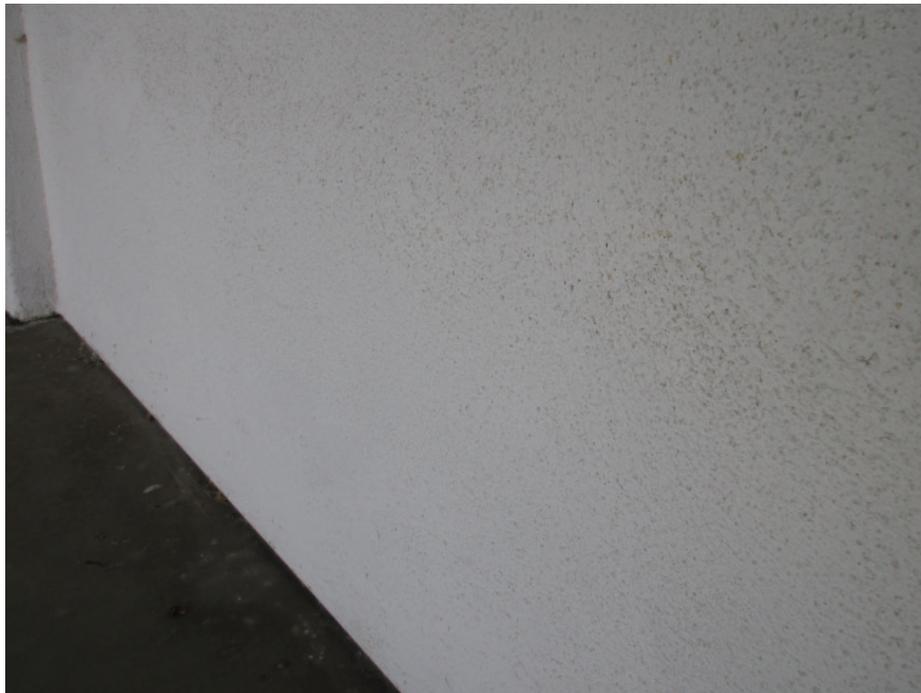
Photo 43: Detail photo showing the rough sand texture stucco finish at the Preschool building.

The 1990 preschool building is located to the south of the Church and Fellowship Hall and to the east of the site parking lot. The resource consists of a rectilinear building with a cast-in-place concrete foundation. It is wood frame construction with a rough sand texture stucco finish with metal weep screed at the base. It has a wood framed hipped roof with no overhang and an asphalt shingle roofing finish. Symmetrically located between the east and west side of the roof ridge are two mechanical penthouses with asphalt shingle roofing, rough sand texture stucco finish, and metal mechanical louvers at the north and south sides.

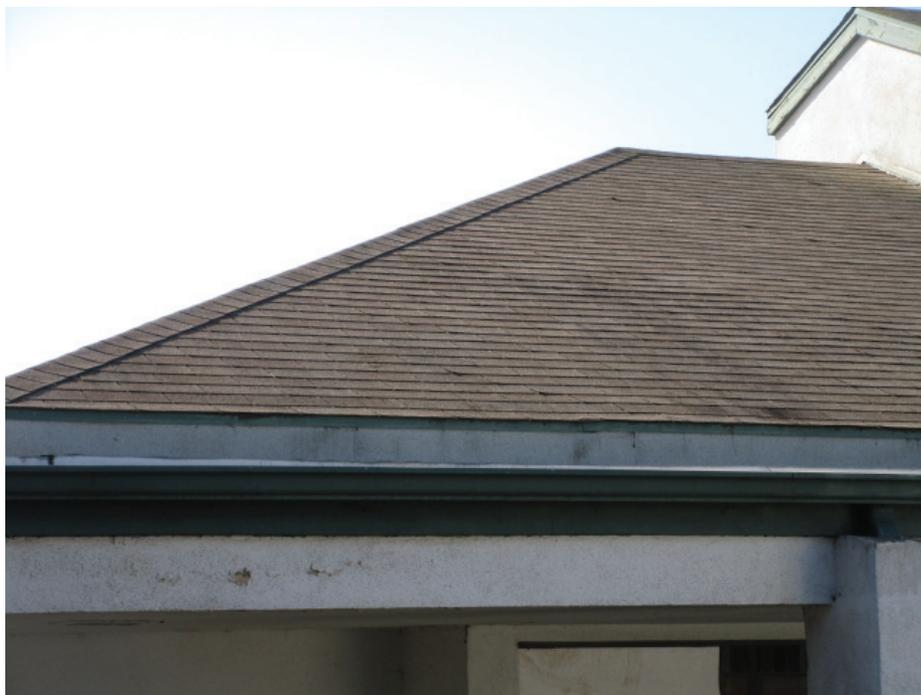
Photo 44: Detail photo showing the asphalt shingle roofing at the Preschool building.

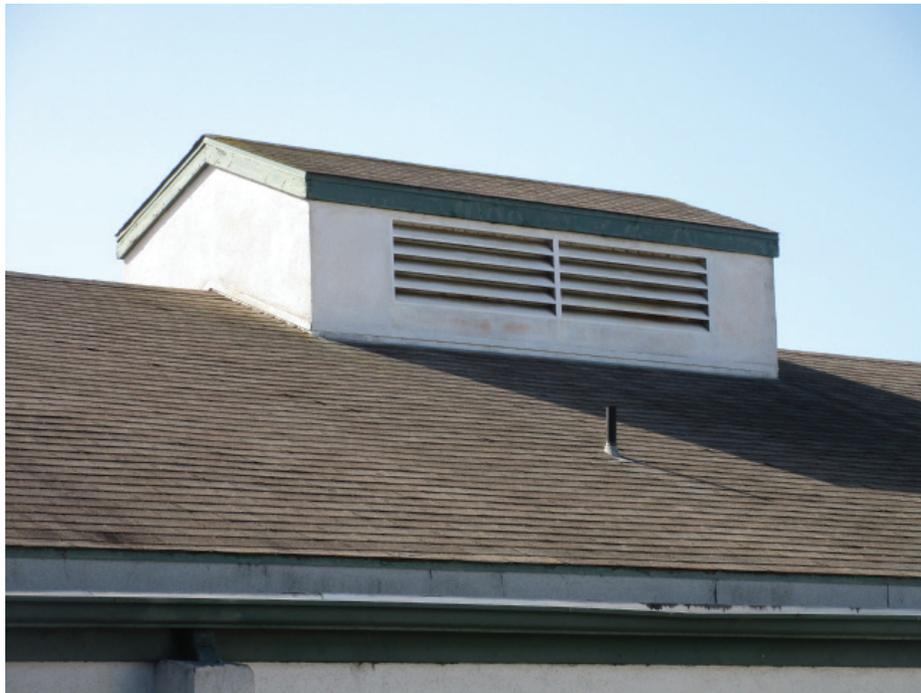
Photo 45: Detail photo showing one of the mechanical penthouses with metal louvers at the north and south sides.

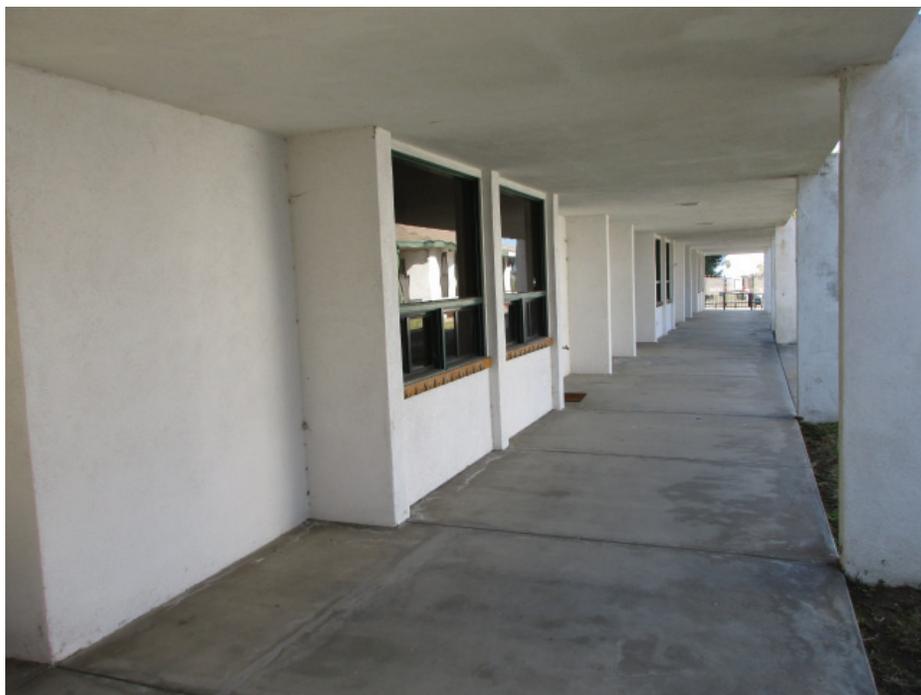
Photo 46: Looking west along the breezway at the north side of the Preschool building showing the enclosed stucco ceiling and columns with cast-in-place concrete walkway.

posts embedded into the cast-in-place concrete walkway. The roofing finish consists of replacement asphalt shingles.

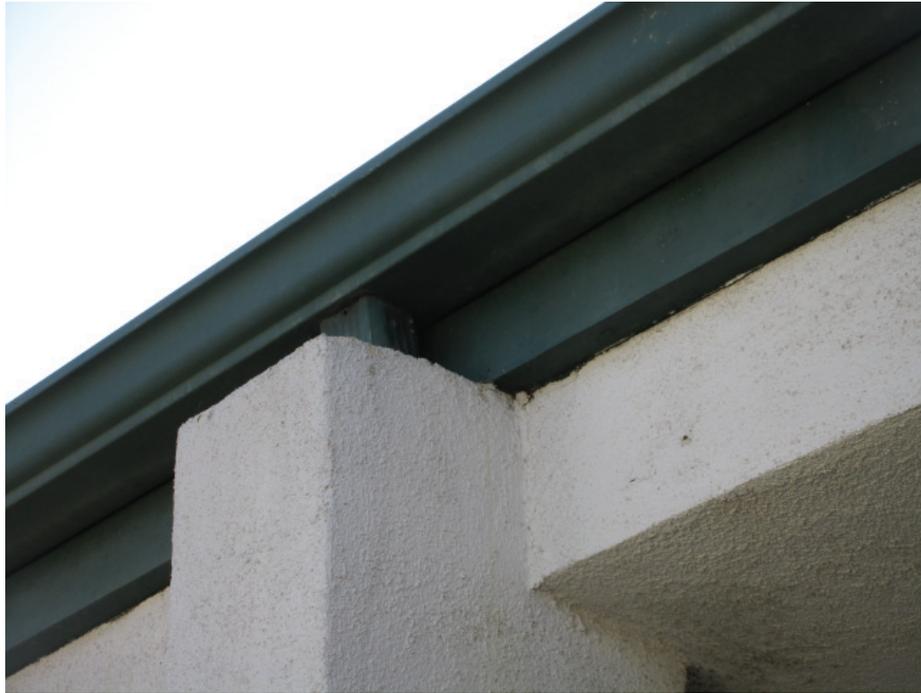
Photo 47: Detail photo showing a typical downspout concealed by a breezeway column.

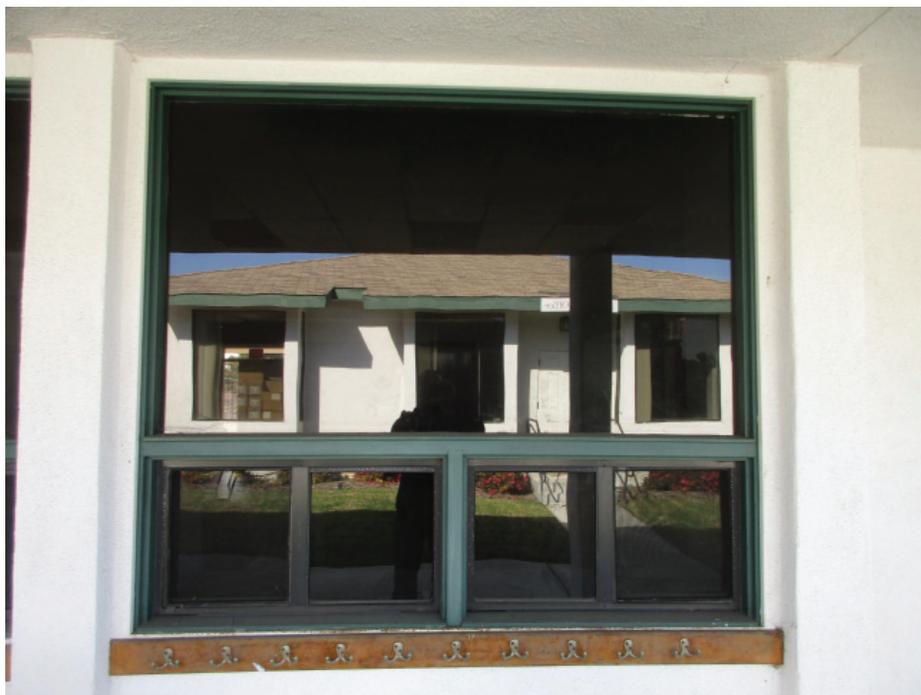
Photo 48: Detail photo showing a typical window configuration at the Preschool consisting of a wood framed fixed window over two aluminum slider windows.

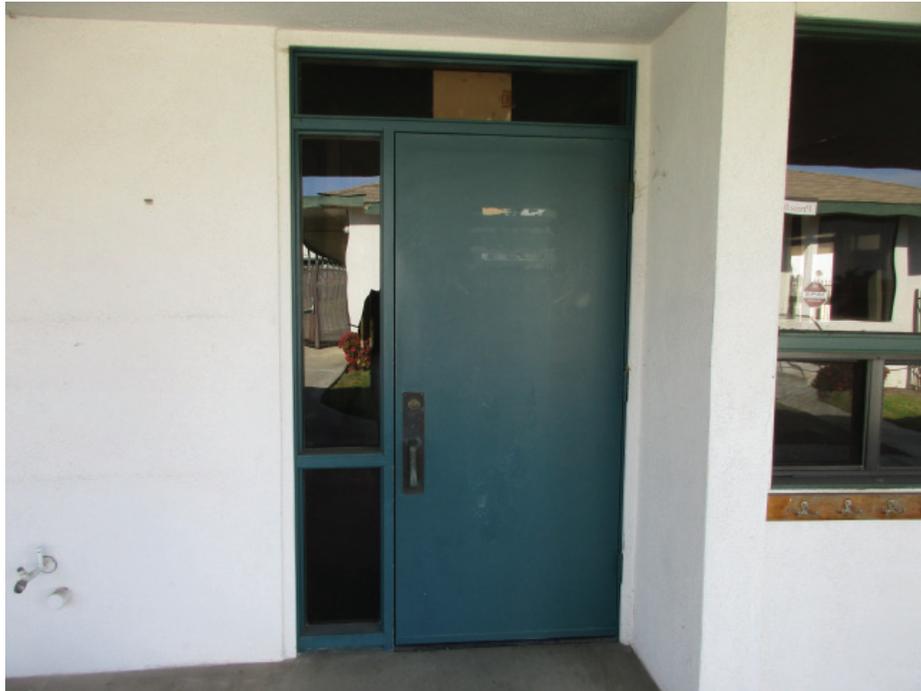
Photo 49: Detail photo showing a typical wood flush door with fixed wood framed sidelite windows and fixed transom windows.

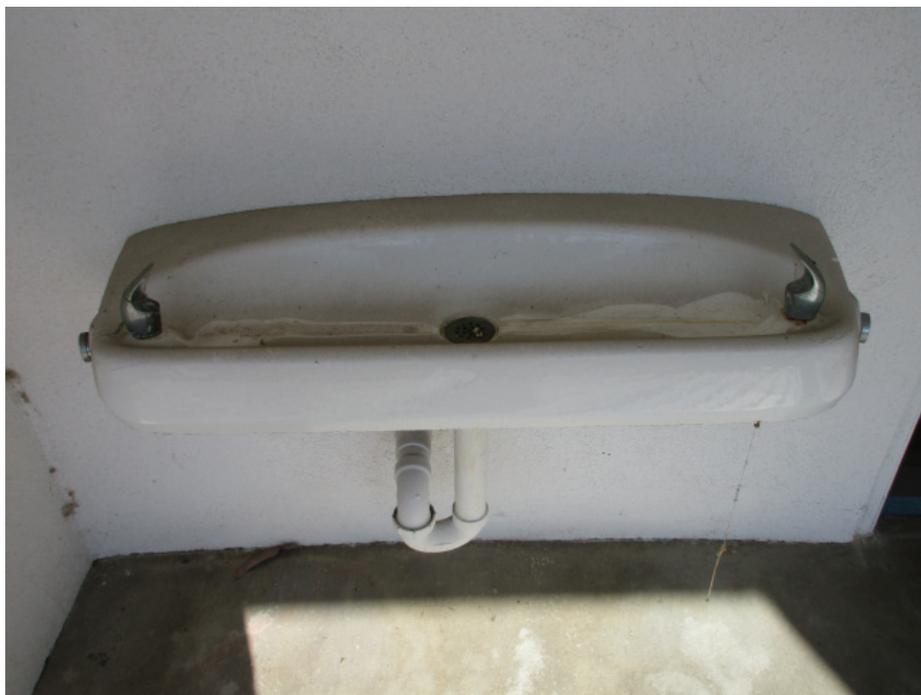
Photo 50: Detail photo showing the wall mounted kids drinking fountain at the rear facade of the Preschool.

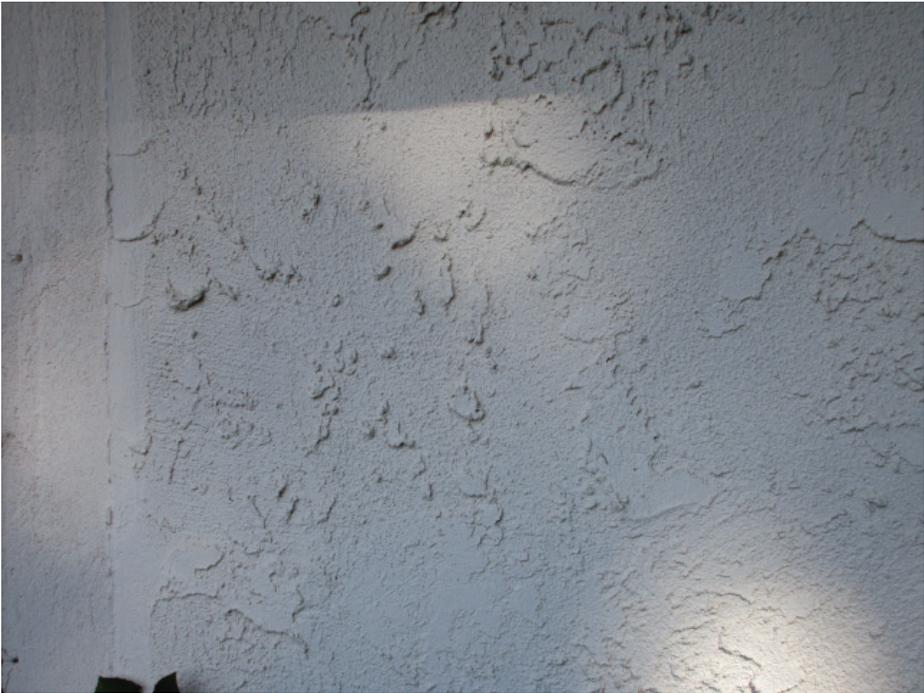
Photo 55: Detail photo showing the heavy-lace textured stucco finish.

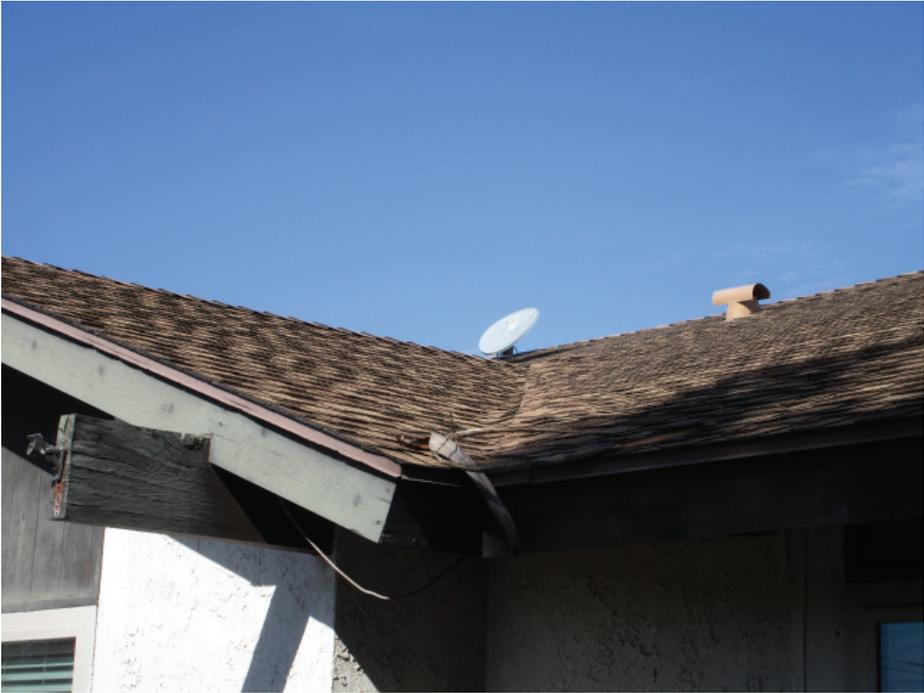
Photo 56: Detail photo showing the replacement asphalt shingle roofing finish.

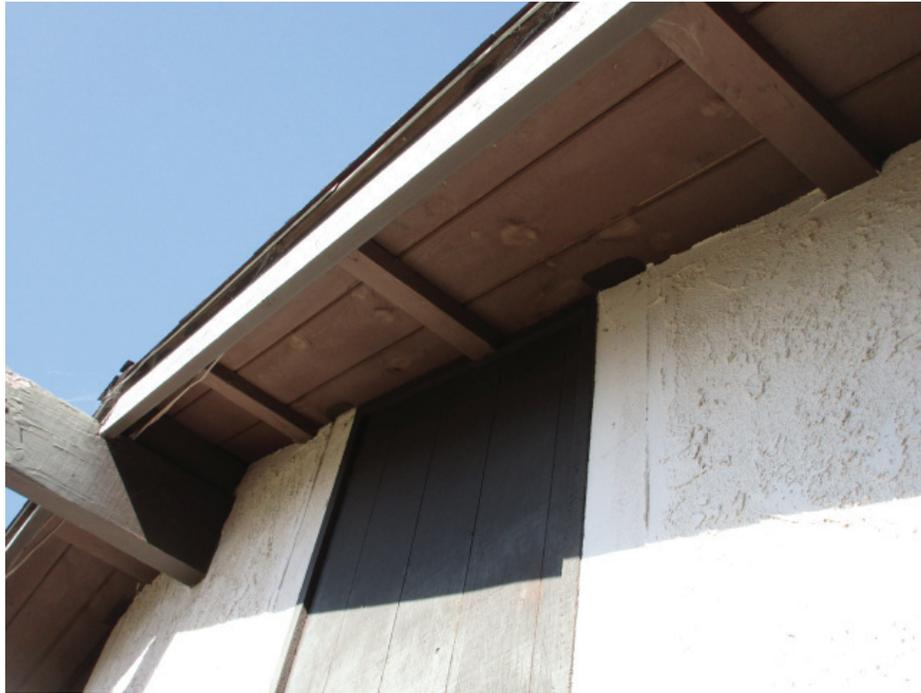
Photo 57: Detail photo showing the underside of the open gable rake at the primary south facade with exposed purlins and wood decking.

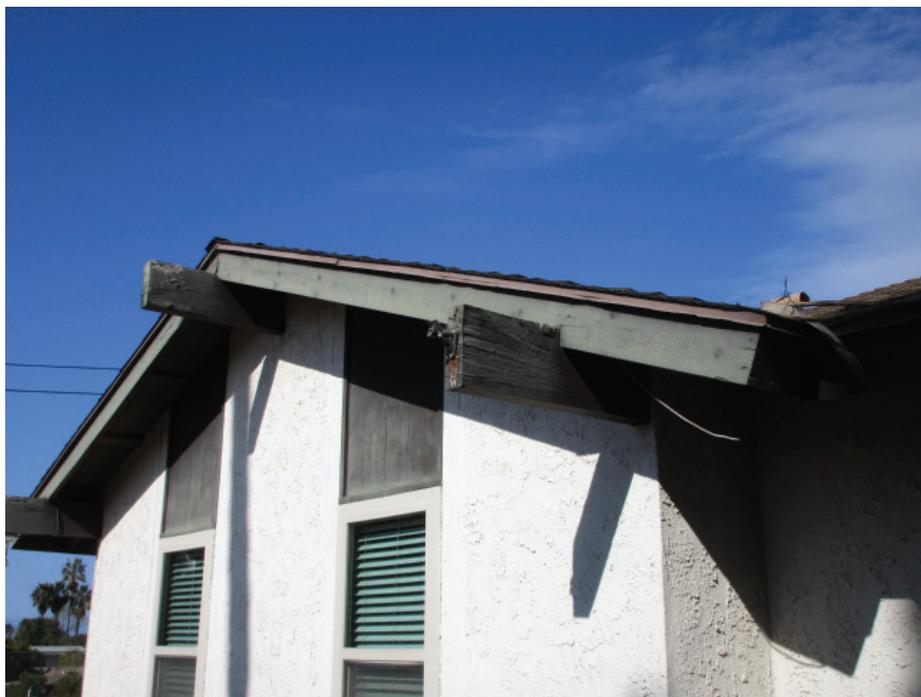
Photo 58: Looking northwest at the three 4x rafter tails supporting the gable roof.

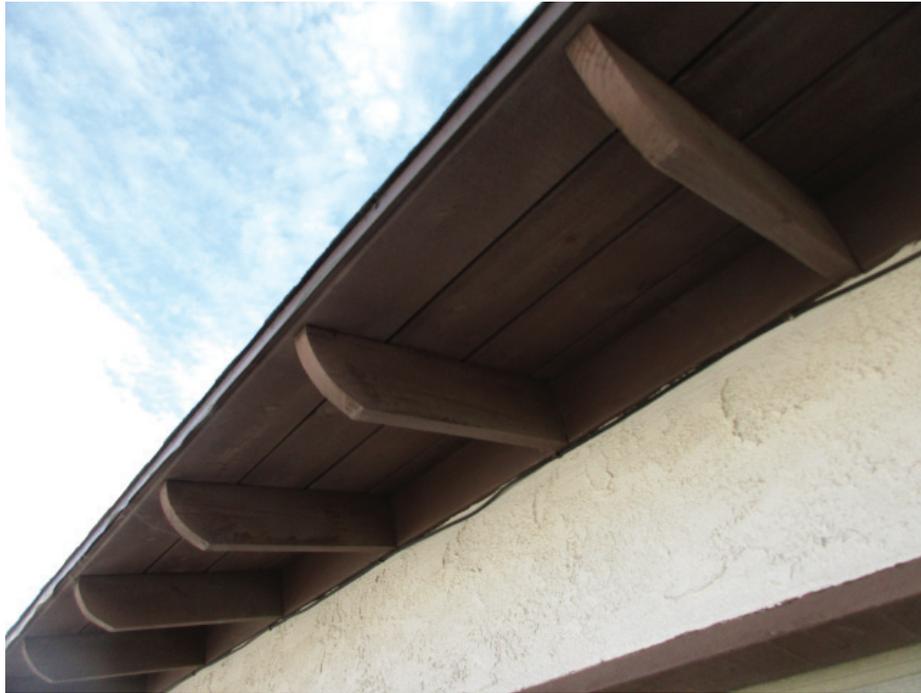
Photo 59: Detail photo showing the curved rafter tails at the secondary west facade.

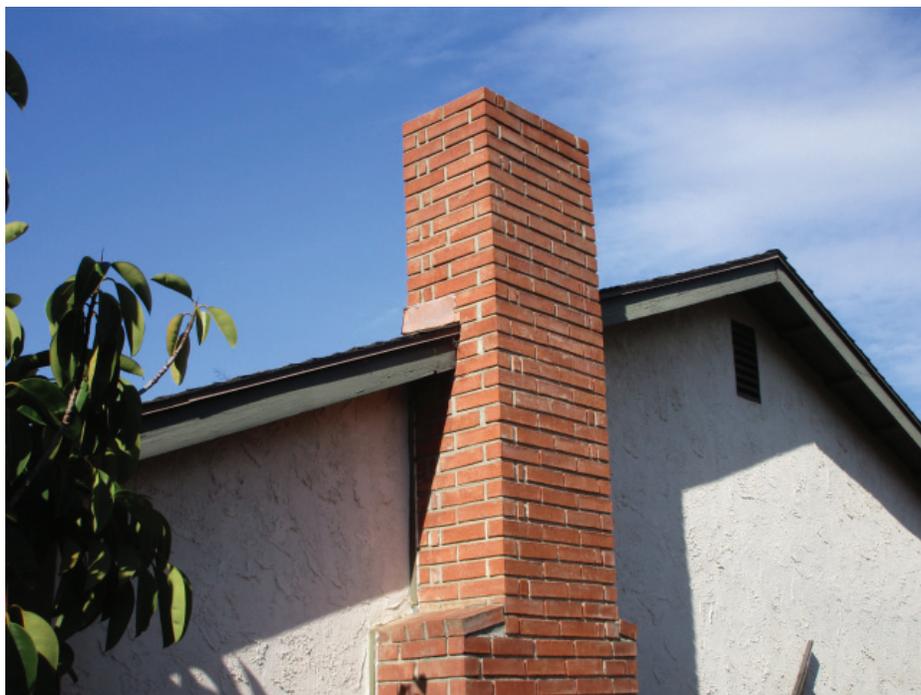
Photo 60: Detail photo showing the non-original brick masonry chimney located at the east facade.

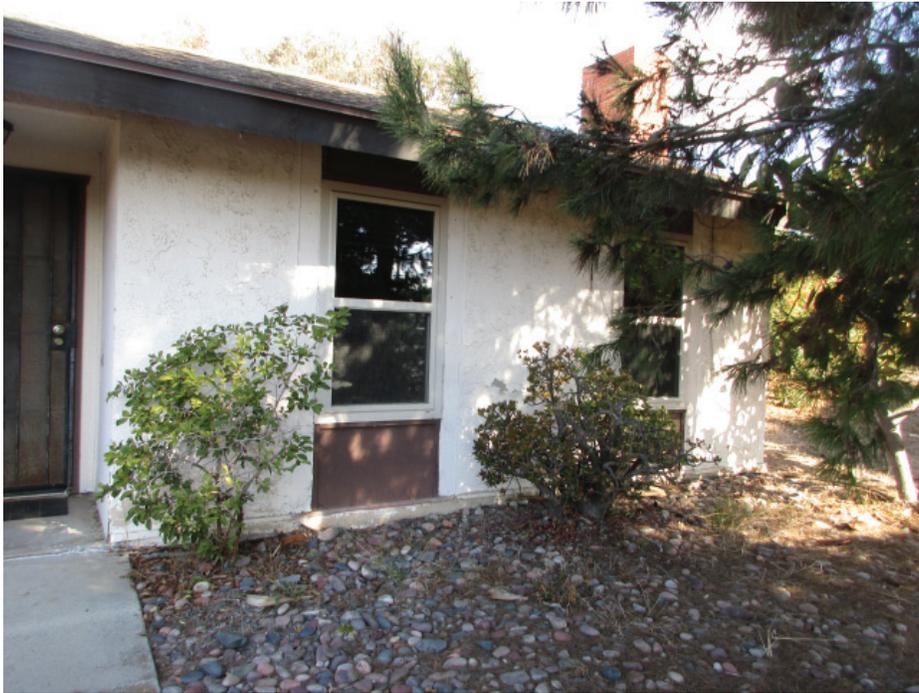
Photo 61: Detail photo showing a typical vinyl replacement window with vertical wood siding at the head and bulkhead of the window.

At the primary façade, fenestration consists of vinyl replacement single-hung windows with vinyl trim surround. At the window head and bulkhead the exterior wall finish consist of vertical wood siding. The primary entry door is asymmetrically located and consists of a wood panel door with

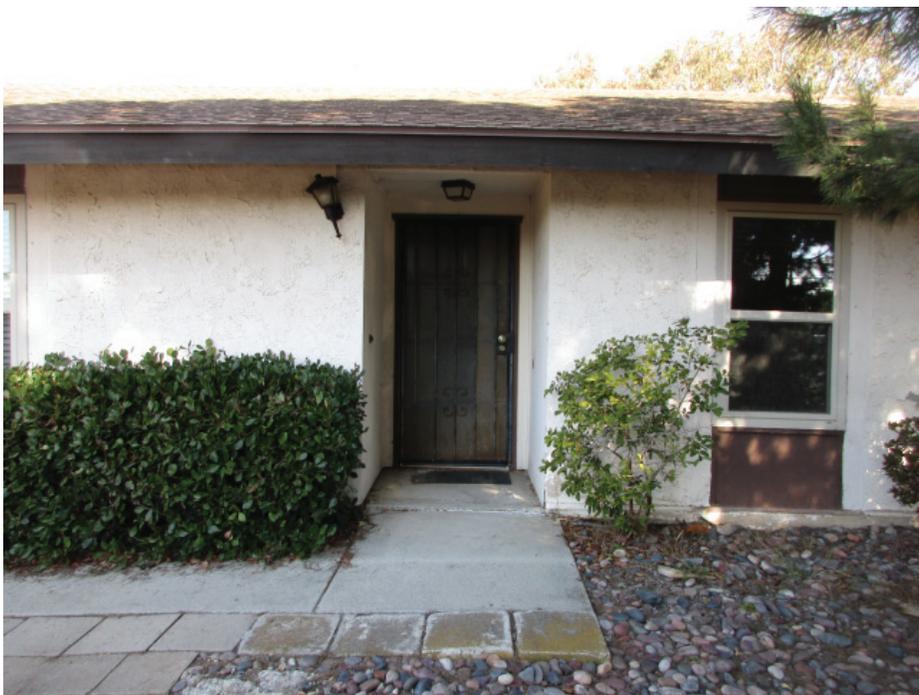
Photo 62: Looking north at the primary entry with metal screen door.

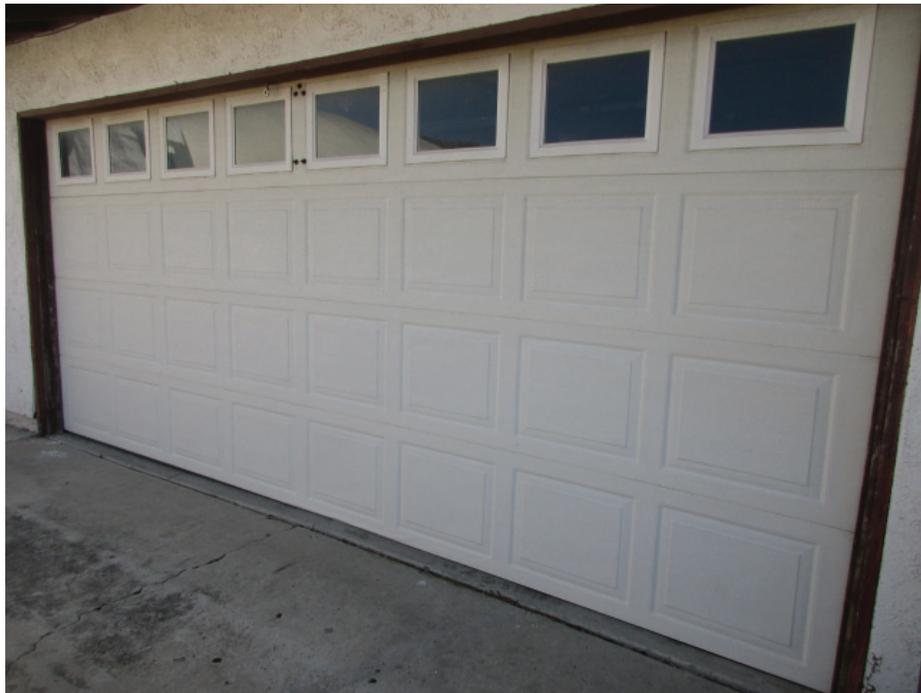
Photo 63: Detail photo showing the contemporary sectional tilt-up garage door.

At the west façade fenestration consists of a vinyl replacement sliding window. At the ridge there is a flush framed wood louvre attic vent. The attached garage contains a contemporary sectional roll-up garage door with a flush wood frame.

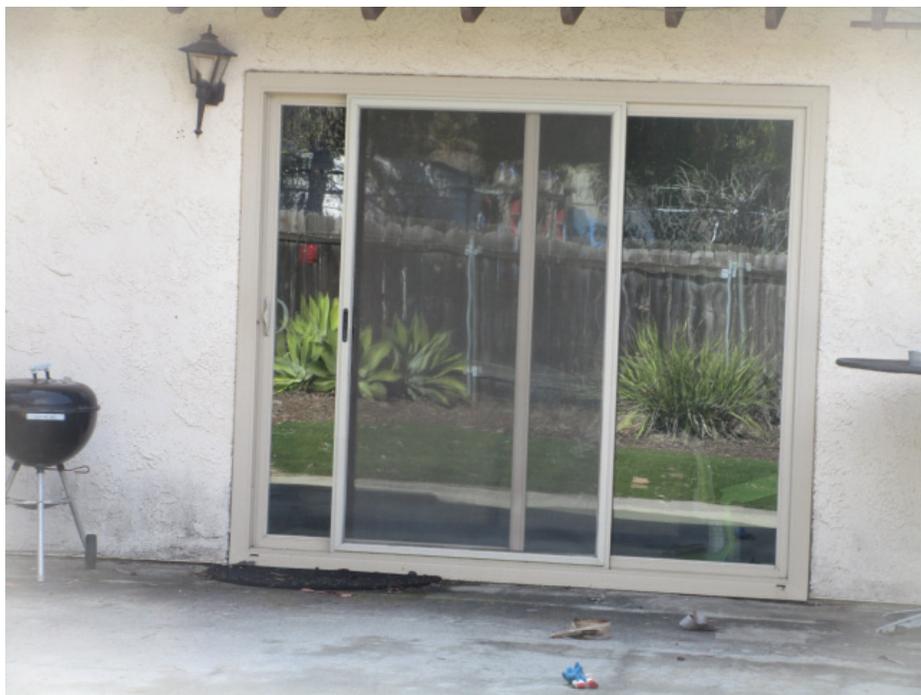
Photo 64: Detail photo showing the vinyl sliding glass door located at the rear facade.

The north façade faces the rear of the property. Fenestration consists of replacement vinyl sliding windows and sliding glass door. There is a flush solid wood core door leading into the attached garage.
